IN THE CIRCUIT COURT OF THE SEVENTEENTH JUDICIAL CIRCUIT  
IN AND FOR BROWARD COUNTY, FLORIDA

HERON POND CONDOMINIUM  
ASSOCIATION, INC.

**VERIFIED PETITION FOR APPOINTMENT OF A RECEIVER**

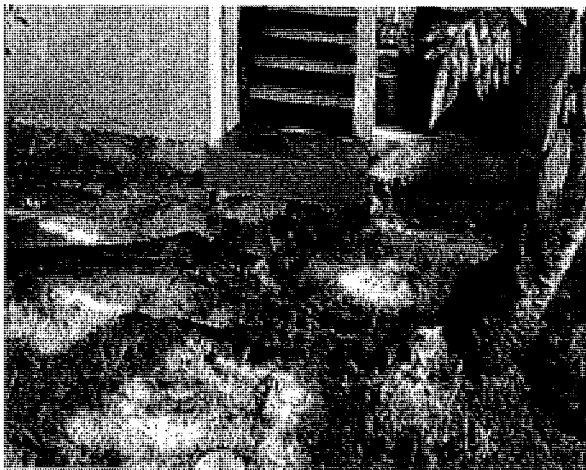
**Photograph 9: Tree roots growing under foundation and soil washout**

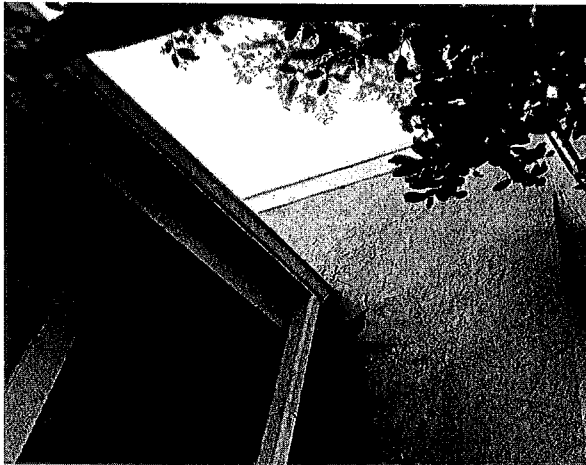
**Photograph 11: Opening in the exterior wall**

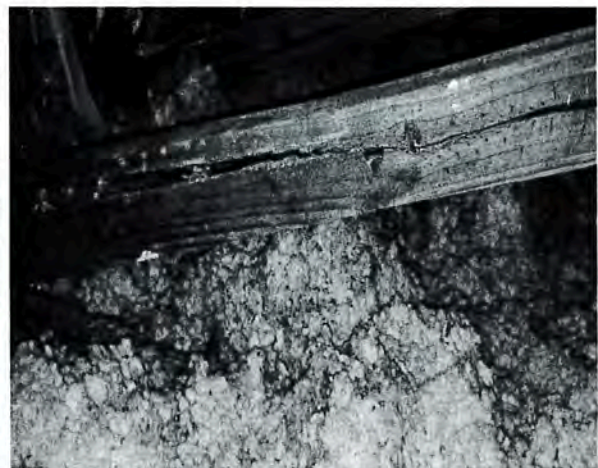
**Photograph 10: Unit 202. Isolated damage to roof truss**

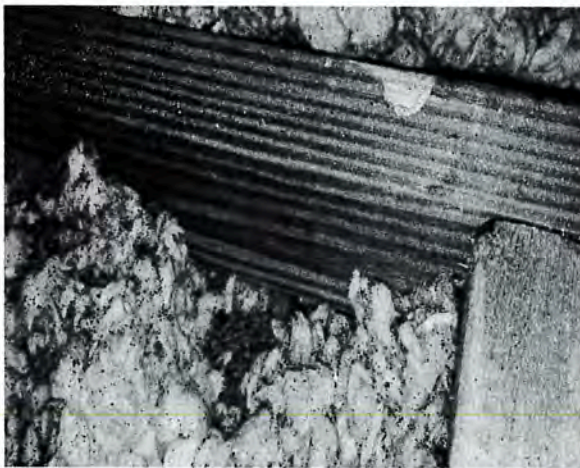
**Photograph 11: Unit 207. Termites infestation**

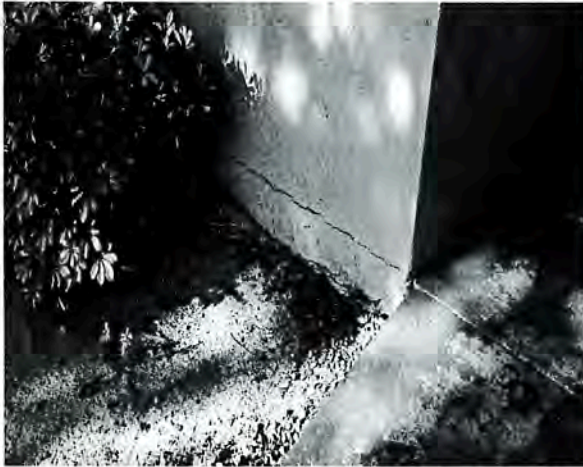
**Photograph 13: Soil washout and exterior wall crack**

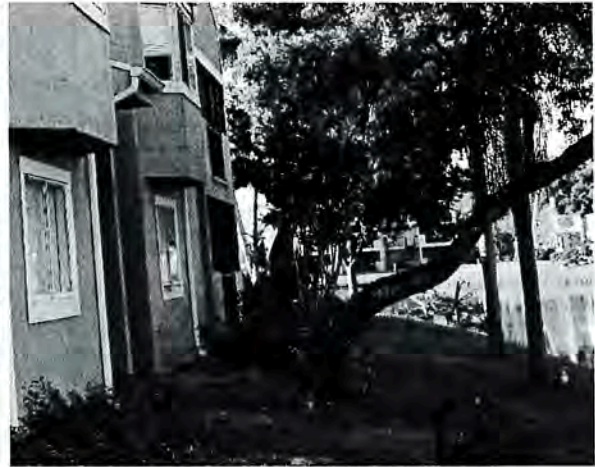
**Photograph 14: Tree roots growing against the foundation**

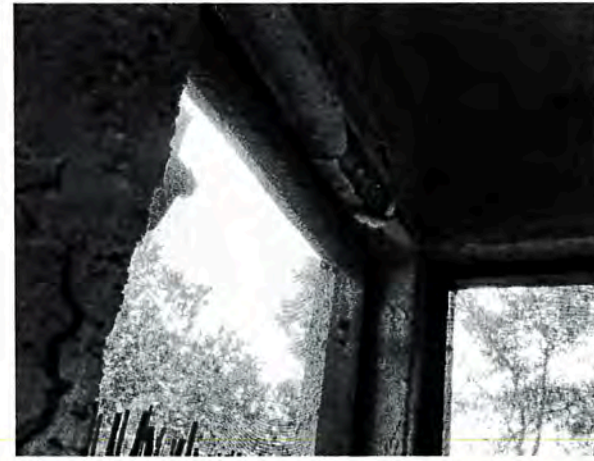
**Photograph 12: Exposed wire lath on Unit 204 balcony**

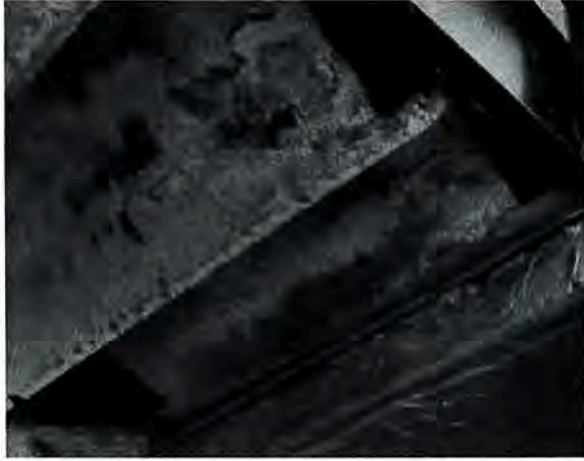
**Photograph 13: Exterior staircase. Spalling and cracks**

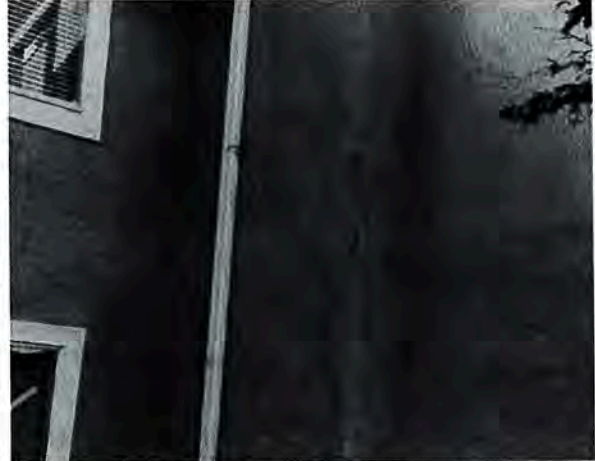
**Photograph 14: Cracks on the exterior walls**

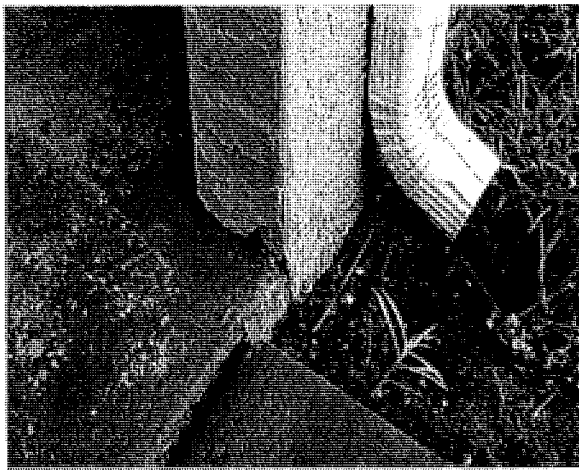
**Photograph 9: Corner crack on exterior wall near downspout**

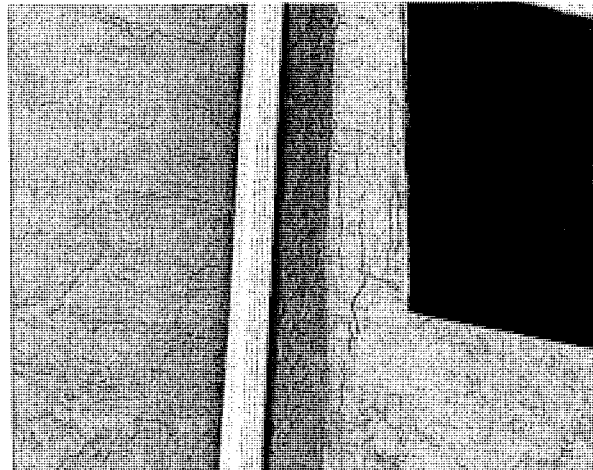
**Photograph 10: Exterior wall cracking**

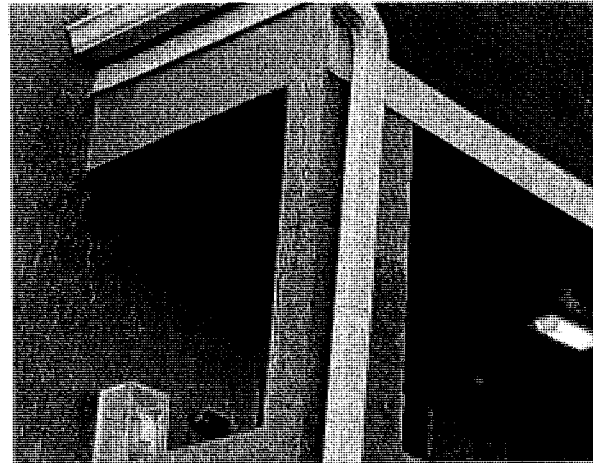
**Photograph 12: Exterior wall cracking**

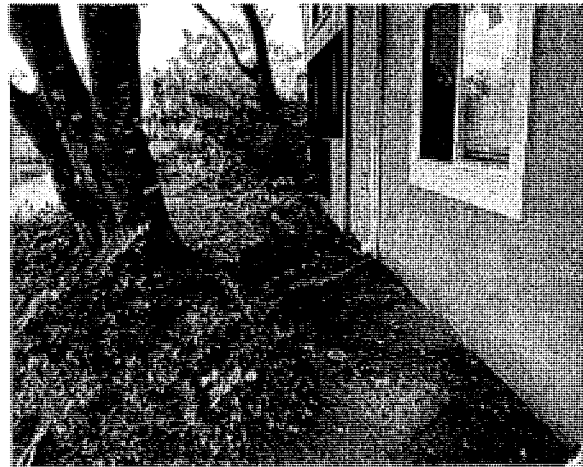
**Photograph 9: Unit 106. Vegetation overgrowth into the foundation.**

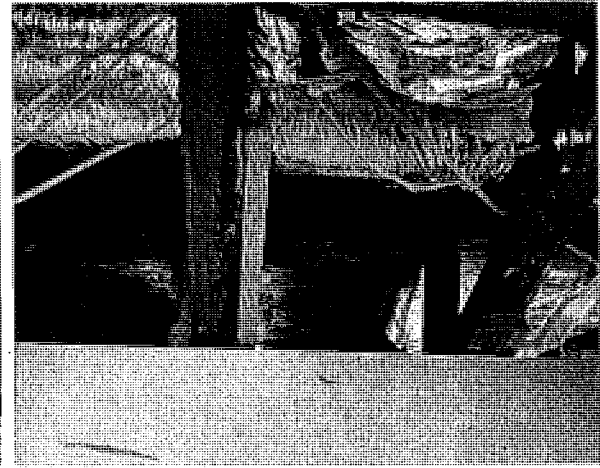
**Photograph 14: Unit 101. Moisture damaged floor framing**

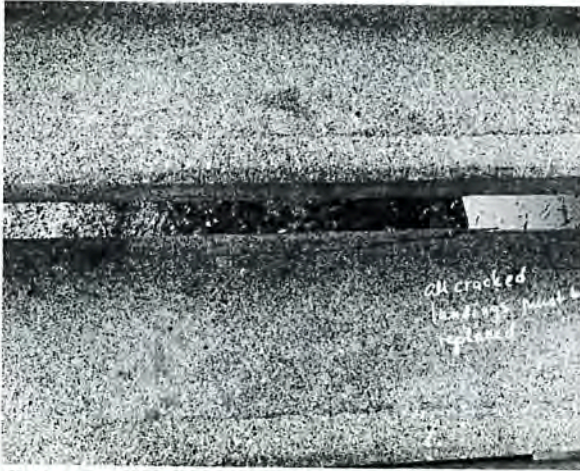
**Photograph 17: Common staircase cracked concrete step**

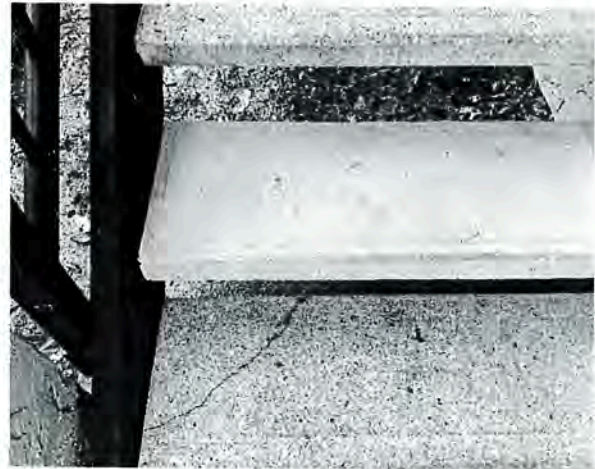
**Photograph 18: Common staircase cracked concrete step**

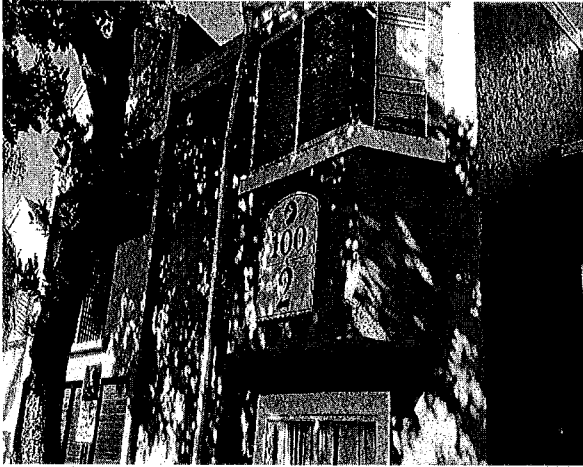
**Photograph 1: Building elevation. Balcony wall cracking**

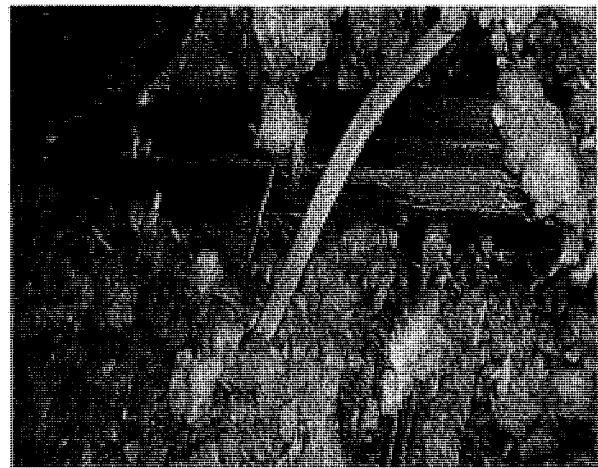
**Photograph 10: Unit 205. Termites infestation and damage to bottom truss chord**

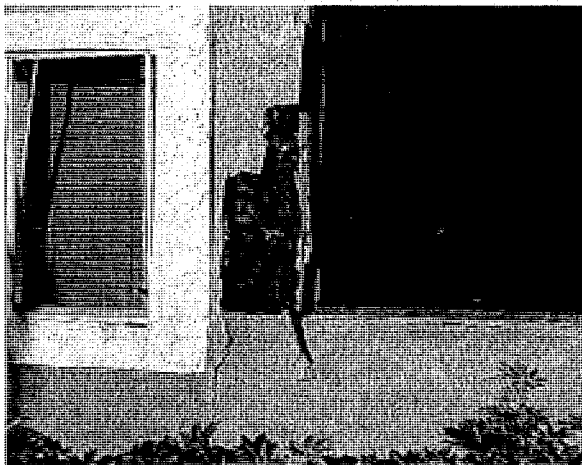
**Photograph 11: Opening in the exterior wall**

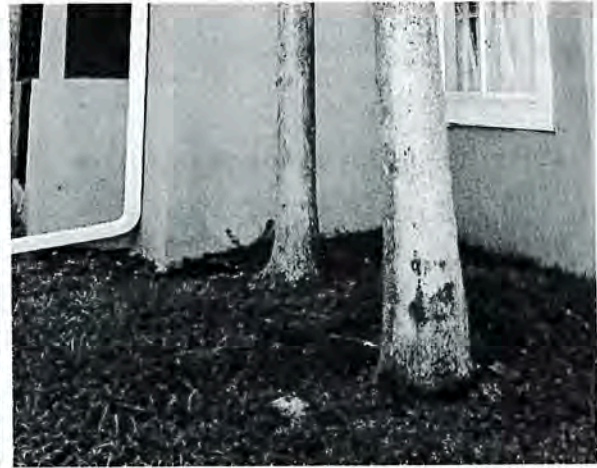
**Photograph 14: Tree roots growing against the foundation**

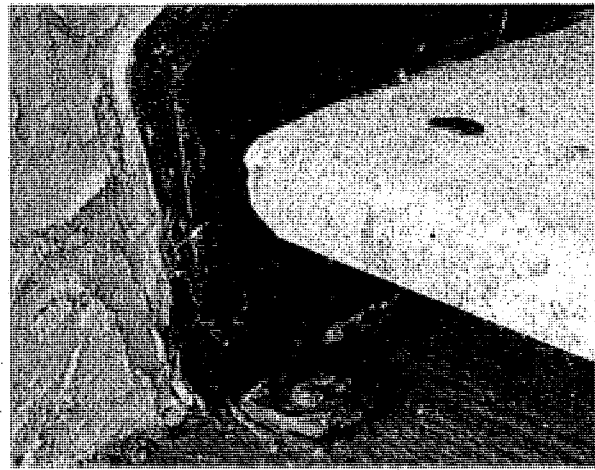
*Photograph 8: Common areas staircase corroded connection*

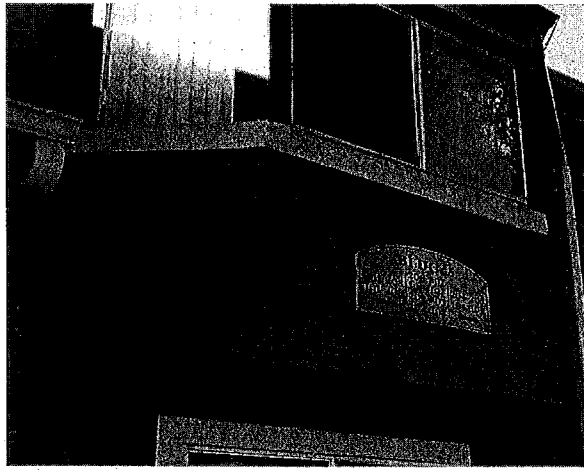
*Photograph 9: Exterior wall cracks*

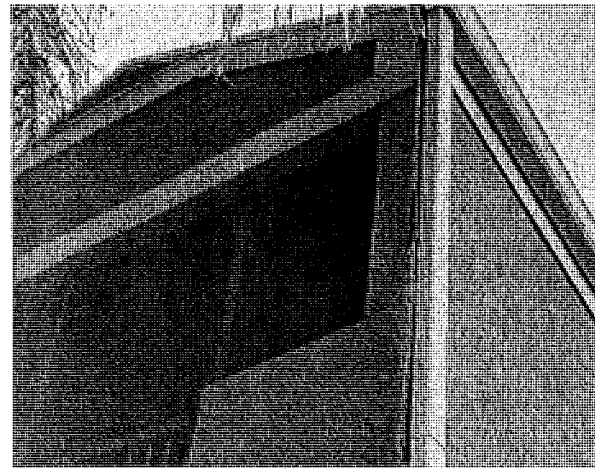
*Photograph 10: Exterior wall cracks*

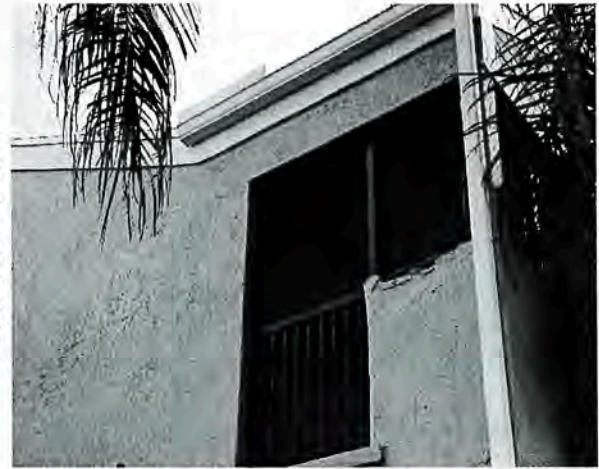
*Photograph 12: Unit 208. Exterior wall opening*

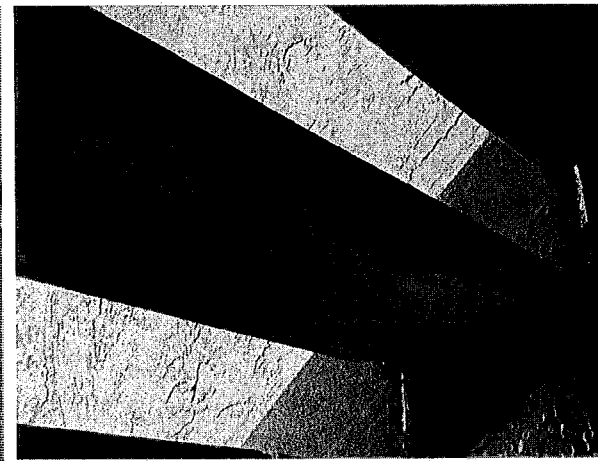
**Photograph 12: Cracks on the stairwell steps**

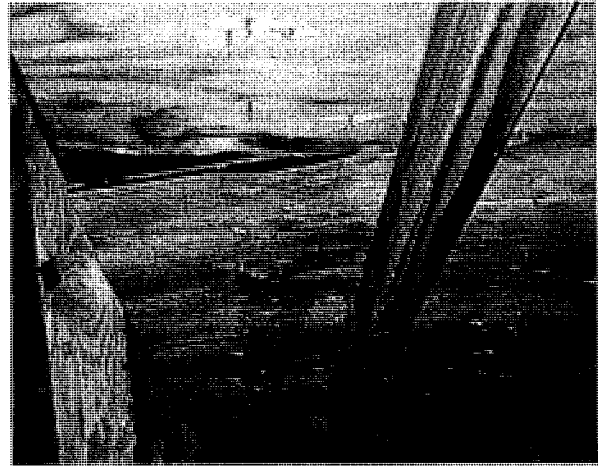
*Photograph 14: Unit 203. Moisture stains and cracked sheathing in the attic.*

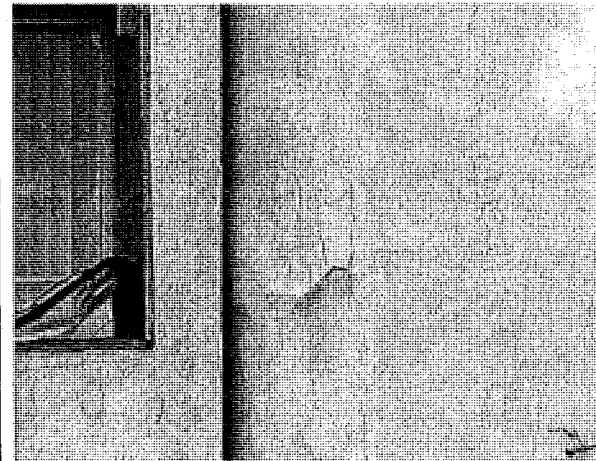
**Photograph 12: Exterior wall cracking**

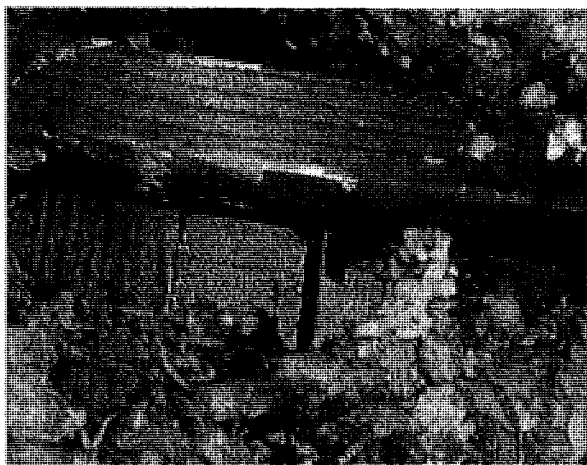
**Photograph 13: Unit 201. Termites Infestation**

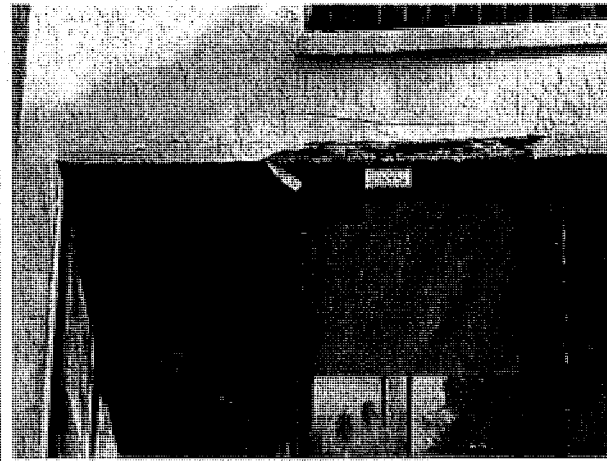
**Photograph 12: Exterior wall cracking and exposed wire lath**

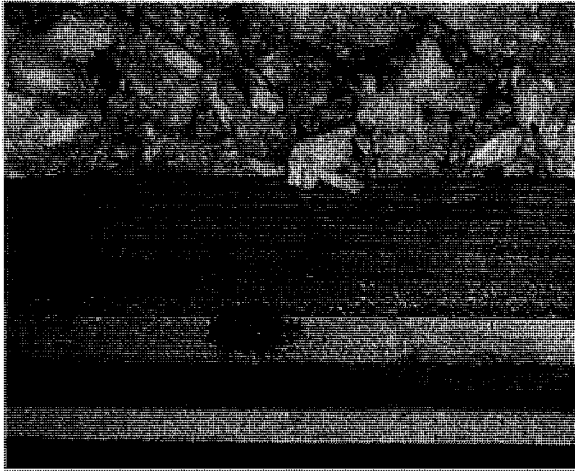
*Photograph 13: Unit 202. Termites Infestation*

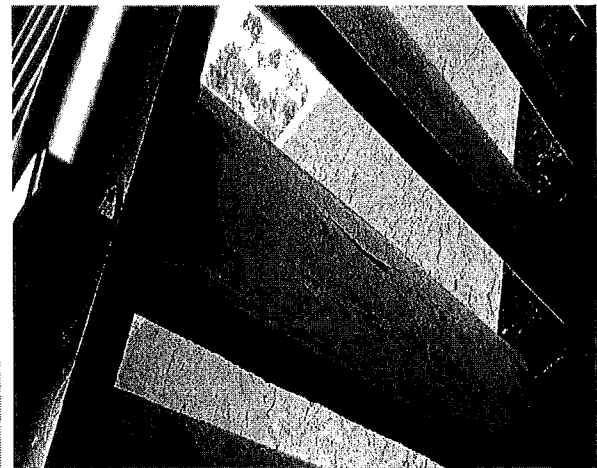
**Photograph 10: Concrete steps cracking**

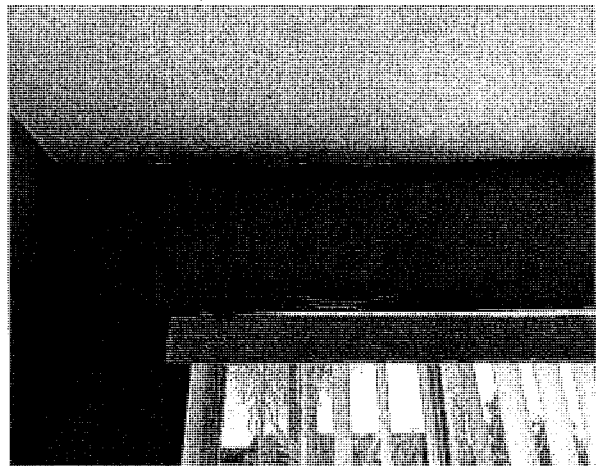
*Photograph 4: Unit 108. Moisture stains and cracks within the interiors*

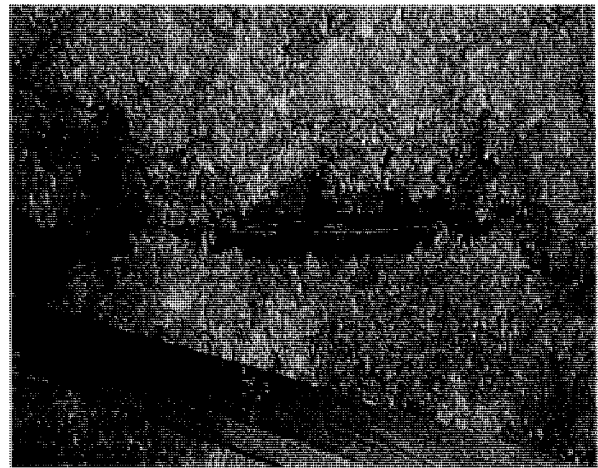
**Photograph 9: Unit 201. Termites infestation and damage to the bottom truss chord**

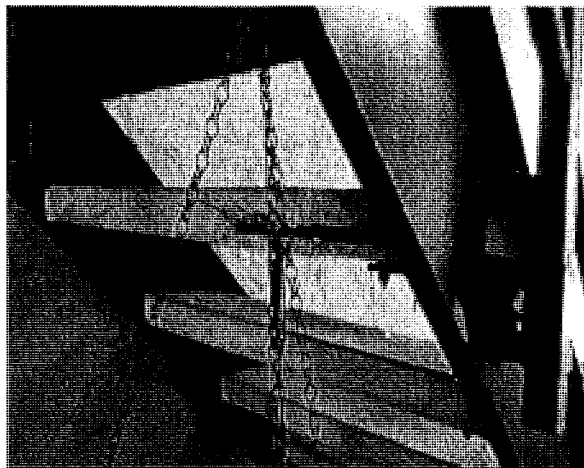
**Photograph 10: Unit 206. Termites infestation and damage to the bottom truss chord**

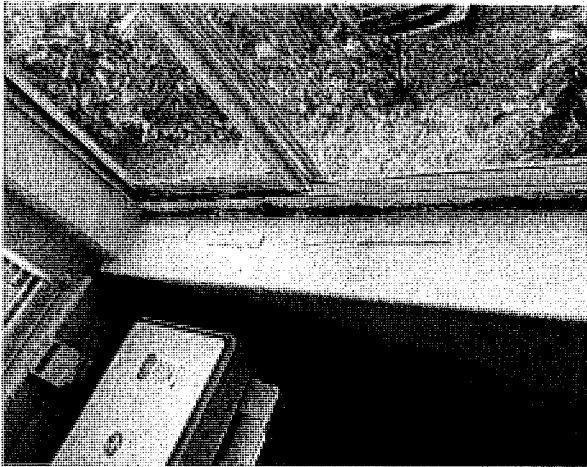
*Photograph 3: Unit 104. Termites infestation and moisture damage*

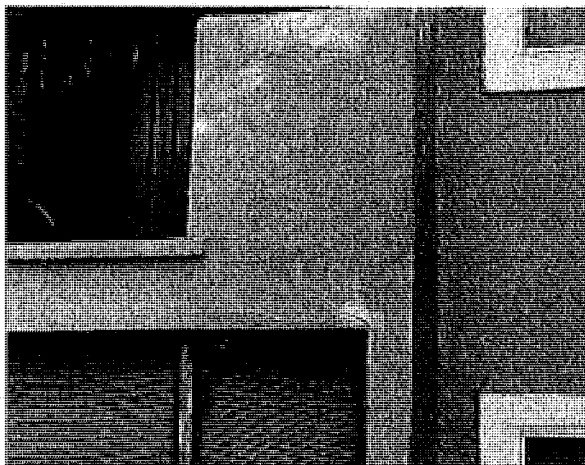
**Photograph 10: Opening in the exterior wall**

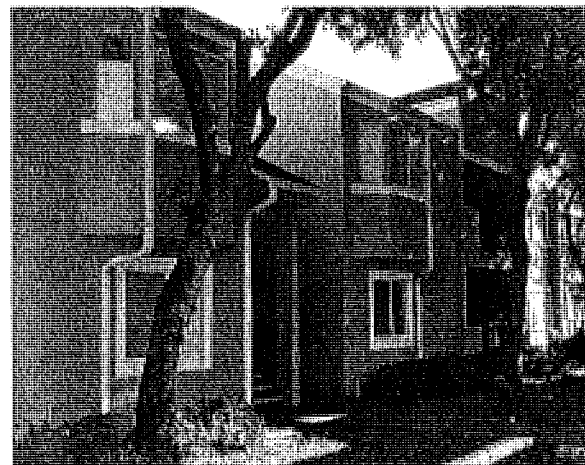
**Photograph 11: Exterior wall crack**

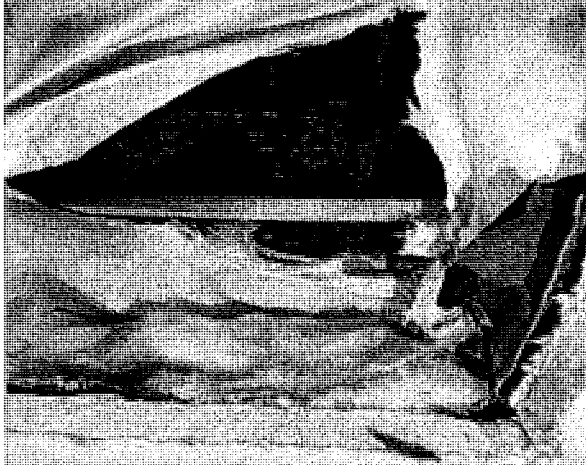
*Photograph 7: Unit 206. Deteriorated sheathing*

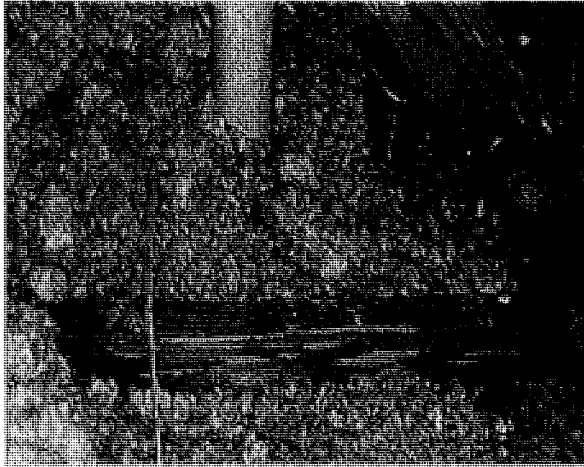
***Photograph 13: Unit 204. Termites infestation and damage to bottom truss chord***

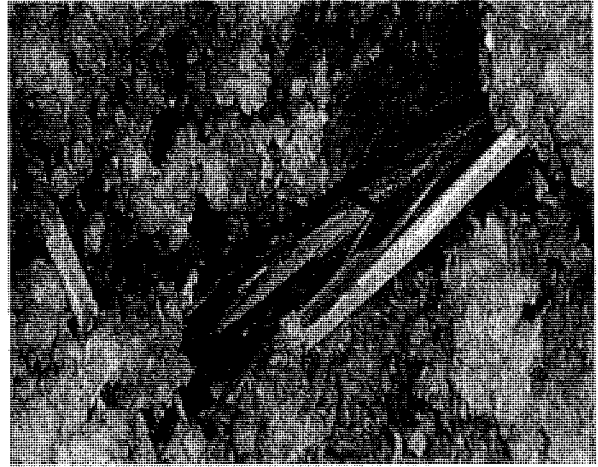
***Photograph 14: Unit 207. Termites infestation and damage to bottom truss chord***

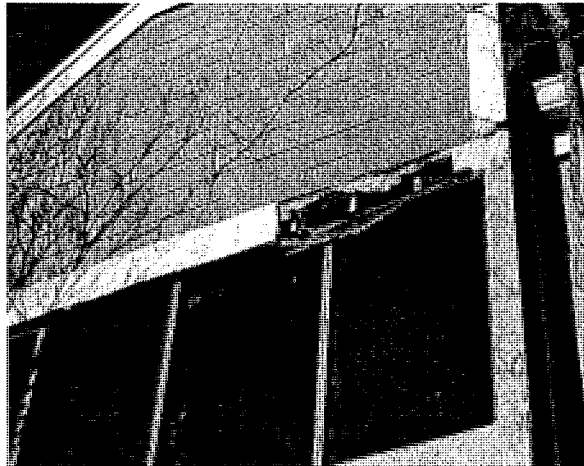
***Photograph 15: Opening in the exterior wall***

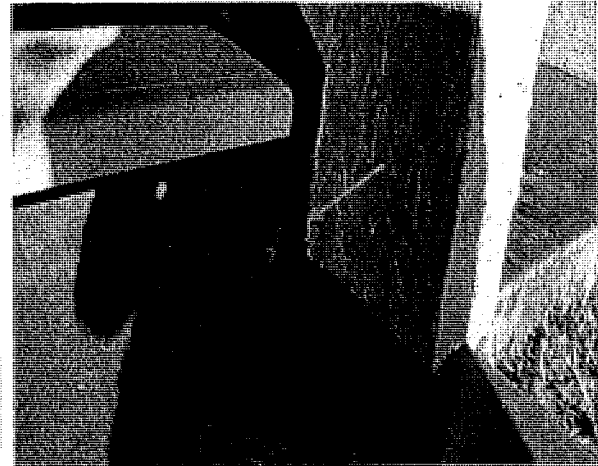
***Photograph 16: Corroded connection for the common metal staircase***
