**NOTICE OF FILING PART 1 OF FINAL ENGINEERING REPORT OF SPECIALTY  
ENGINEERING CONSULTANTS, INC. DATED NOVEMBER 5, 2024**

**PROFESSIONAL CONSULTING SERVICES FOR:  
Heron Pond Condominium Association, Inc.**

Building #9  
8343 SW 5<sup>th</sup> Street,  
Pembroke Pines, FL 33025

Re: Investigation and Documentation of Deteriorated and Damaged Structural Items

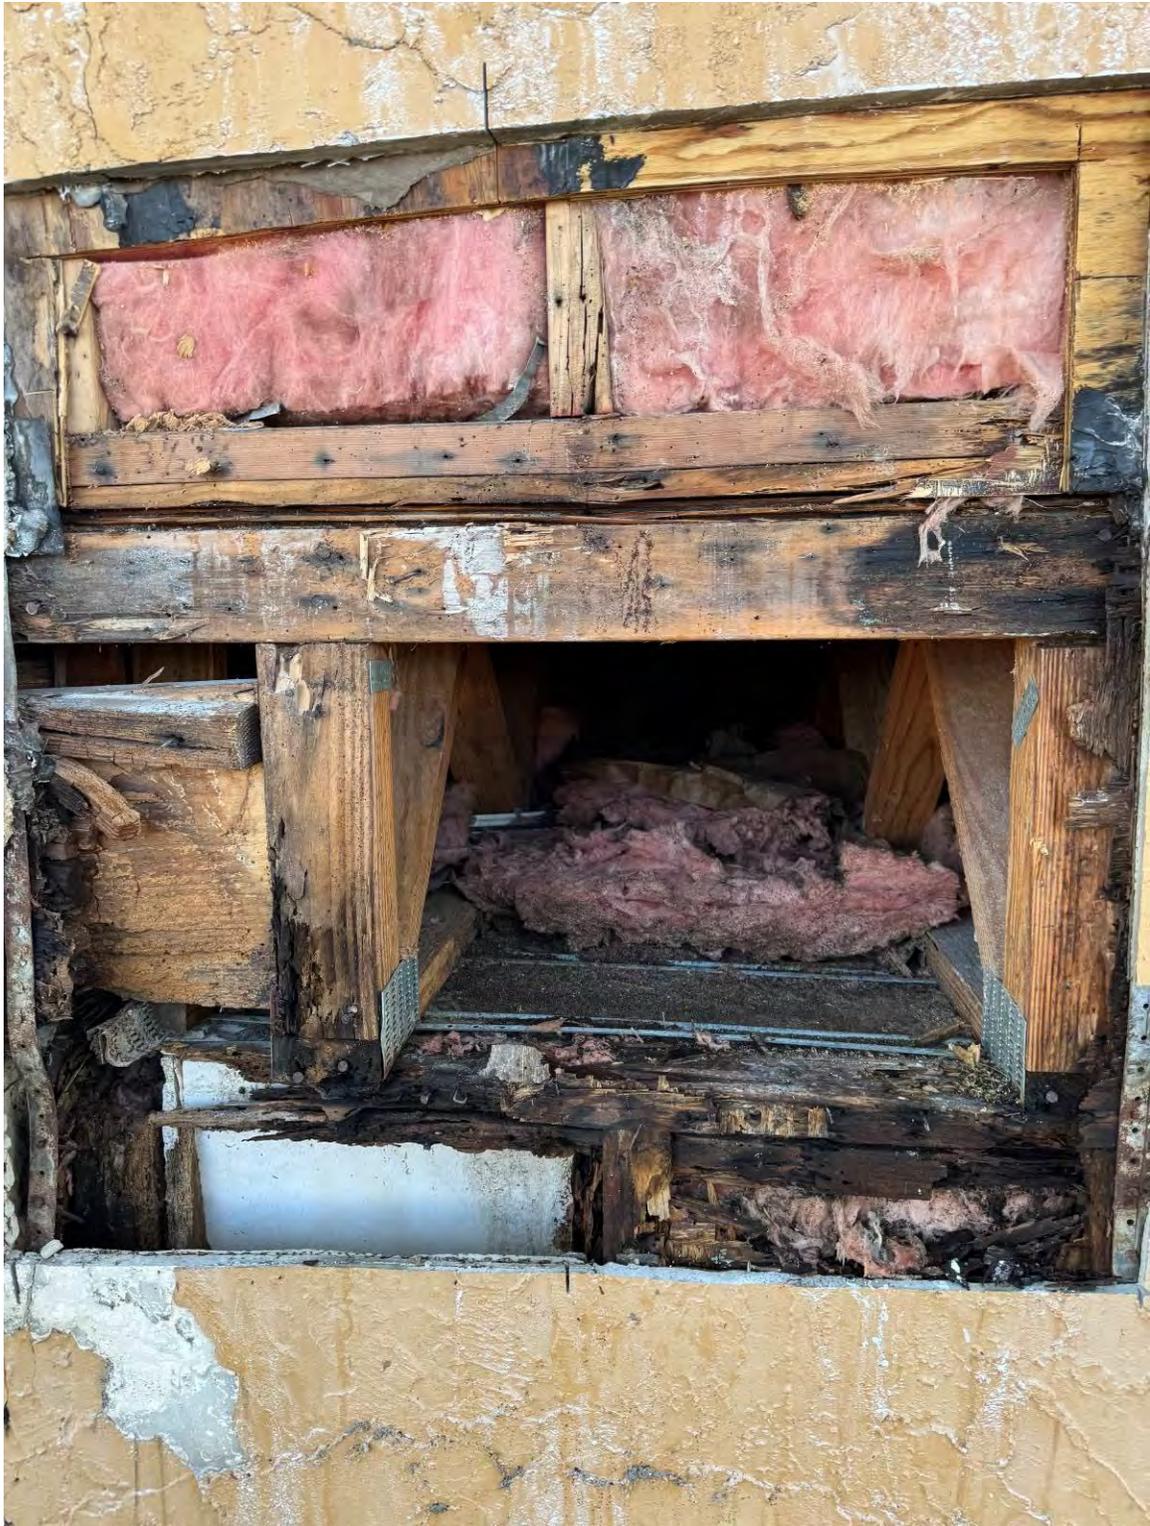
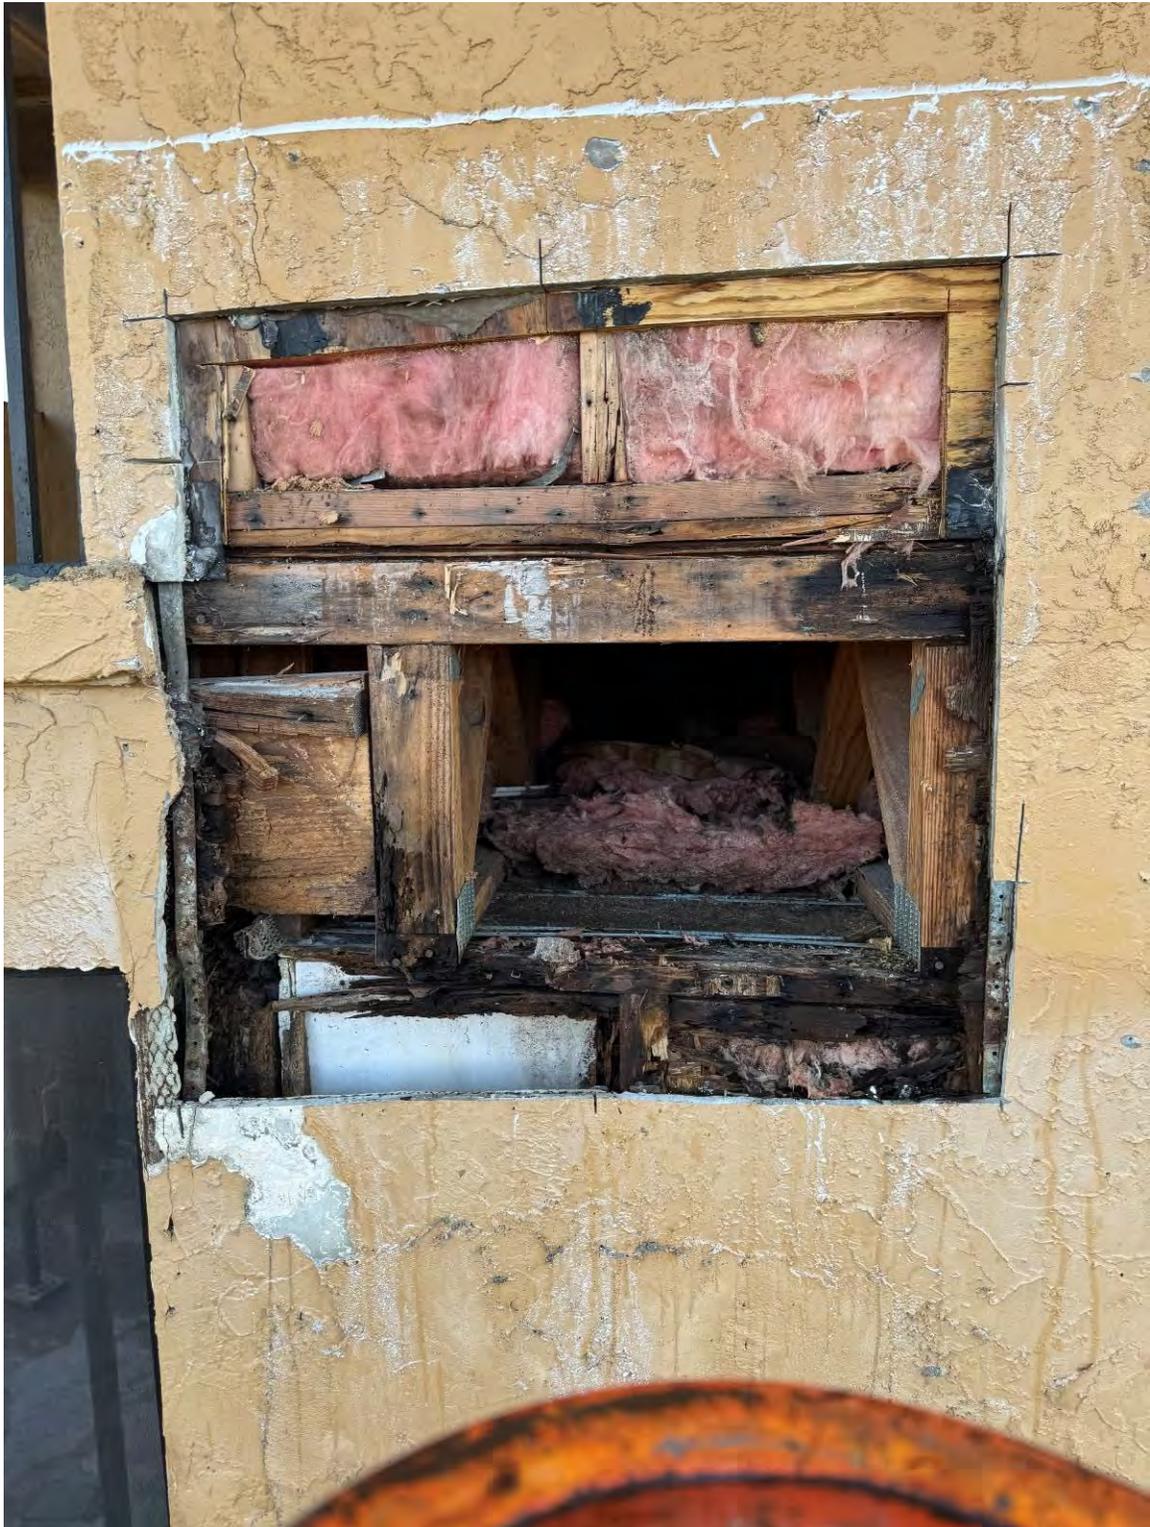
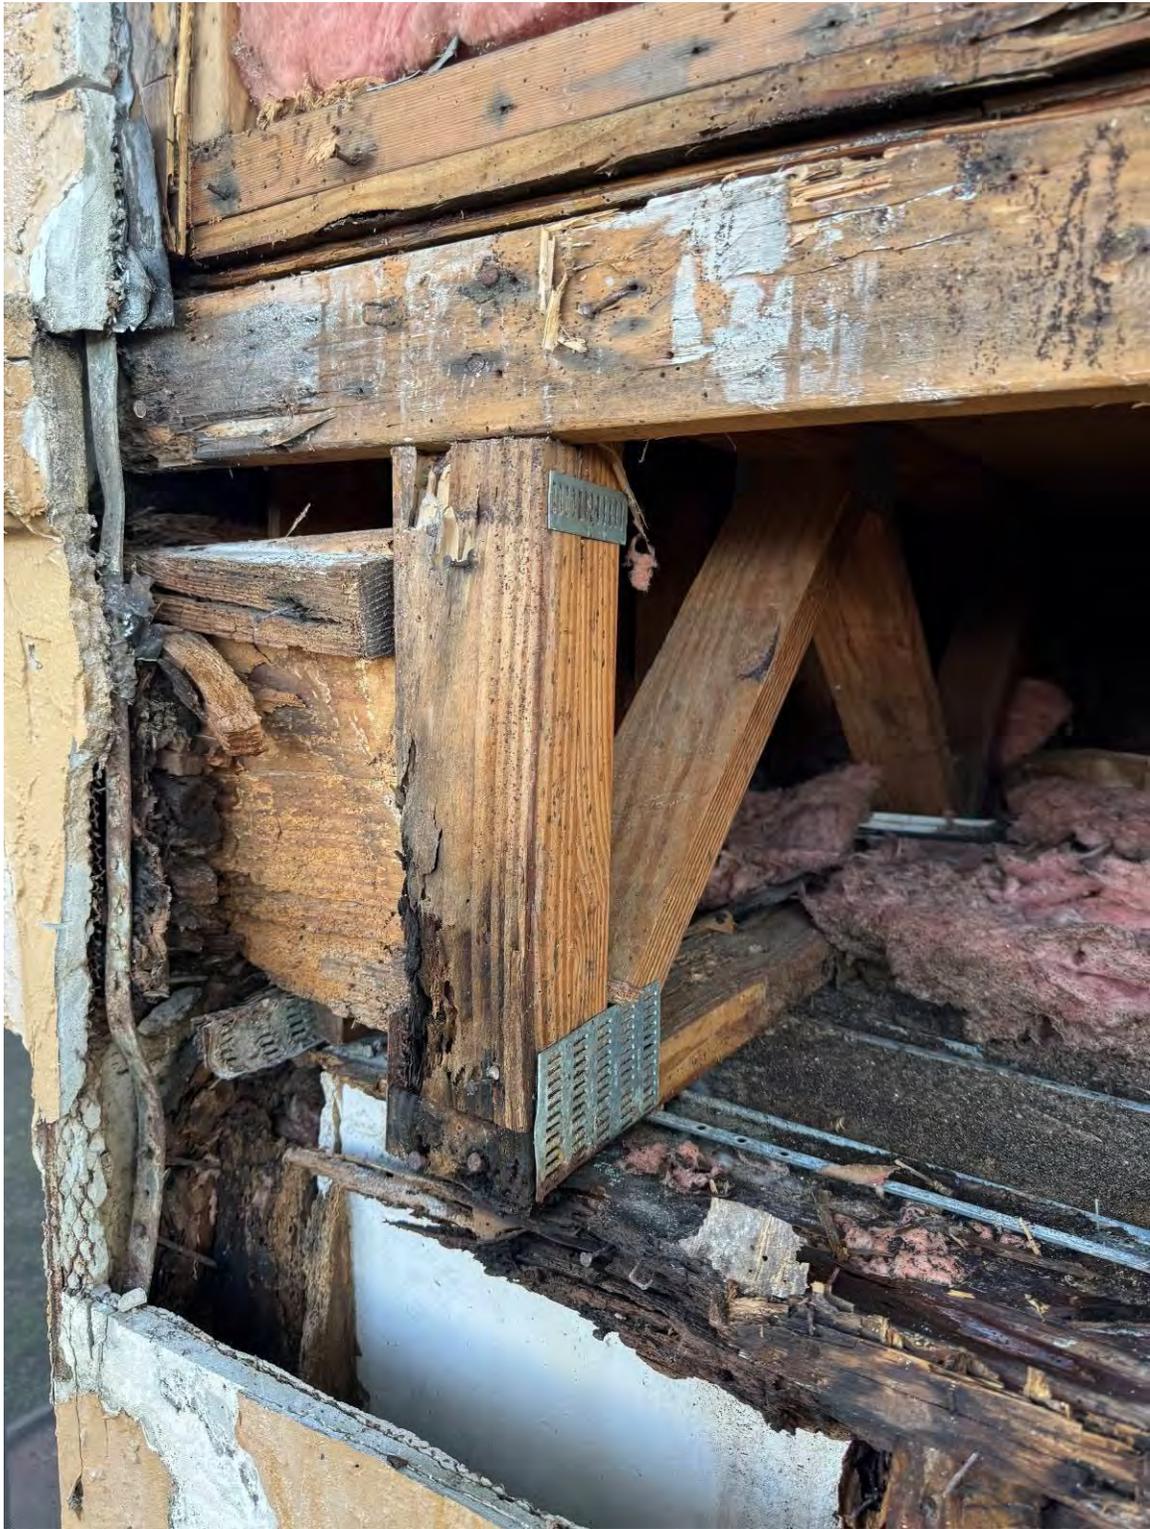
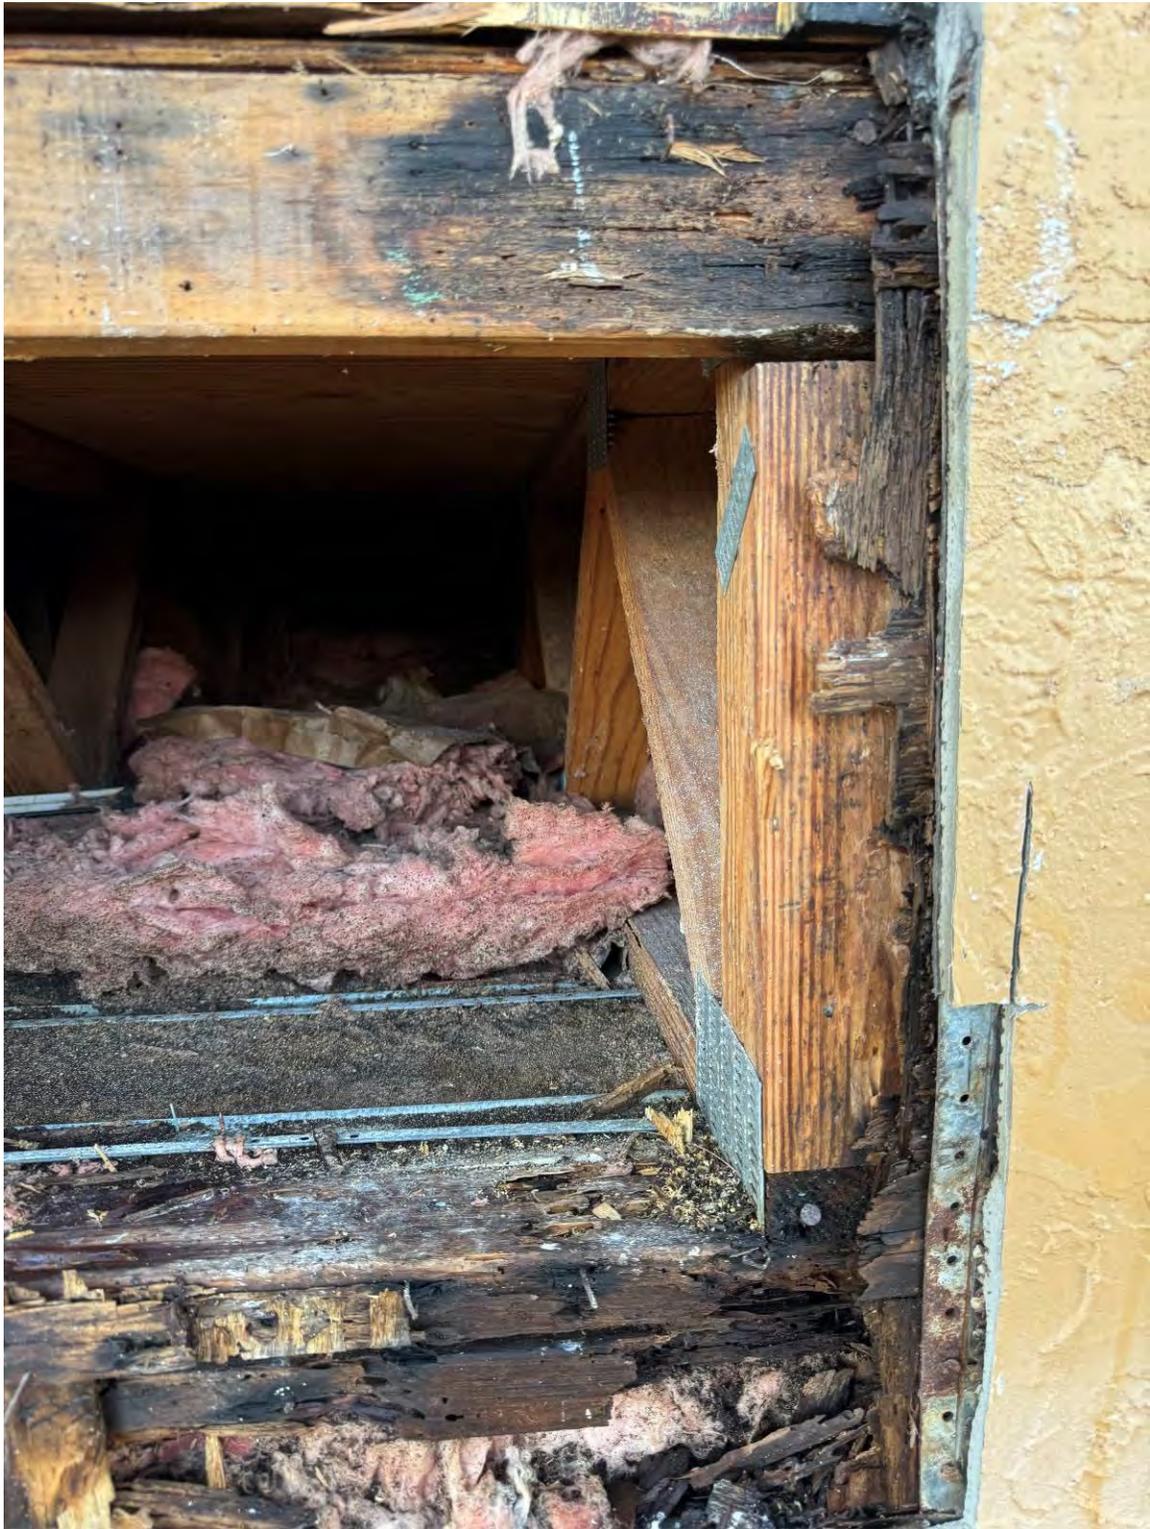
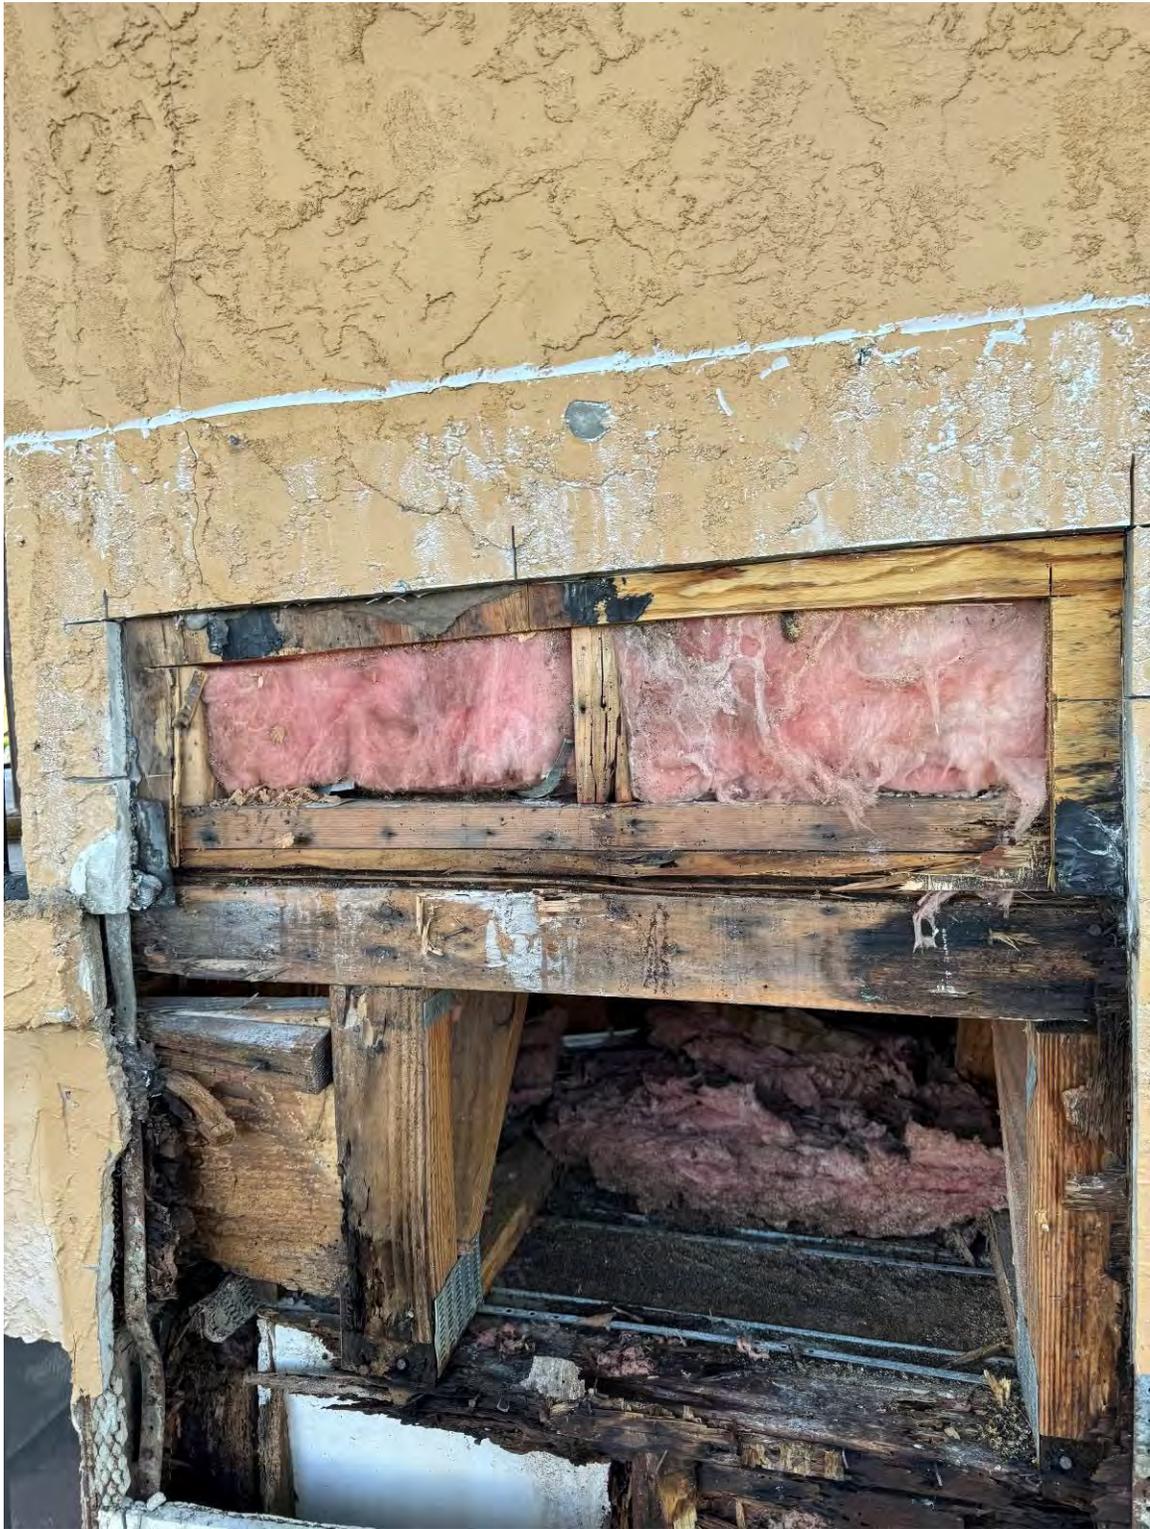
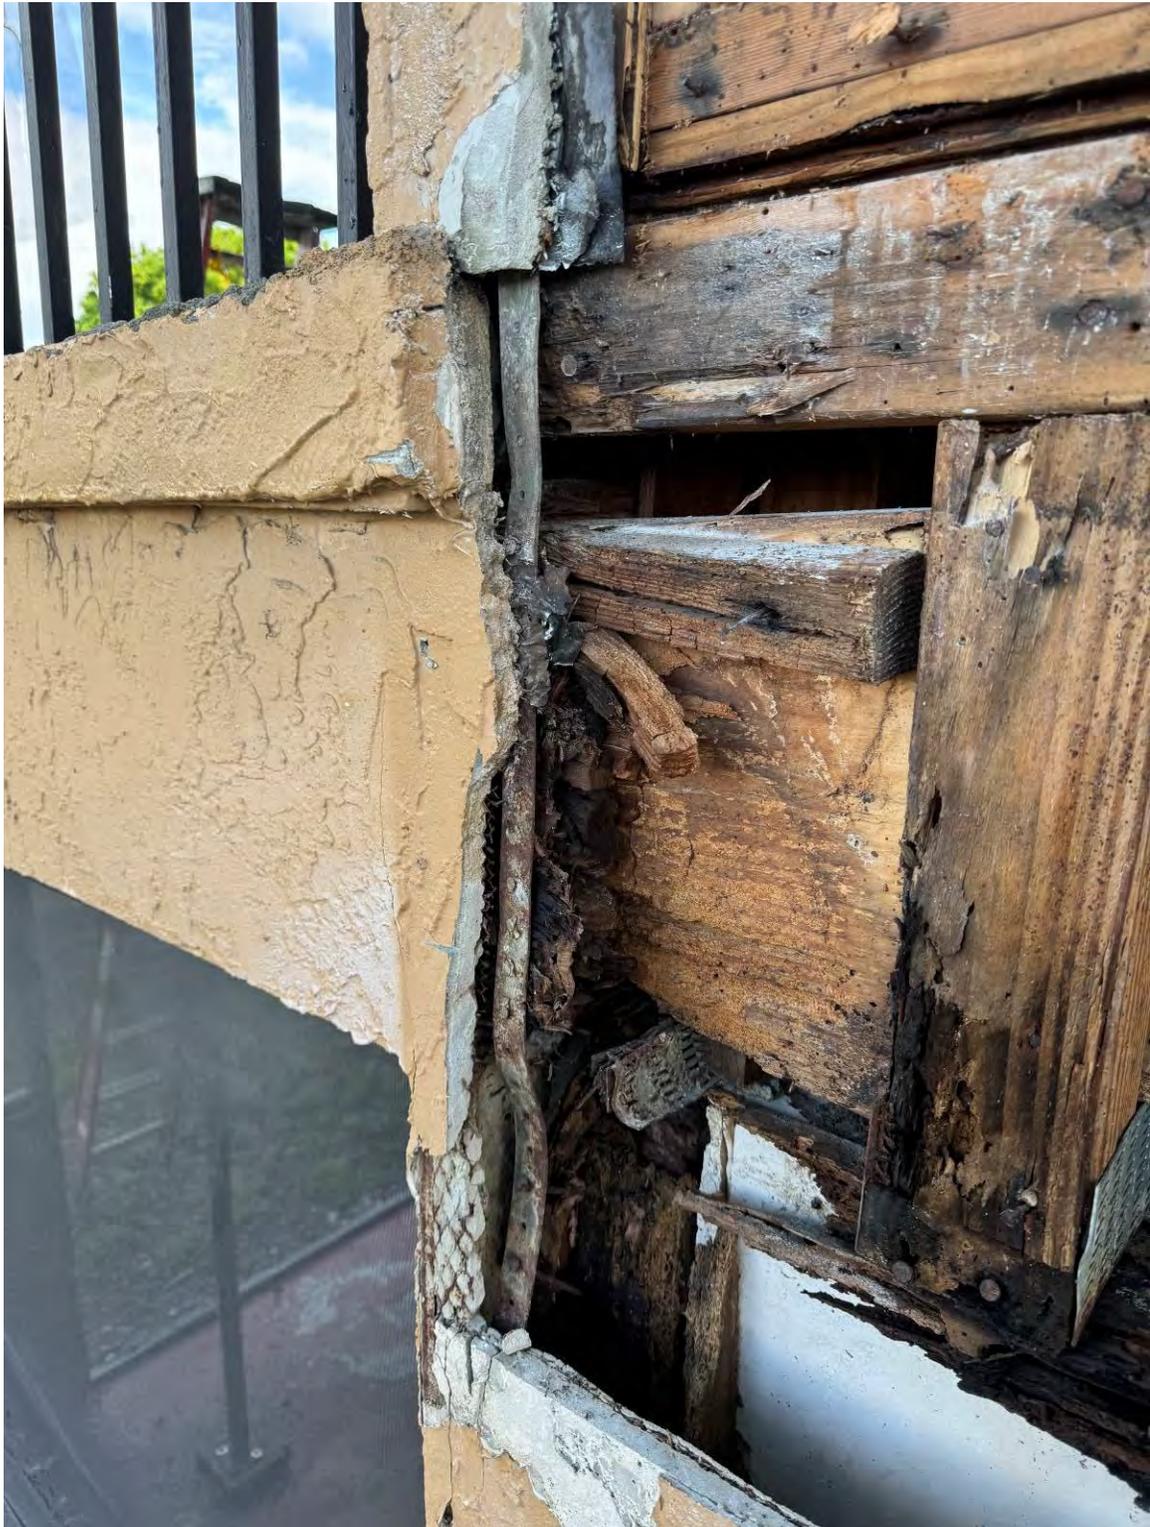
# OPENING #1

- Floor trusses are rotted
- Tie down strap to bearing wall not nailed
- Bearing wall studs rotted away
- Top bearing wall top plate rotted
- End of patio joist is rotted with termite damage
- Insulation is wet
- Damage to floor trusses about 12" deep
- Floor framing is rotted
- Floor sheathing is rotted
- Bottom sill has termite damage, rotted wood and water damage
- Damage to stud

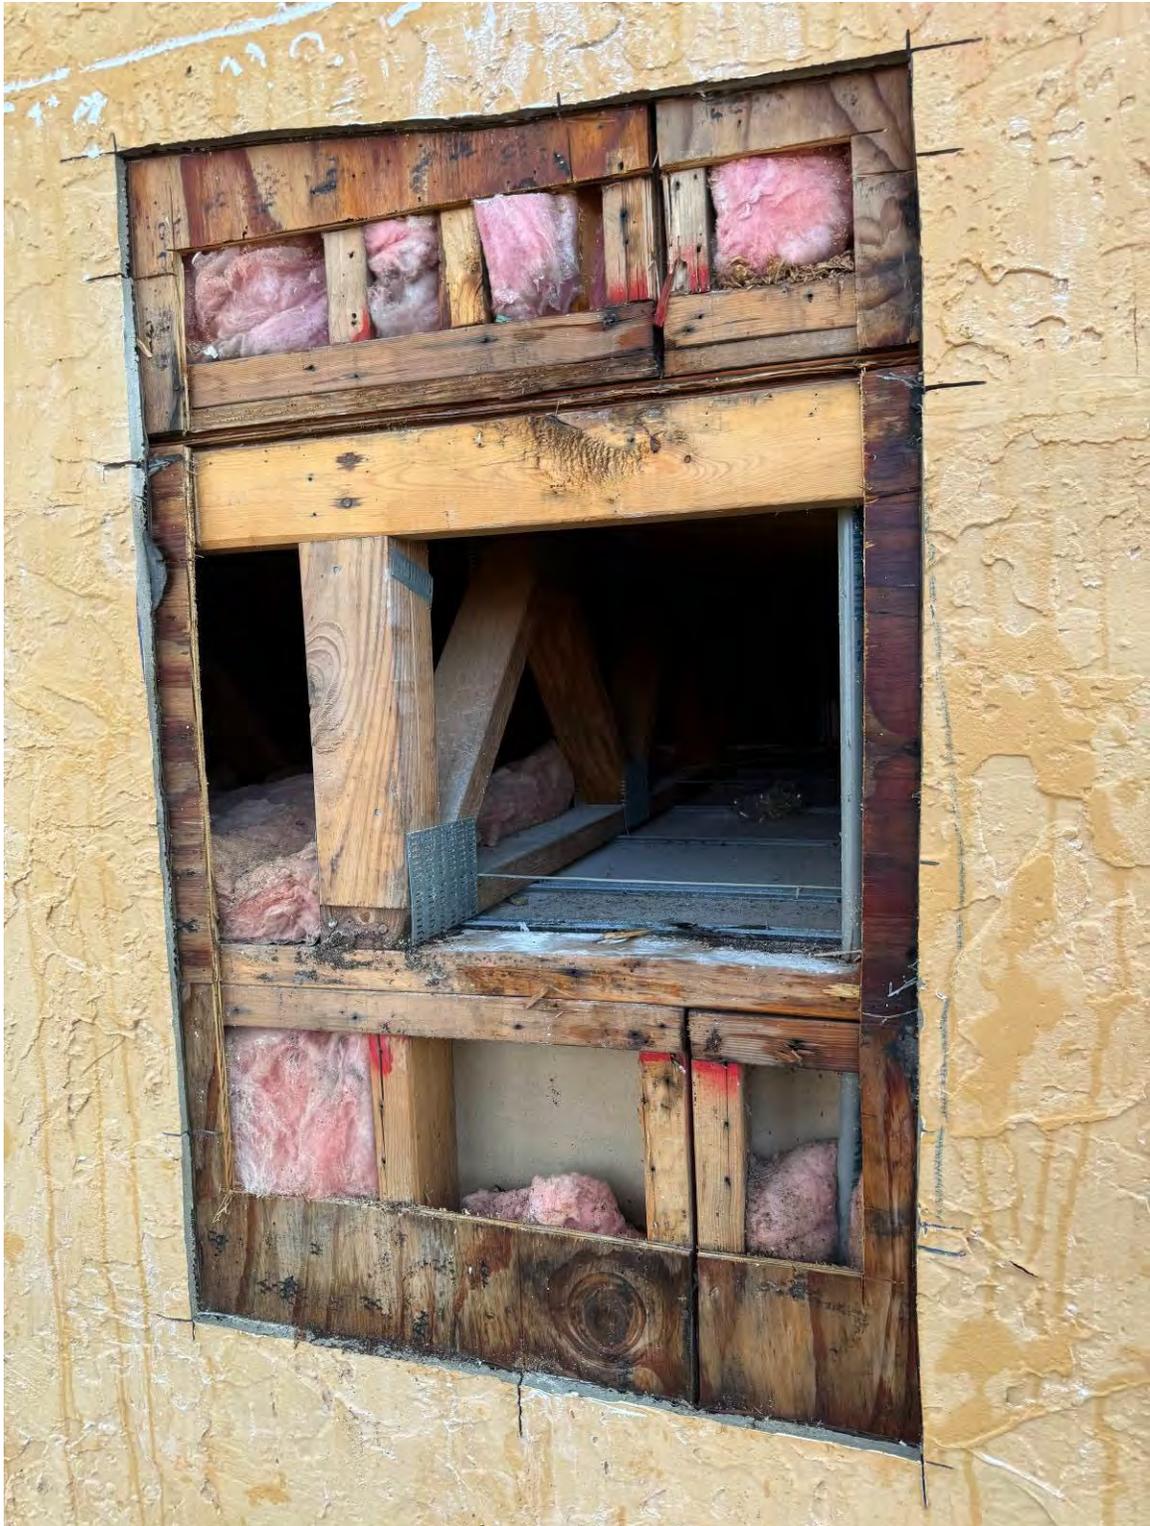
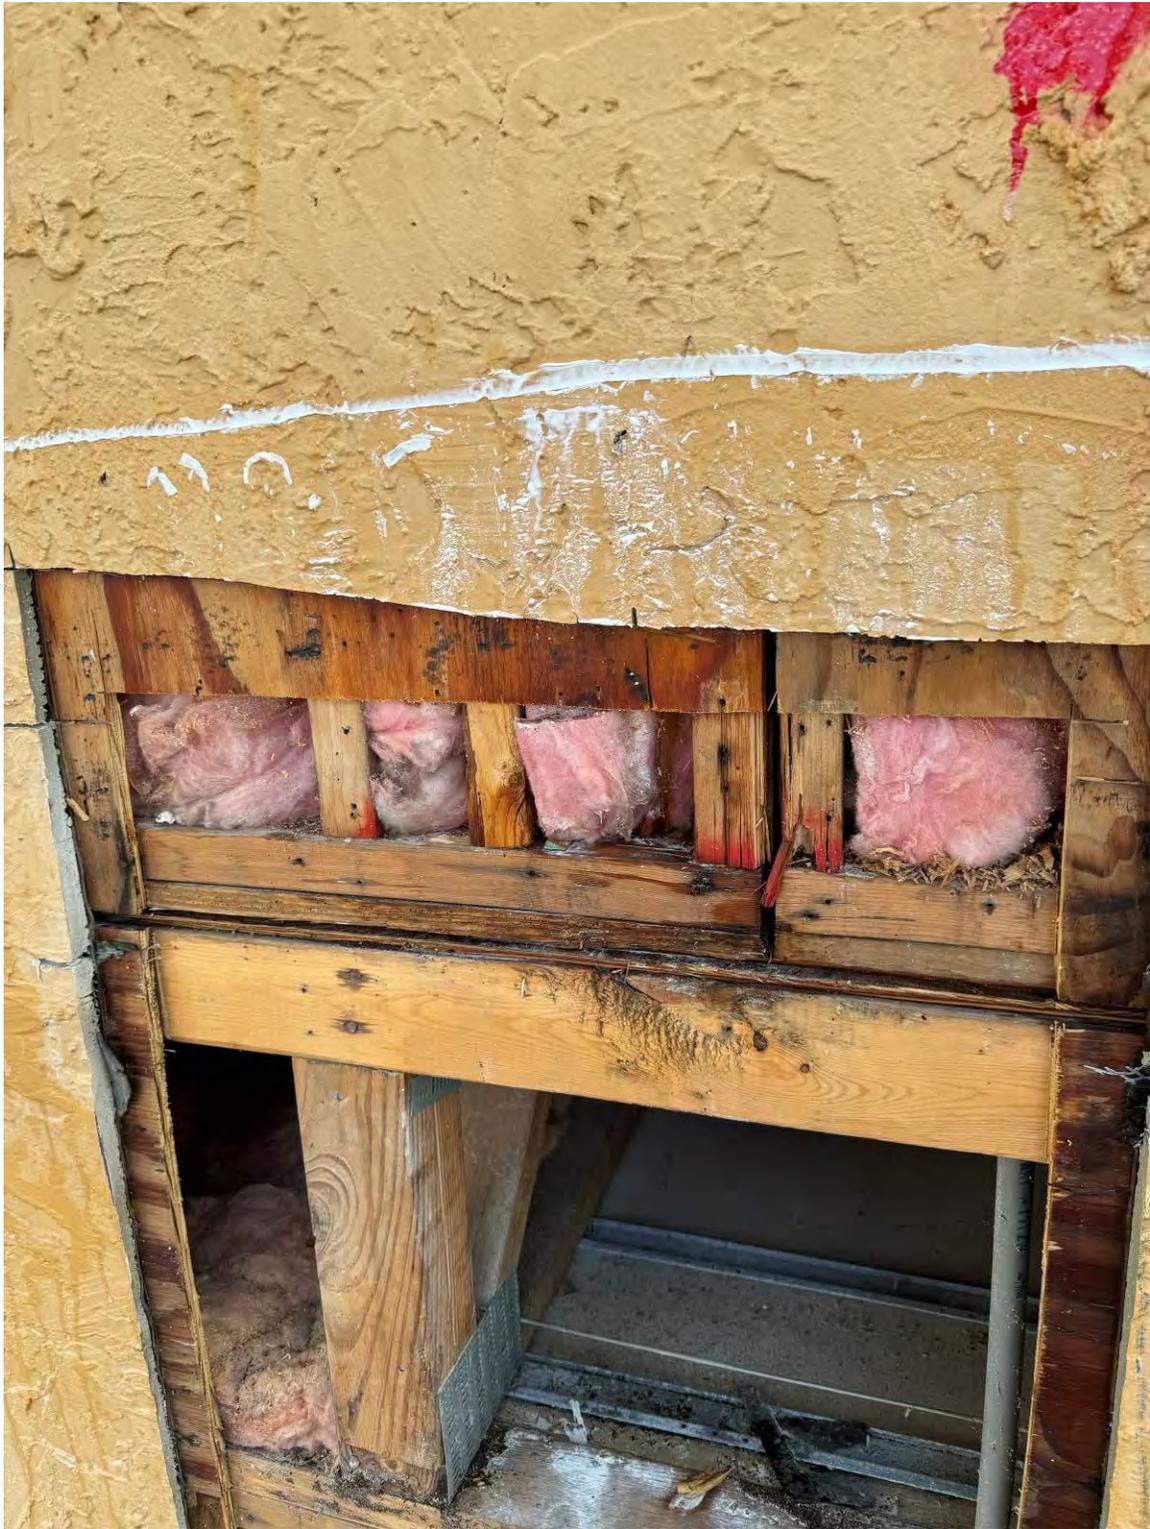
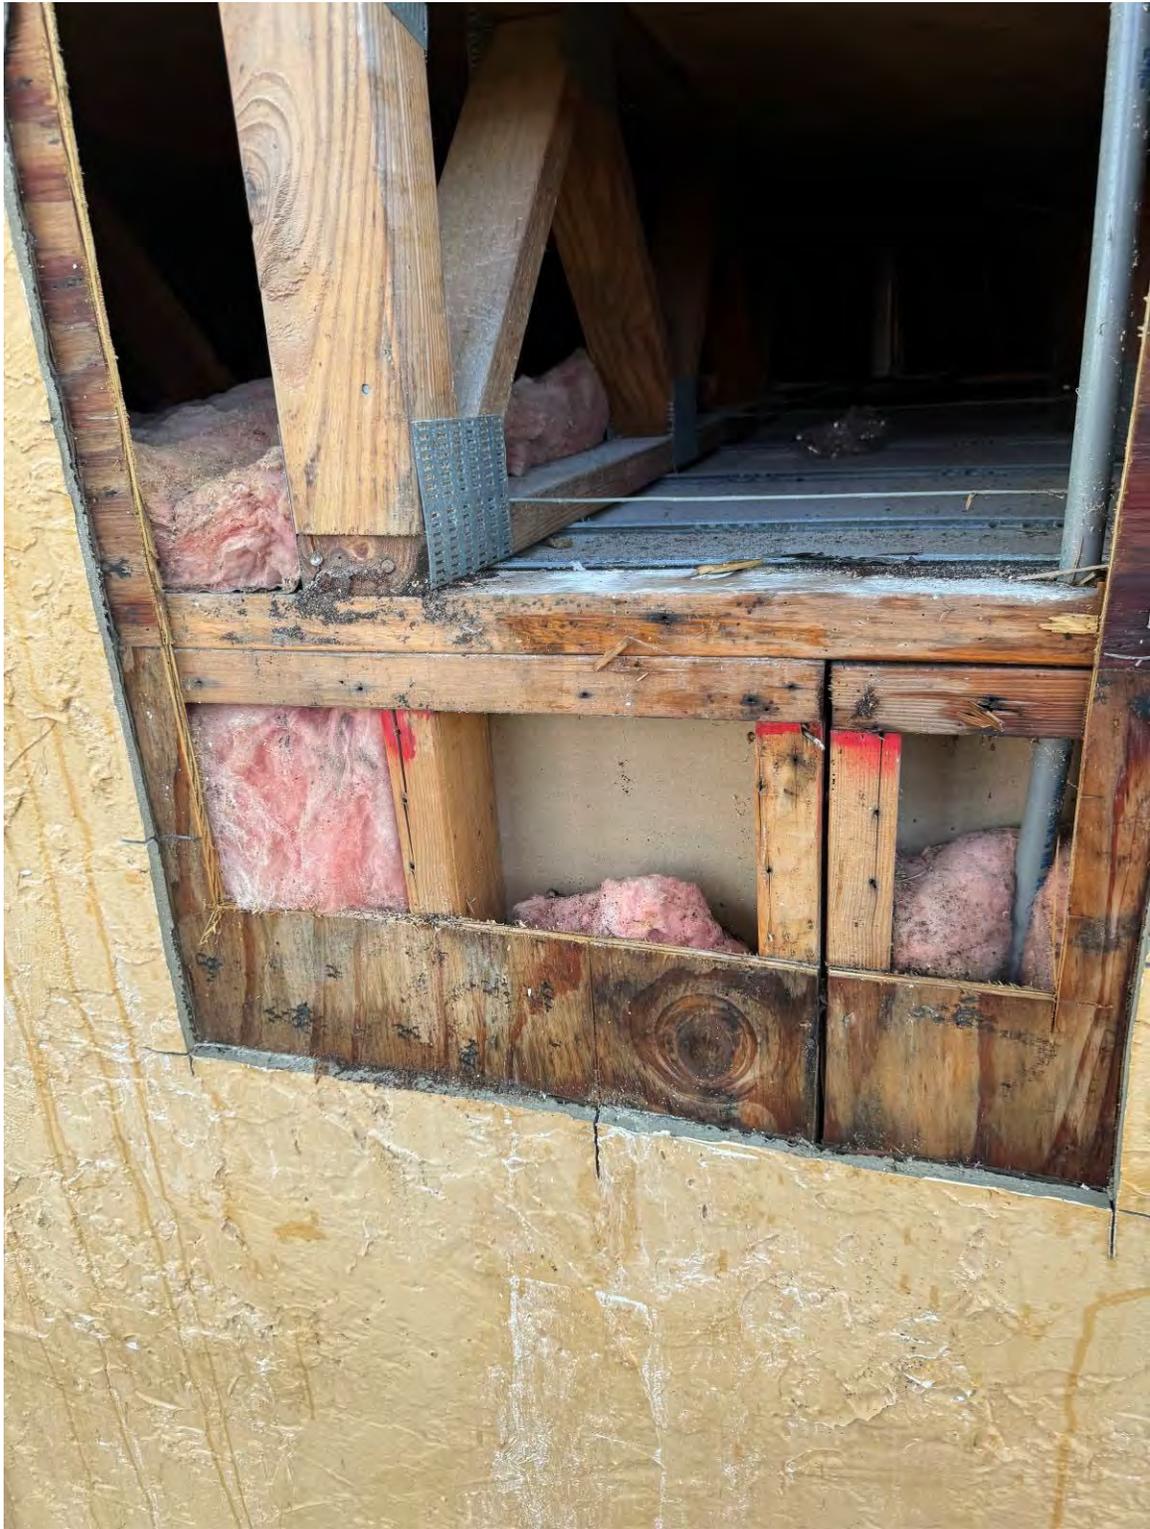
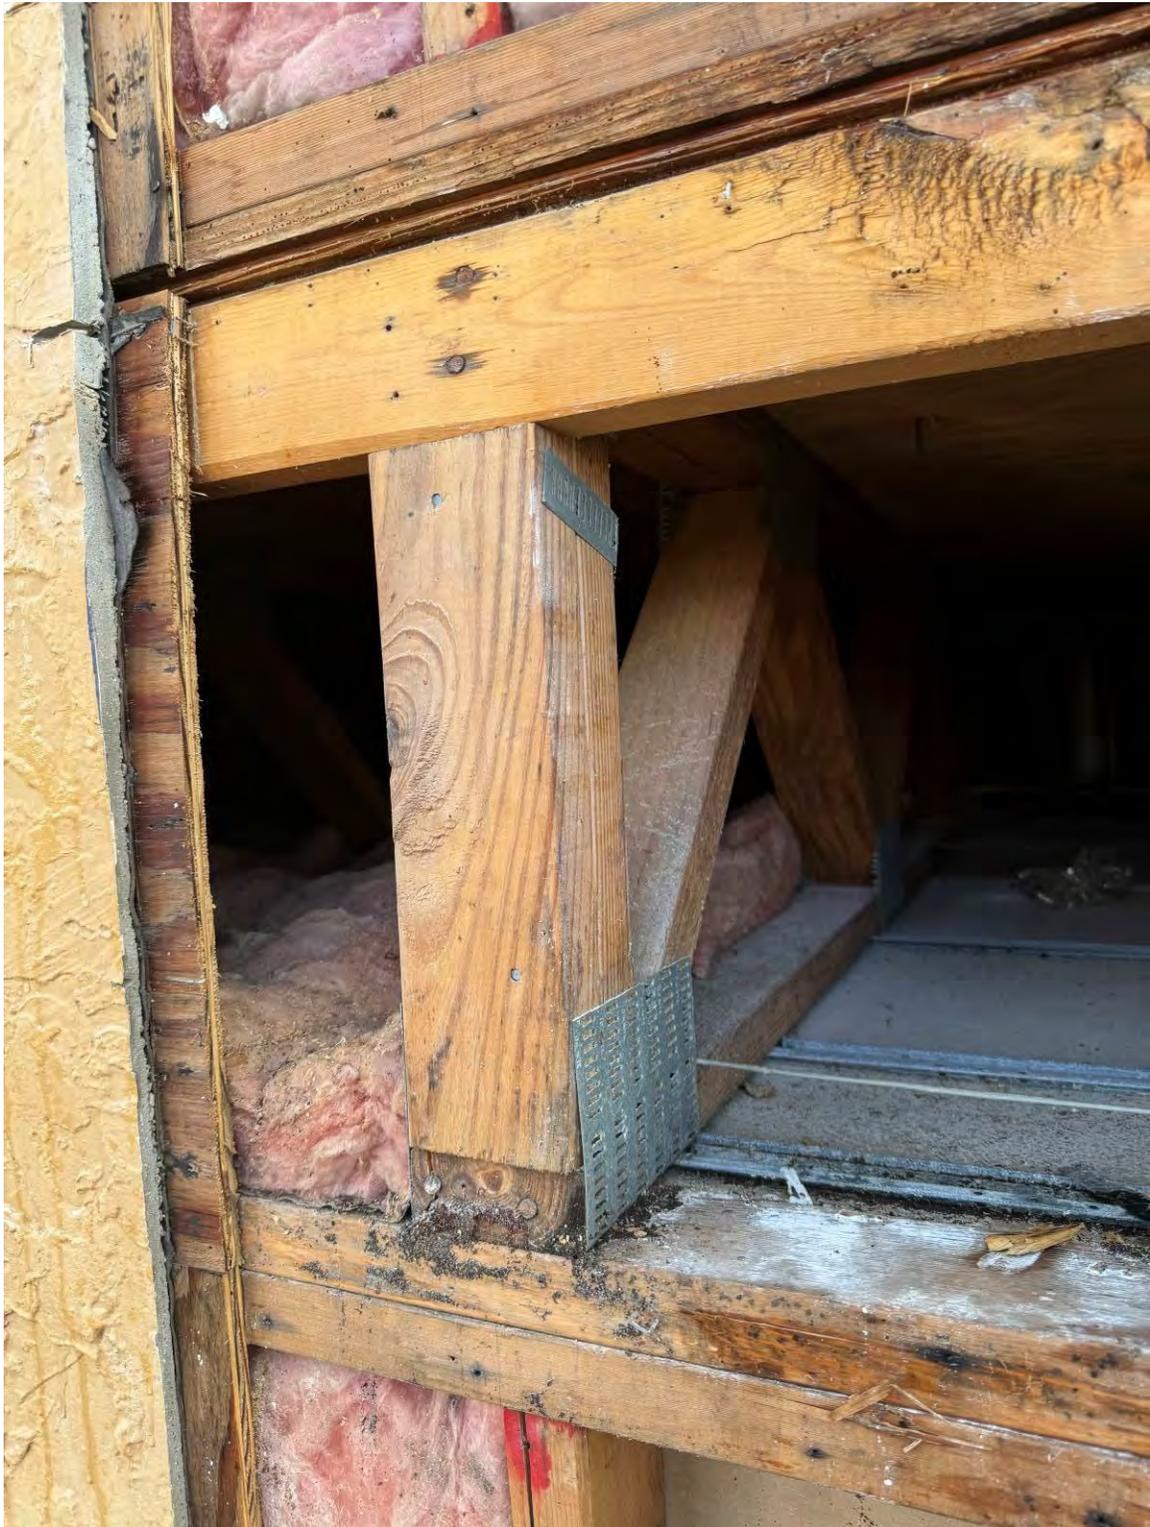
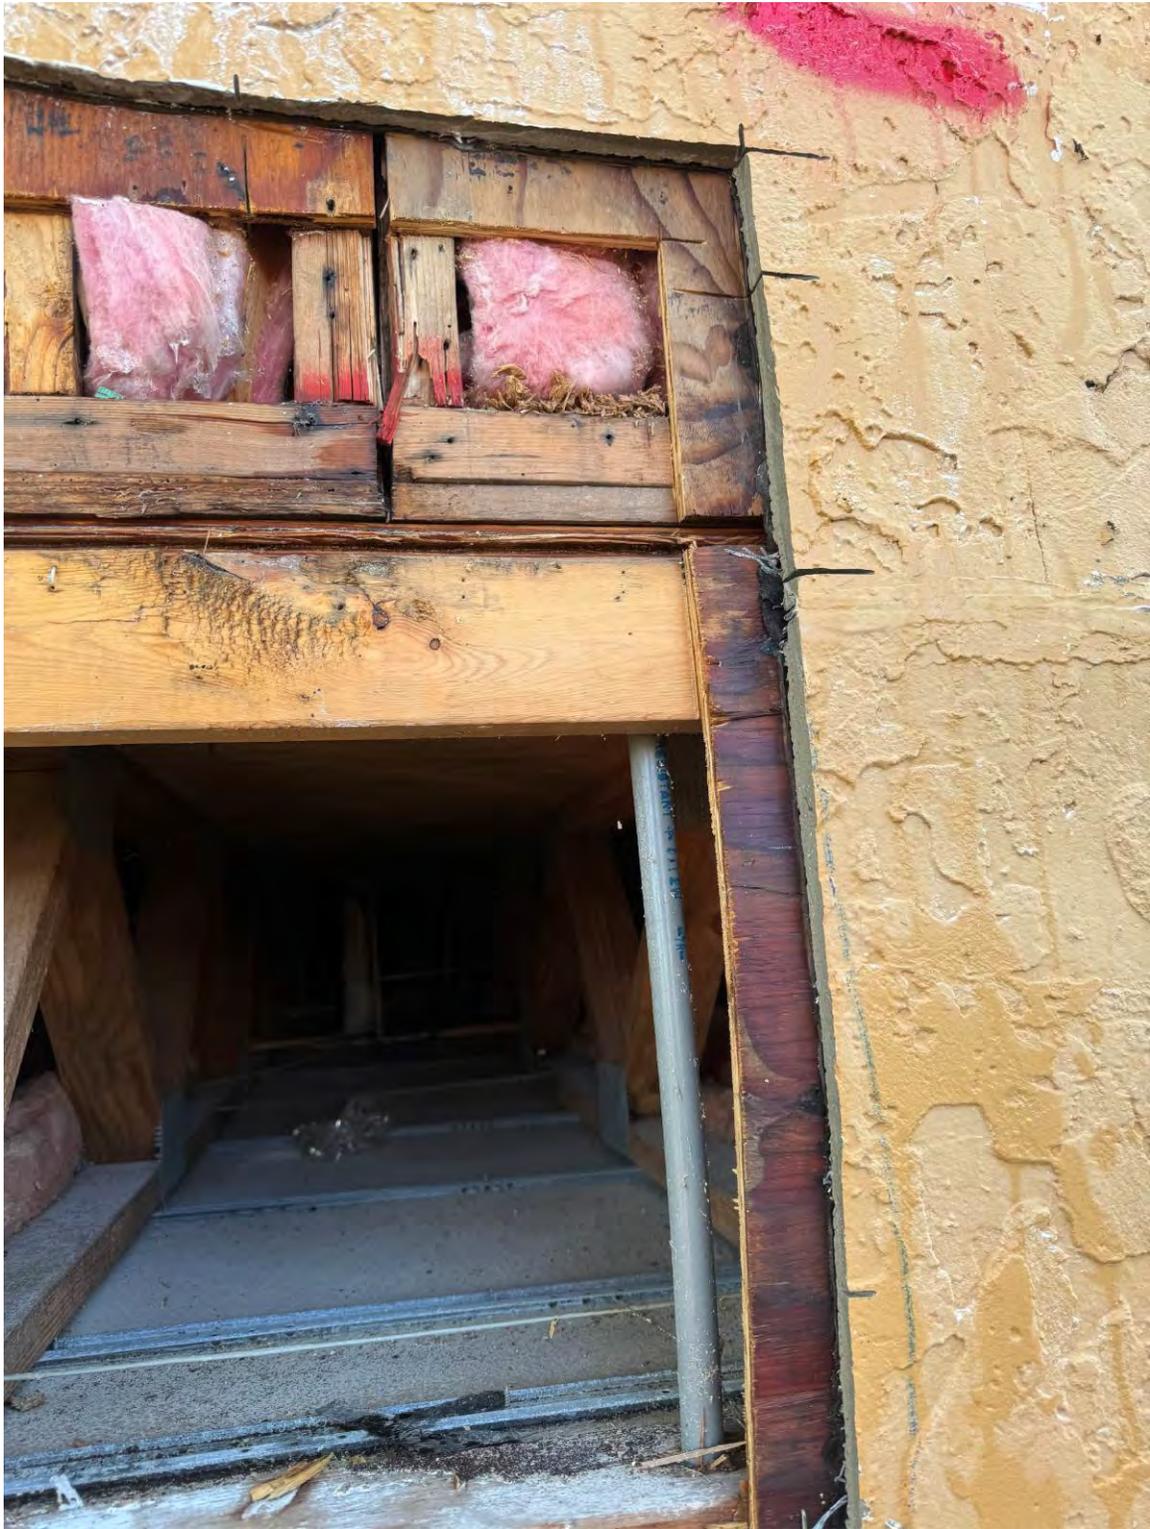
# OPENING #2

- Evidence of termites
- 1st floor bearing wall studs have no mechanical connection to the top plate
- Some damage to the studs for the bottom of the 2<sup>nd</sup> floor bearing wall
- Some damage to the 1<sup>st</sup> floor studs to their top plate
- Plywood is half inch
