**NOTICE OF FILING PART 1 OF FINAL ENGINEERING REPORT OF SPECIALTY  
ENGINEERING CONSULTANTS, INC. DATED NOVEMBER 5, 2024**

**PROFESSIONAL CONSULTING SERVICES FOR:  
Heron Pond Condominium Association, Inc.**

Building #9  
8343 SW 5<sup>th</sup> Street,  
Pembroke Pines, FL 33025

Re: Investigation and Documentation of Deteriorated and Damaged Structural Items

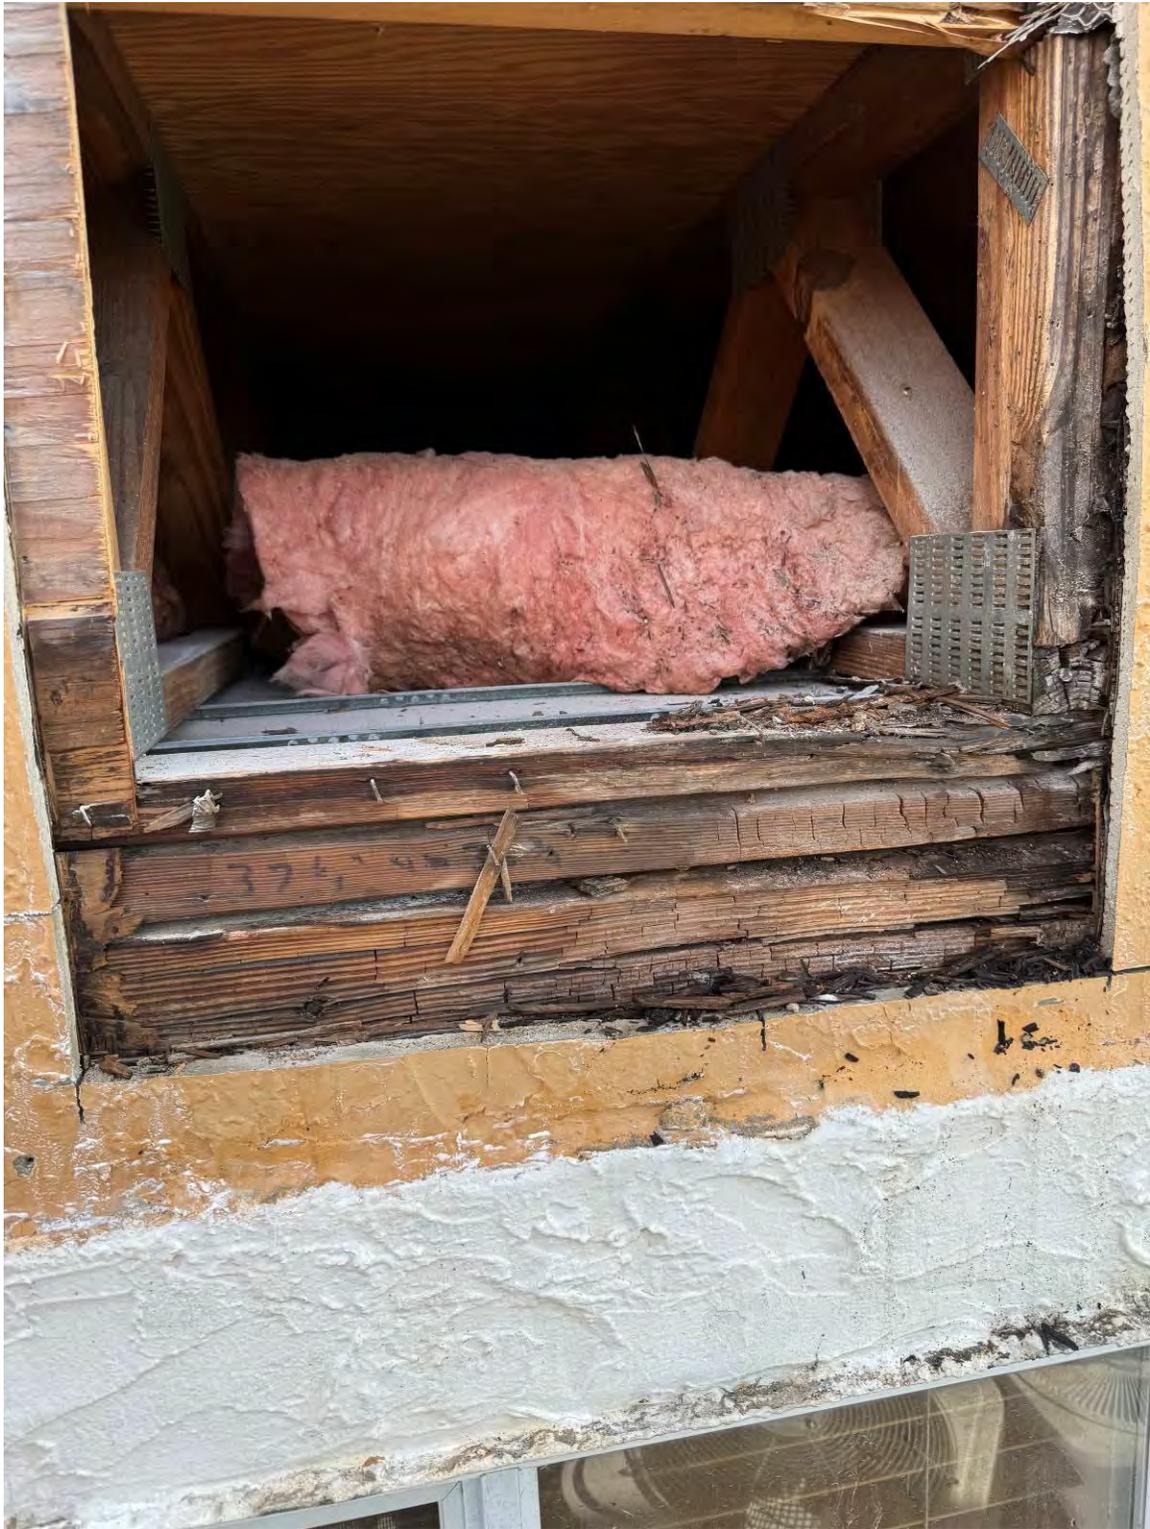
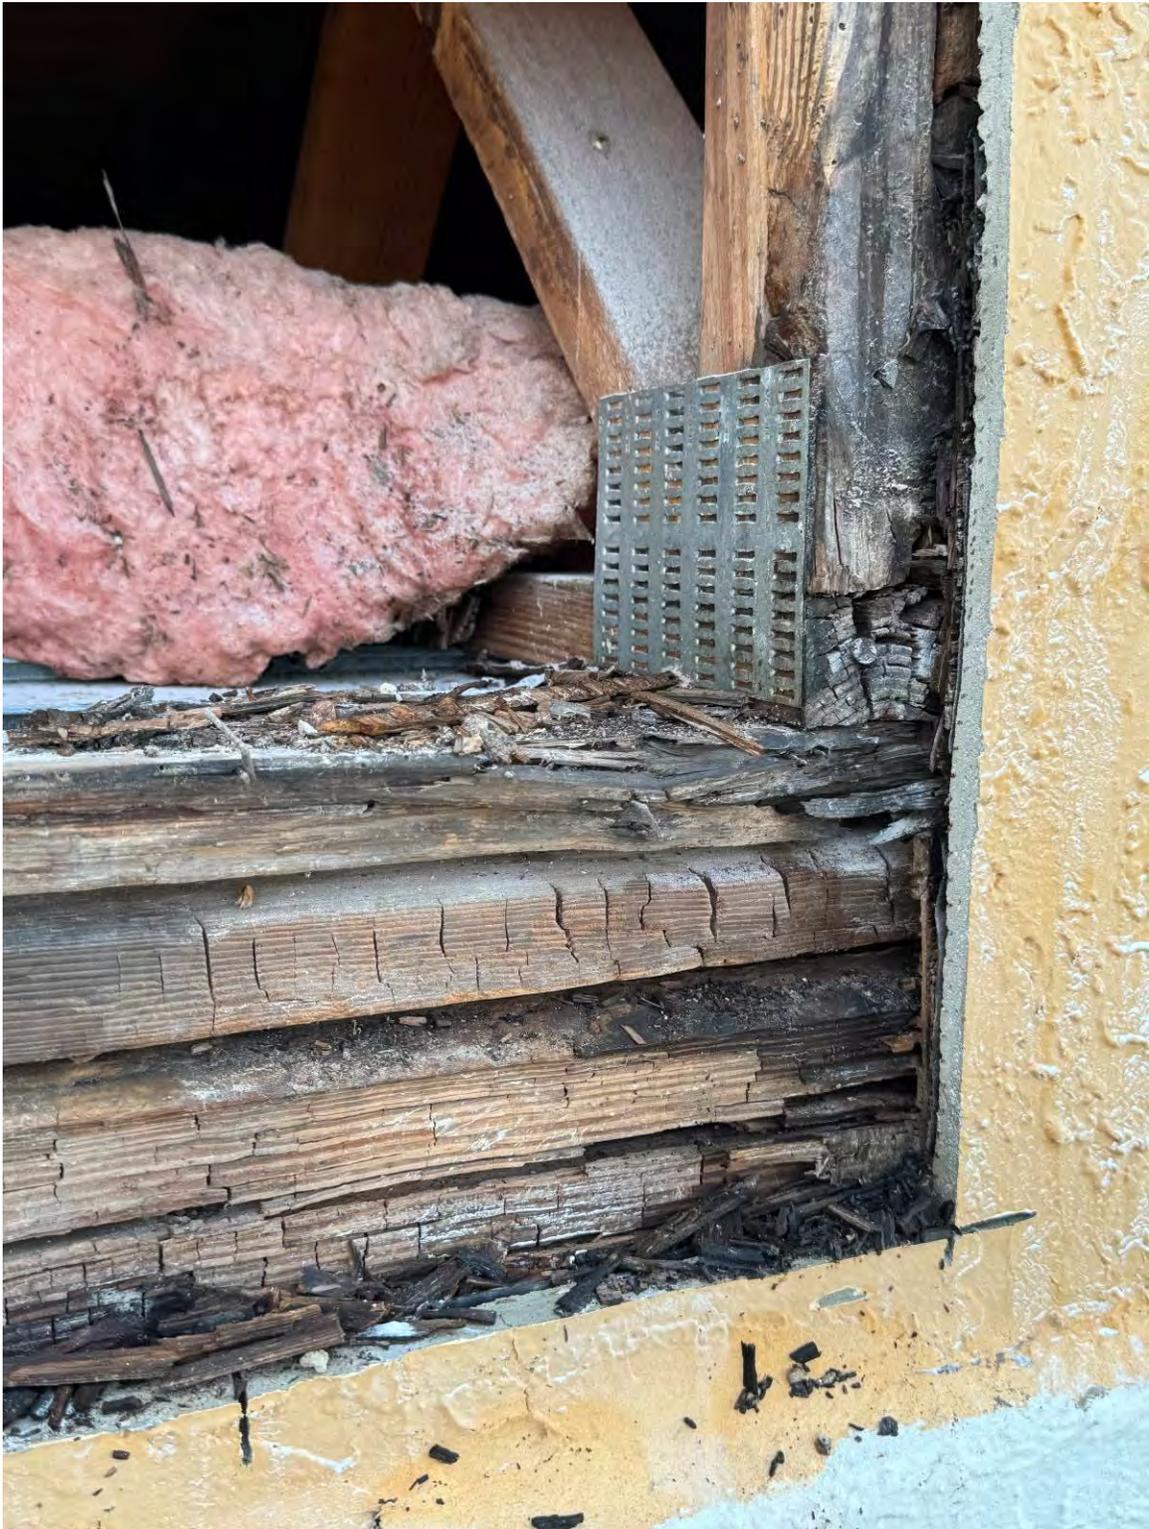
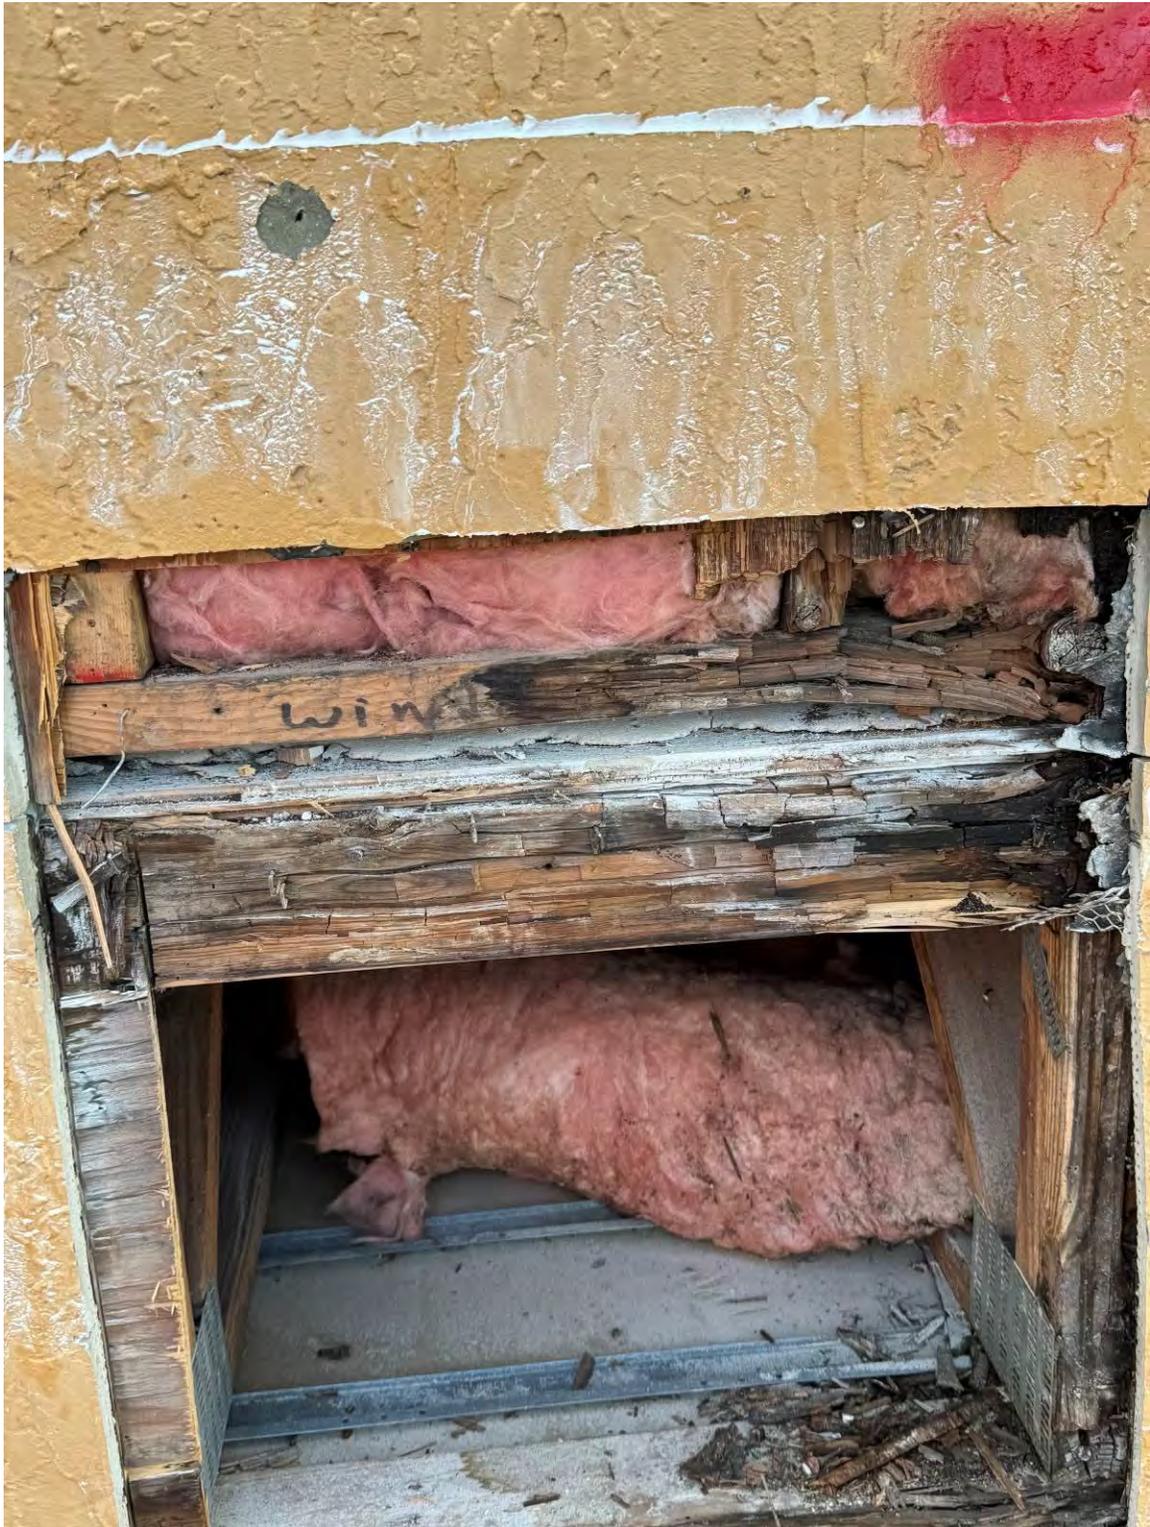
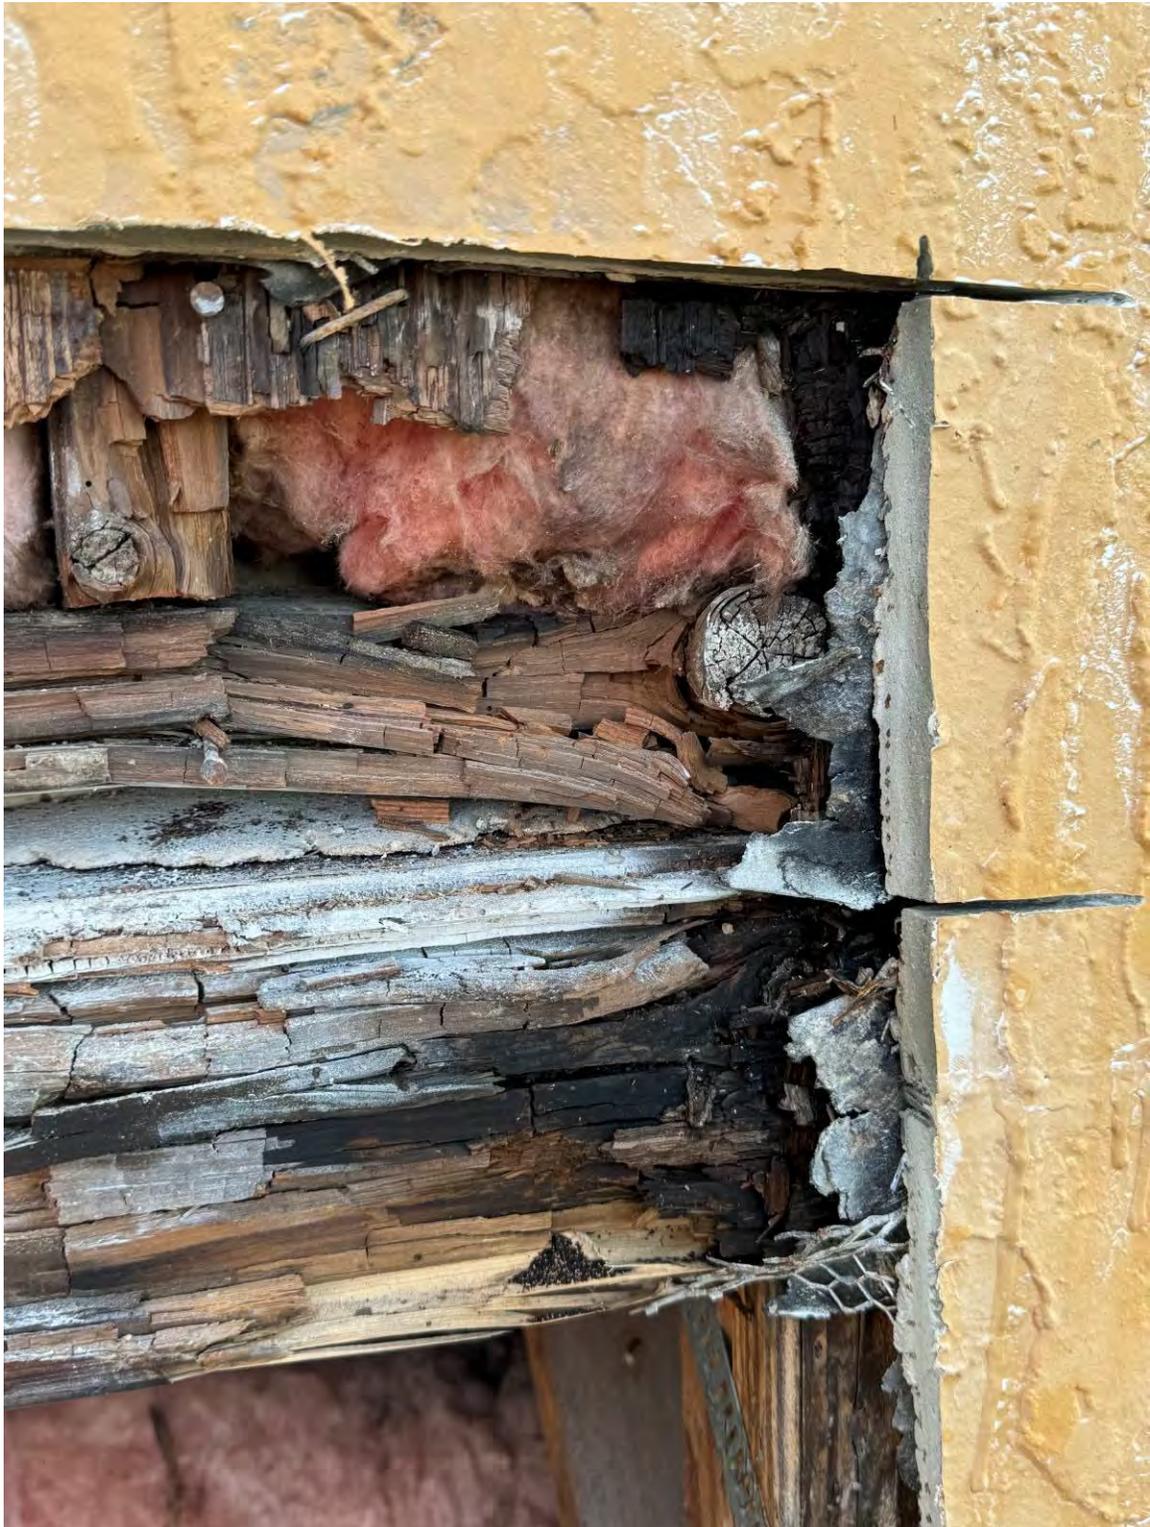
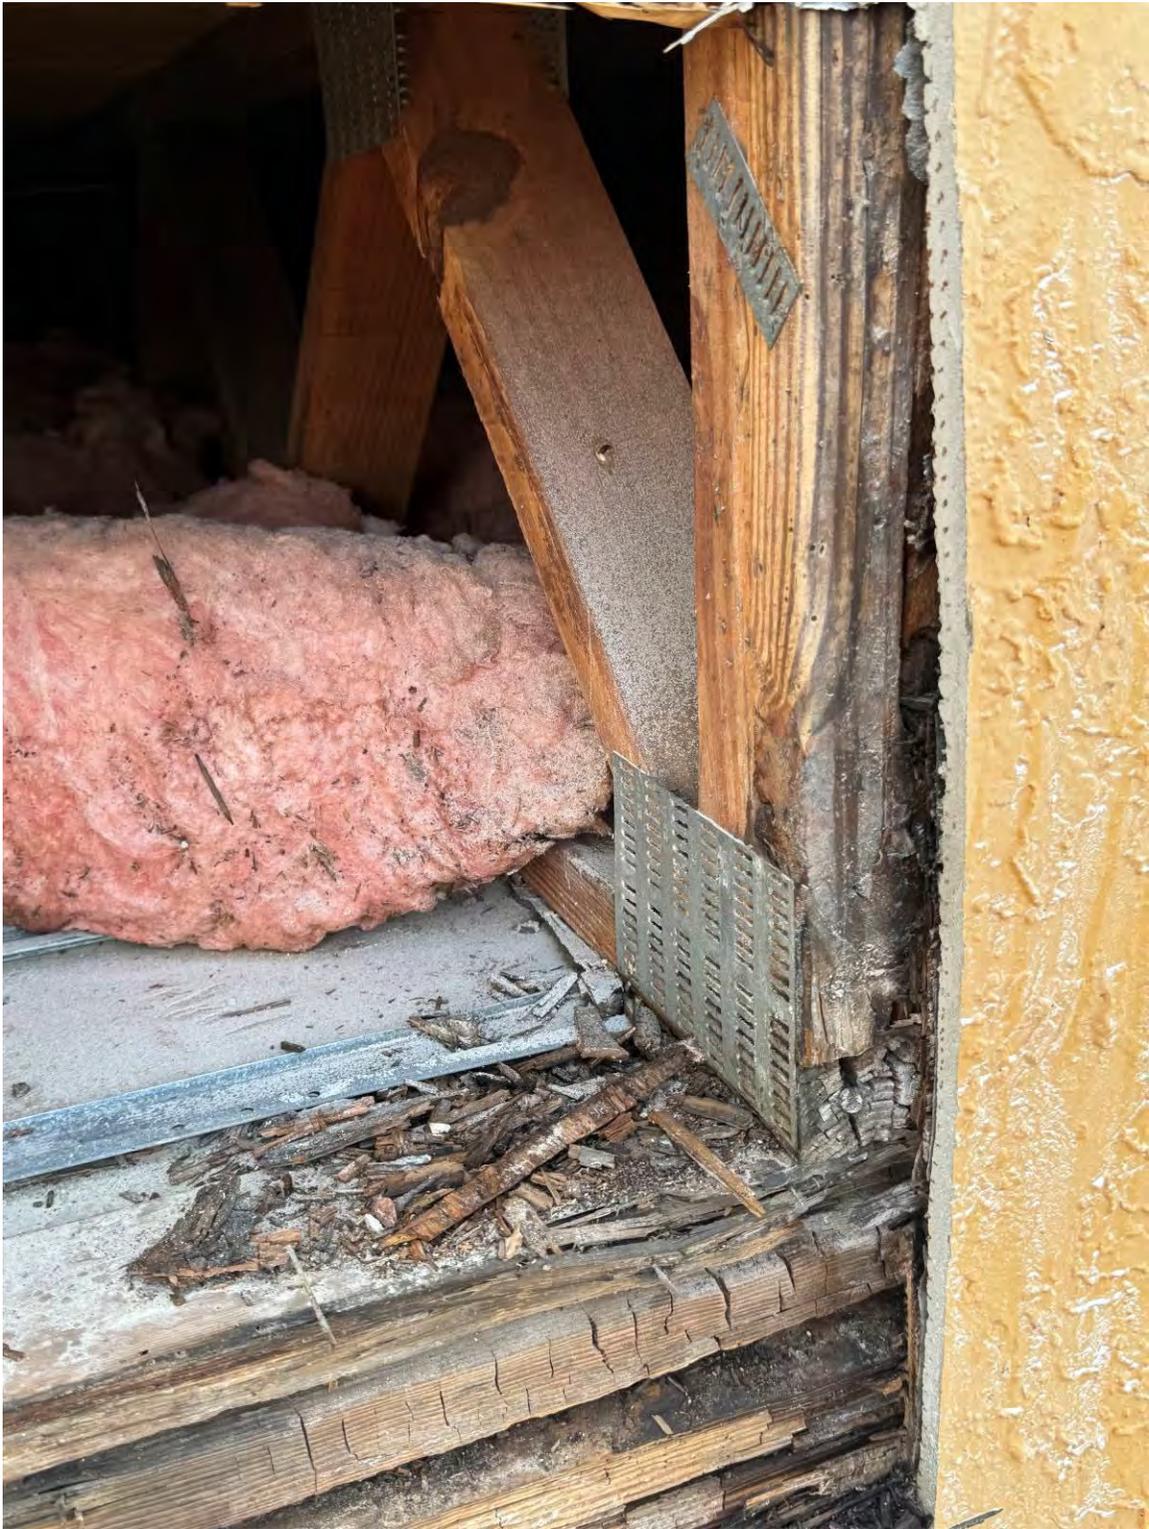
# OPENING #3

- Wood rot at top plate of 1<sup>st</sup> floor bearing wall
- Wood rot at end of ceiling floor truss
- Wood rot to sill plate for 2<sup>nd</sup> floor bearing wall
- Wood rot at 2<sup>nd</sup> floor wall studs

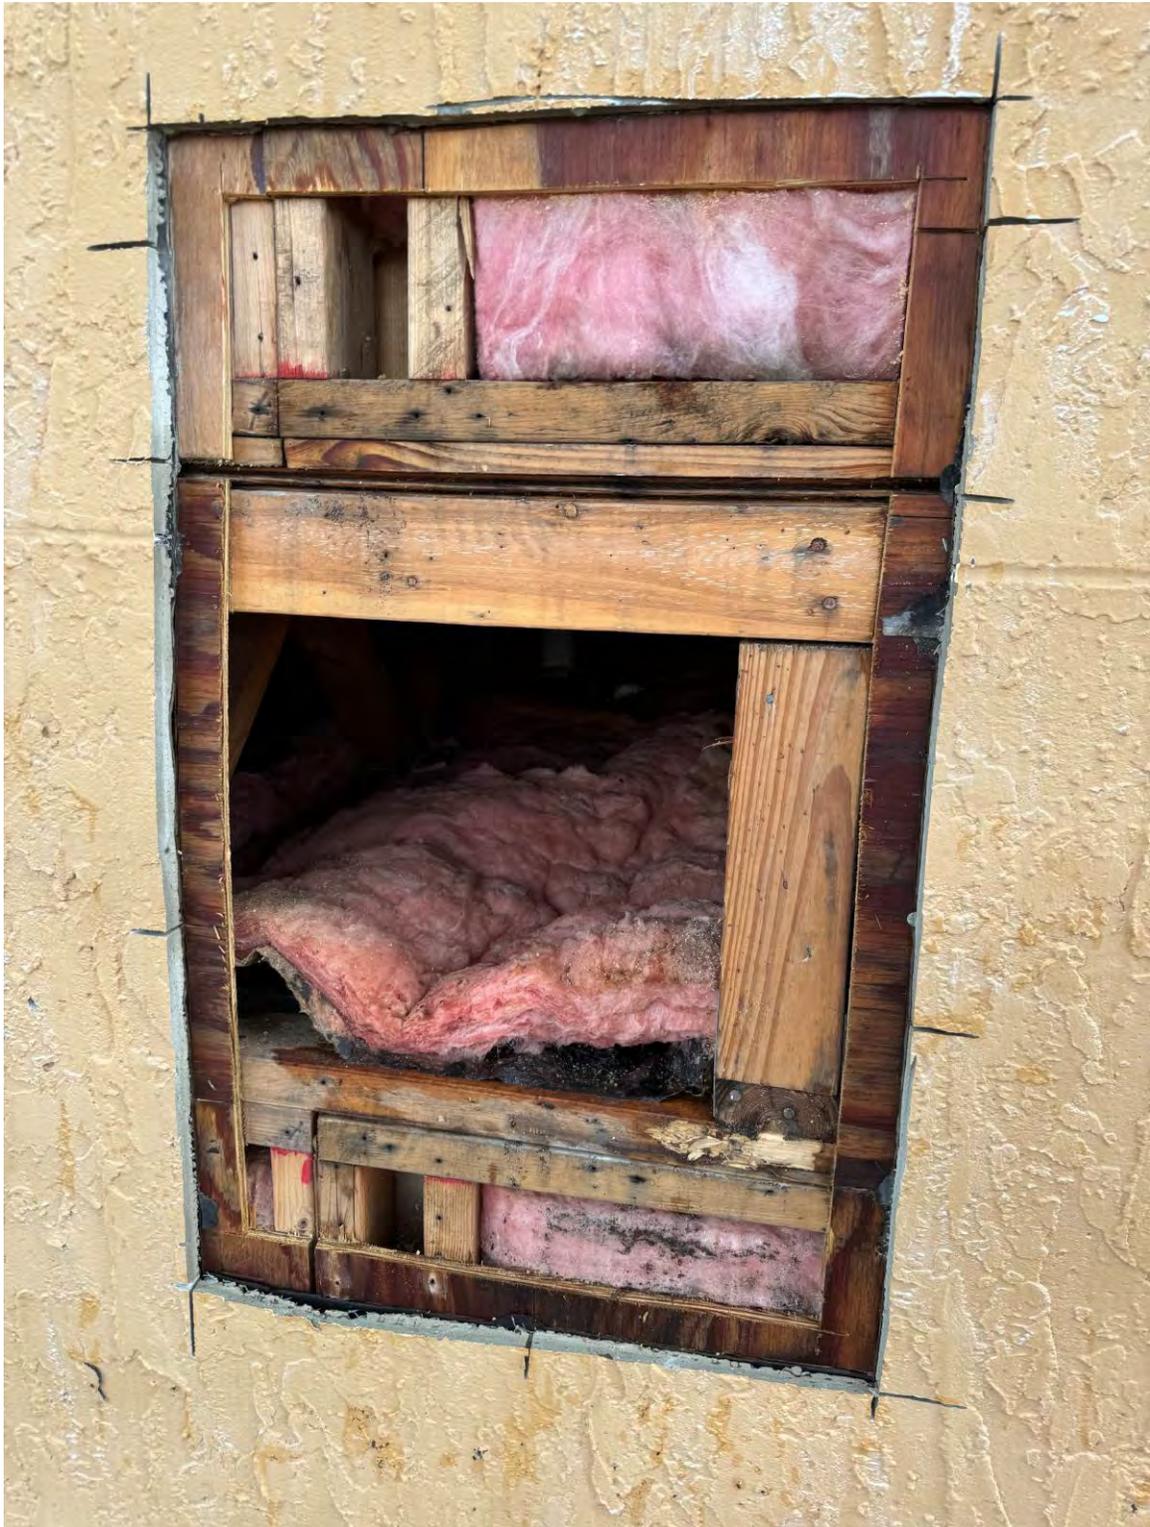
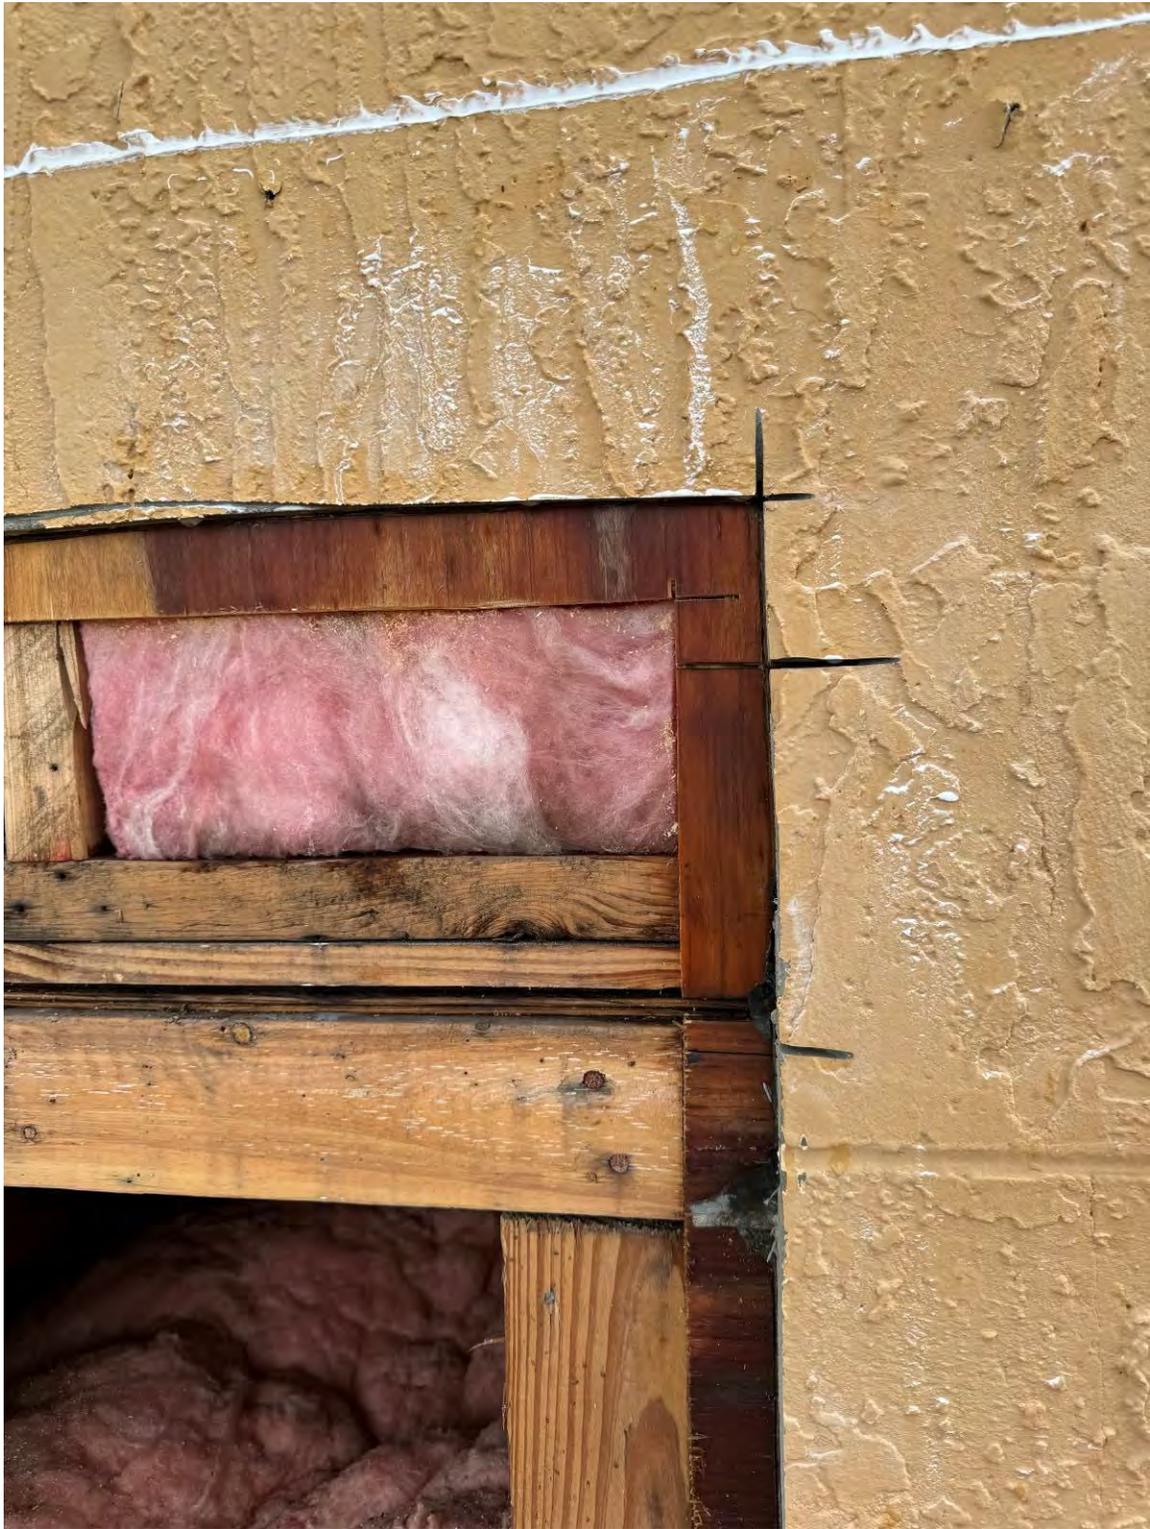
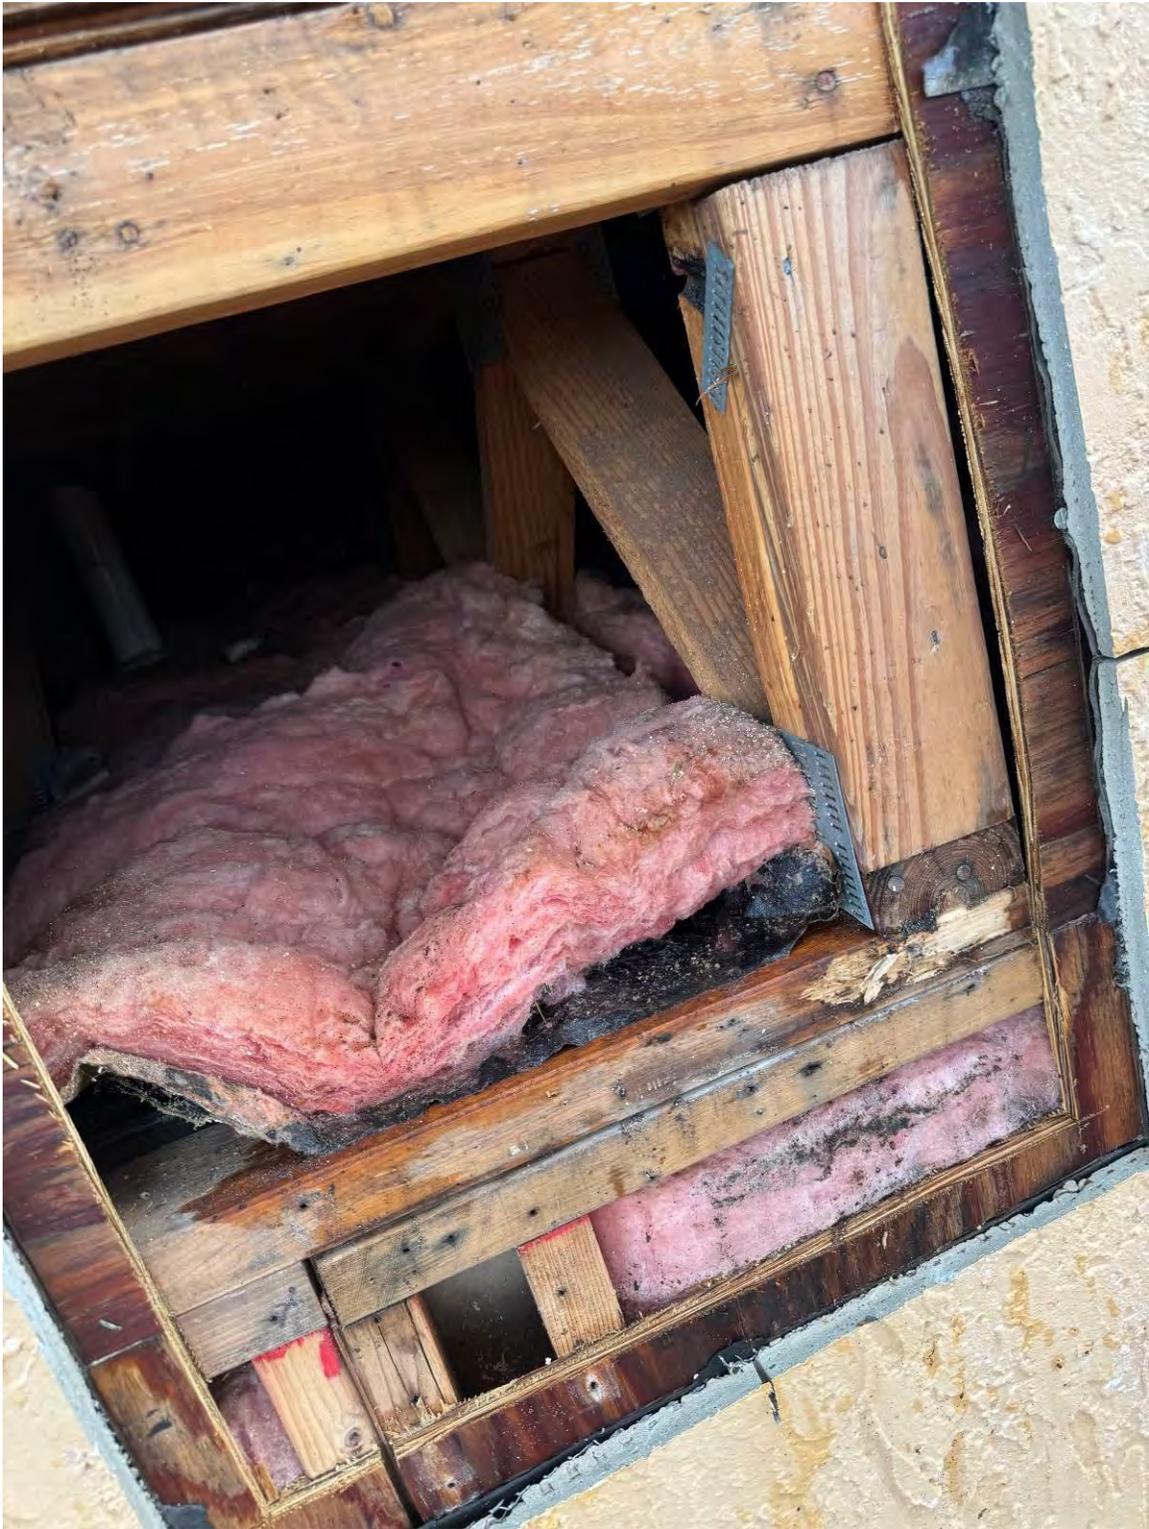
# OPENING #4

- Minor water damage to plywood flooring
- No mechanical connections from studs to bottom plate or sill plate
