**NOTICE OF FILING PART 1 OF FINAL ENGINEERING REPORT OF SPECIALTY  
ENGINEERING CONSULTANTS, INC. DATED NOVEMBER 5, 2024**

**PROFESSIONAL CONSULTING SERVICES FOR:  
Heron Pond Condominium Association, Inc.**

Building #9  
8343 SW 5<sup>th</sup> Street,  
Pembroke Pines, FL 33025

Re: Investigation and Documentation of Deteriorated and Damaged Structural Items

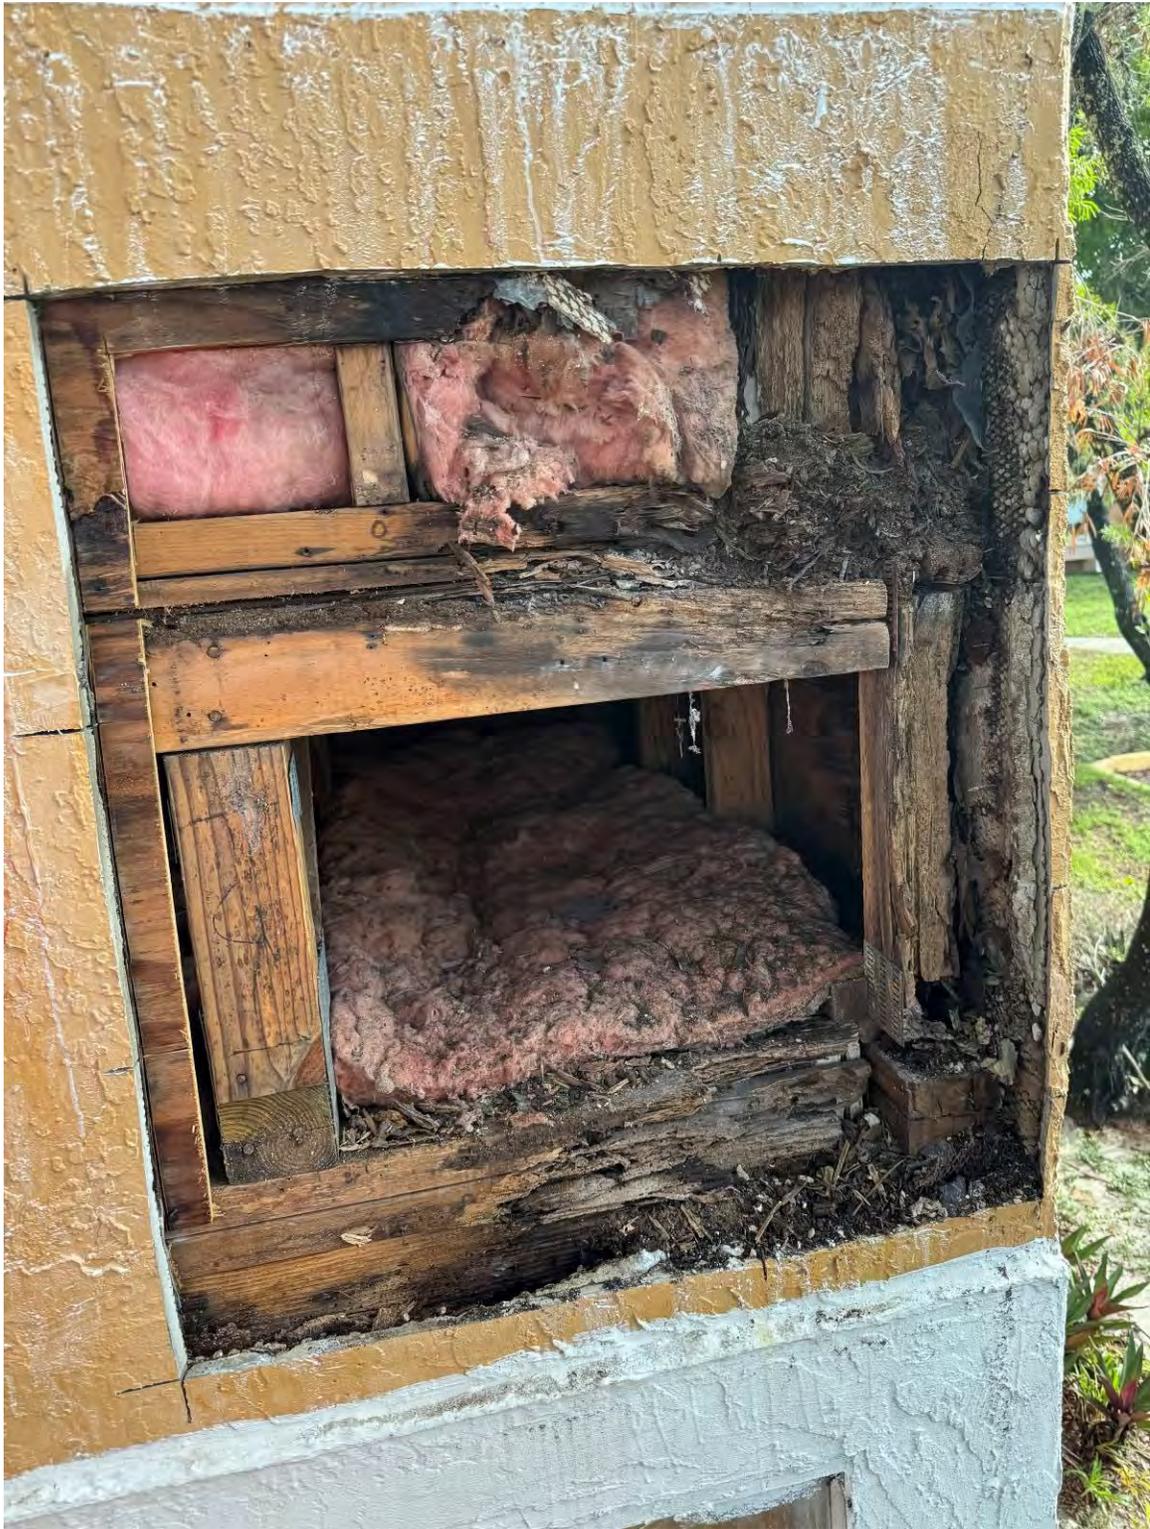
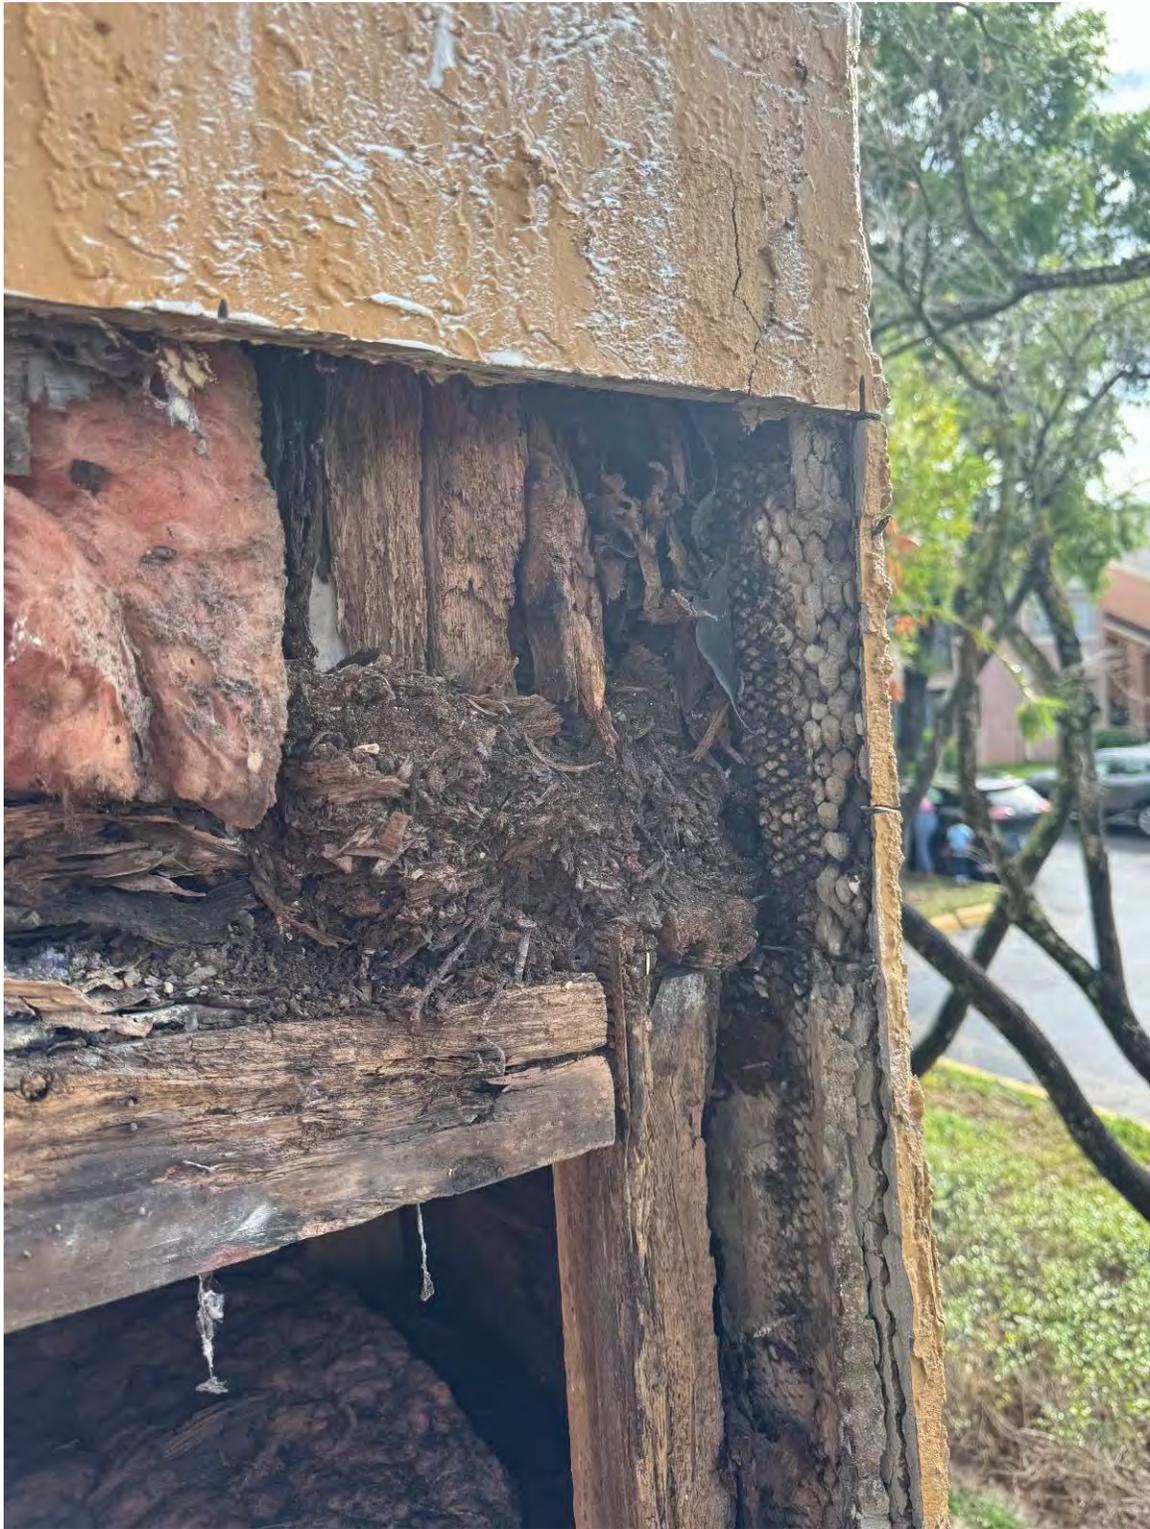
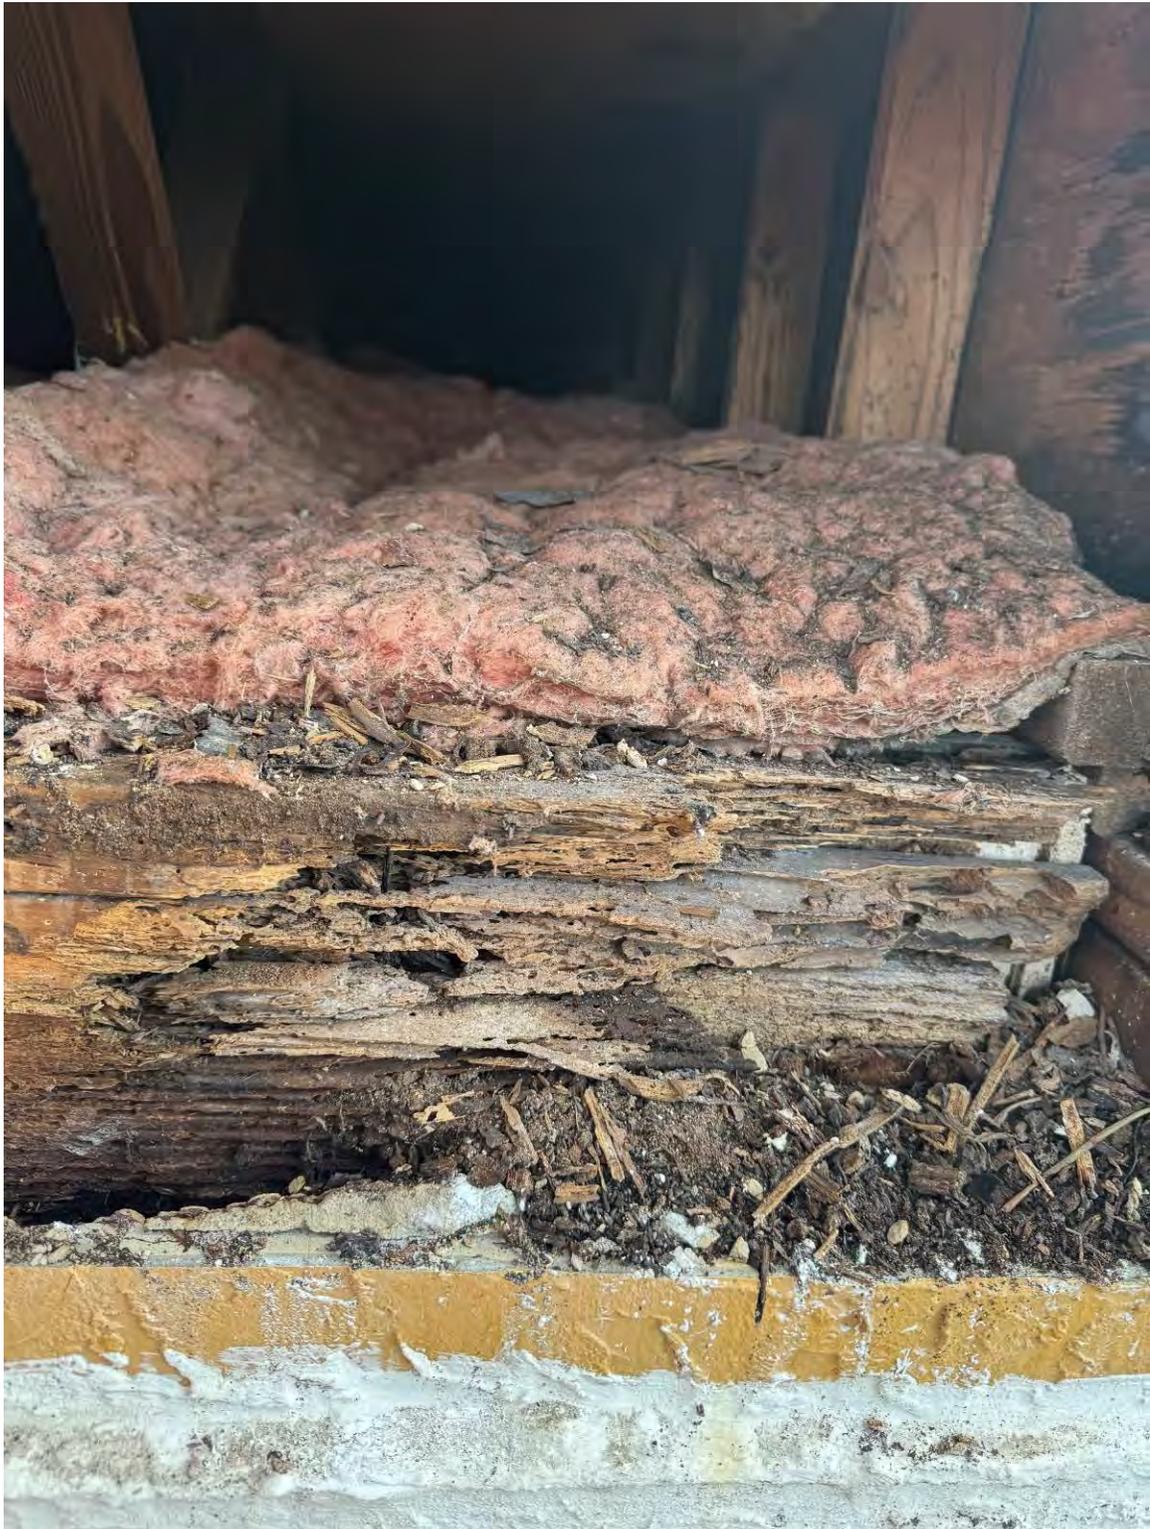
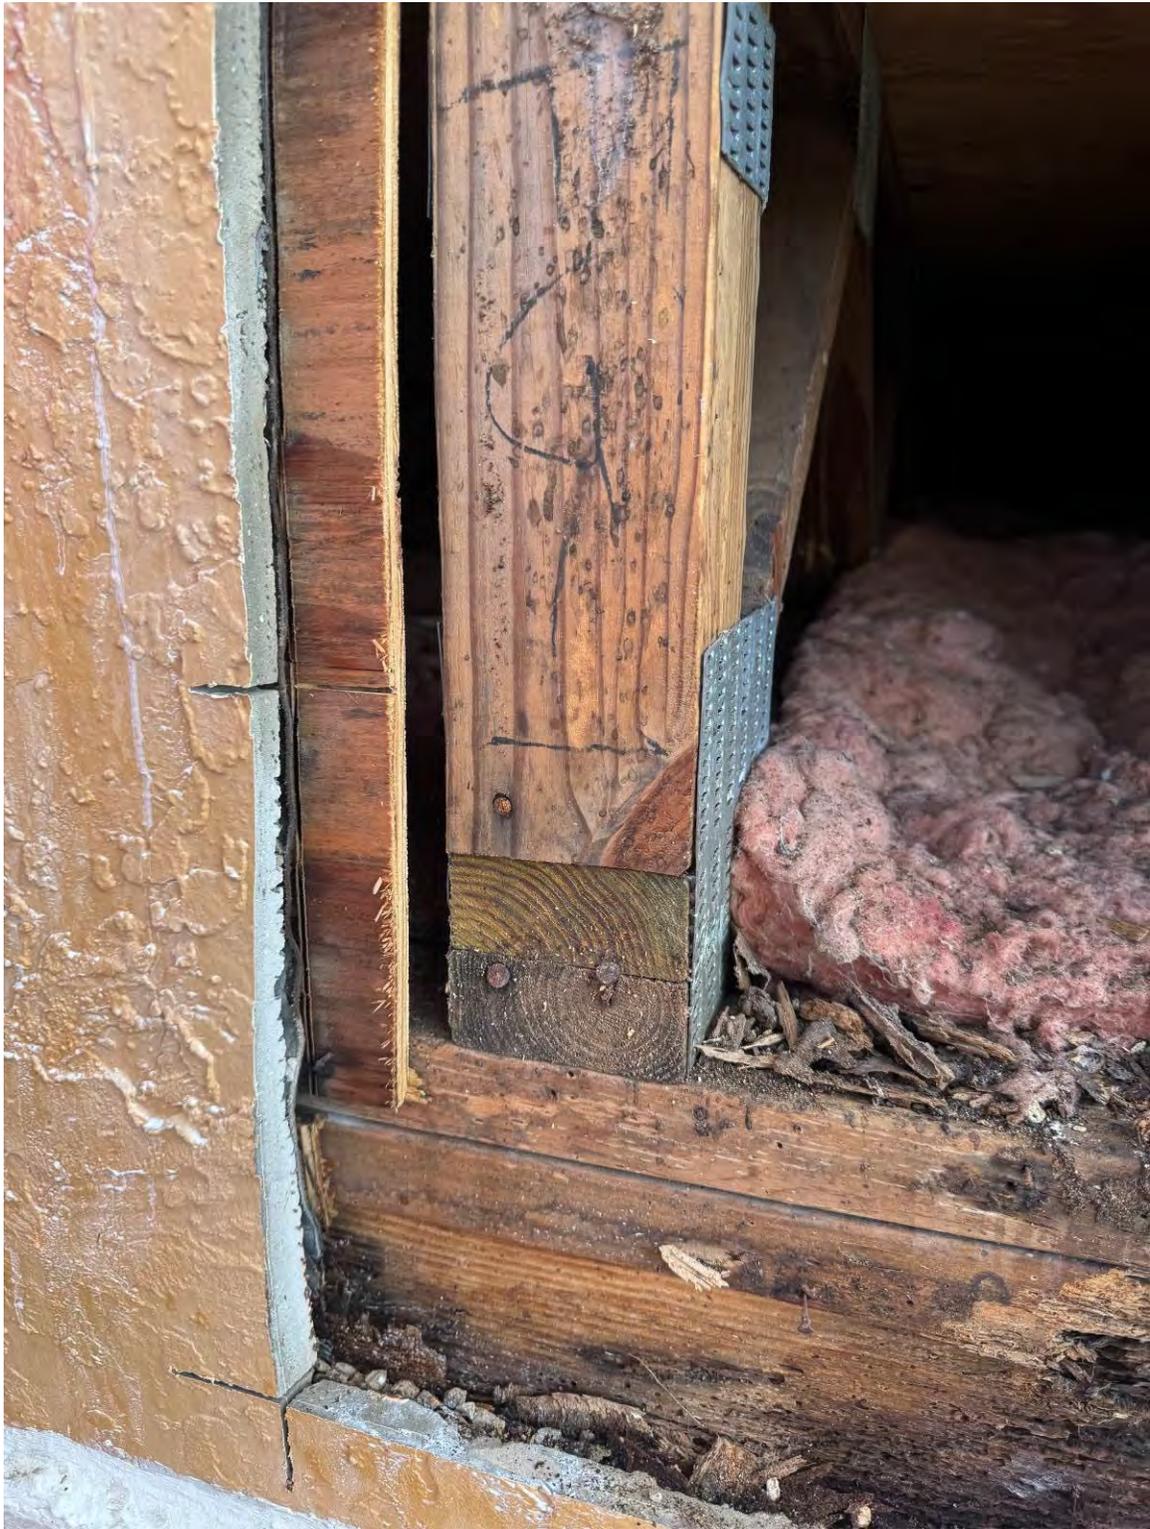
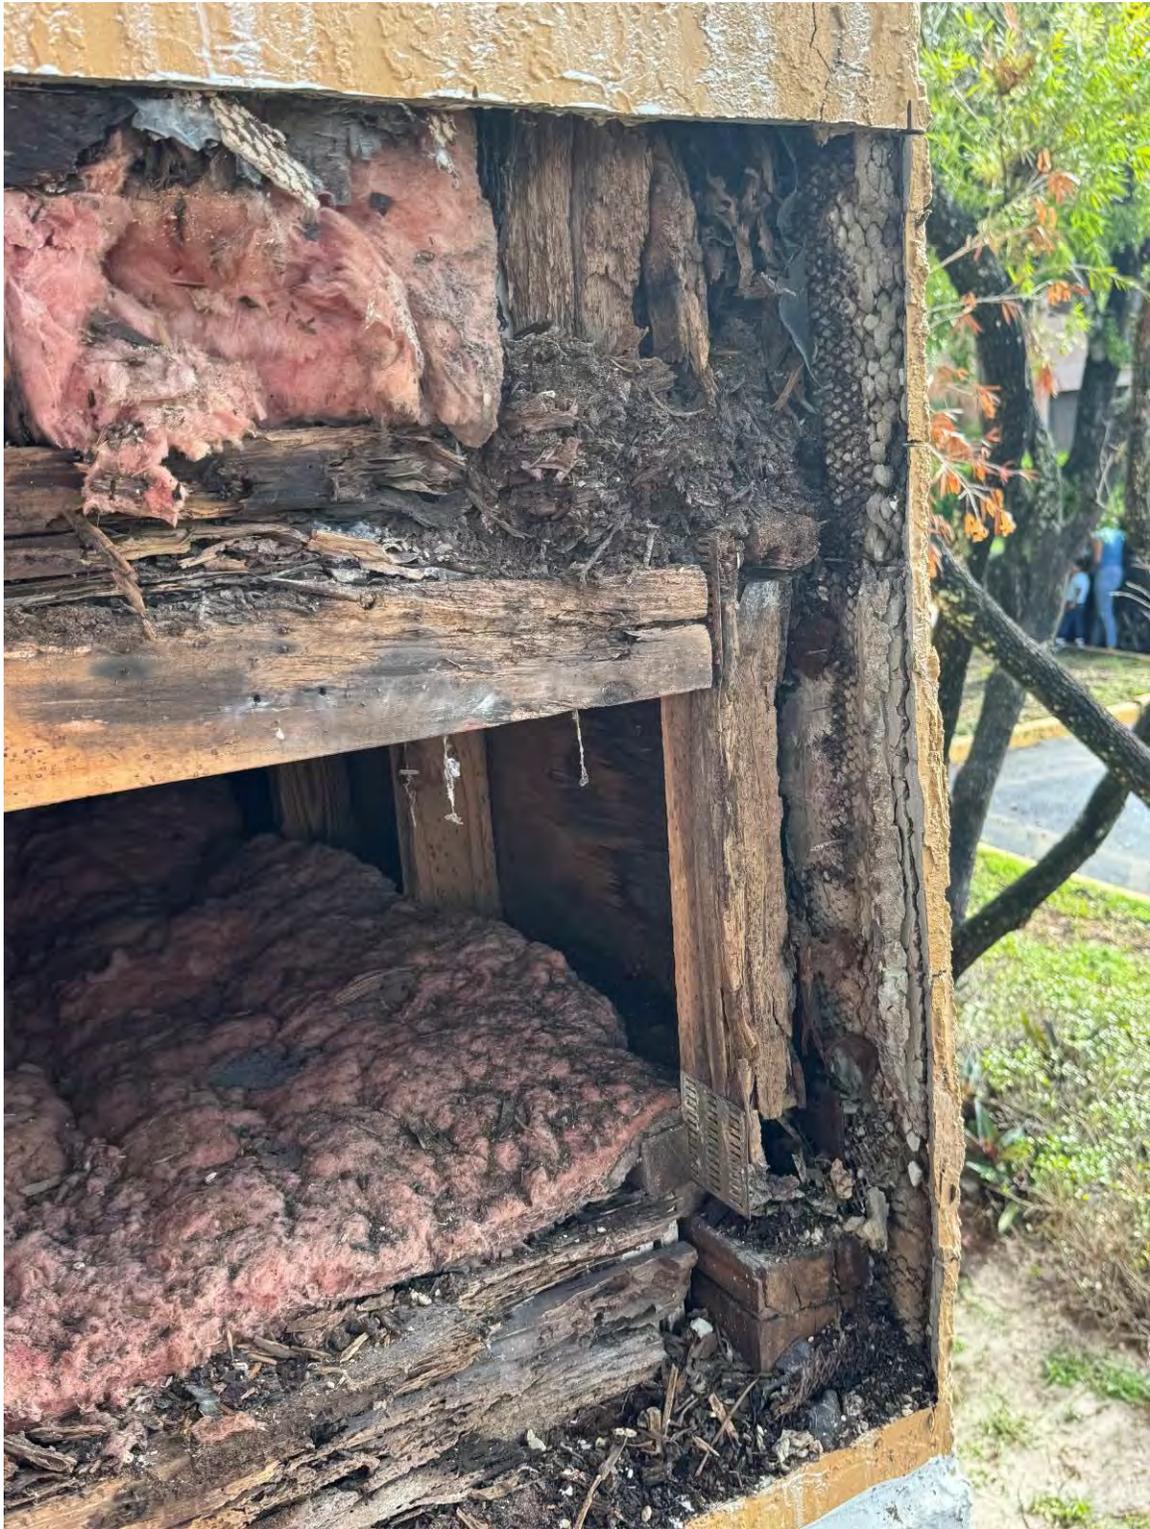
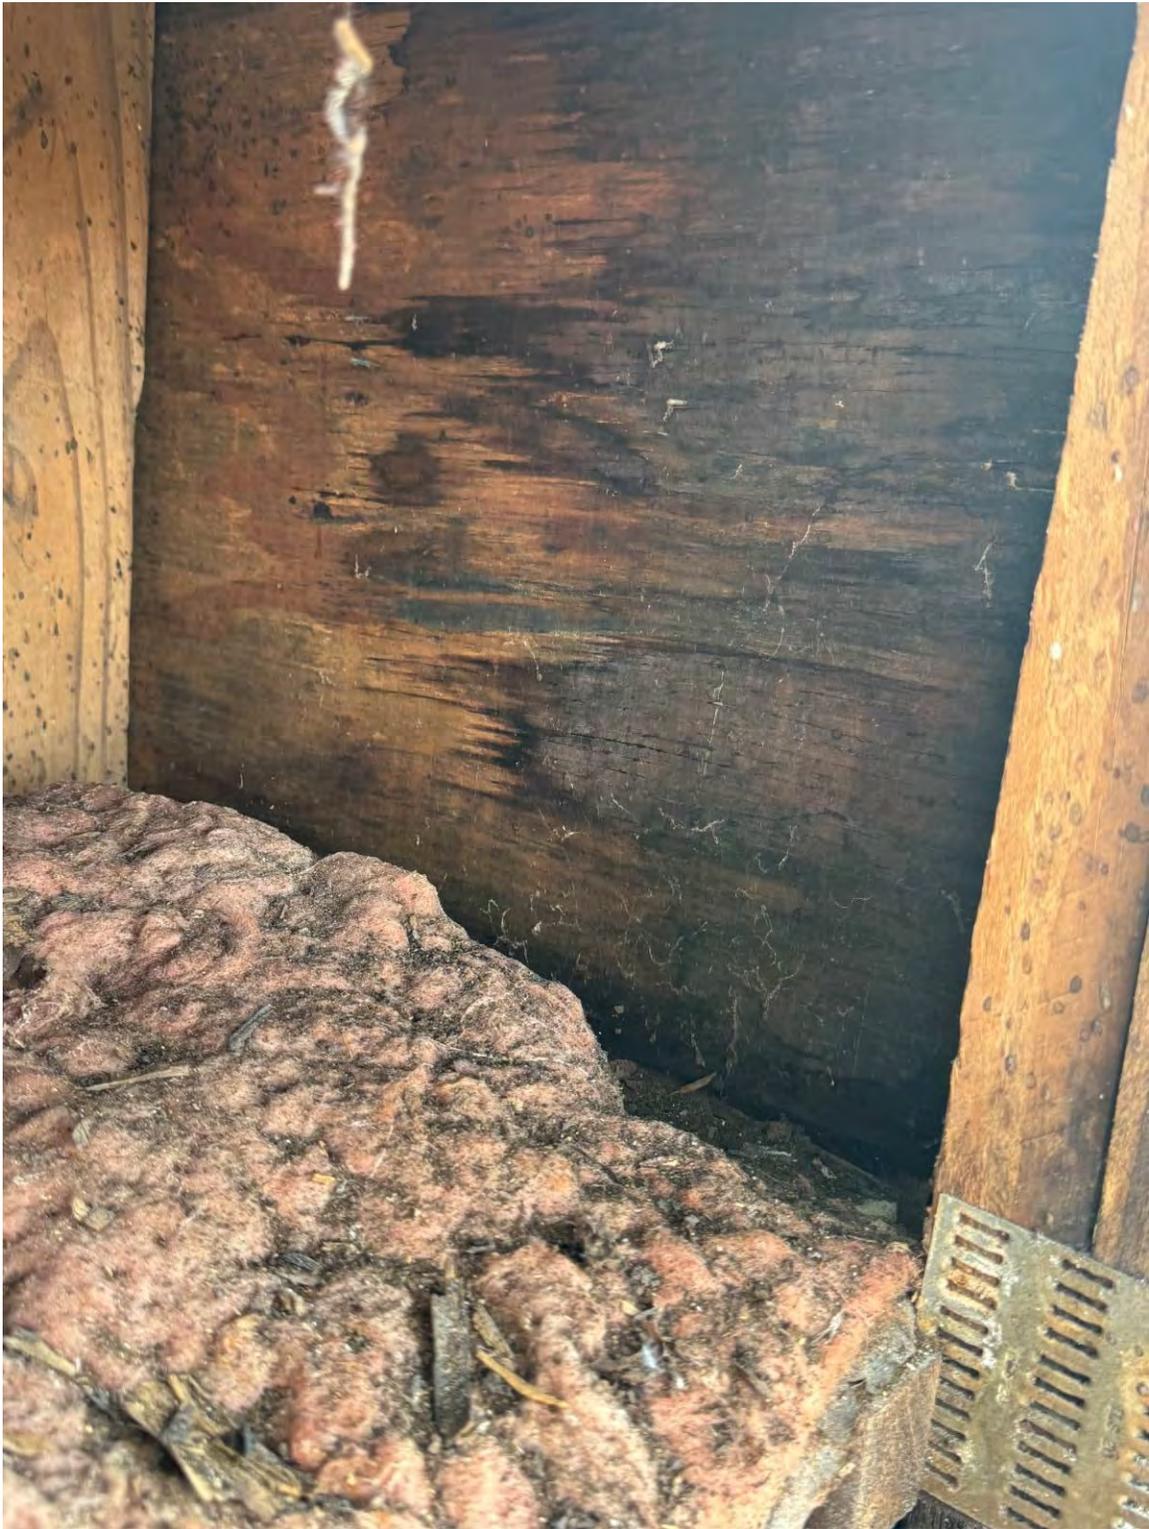
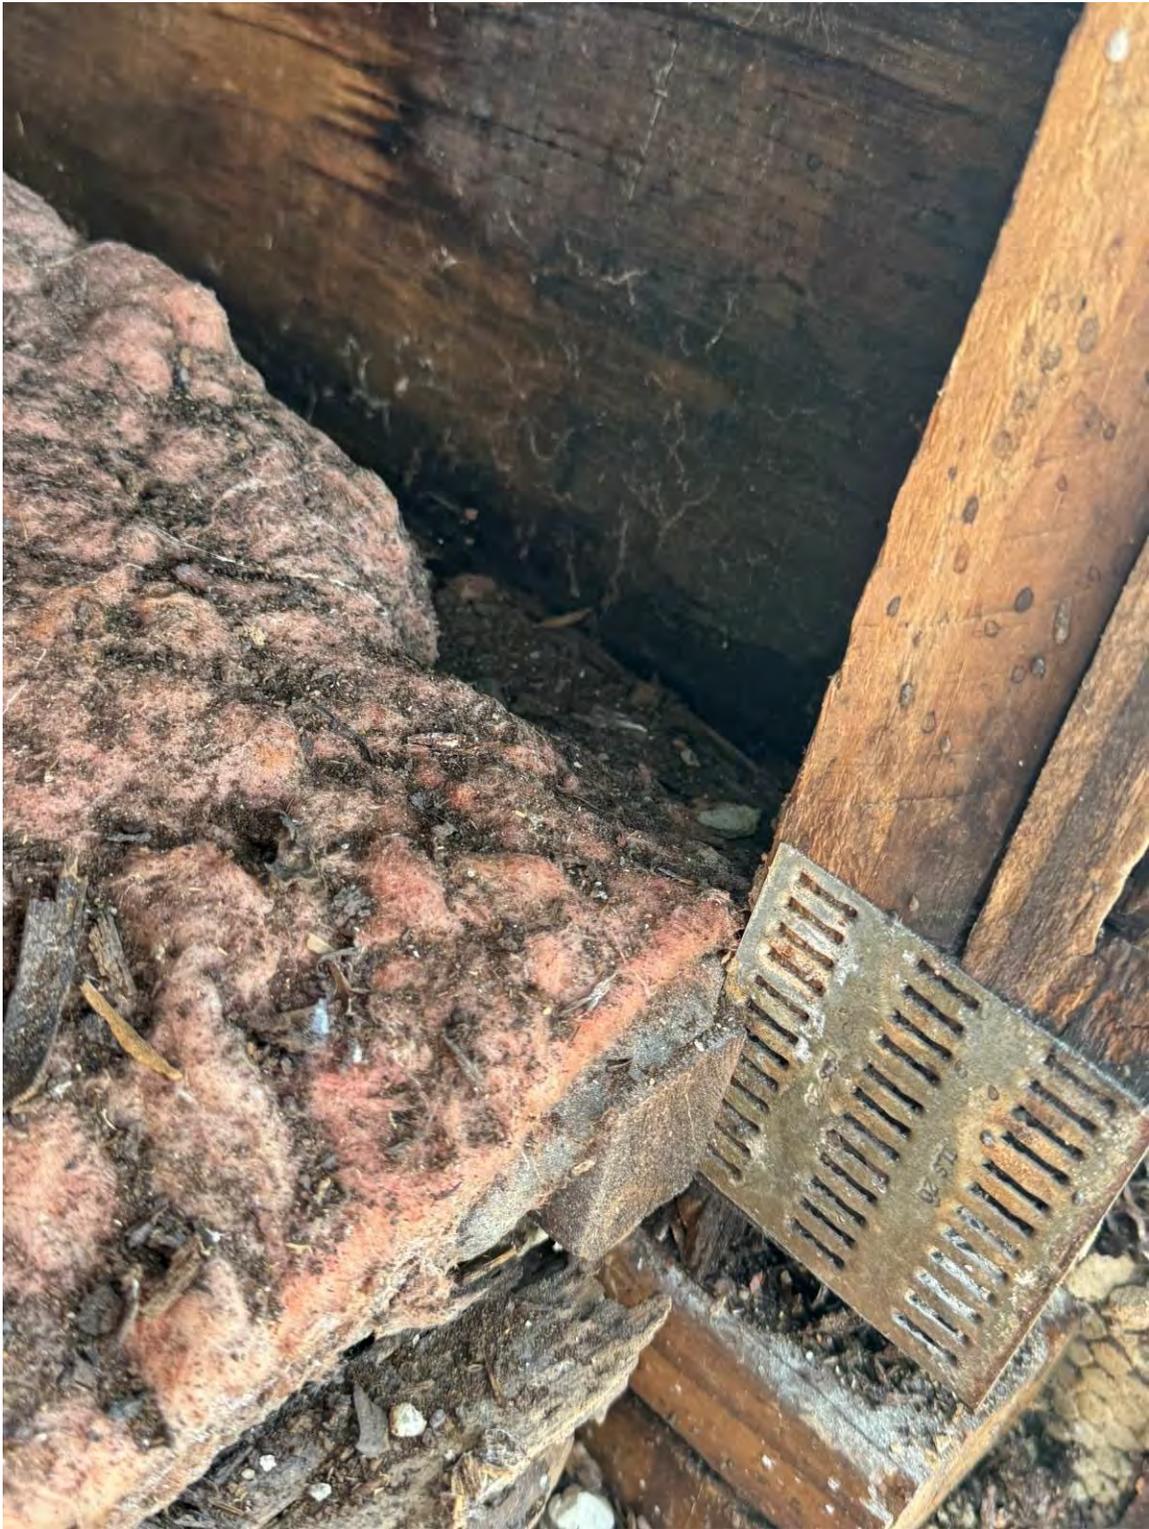
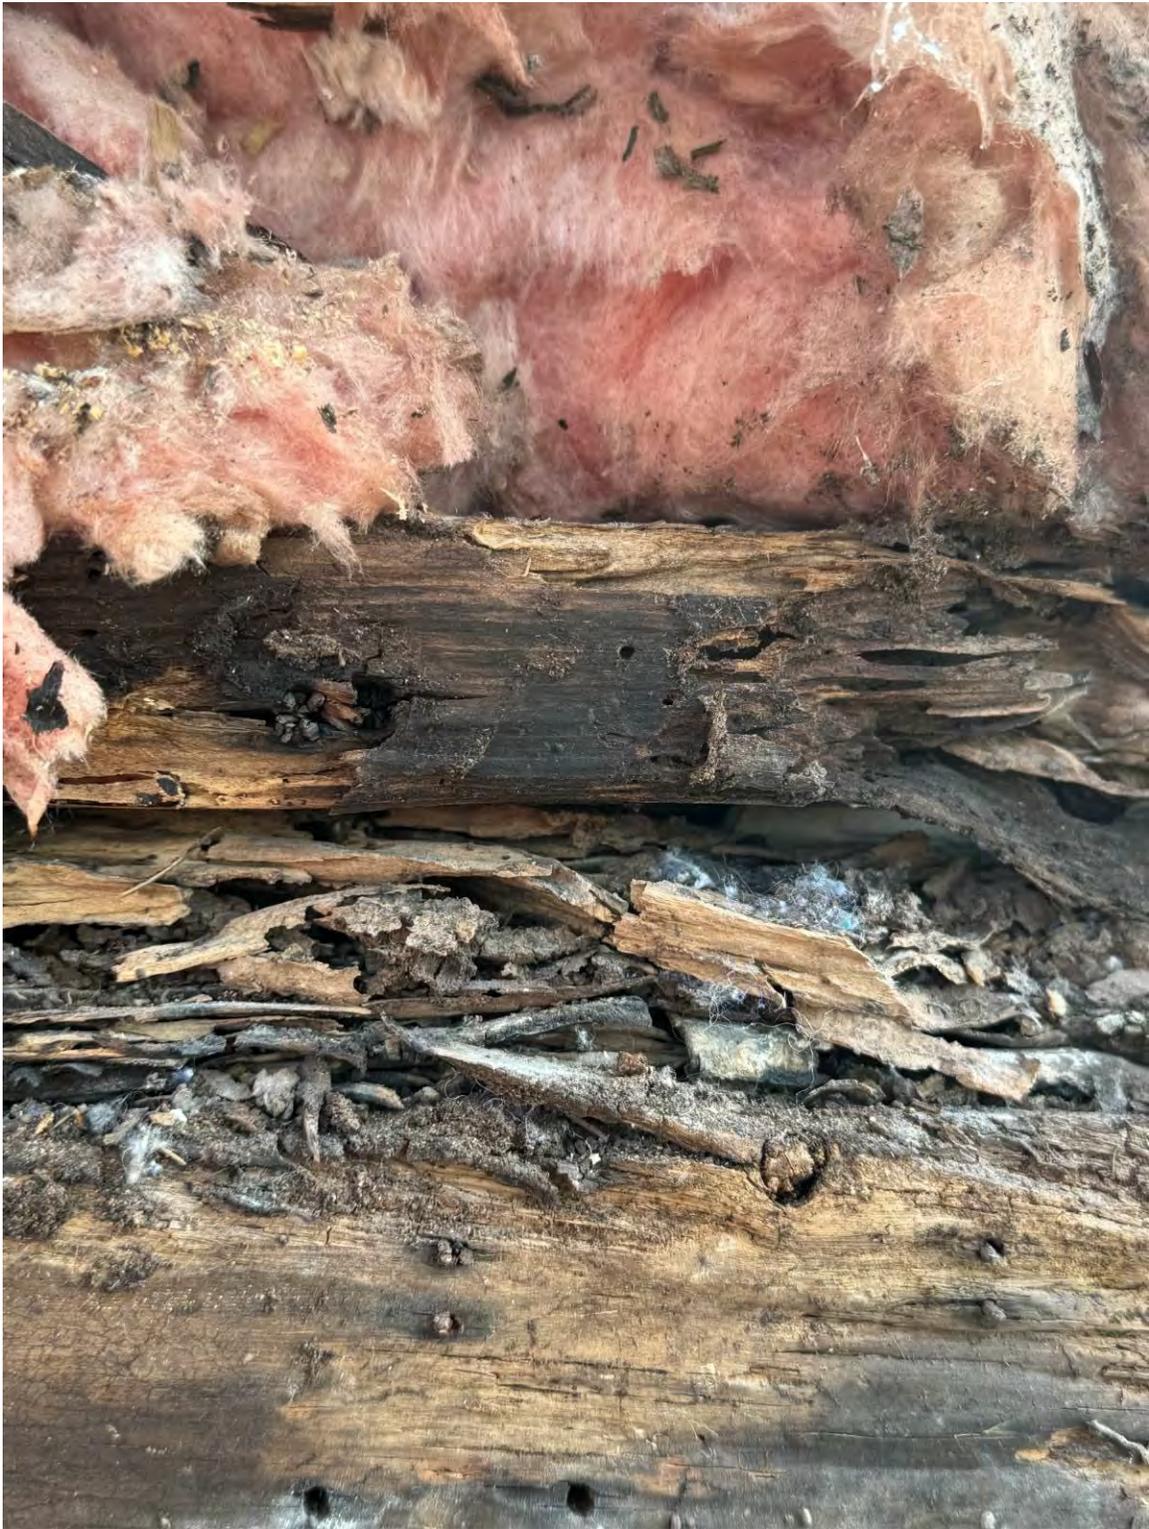
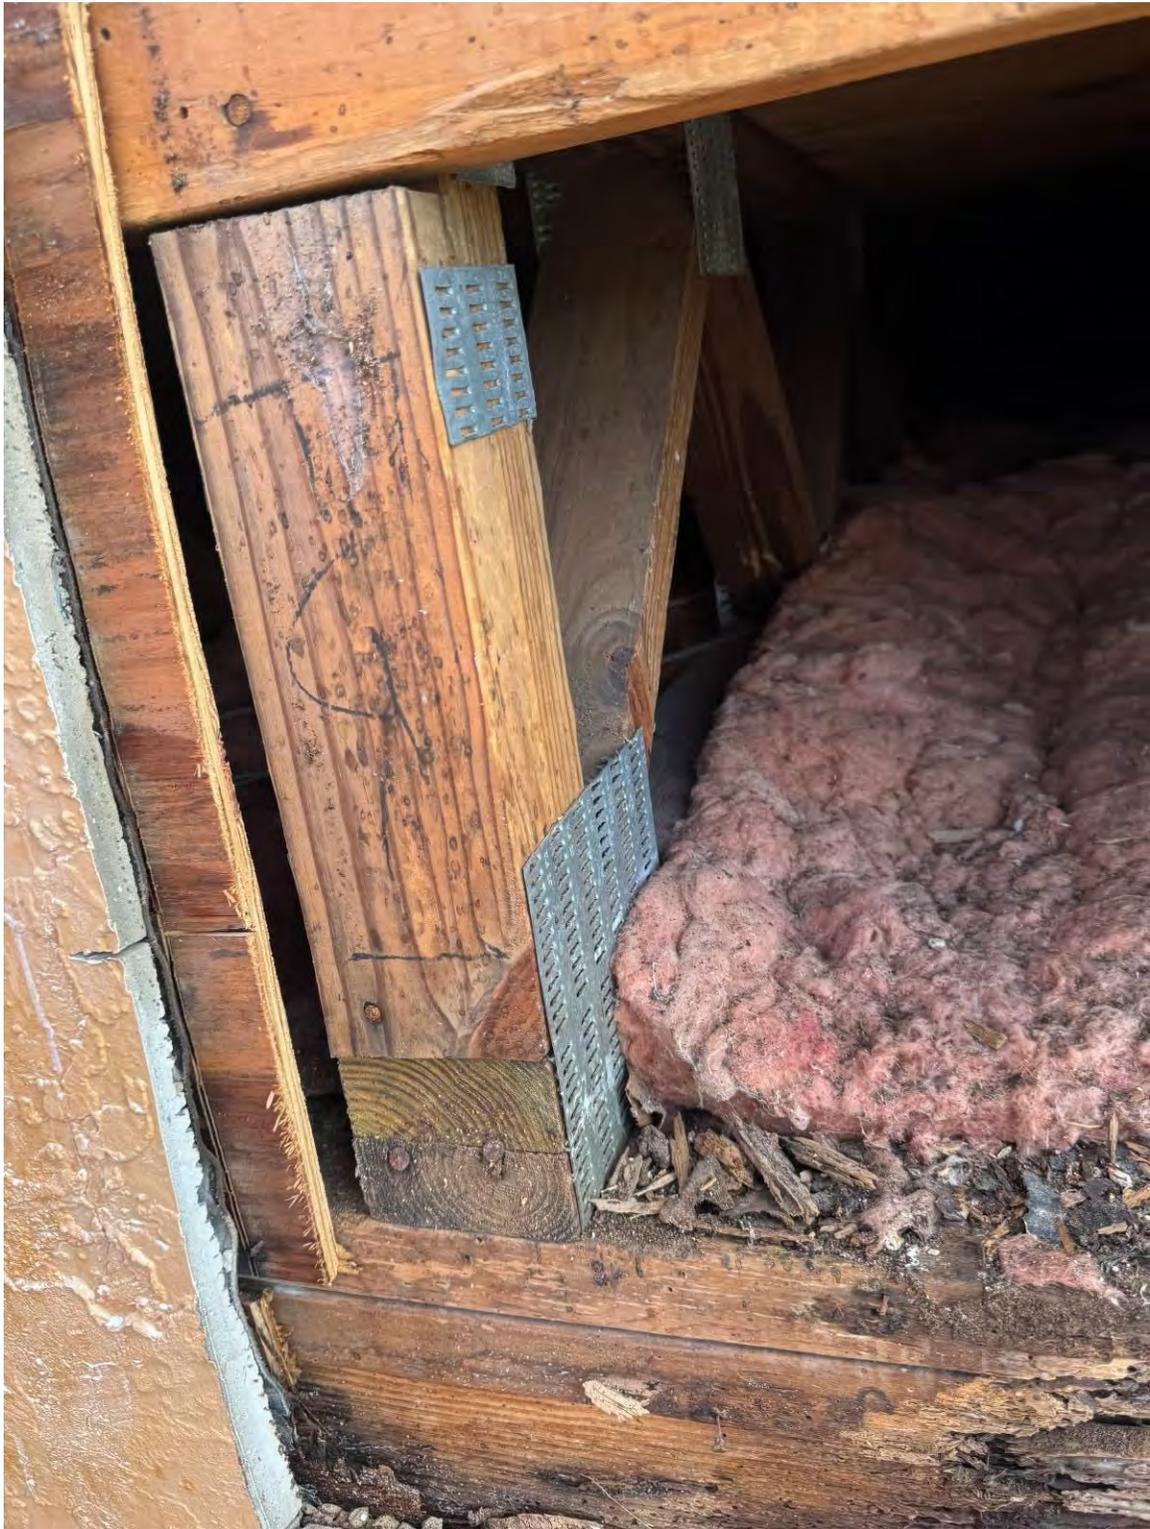
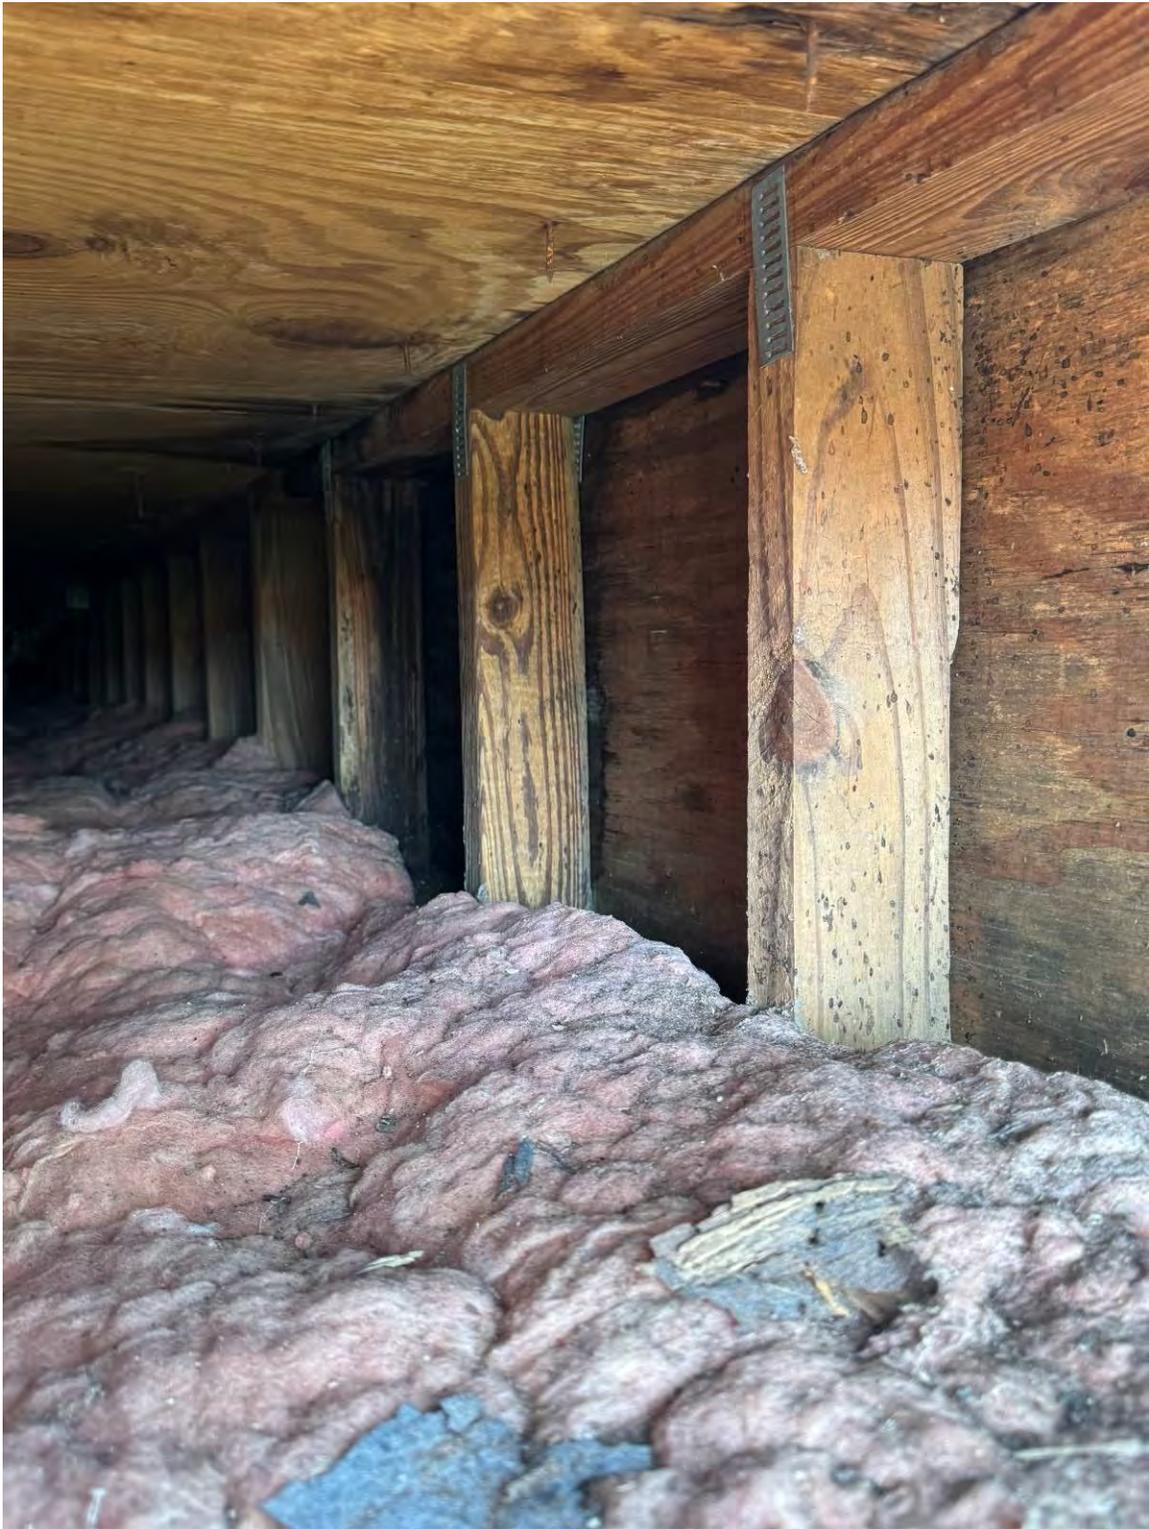
# OPENING #5

- Exterior sheathing has water damage and is destroyed
- Bearing wall 1<sup>st</sup> floor has termite damage and water damage
- Top plate of bearing wall has water damage
- End of exterior floor joist is destroyed
- 2<sup>nd</sup> floor sheathing has water damage and termite damage
- 2<sup>nd</sup> floor bearing wall bottom plate is destroyed
- 2<sup>nd</sup> floor wall studs have water damage and are destroyed
- 2<sup>nd</sup> floor wall sheathing on east side has water damage
