**NOTICE OF FILING PART 1 OF FINAL ENGINEERING REPORT OF SPECIALTY  
ENGINEERING CONSULTANTS, INC. DATED NOVEMBER 5, 2024**

**PROFESSIONAL CONSULTING SERVICES FOR:  
Heron Pond Condominium Association, Inc.**

Building #9  
8343 SW 5<sup>th</sup> Street,  
Pembroke Pines, FL 33025

Re: Investigation and Documentation of Deteriorated and Damaged Structural Items

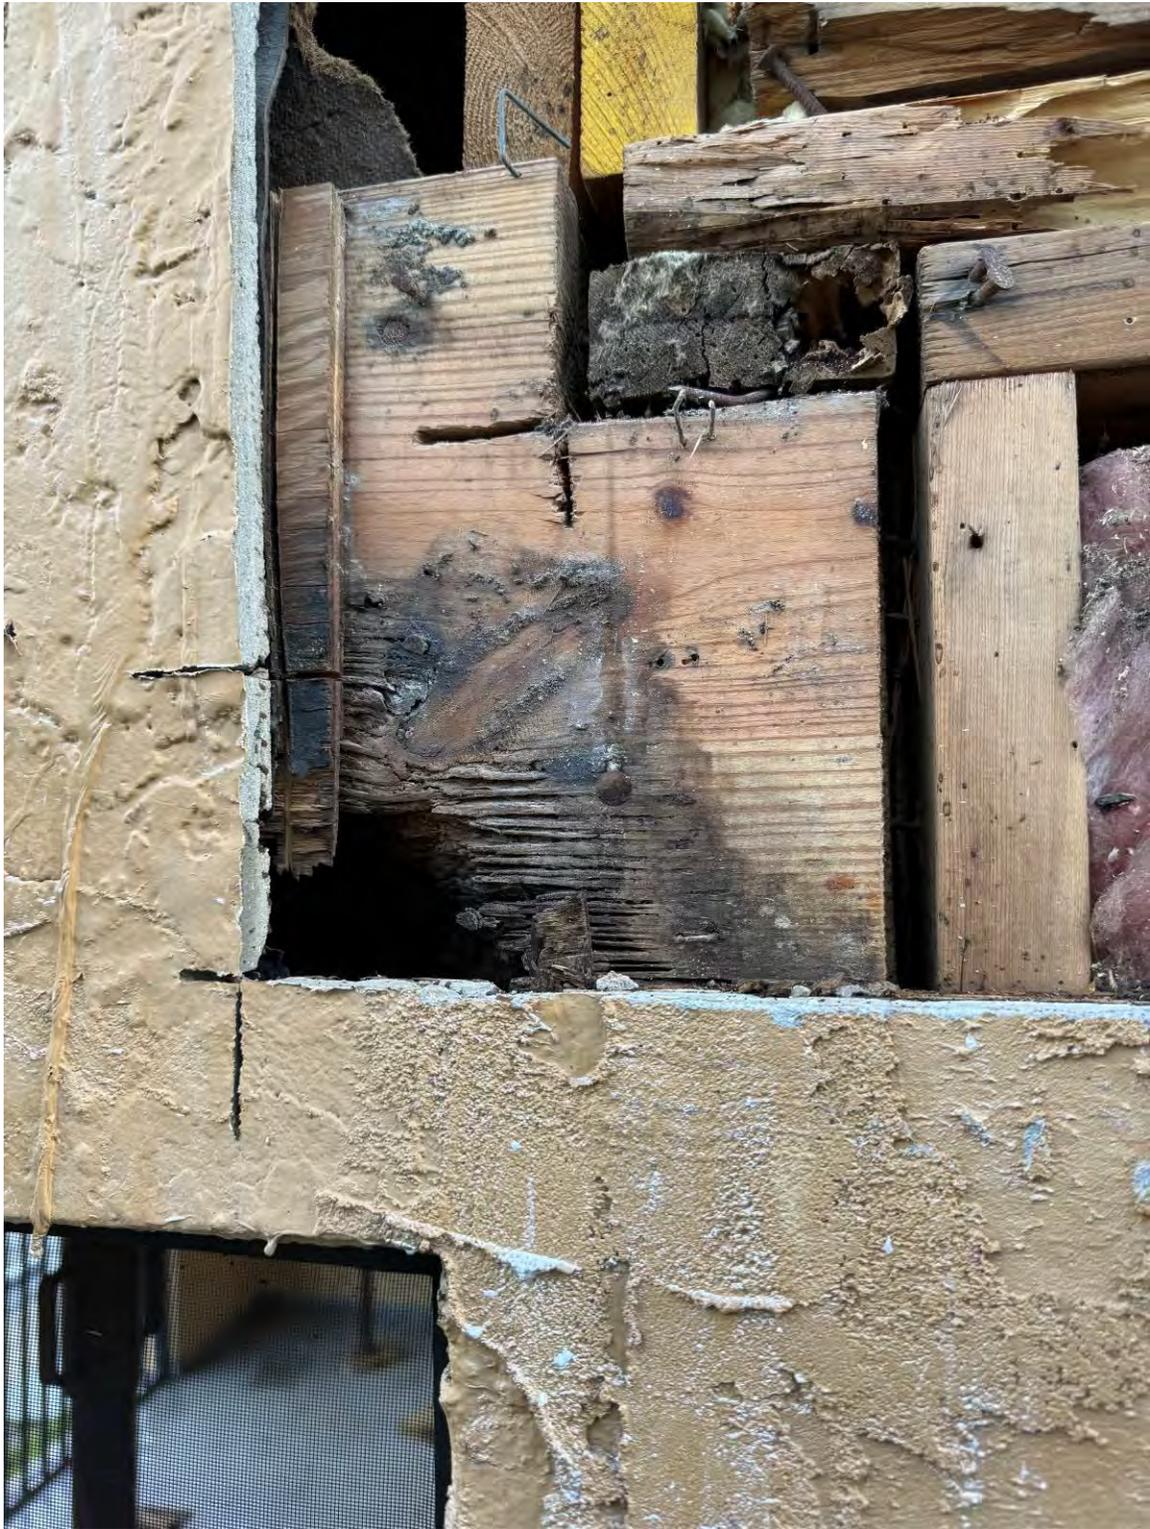
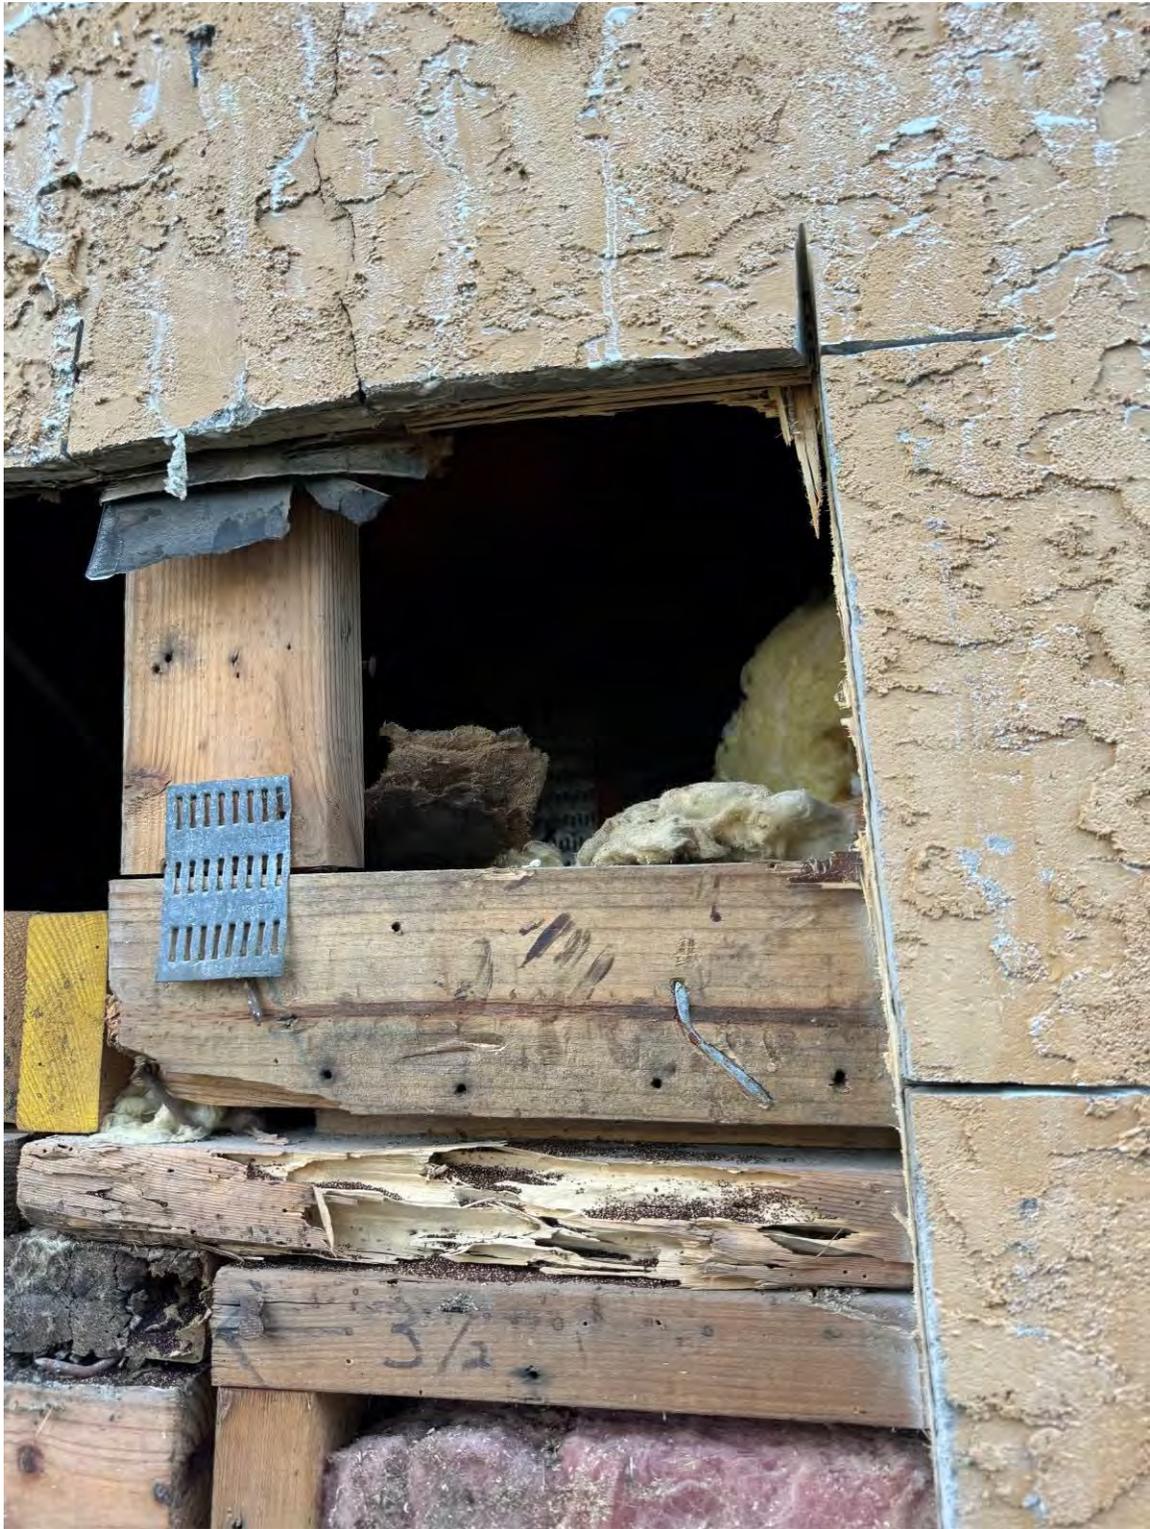
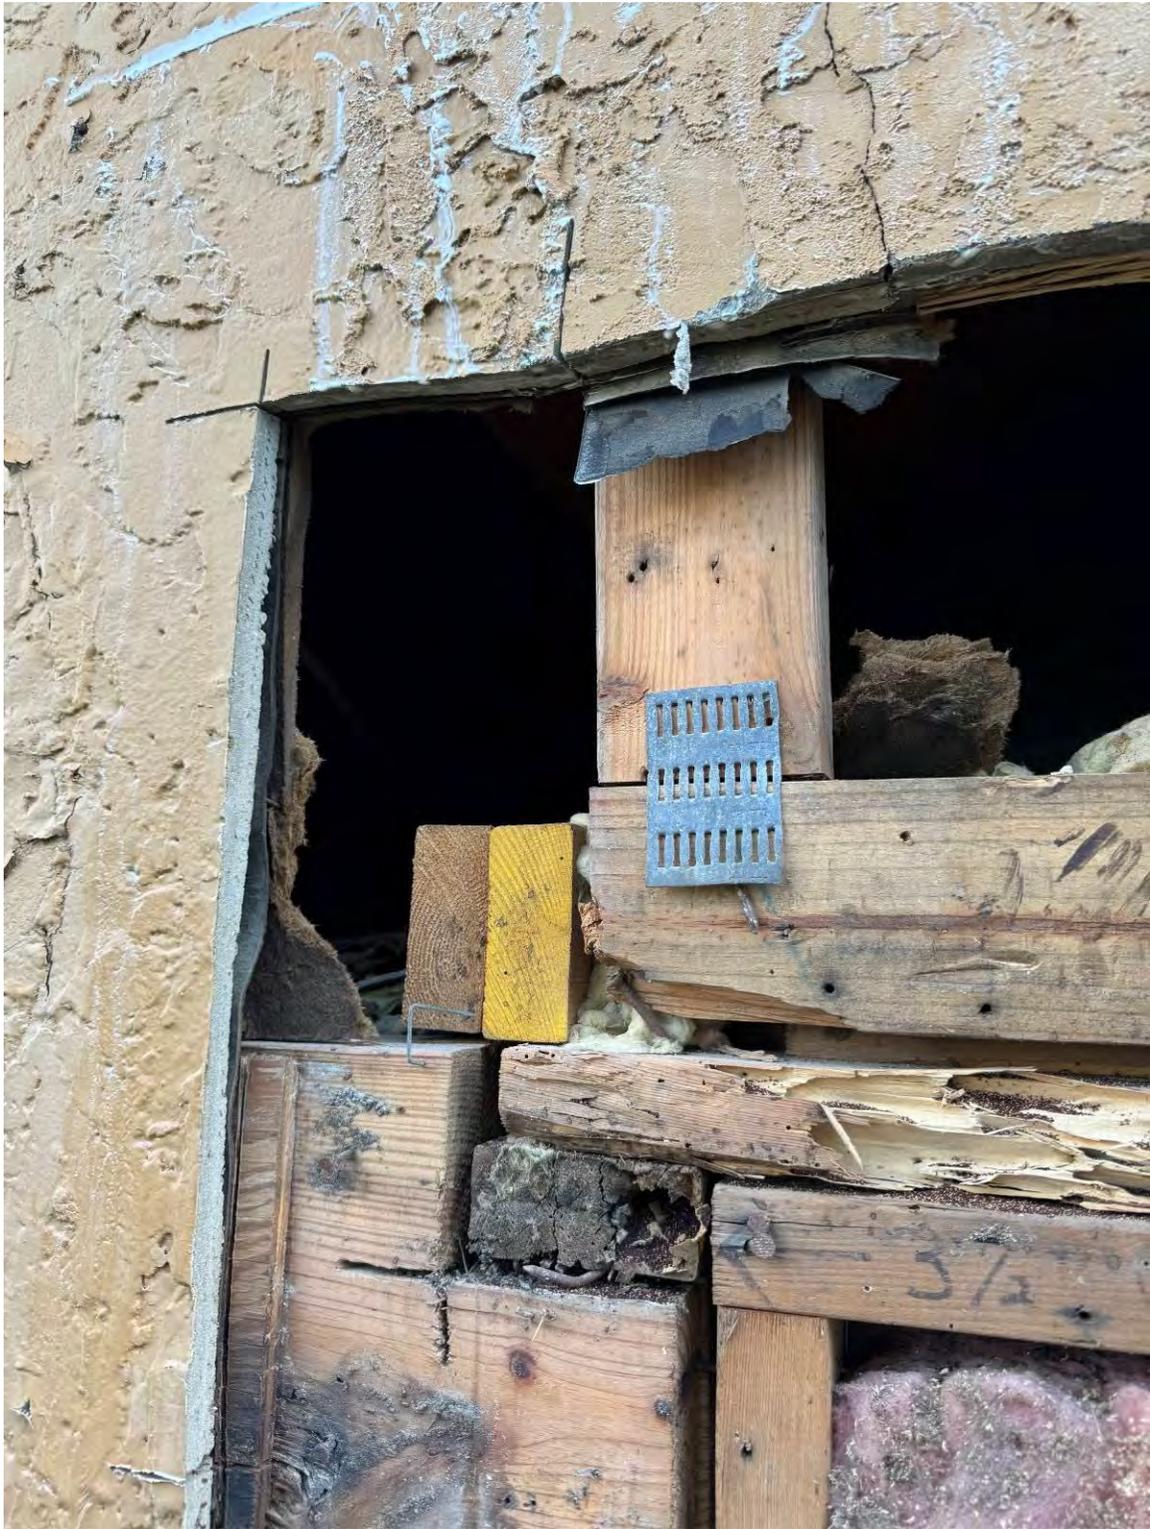
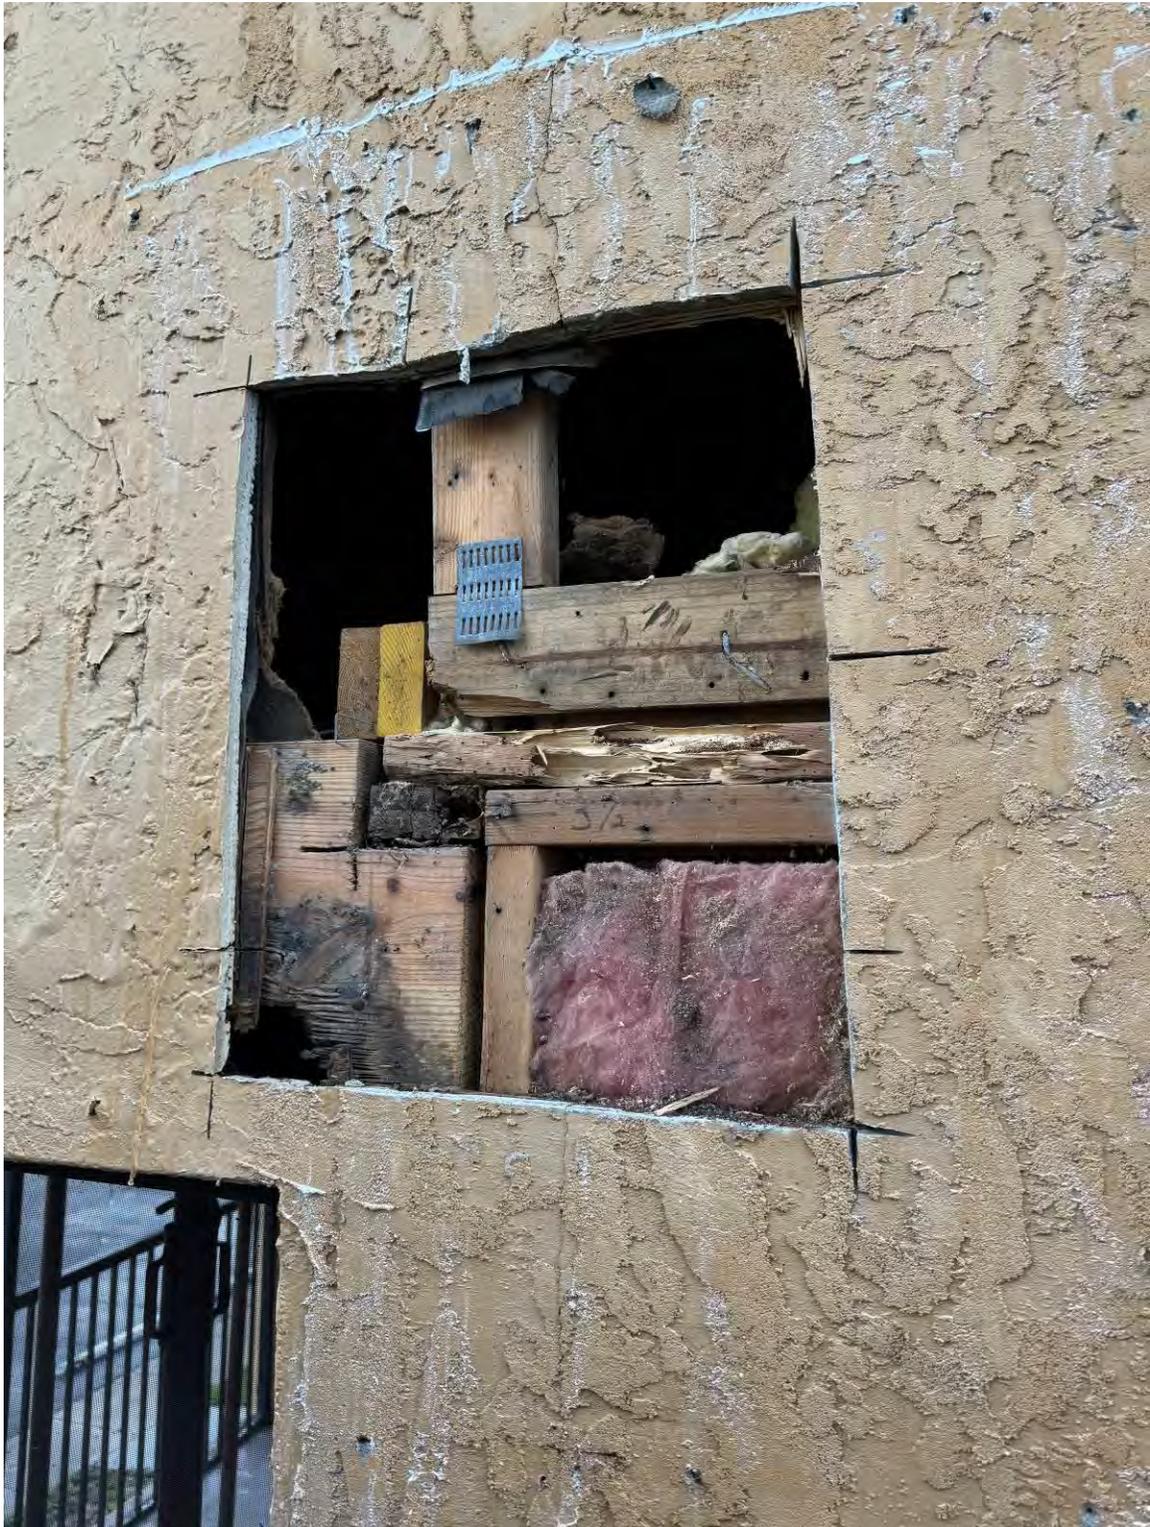
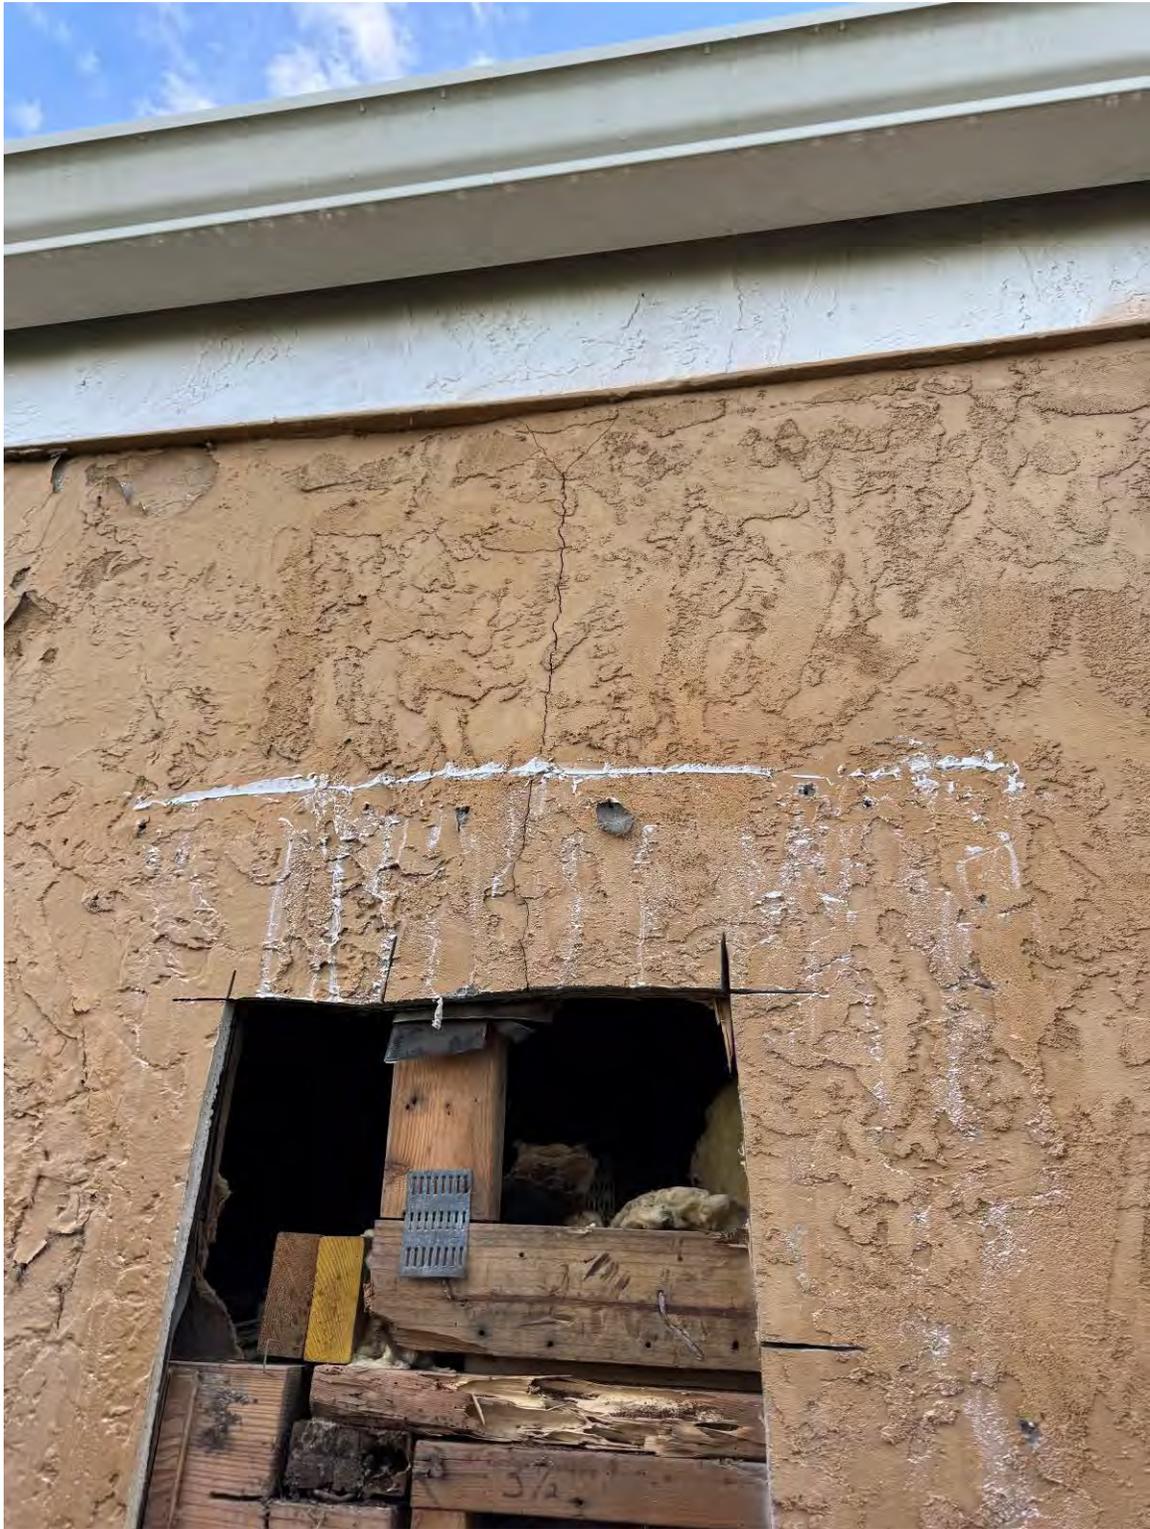
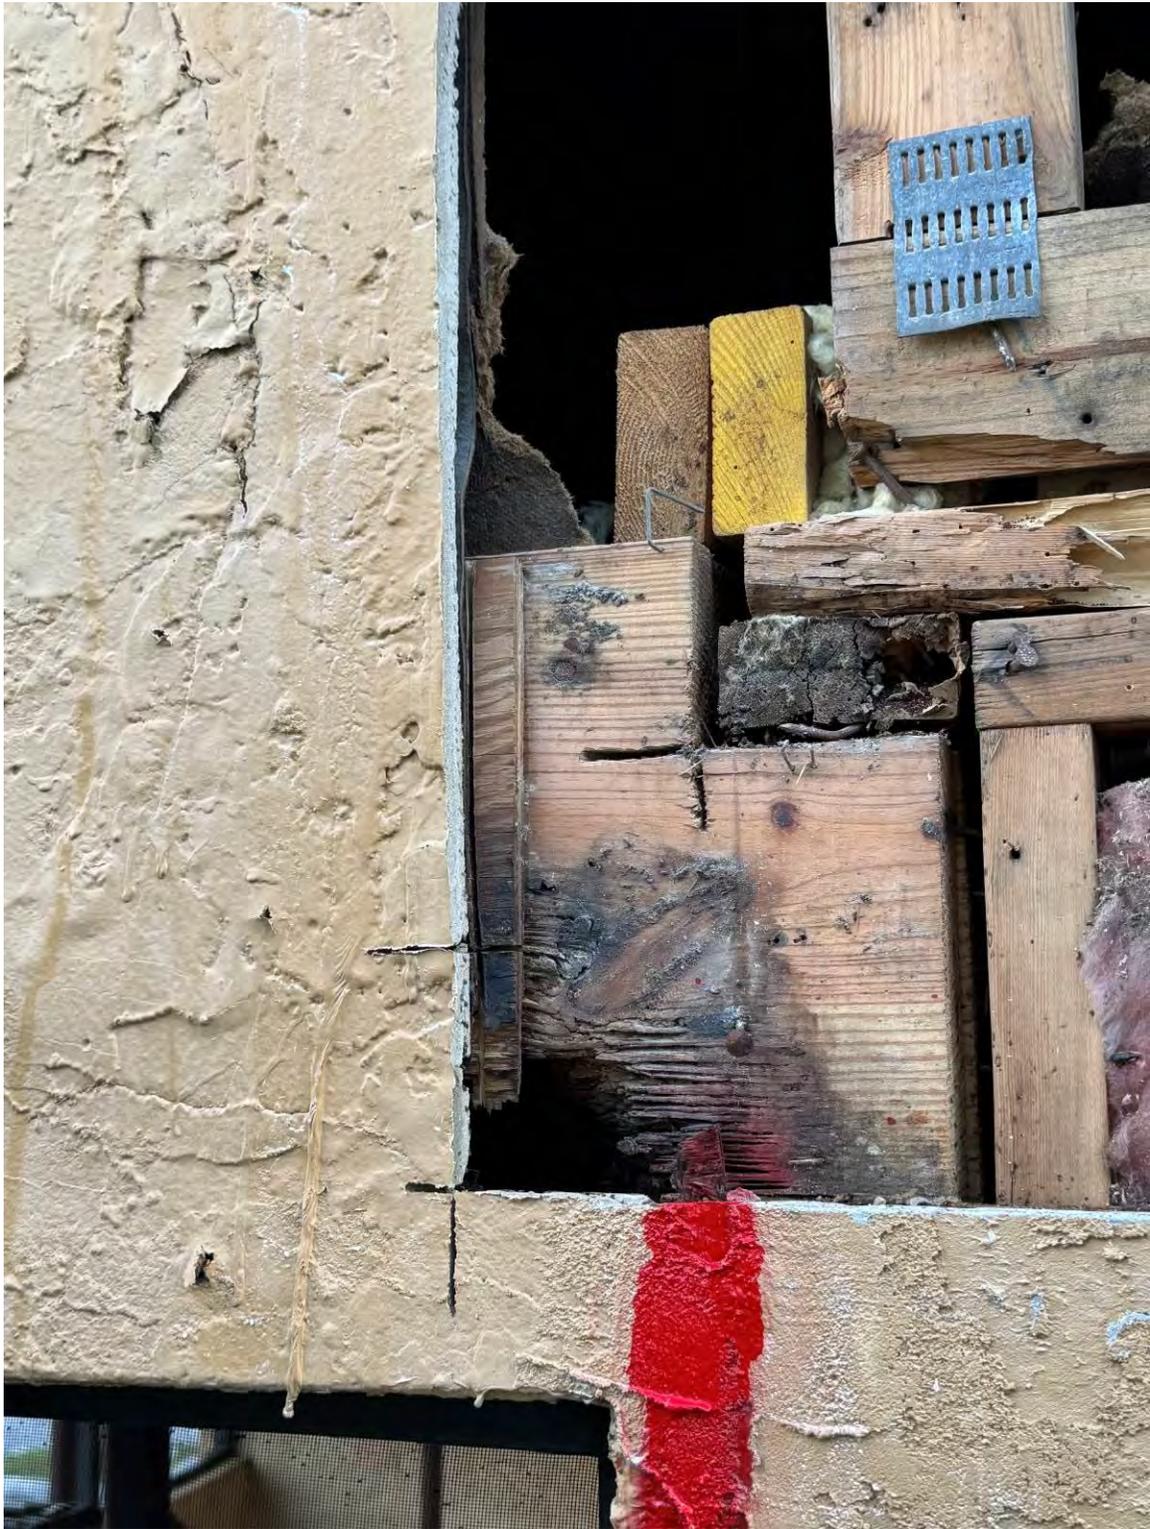
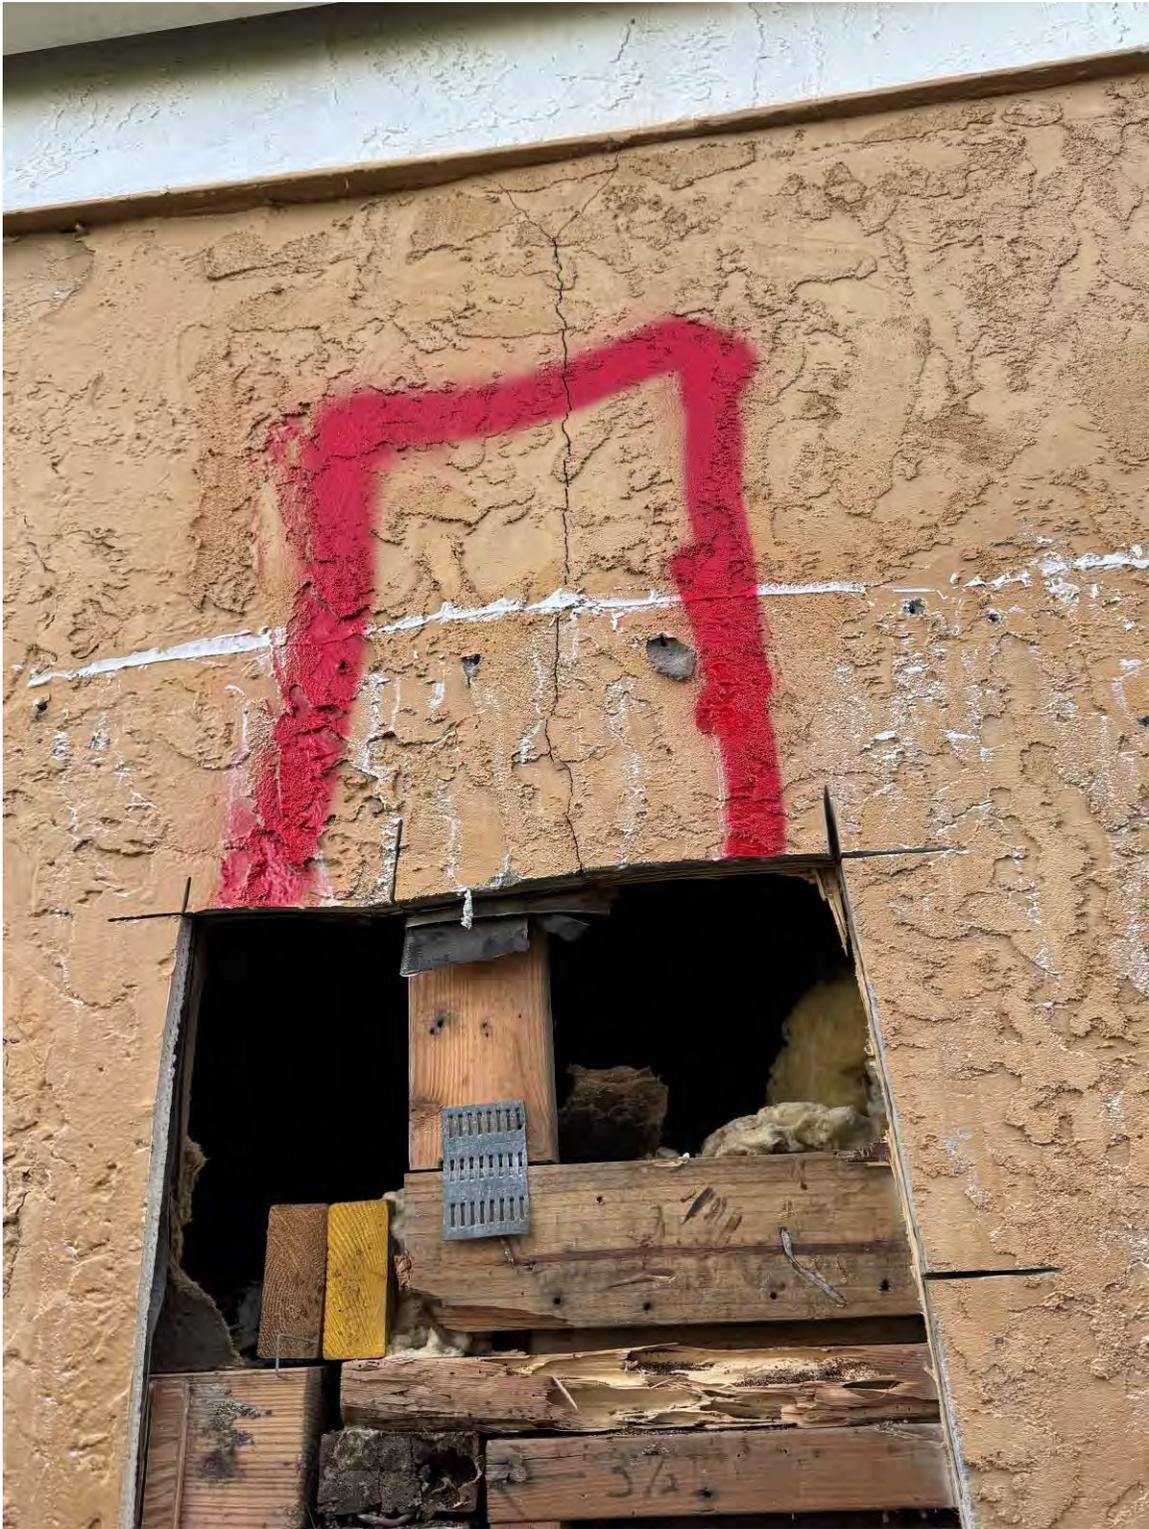
# OPENING #6

- Floor joist rotted away
- Bearing wall top plate has termite damage
- Gabled end of truss connector plate is damaged
- No visible attachments for joists to bearing wall or bearing wall to trusses
- Large crack above hole to be investigated
- 2 more areas need to be cut out and investigated
- Stucco above joists appears to have no plywood backing

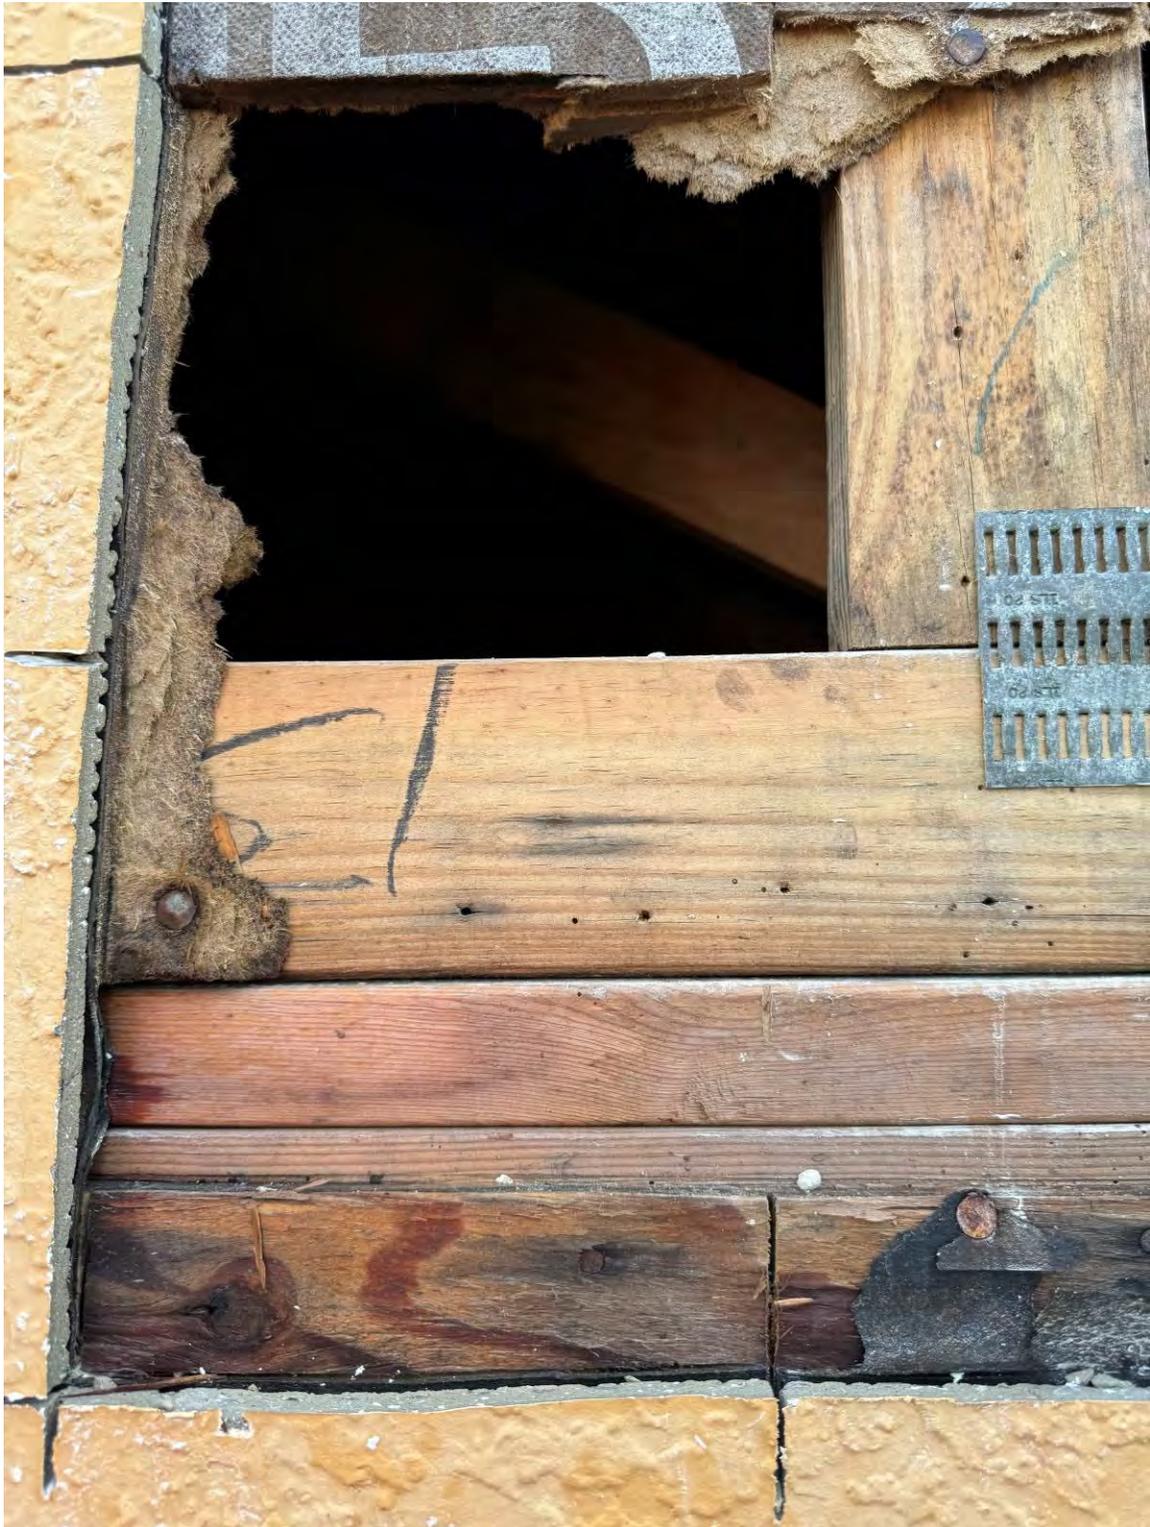
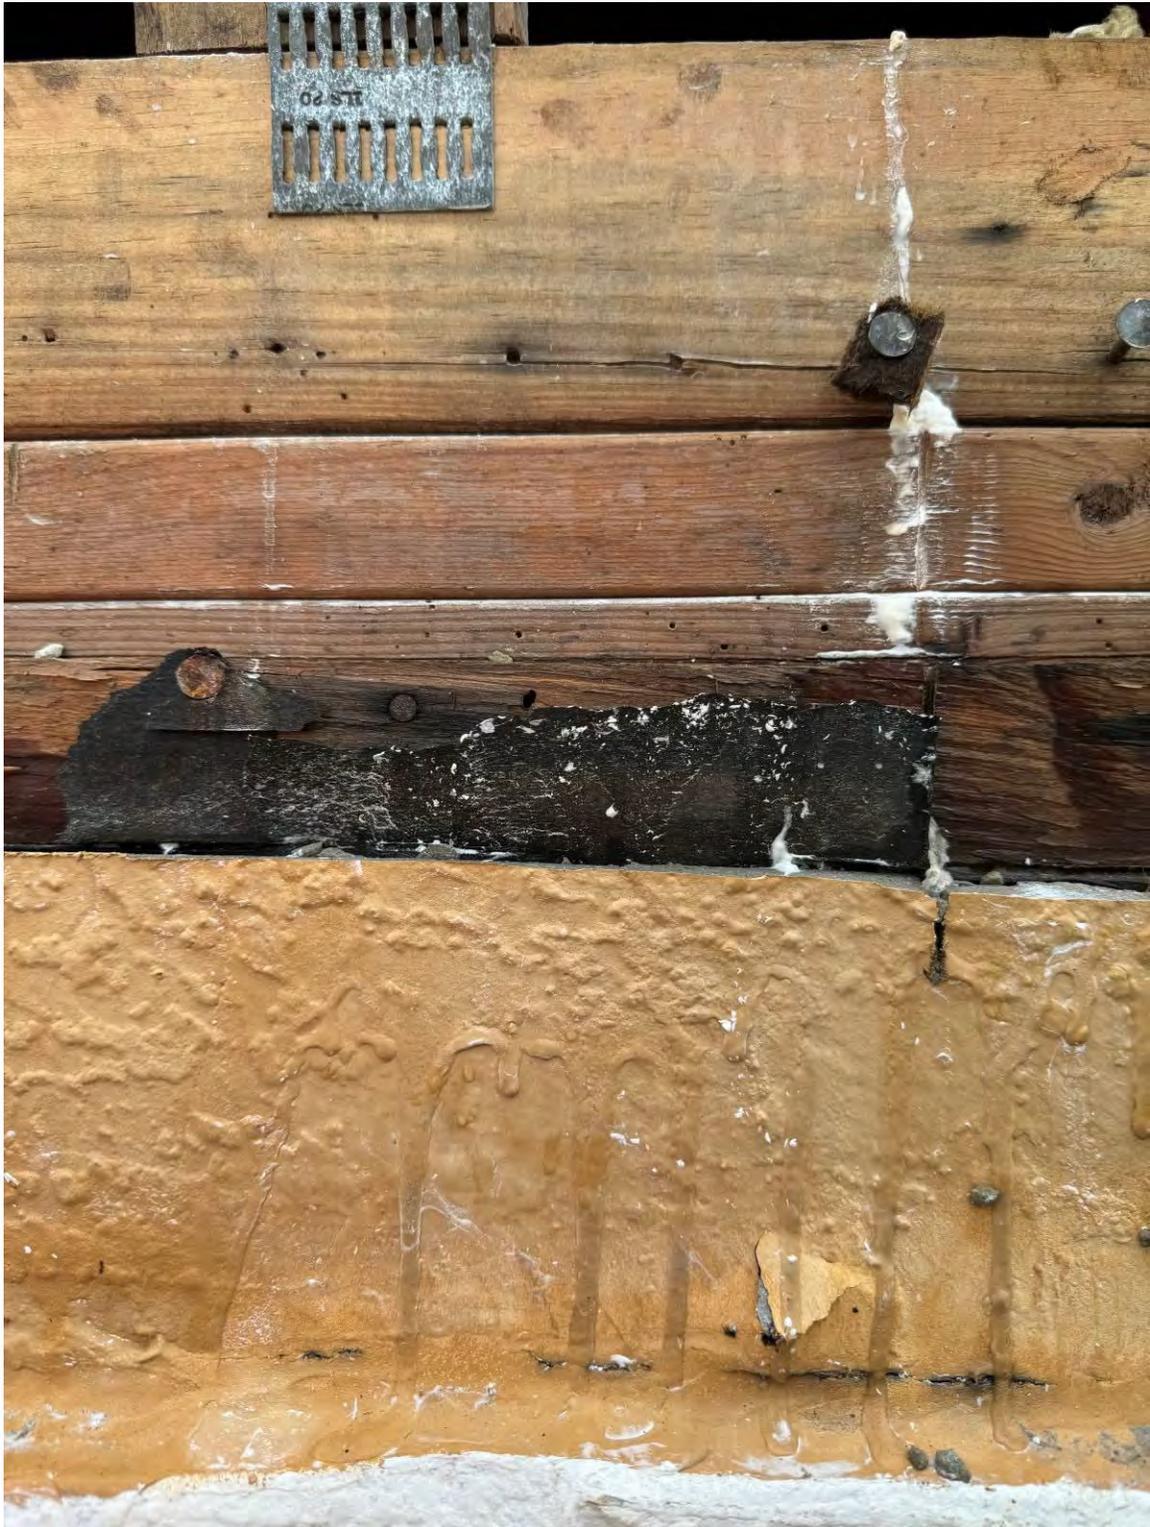
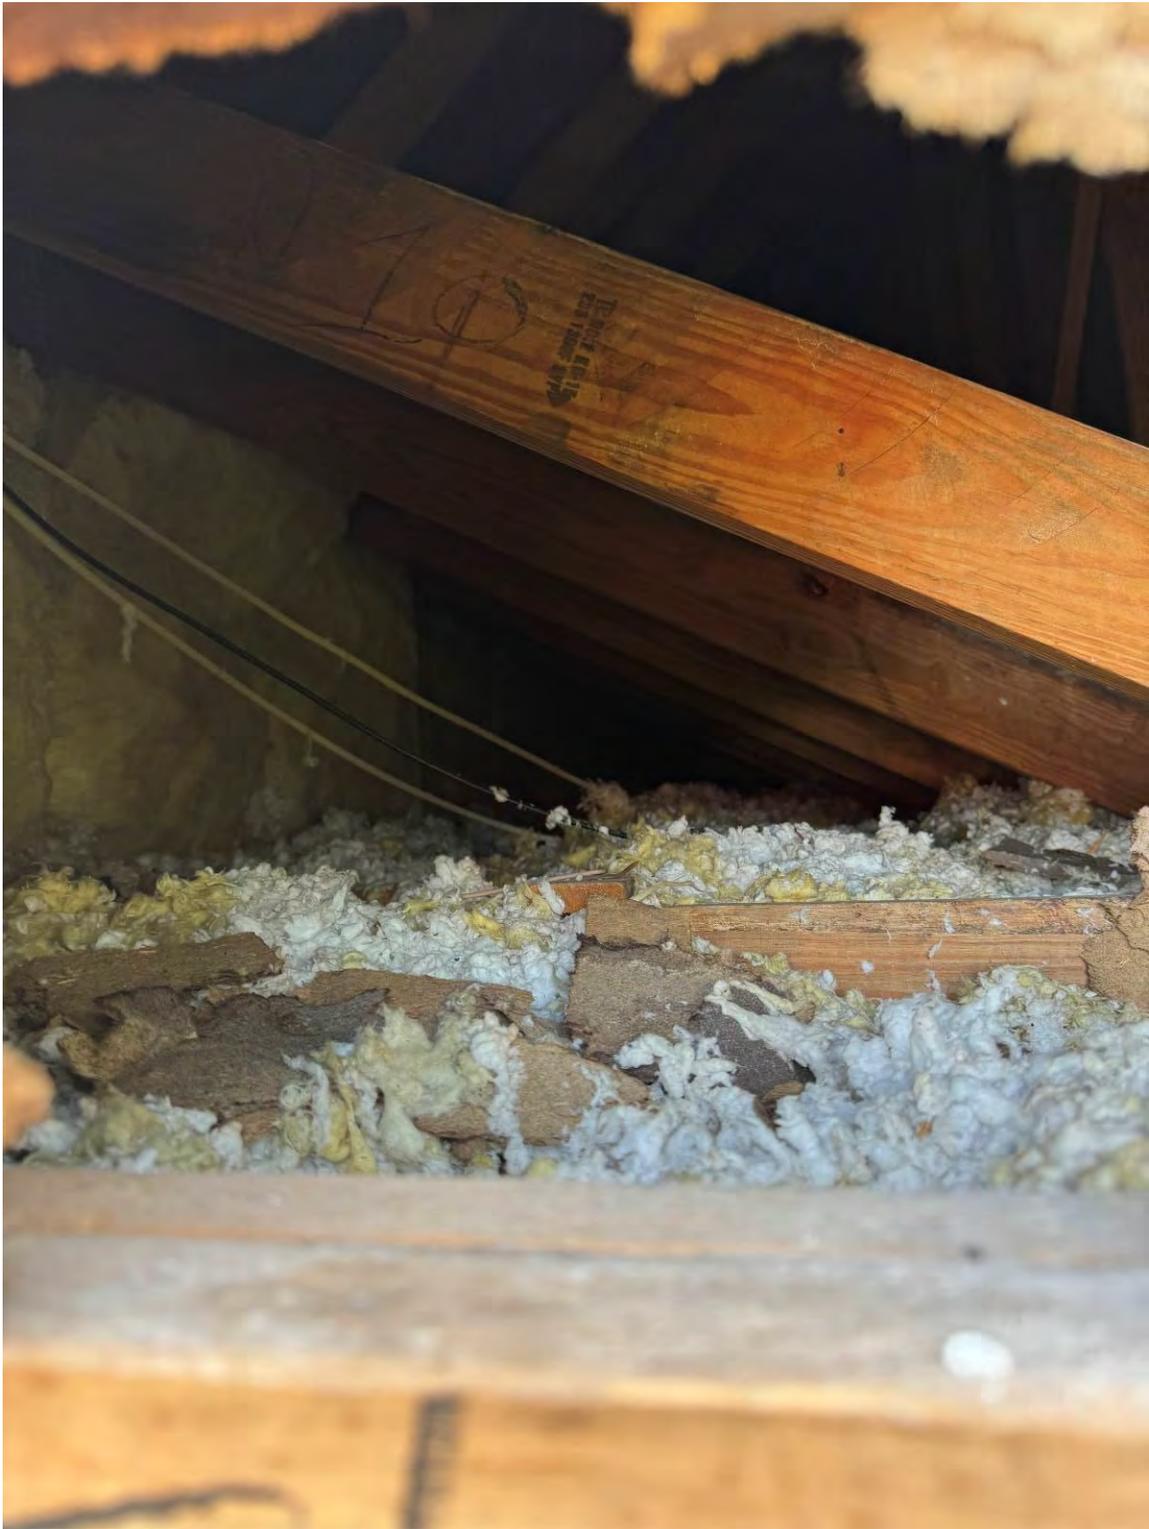
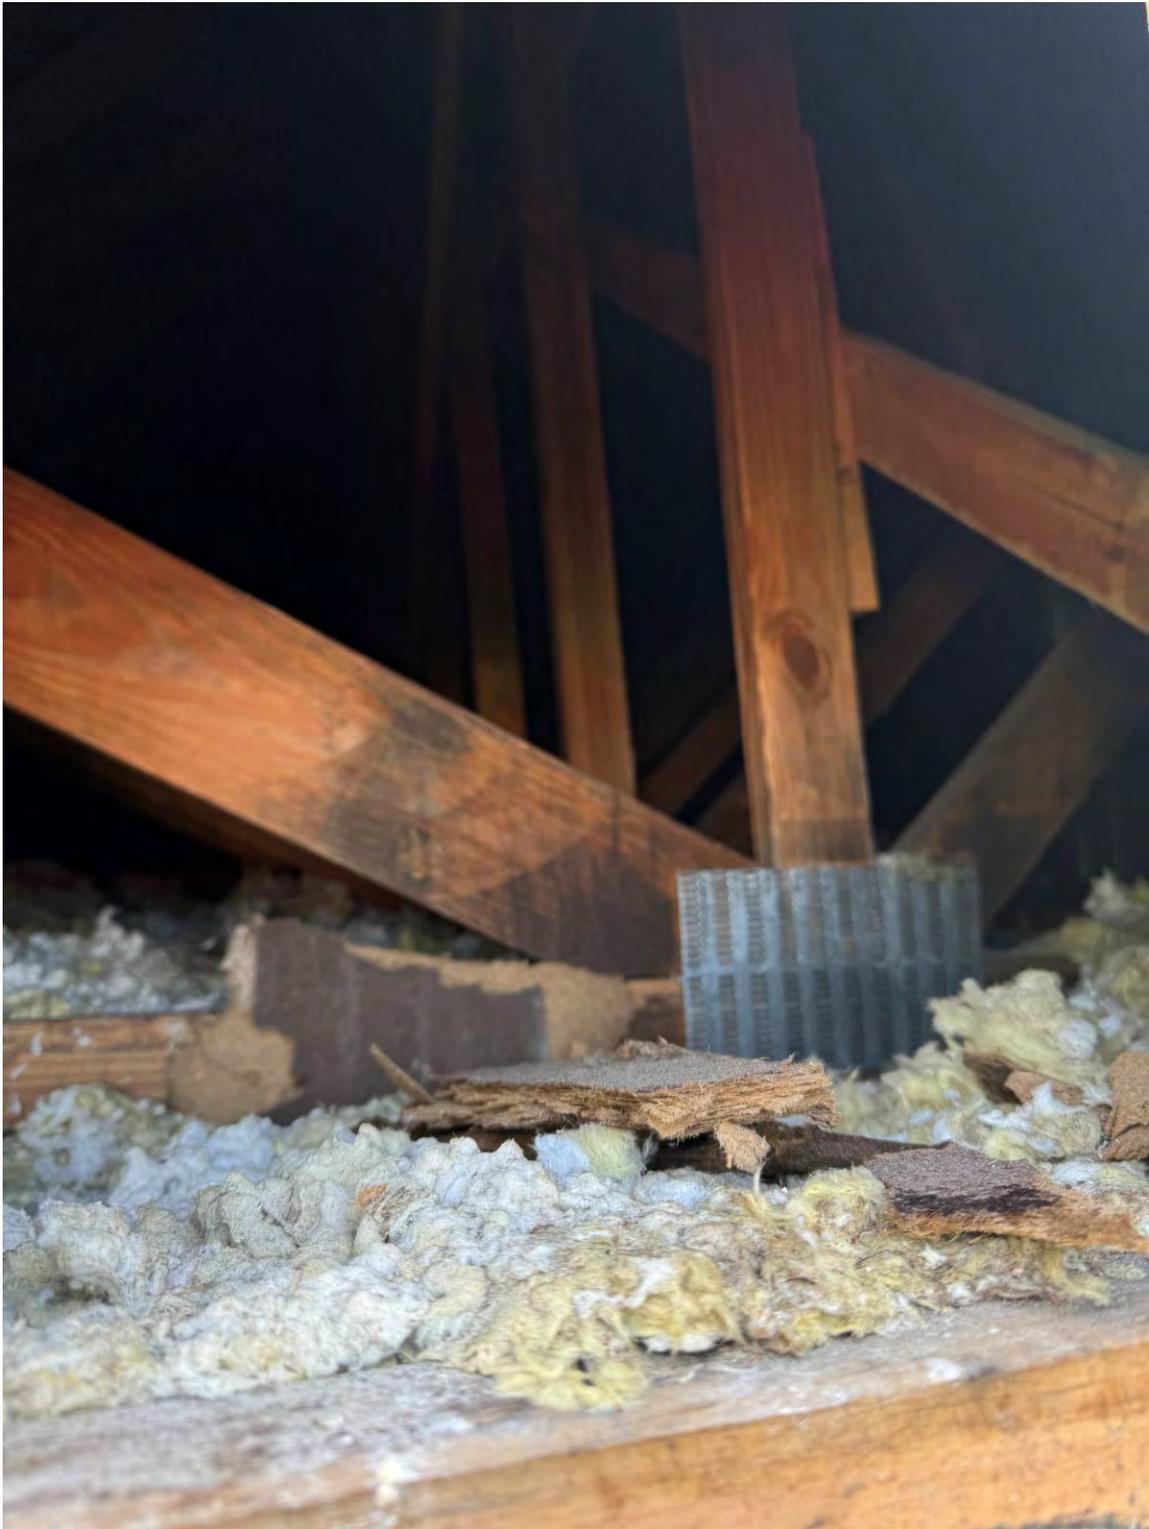
# OPENING #7

- Wall sheathing nails are rusted
- Gabled end truss connector plate is loose
- Gabled end not faced with plywood
- Gabled end faced with felt board
