**NOTICE OF FILING PART 1 OF FINAL ENGINEERING REPORT OF SPECIALTY  
ENGINEERING CONSULTANTS, INC. DATED NOVEMBER 5, 2024**

**PROFESSIONAL CONSULTING SERVICES FOR:  
Heron Pond Condominium Association, Inc.**

Building #9  
8343 SW 5<sup>th</sup> Street,  
Pembroke Pines, FL 33025

Re: Investigation and Documentation of Deteriorated and Damaged Structural Items

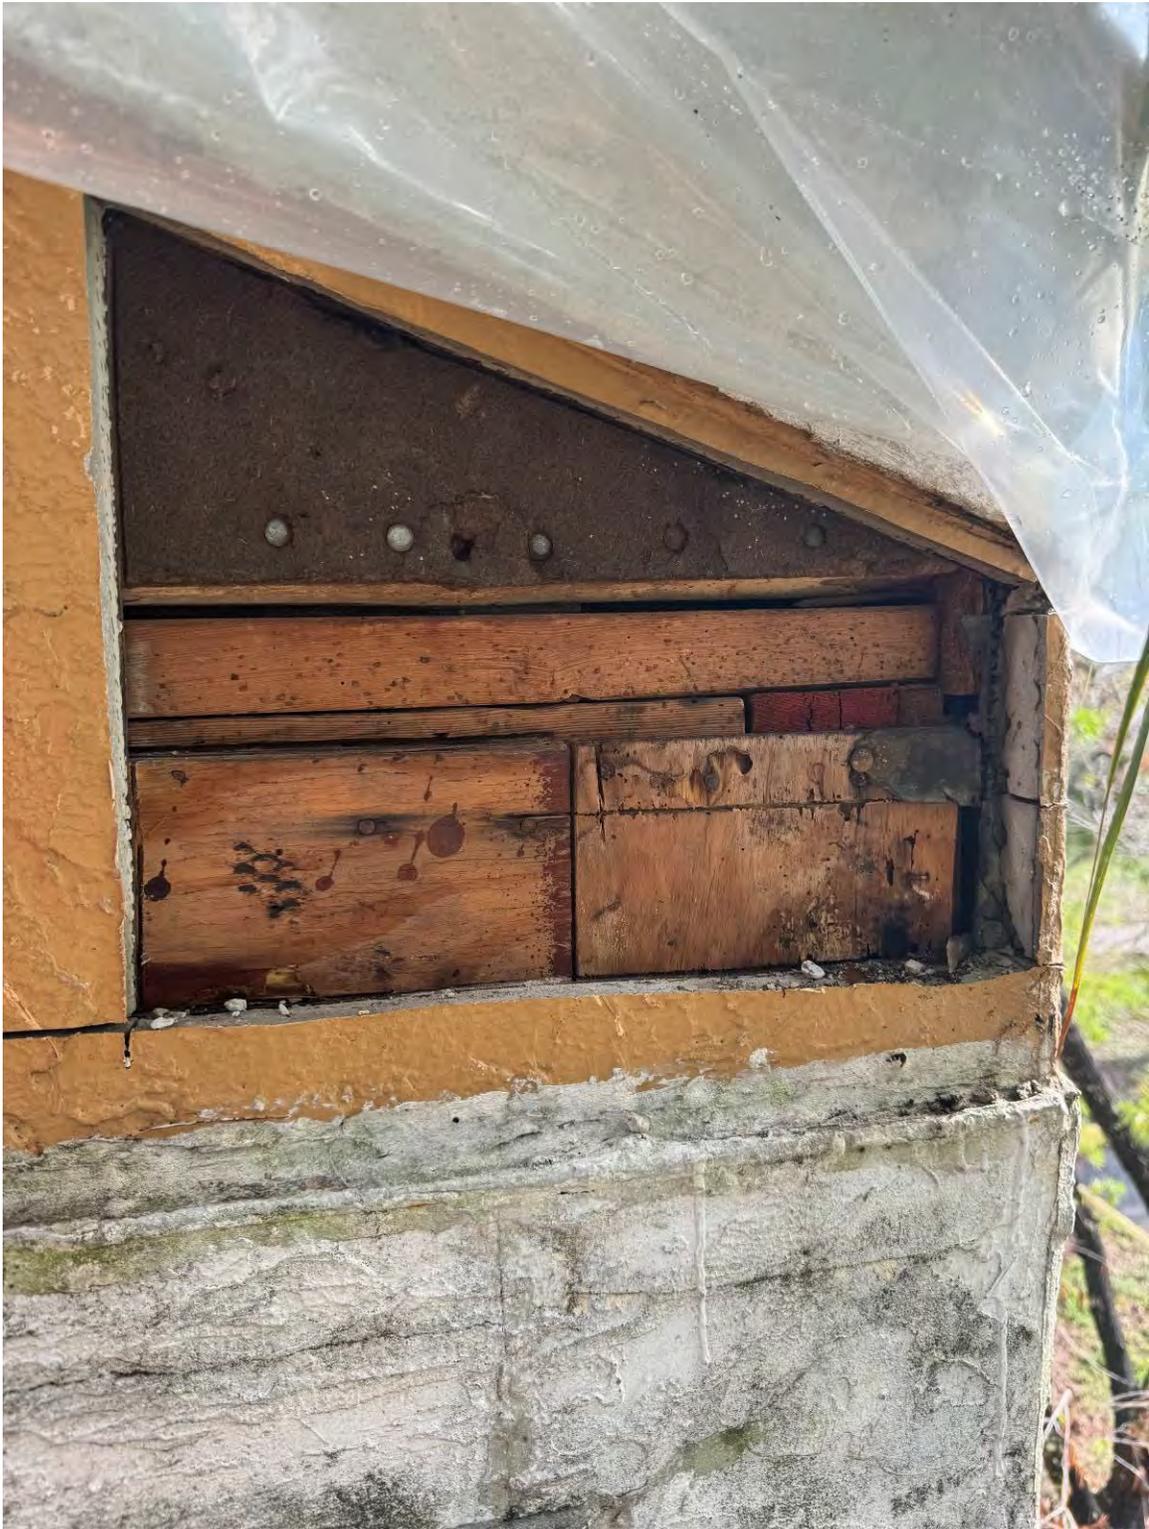
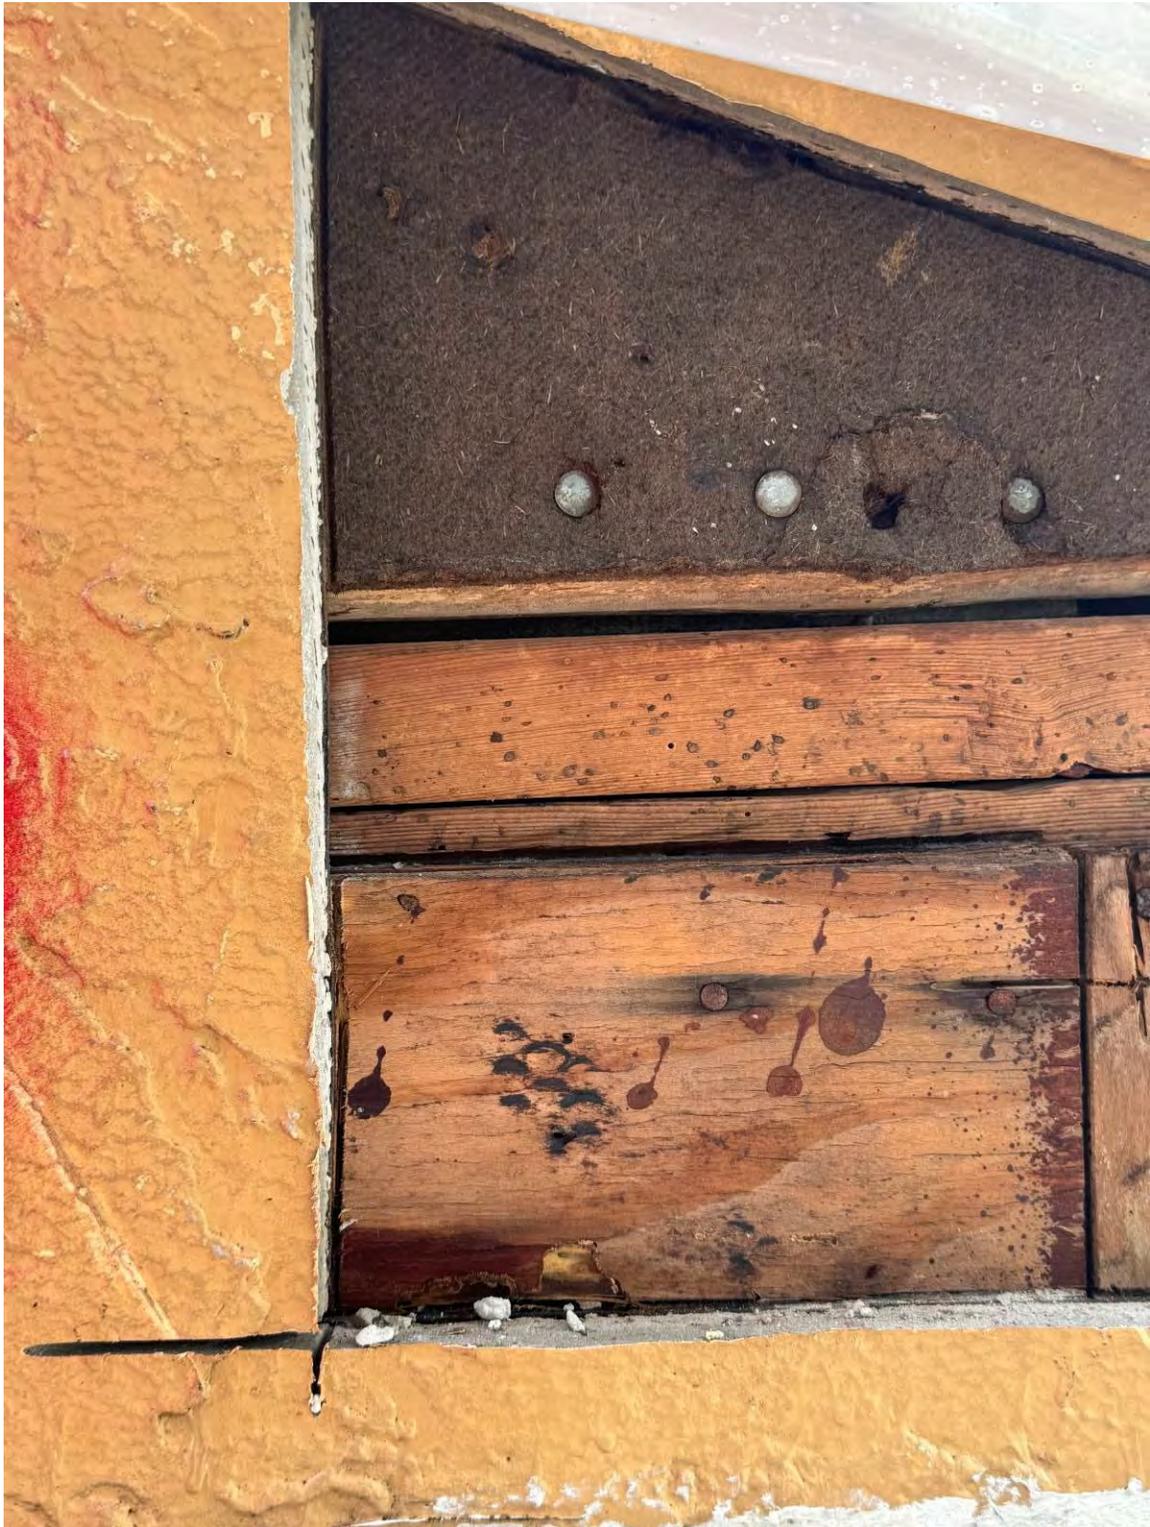
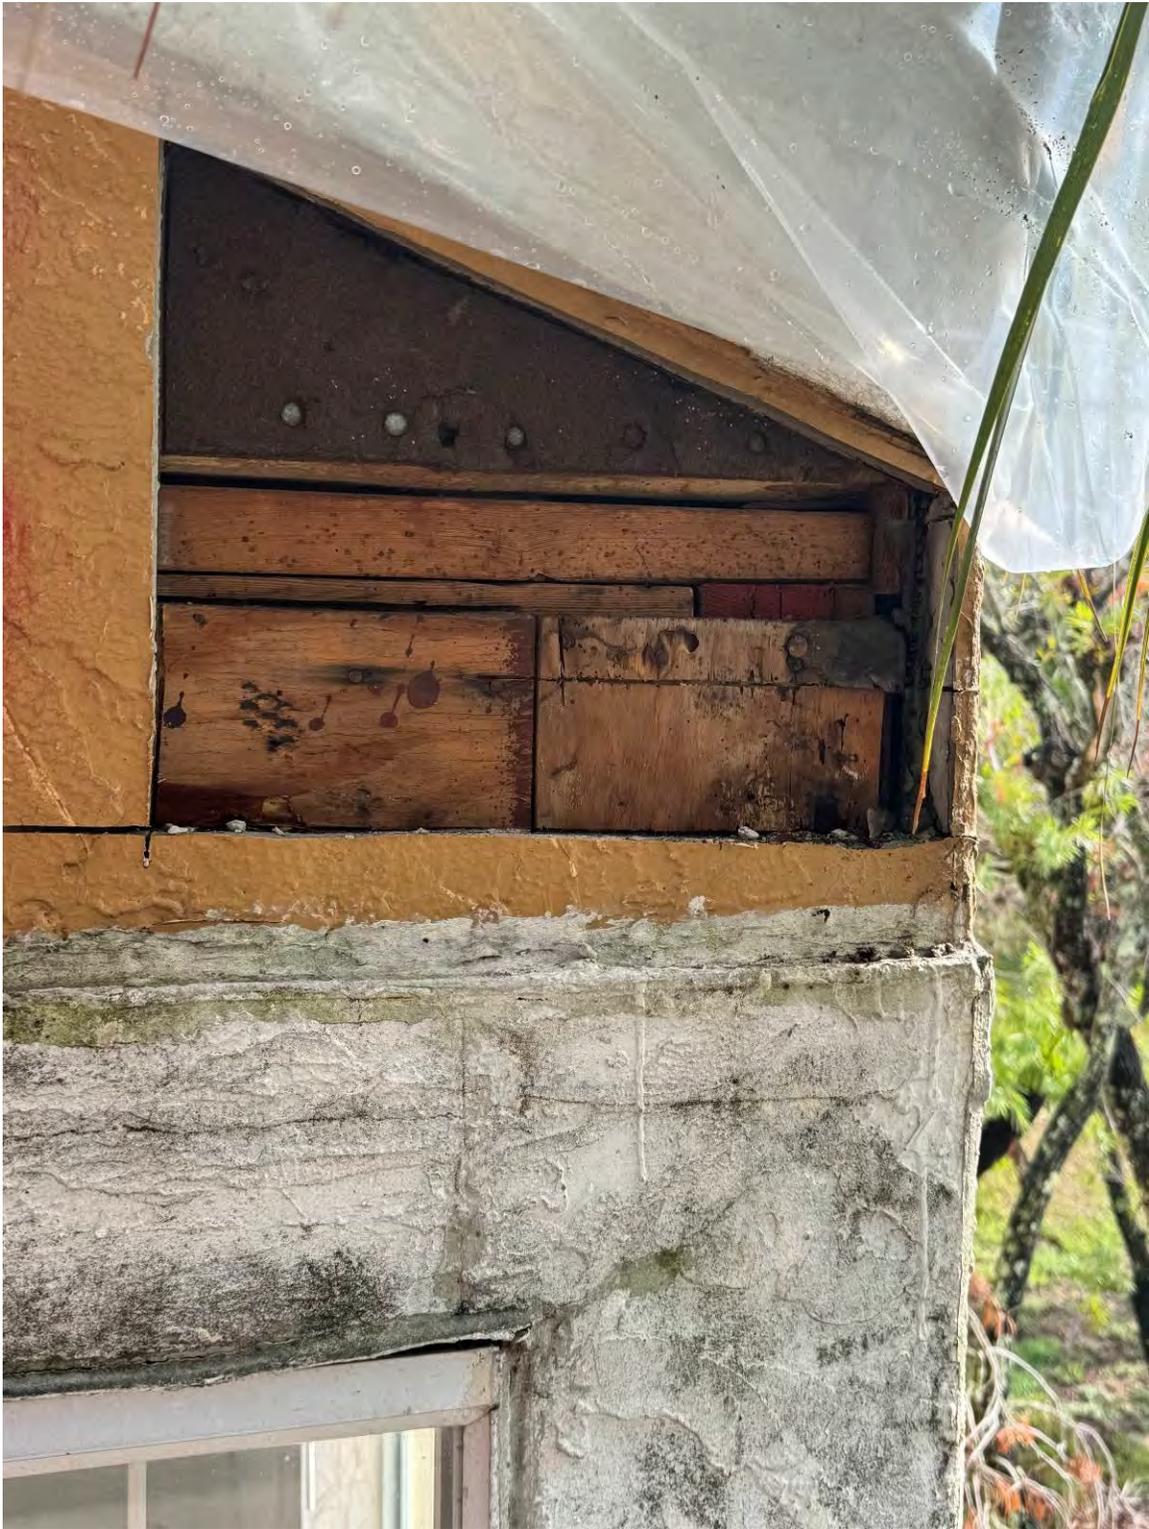
# OPENING #8

- Water damage to wall sheathing
- No connectors from gabled end to the 2<sup>nd</sup> floor bearing wall

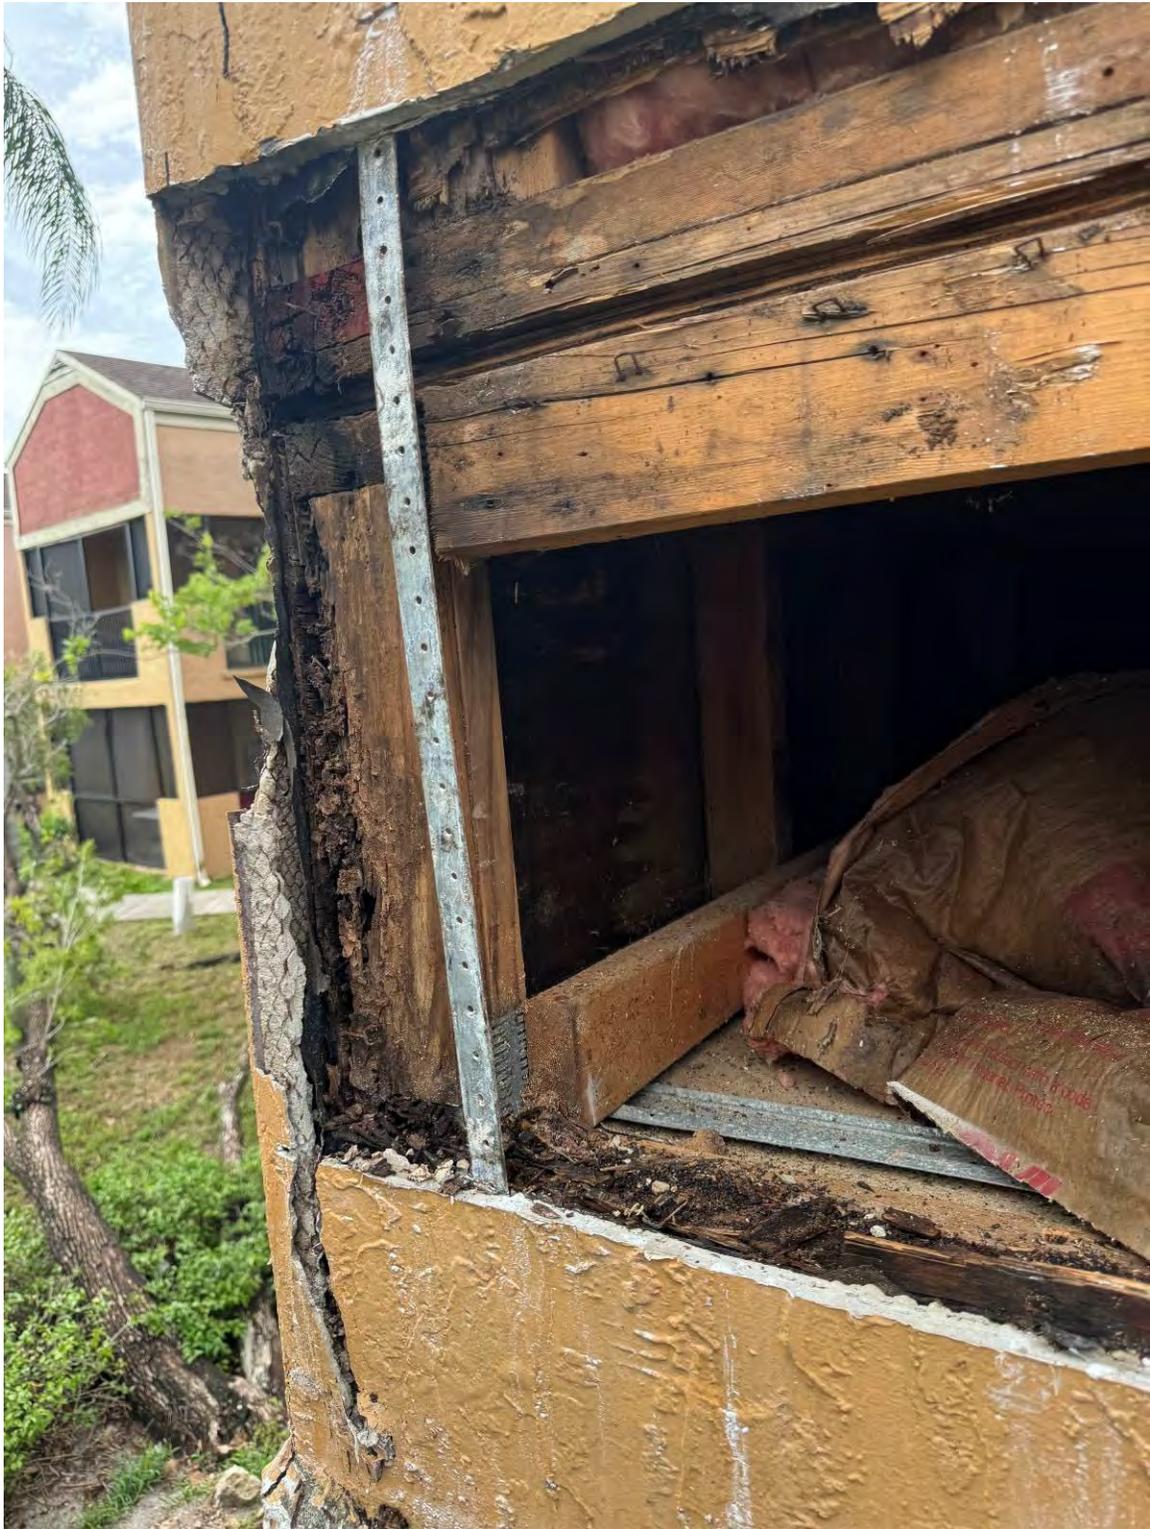
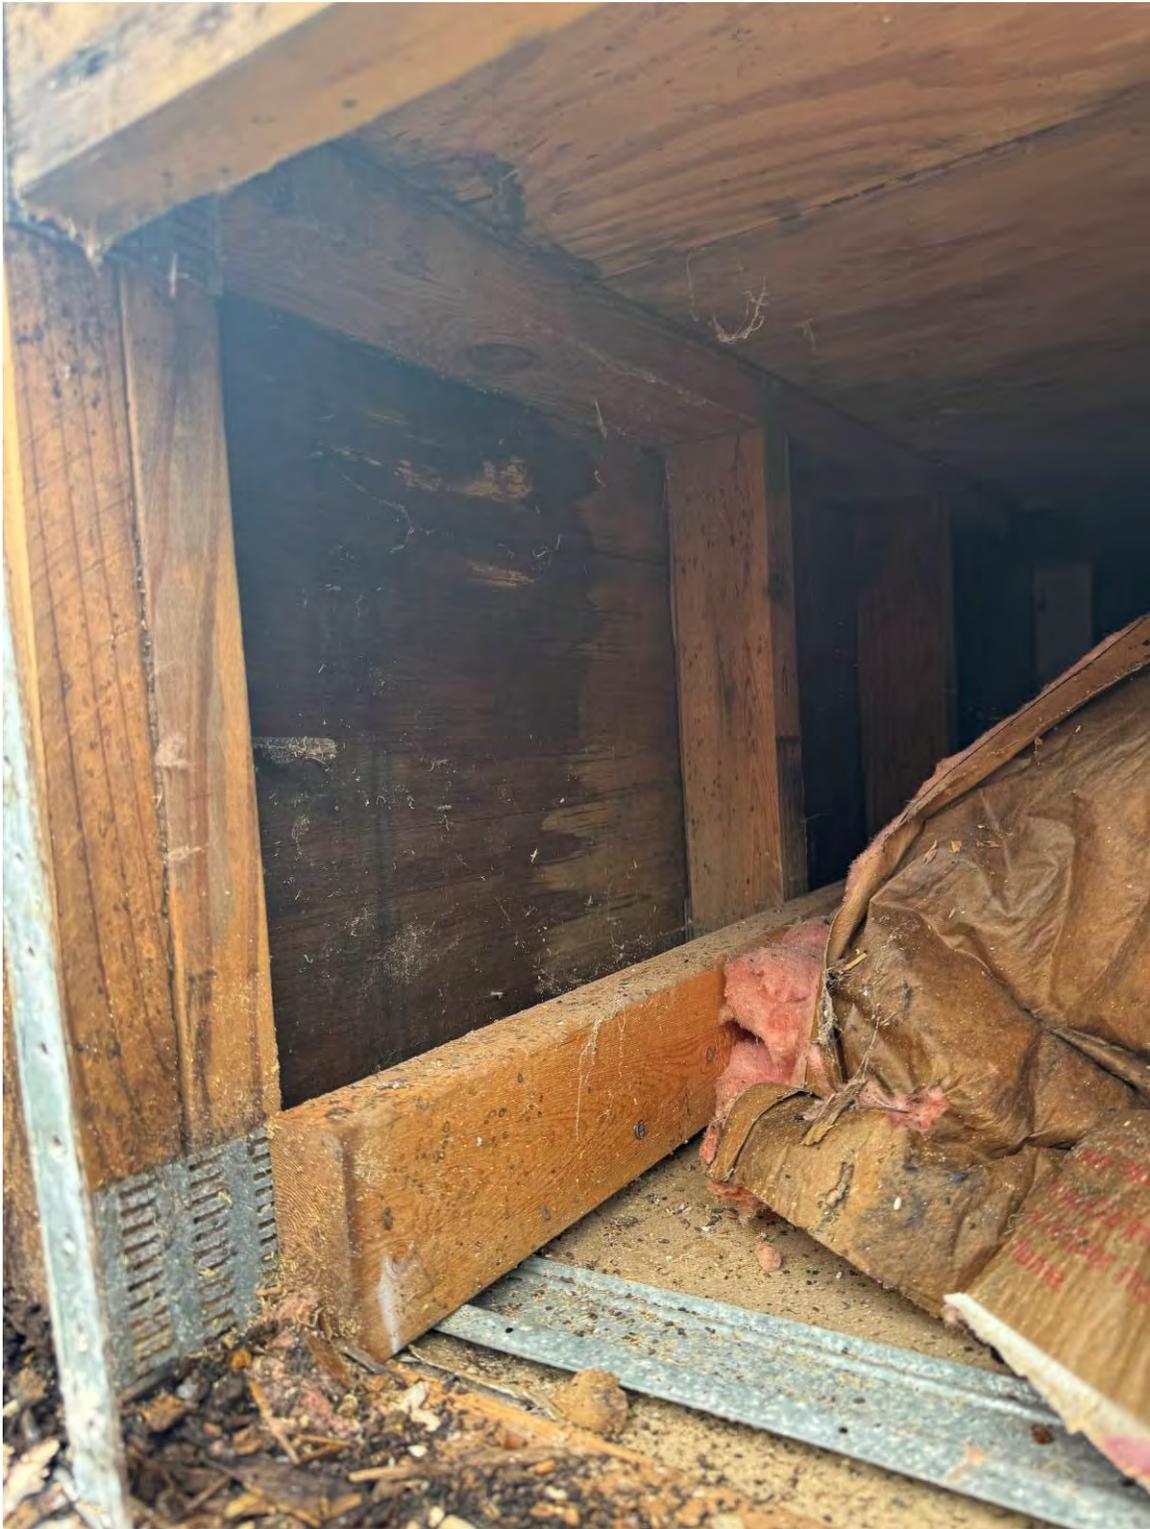
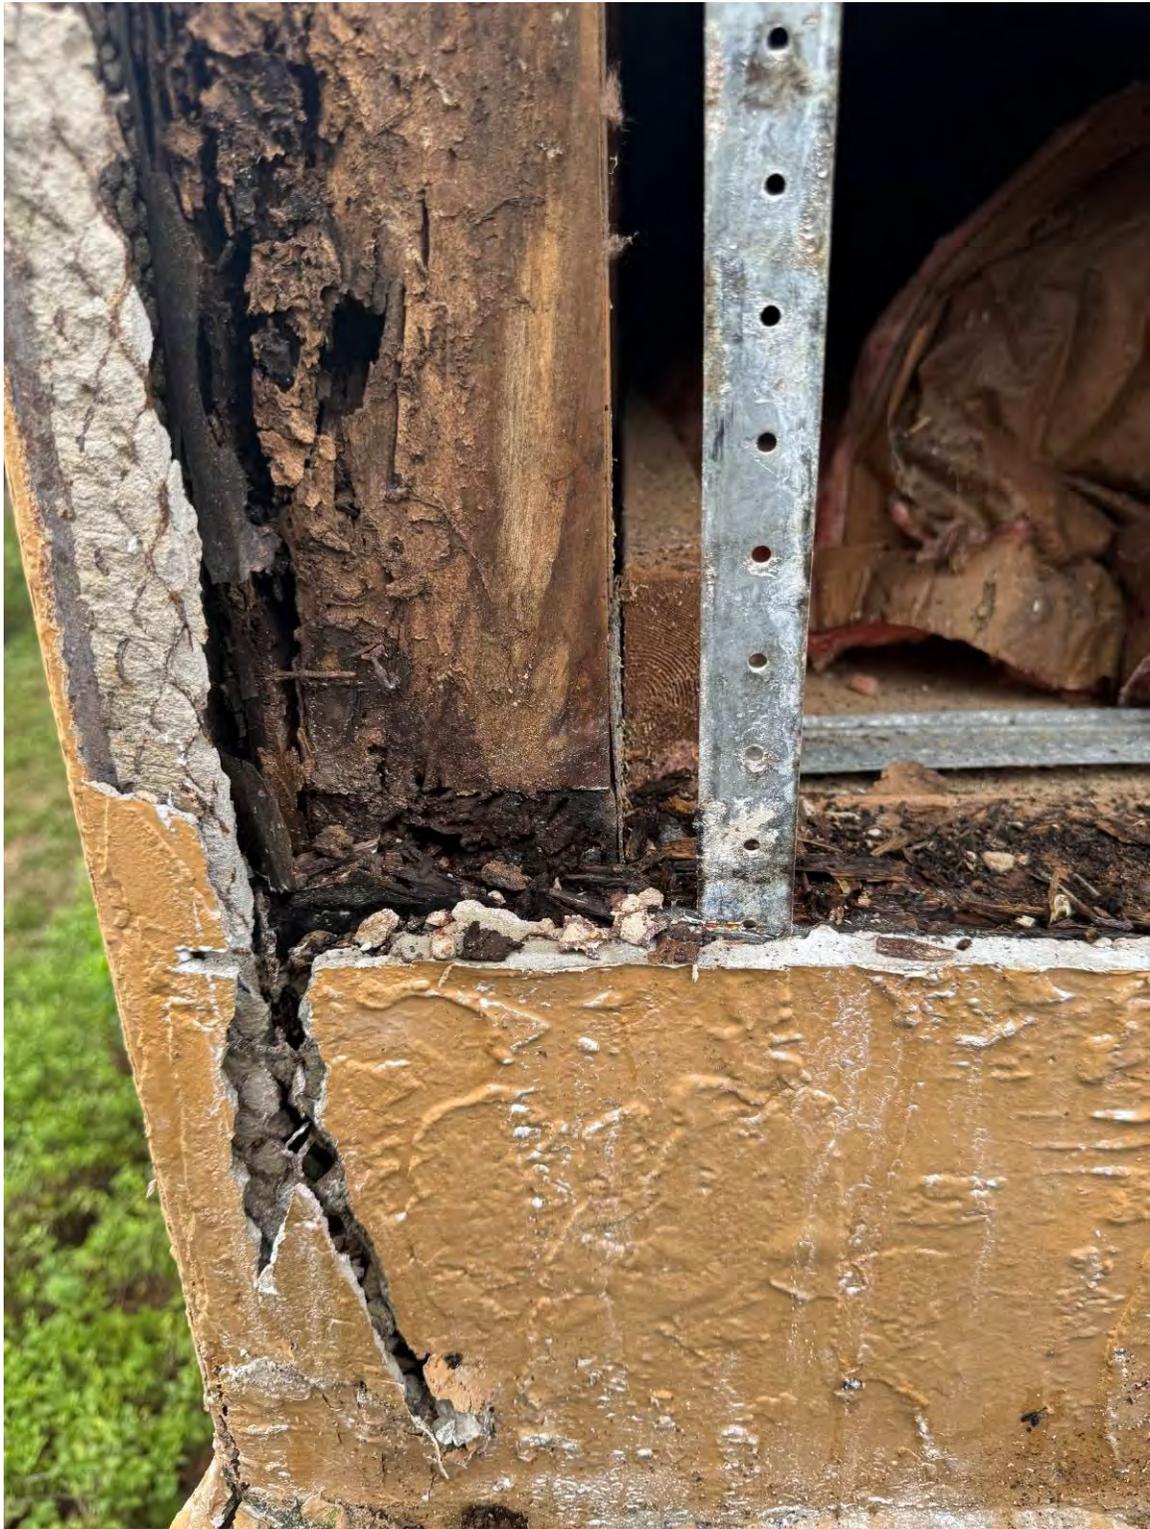
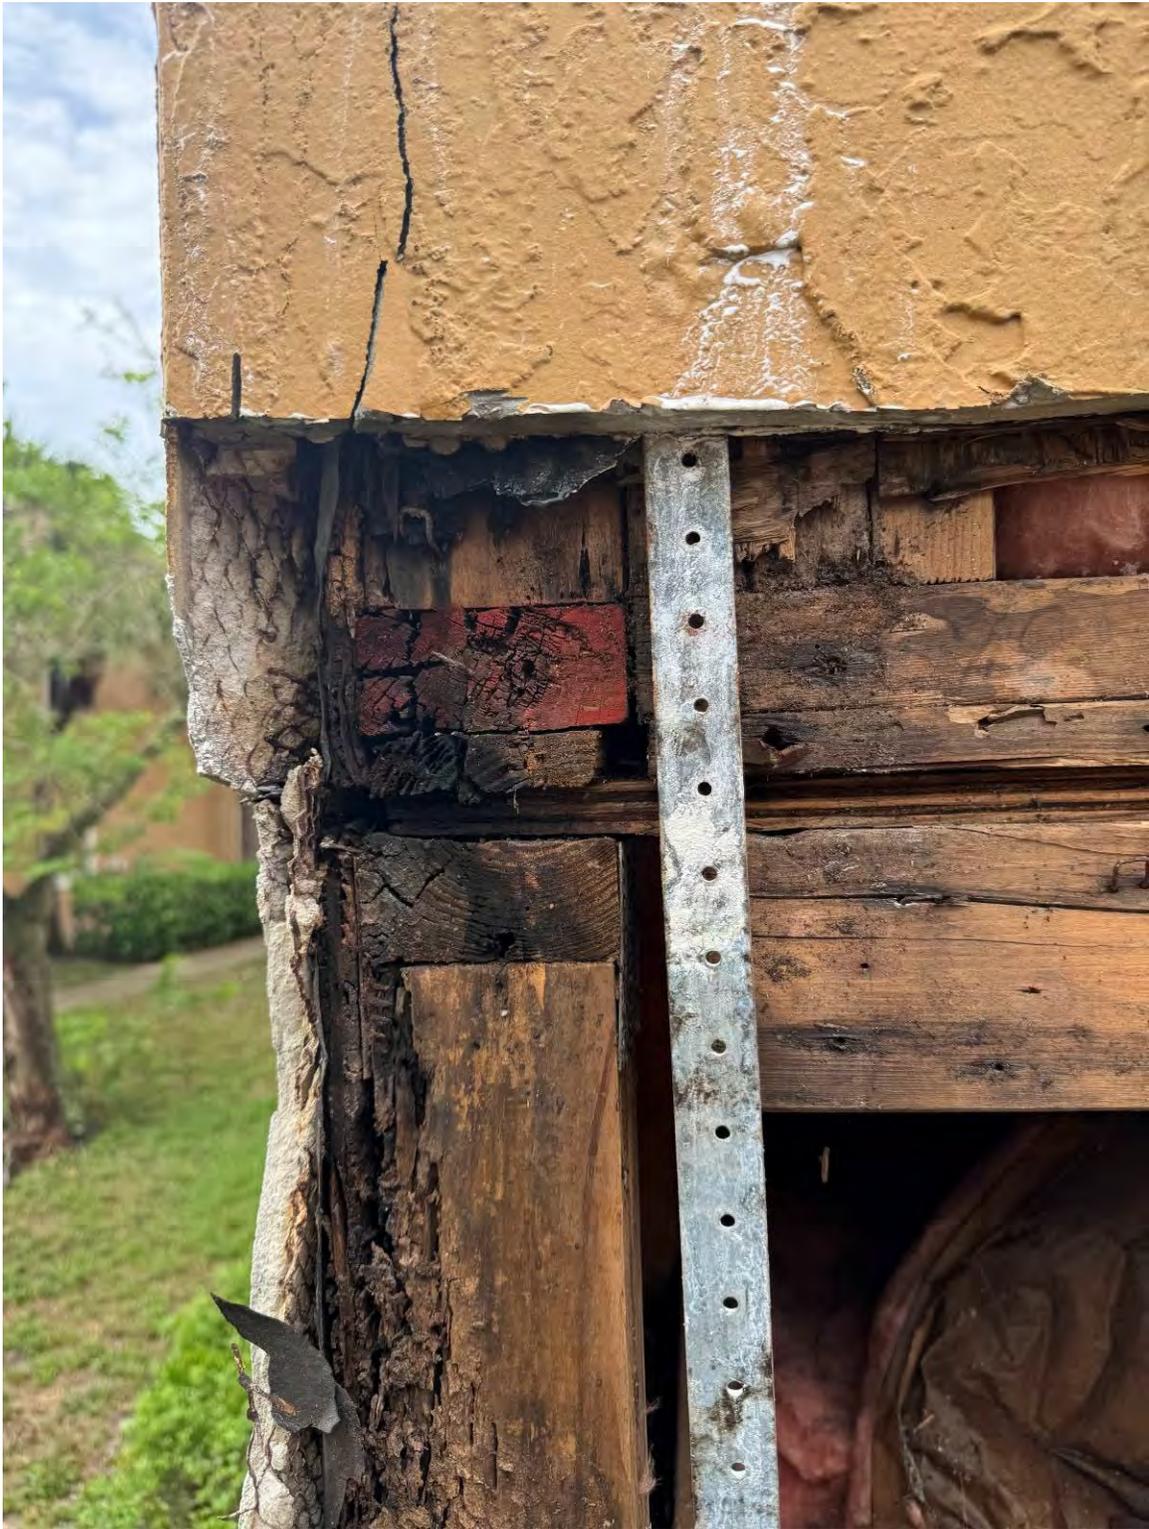
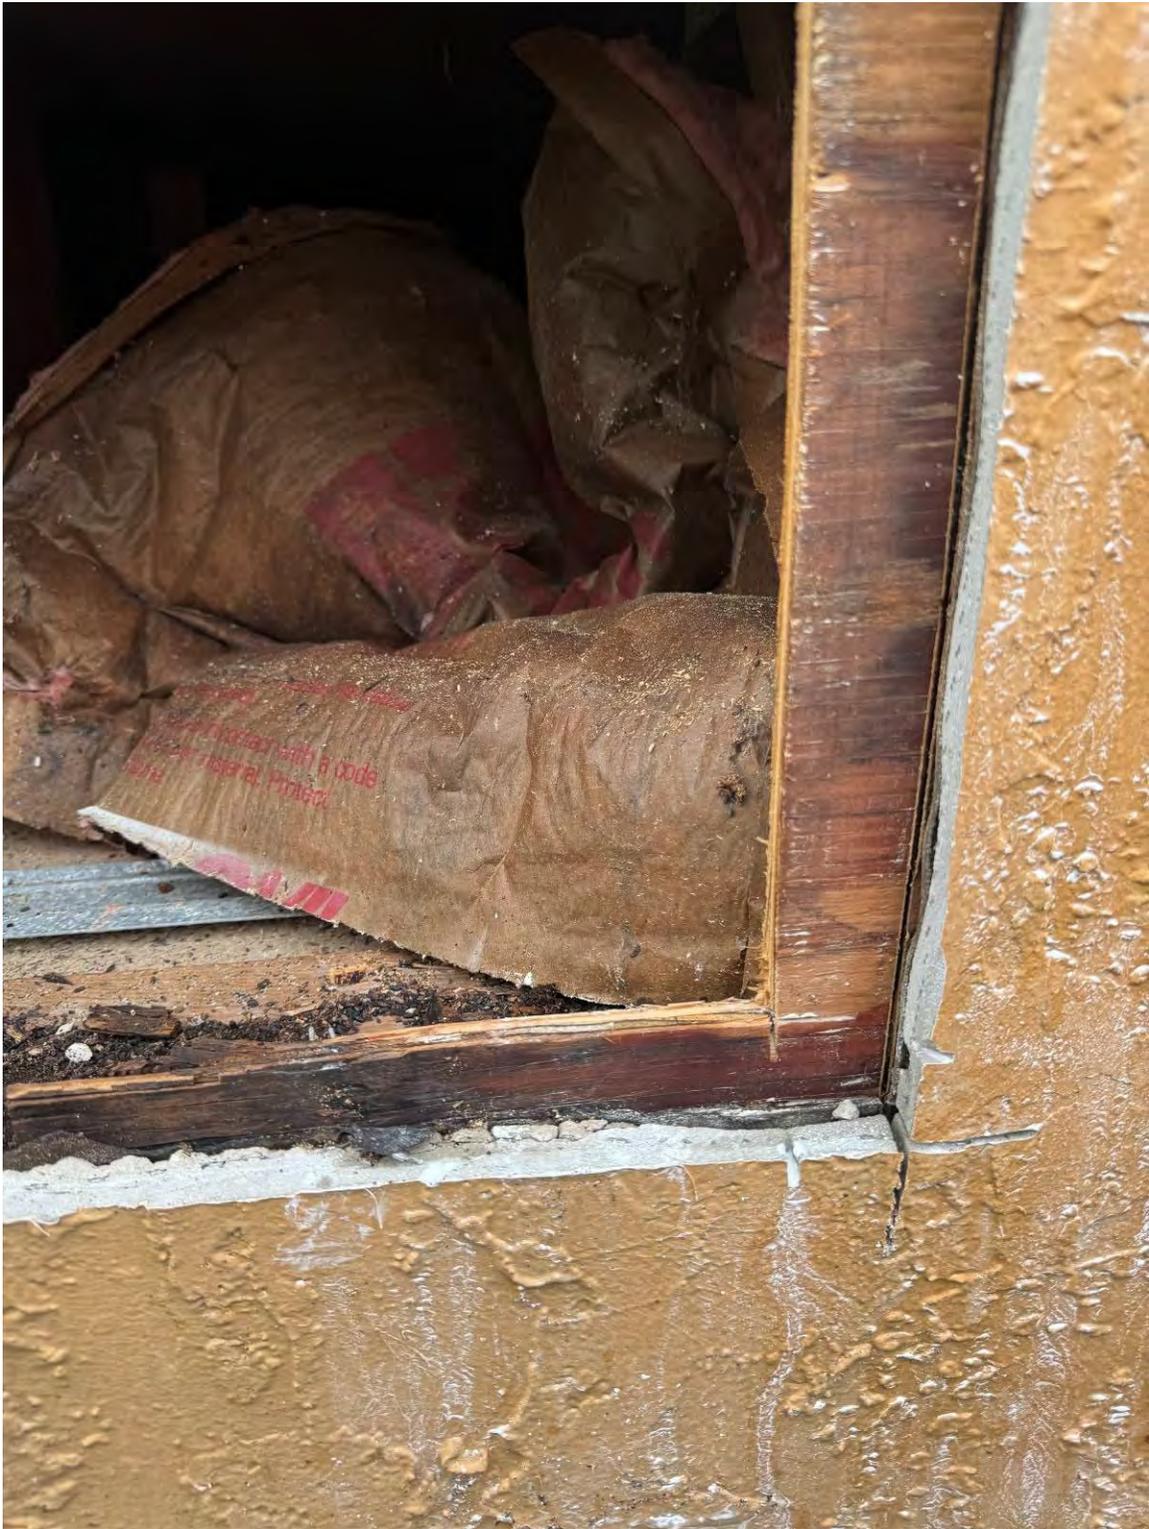
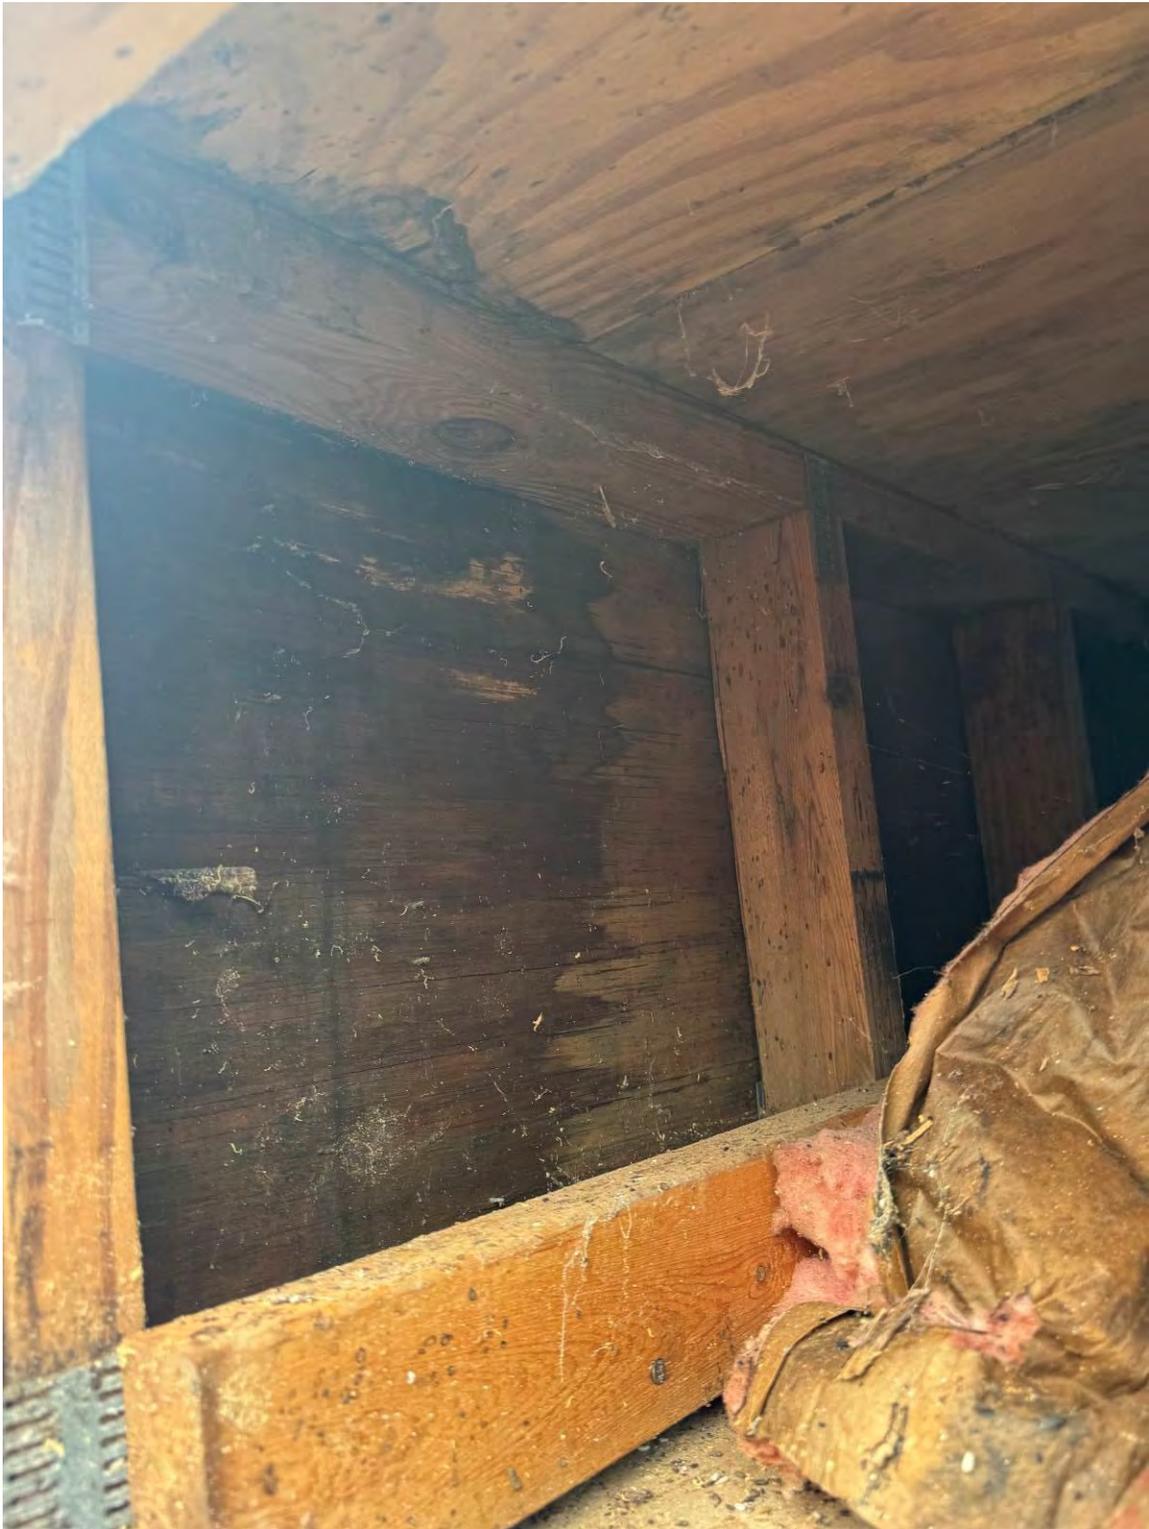
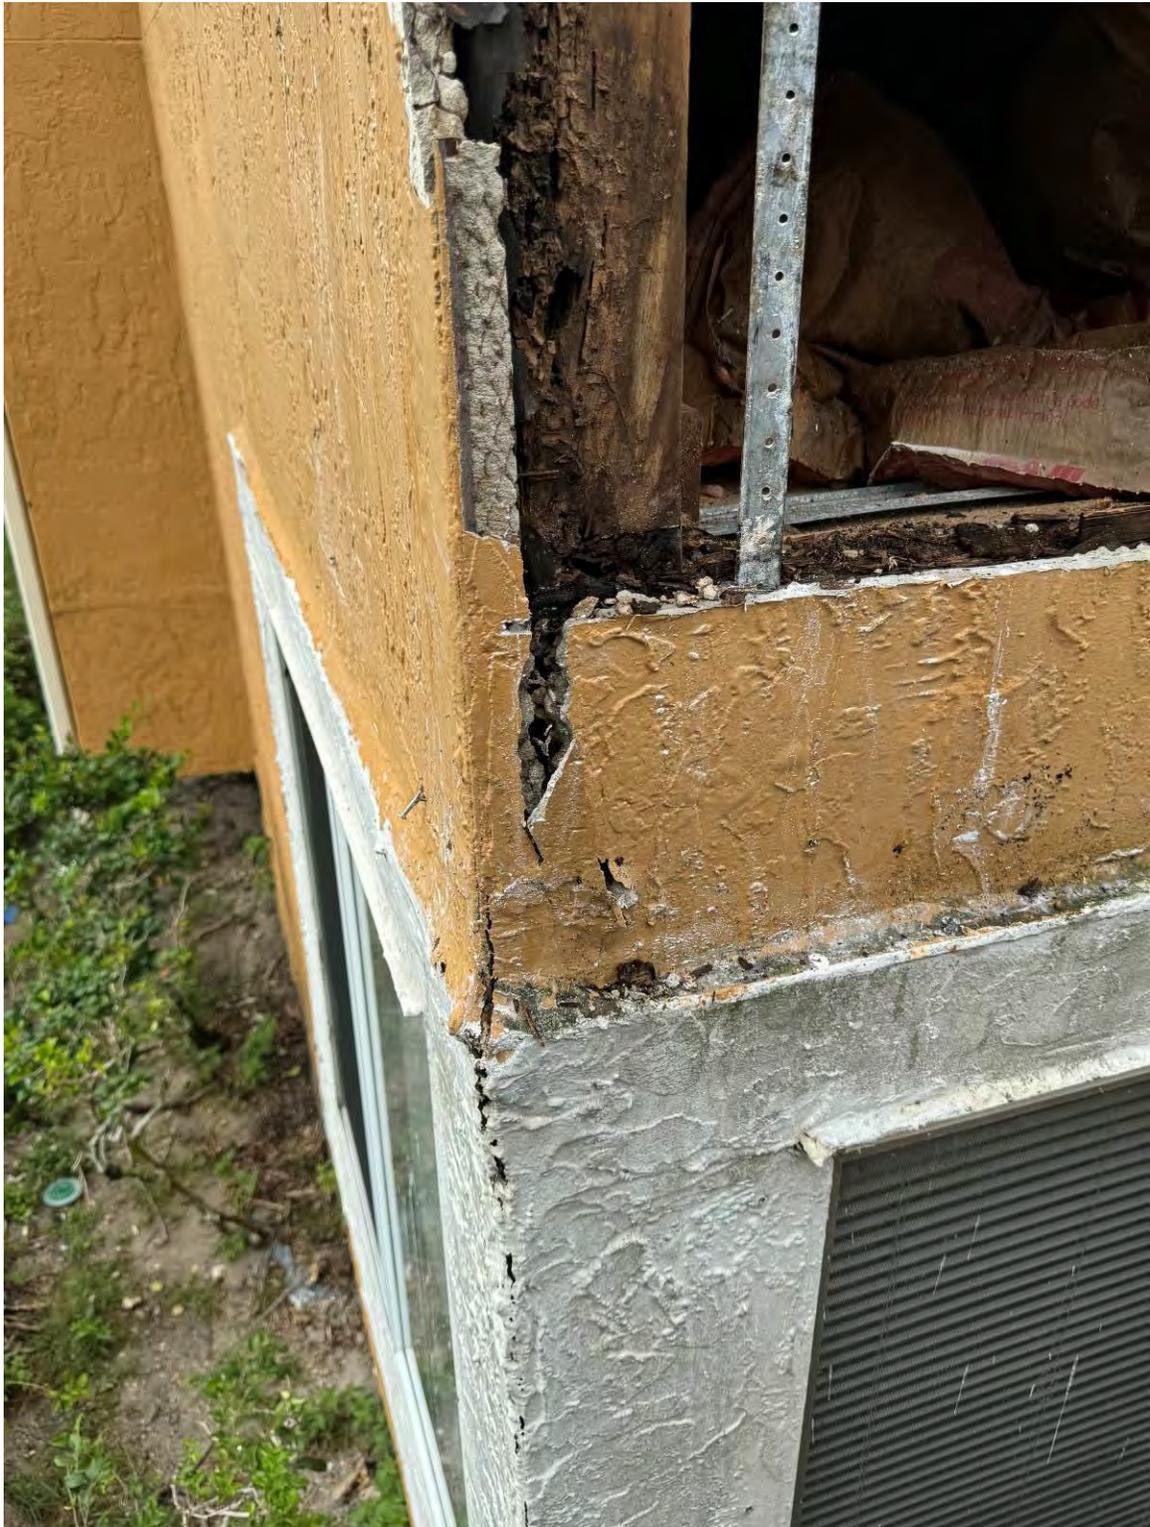
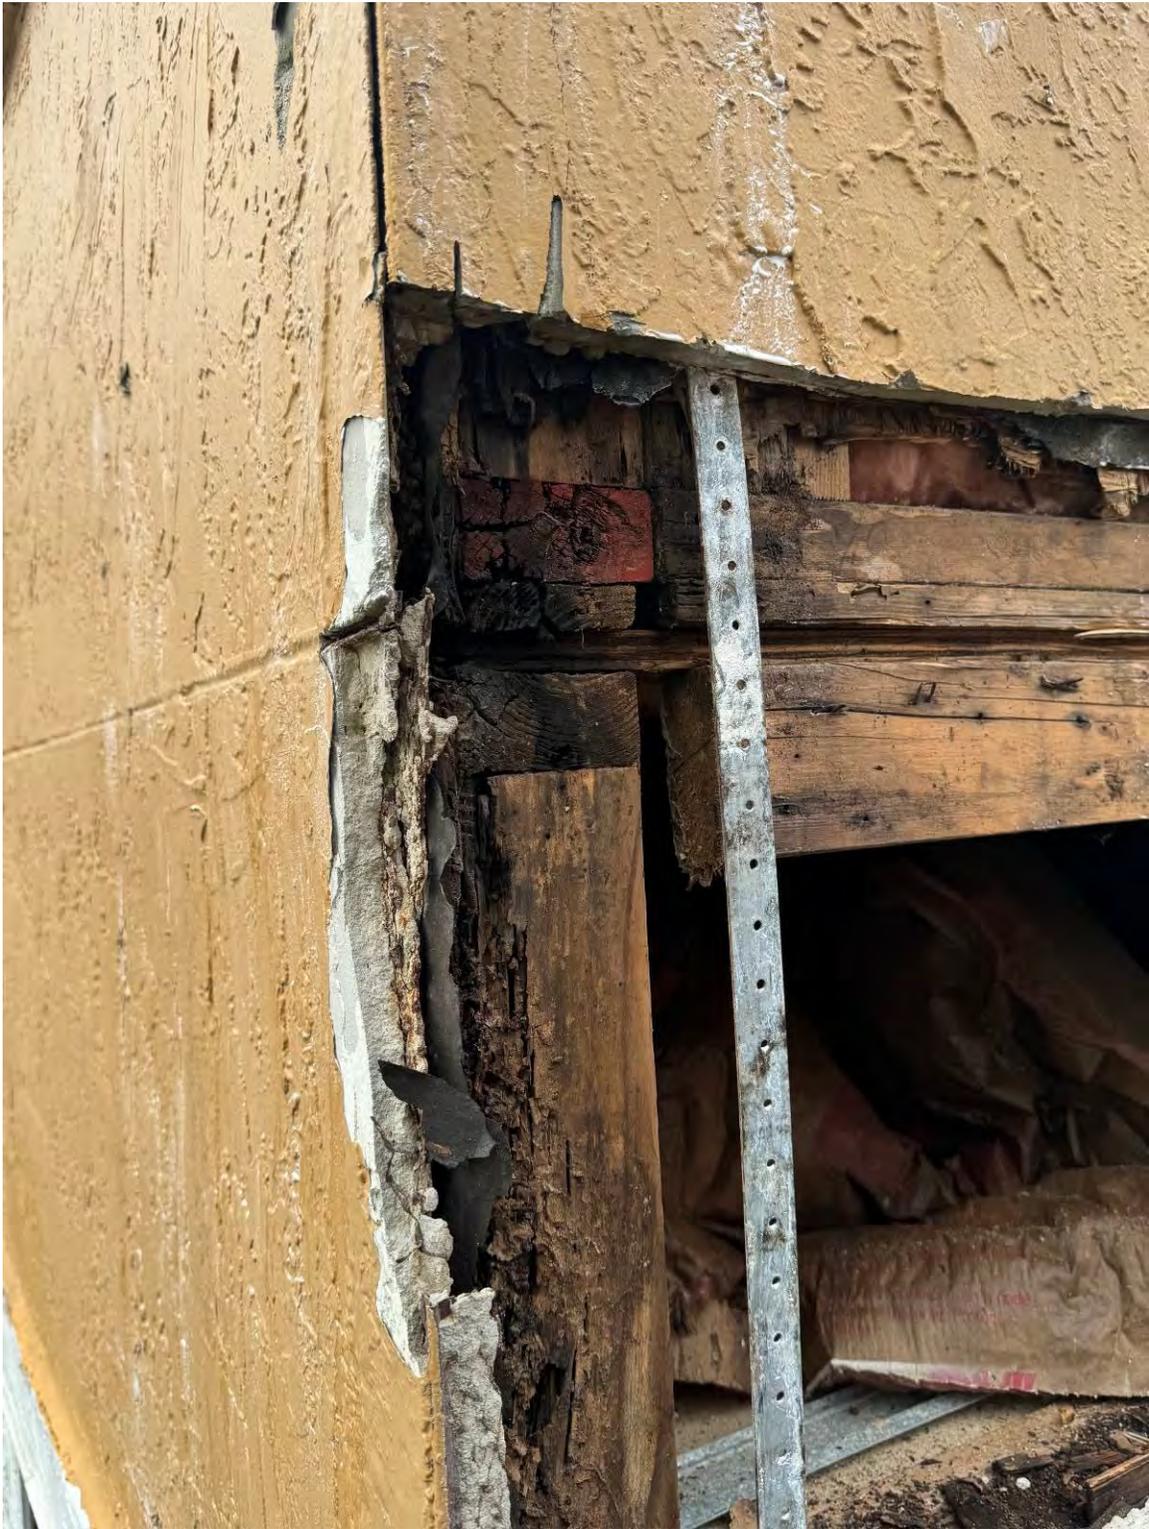
# OPENING #9

- East floor joist has water damage and termite damage
- Wall sheathing has water damage
- Interior ceiling has water damage \*double check fire assembly
- 2<sup>nd</sup> floor sheathing has water damage and termite damage
- 2<sup>nd</sup> floor studs have water damage and termite damage
- Metal strap not tight
