**NOTICE OF FILING PART 1 OF FINAL ENGINEERING REPORT OF SPECIALTY  
ENGINEERING CONSULTANTS, INC. DATED NOVEMBER 5, 2024**

**PROFESSIONAL CONSULTING SERVICES FOR:  
Heron Pond Condominium Association, Inc.**

Building #9  
8343 SW 5<sup>th</sup> Street,  
Pembroke Pines, FL 33025

Re: Investigation and Documentation of Deteriorated and Damaged Structural Items

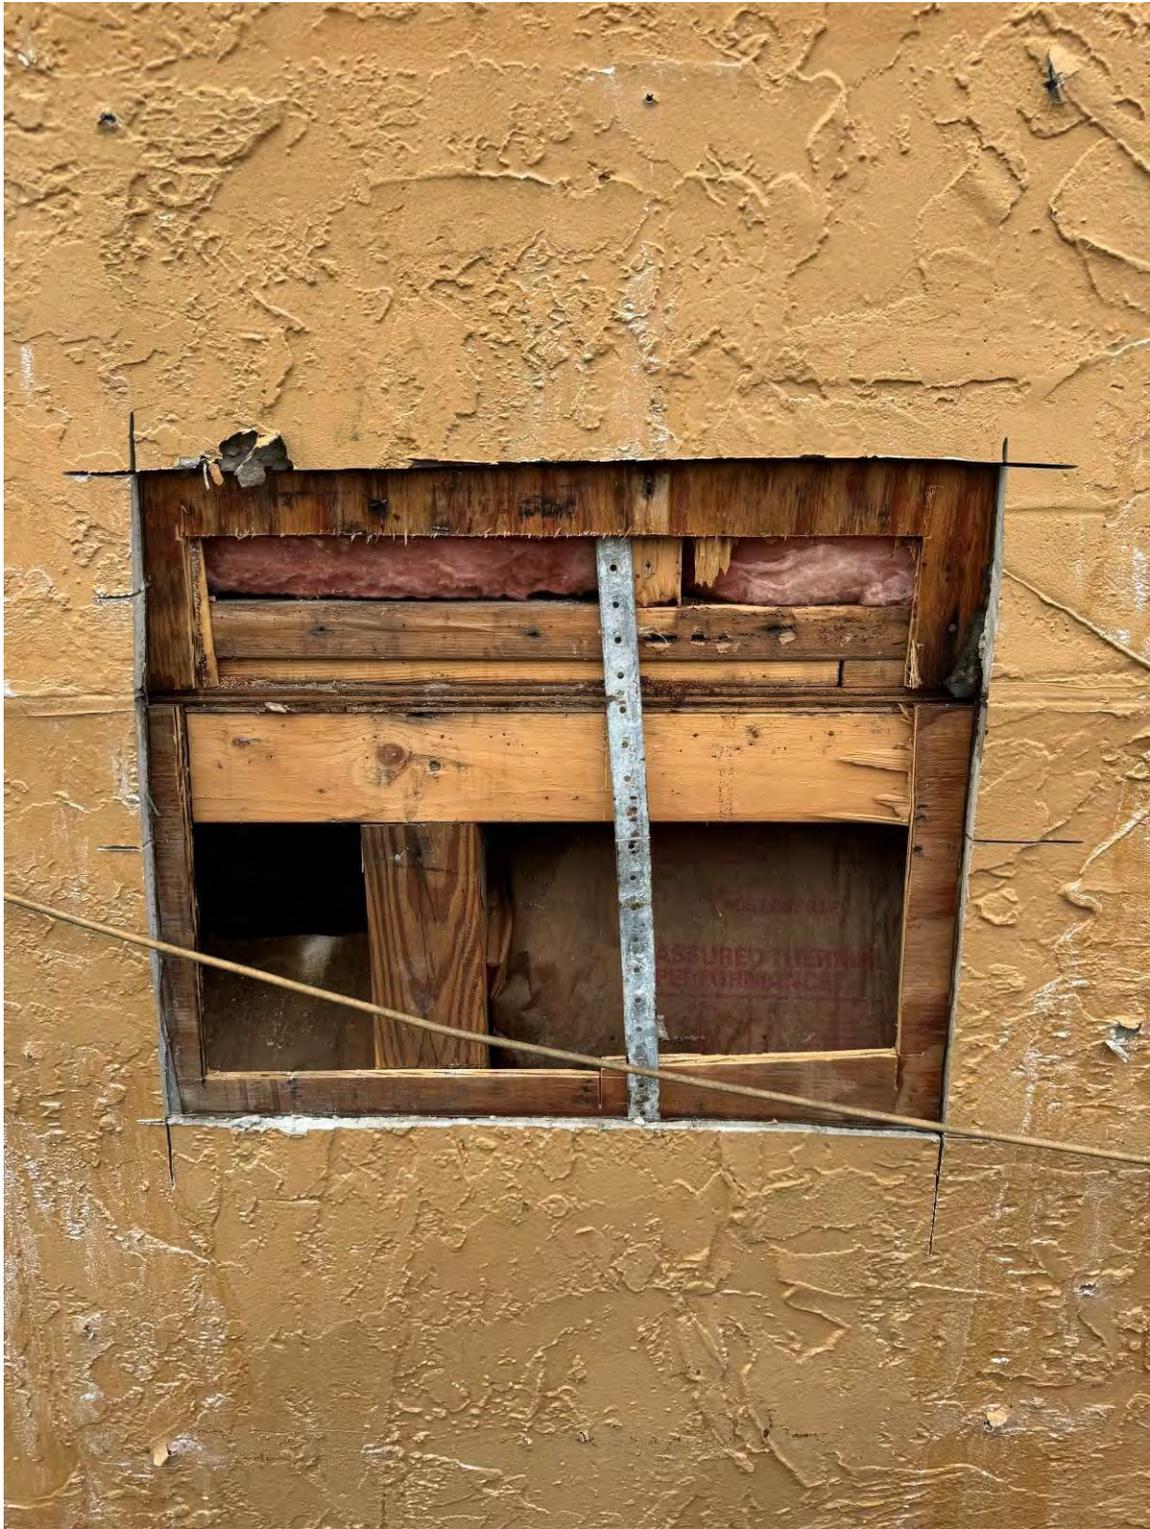
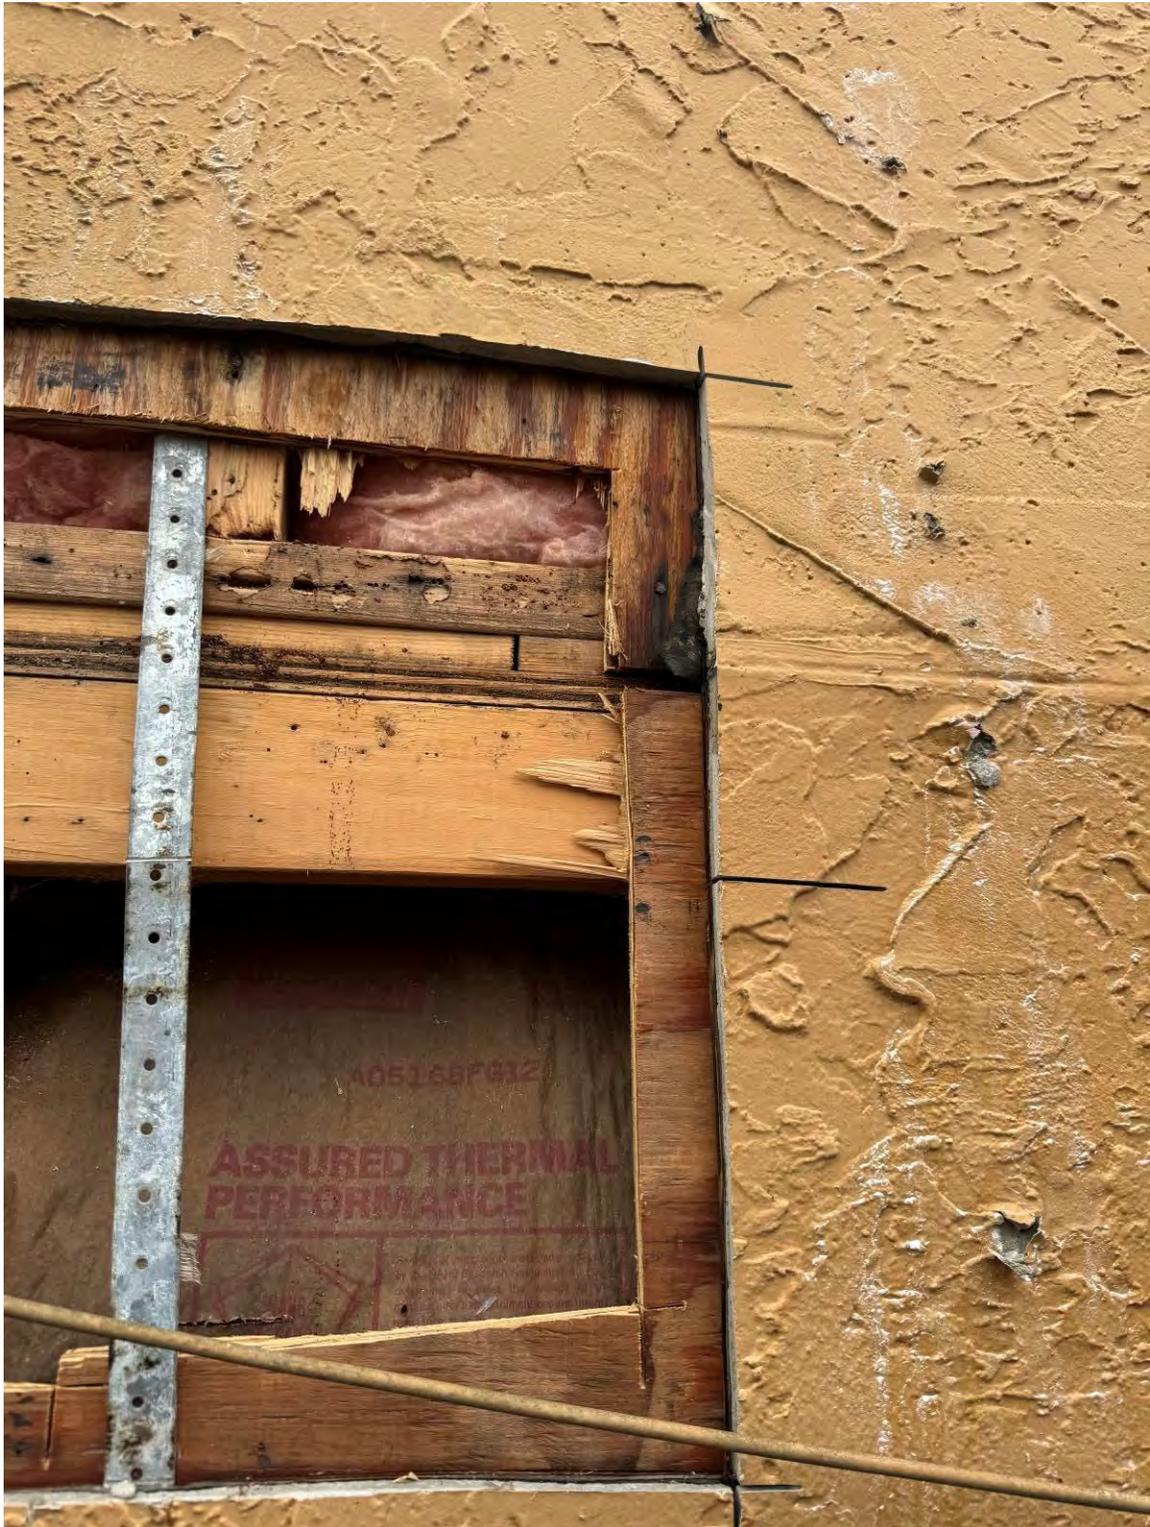
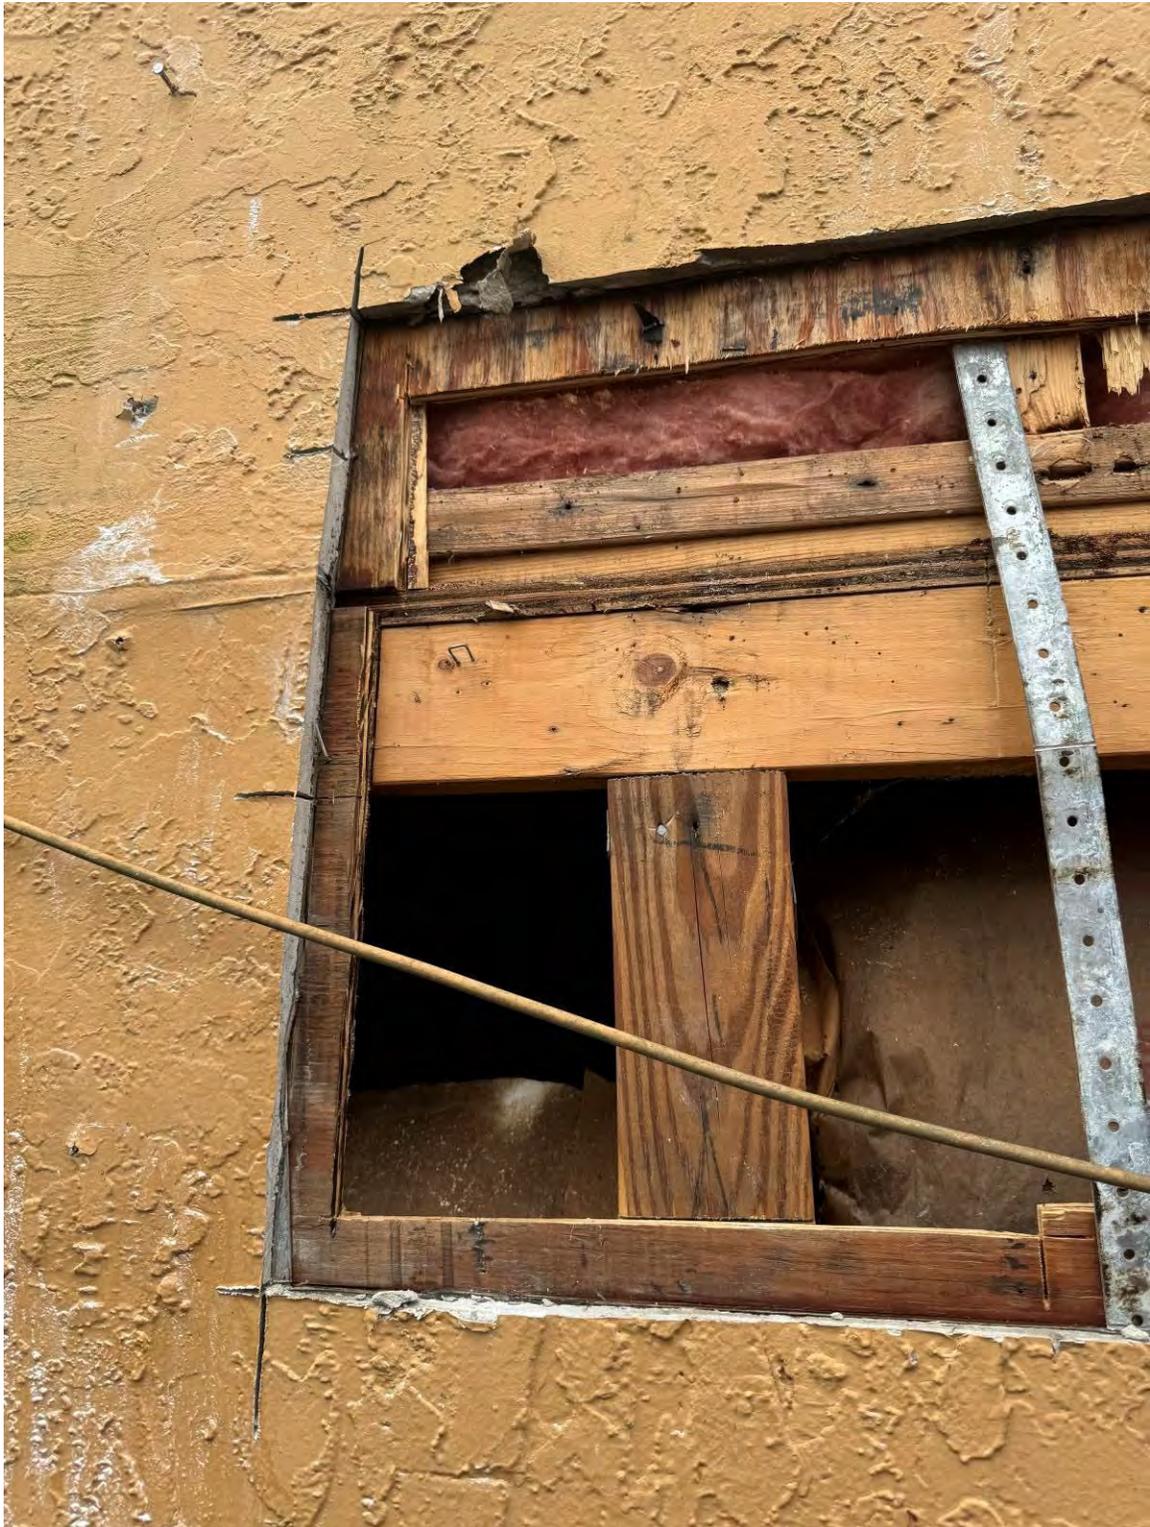
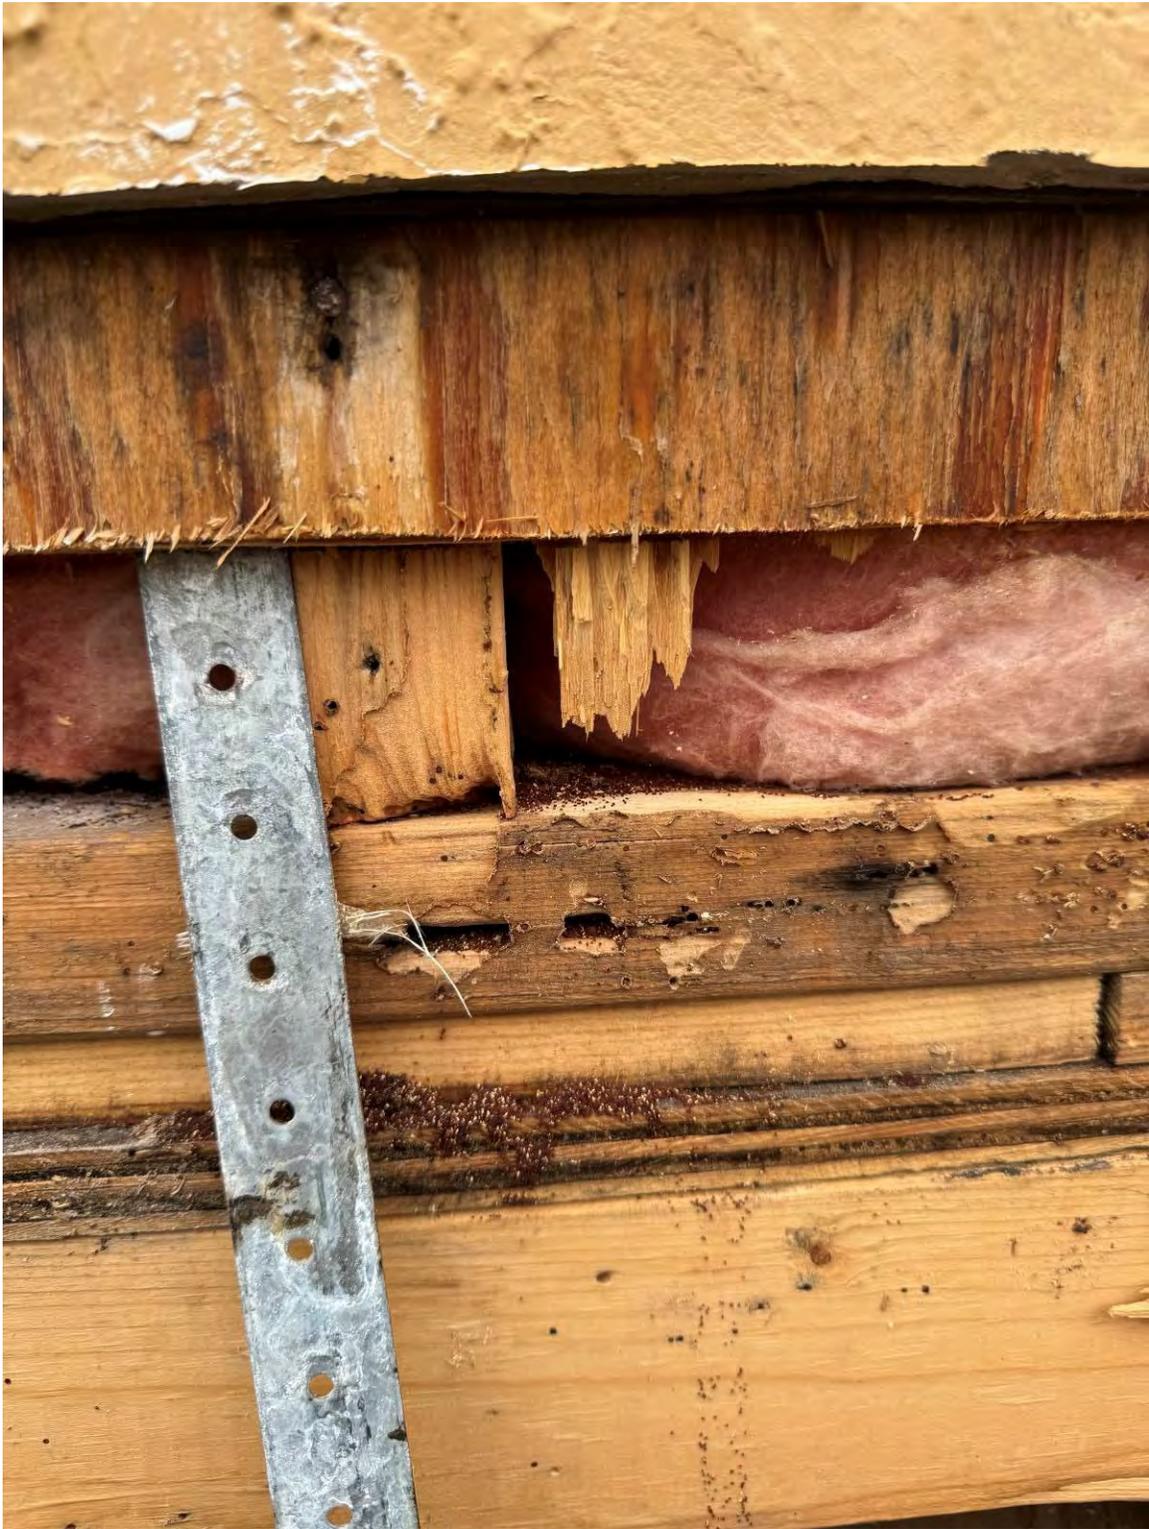
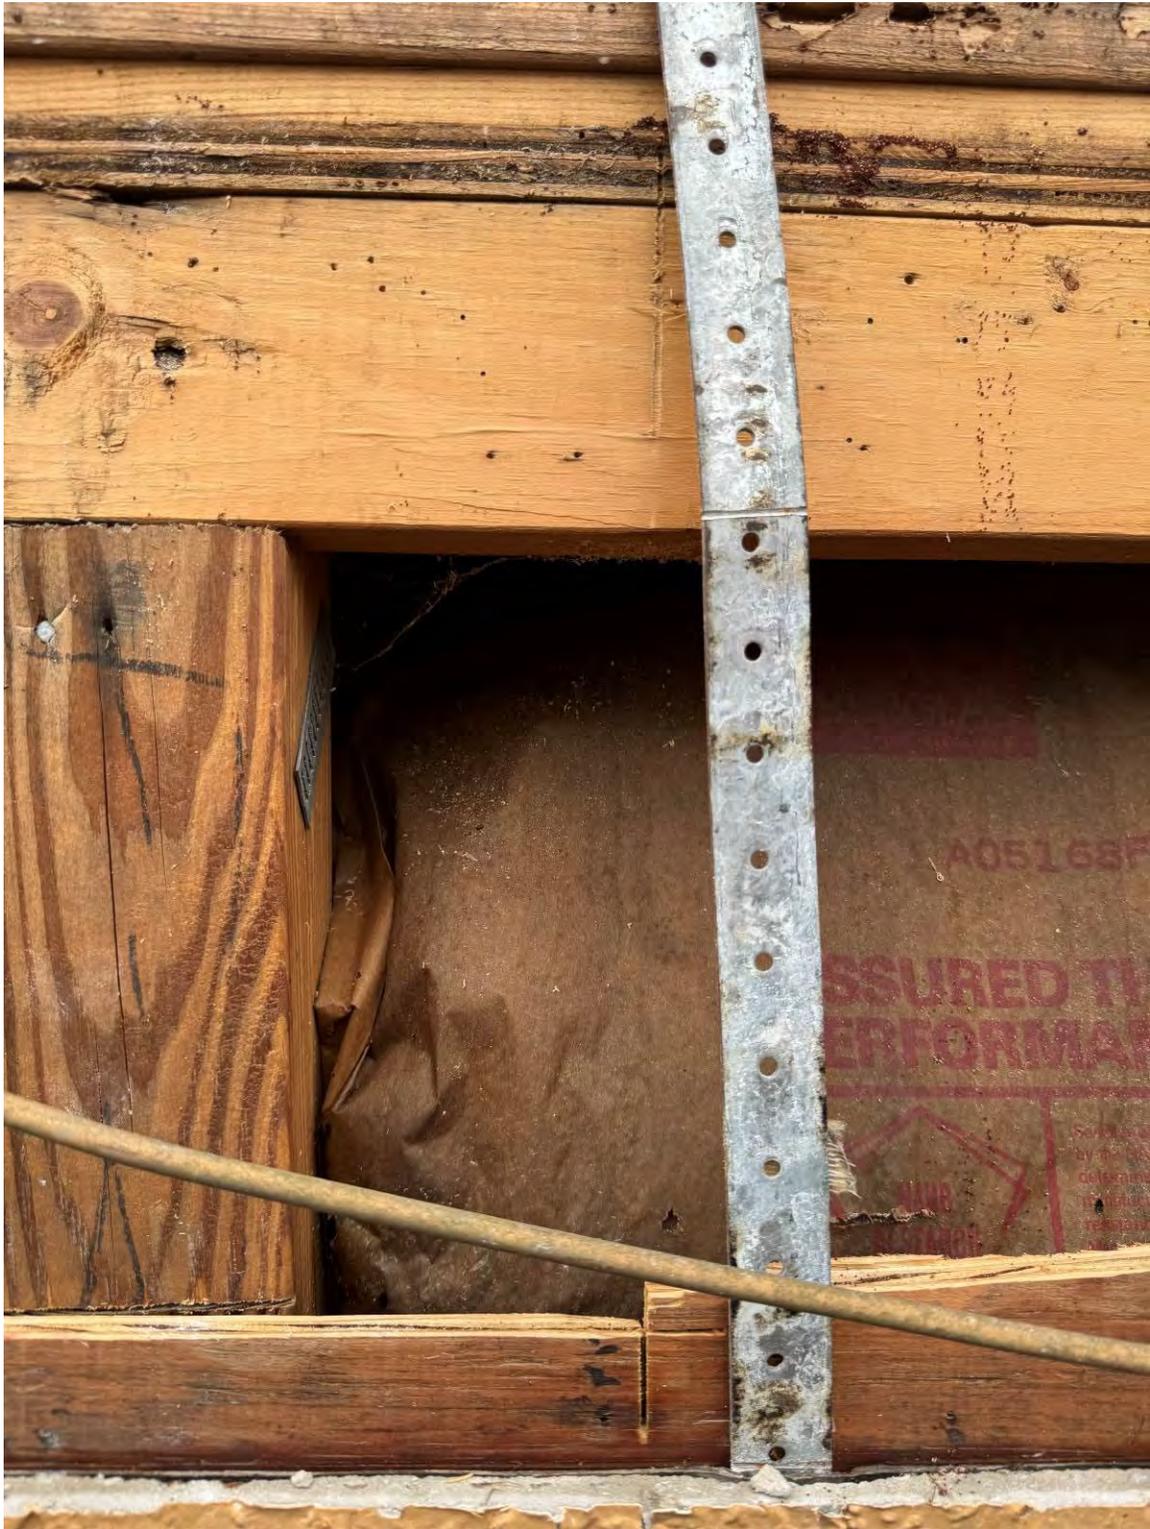
# OPENING #10

- Exterior sheathing has water damage
- Stucco is 5/8" thick
- 2<sup>nd</sup> floor sill plate has termite damage
- 2<sup>nd</sup> floor wall stud has termite damage
- Metal strap not tight

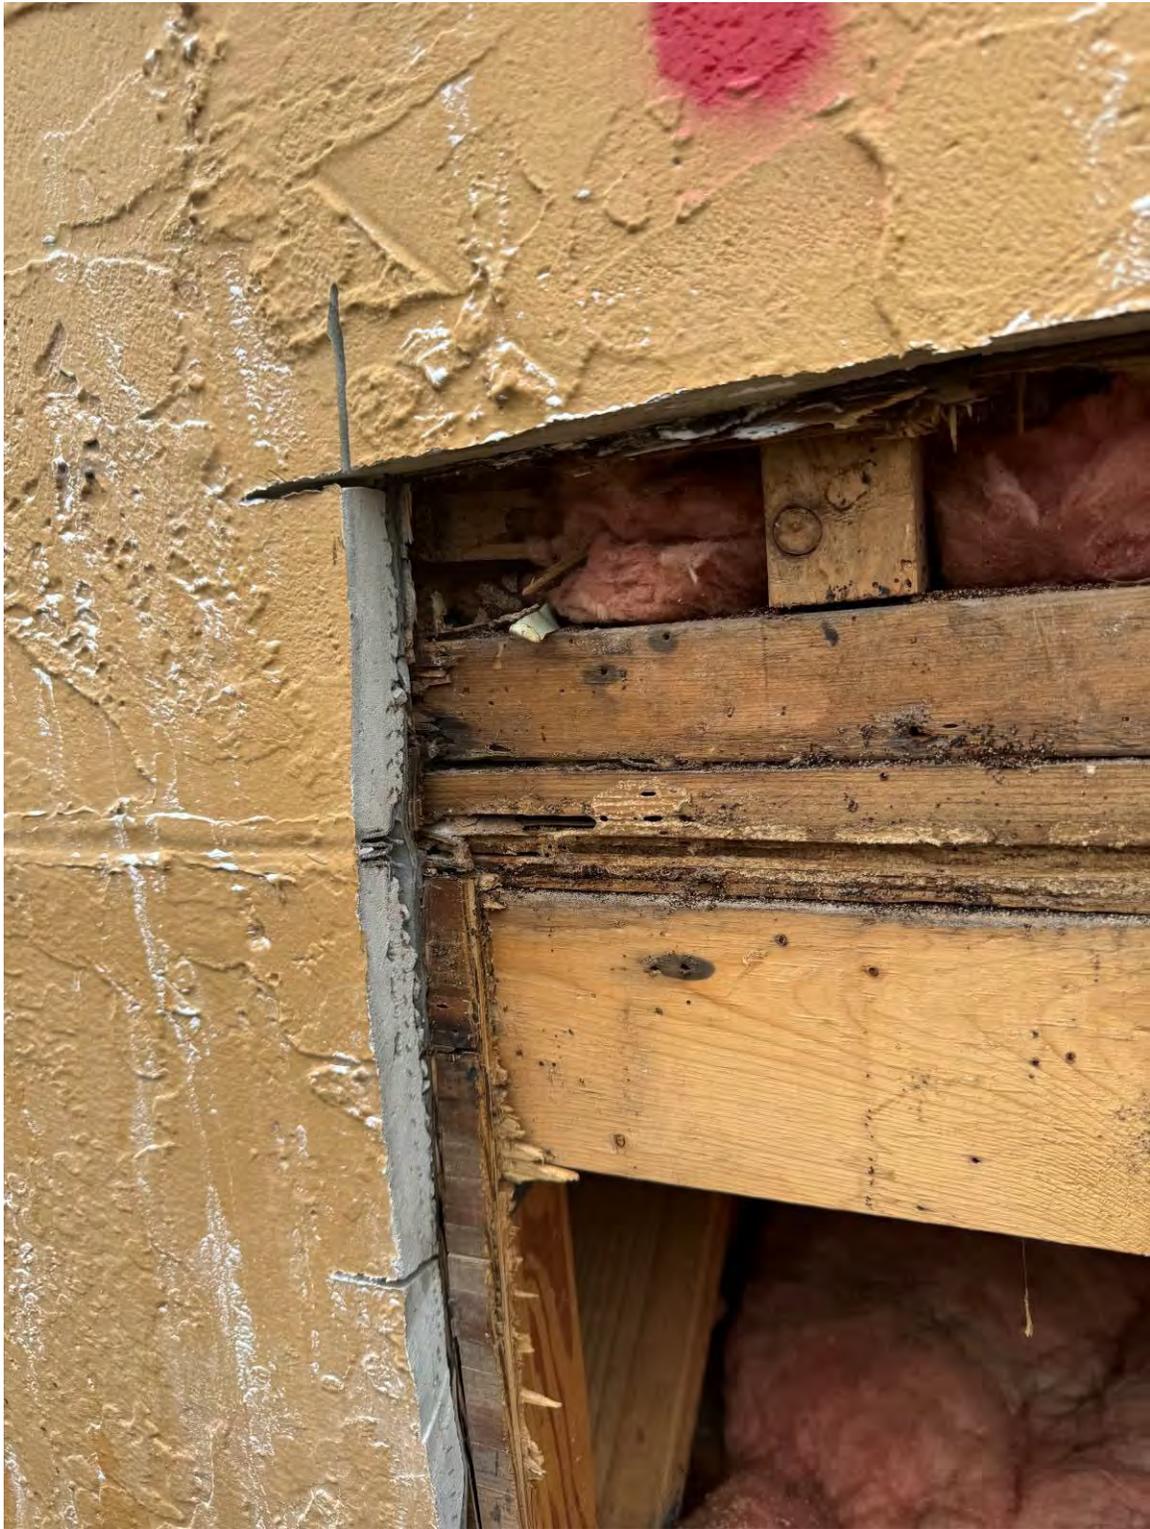
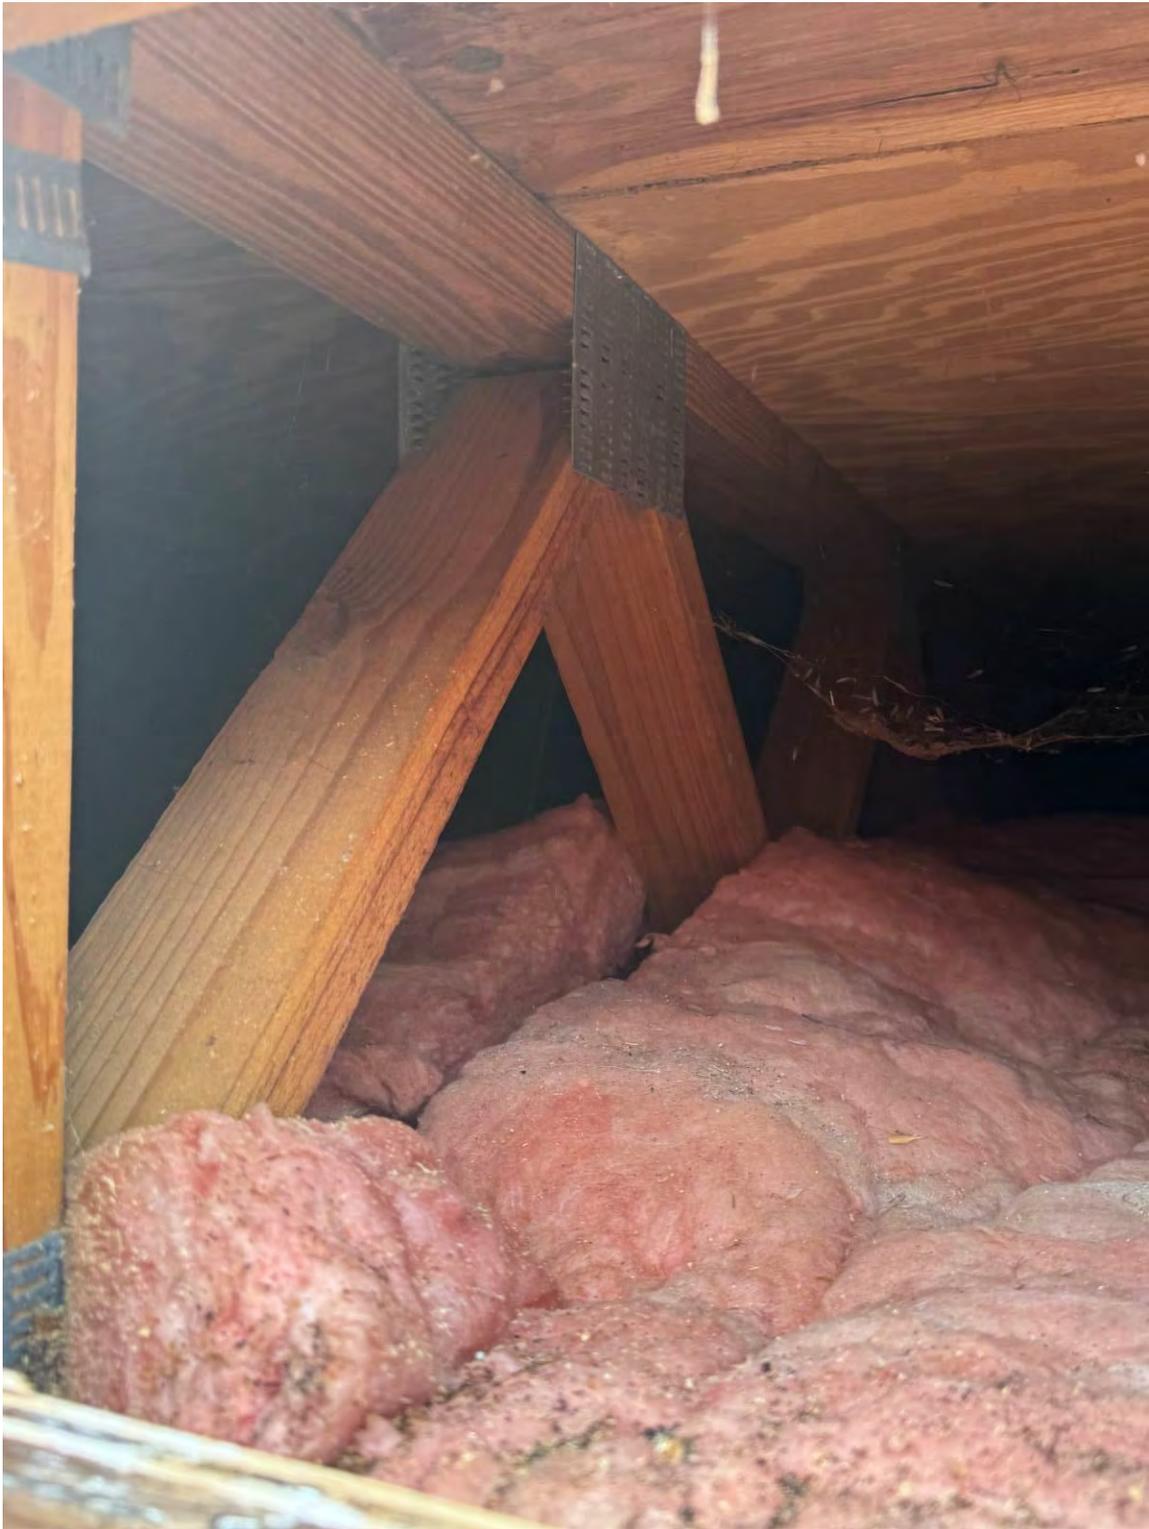
# OPENING #11

- Wall sheathing has water damage and termite damage
- 2<sup>nd</sup> floor sheathing has water damage and termite damage
- 2<sup>nd</sup> floor bearing wall bottom plate has termite damage
- 2<sup>nd</sup> floor wall studs have termite damage

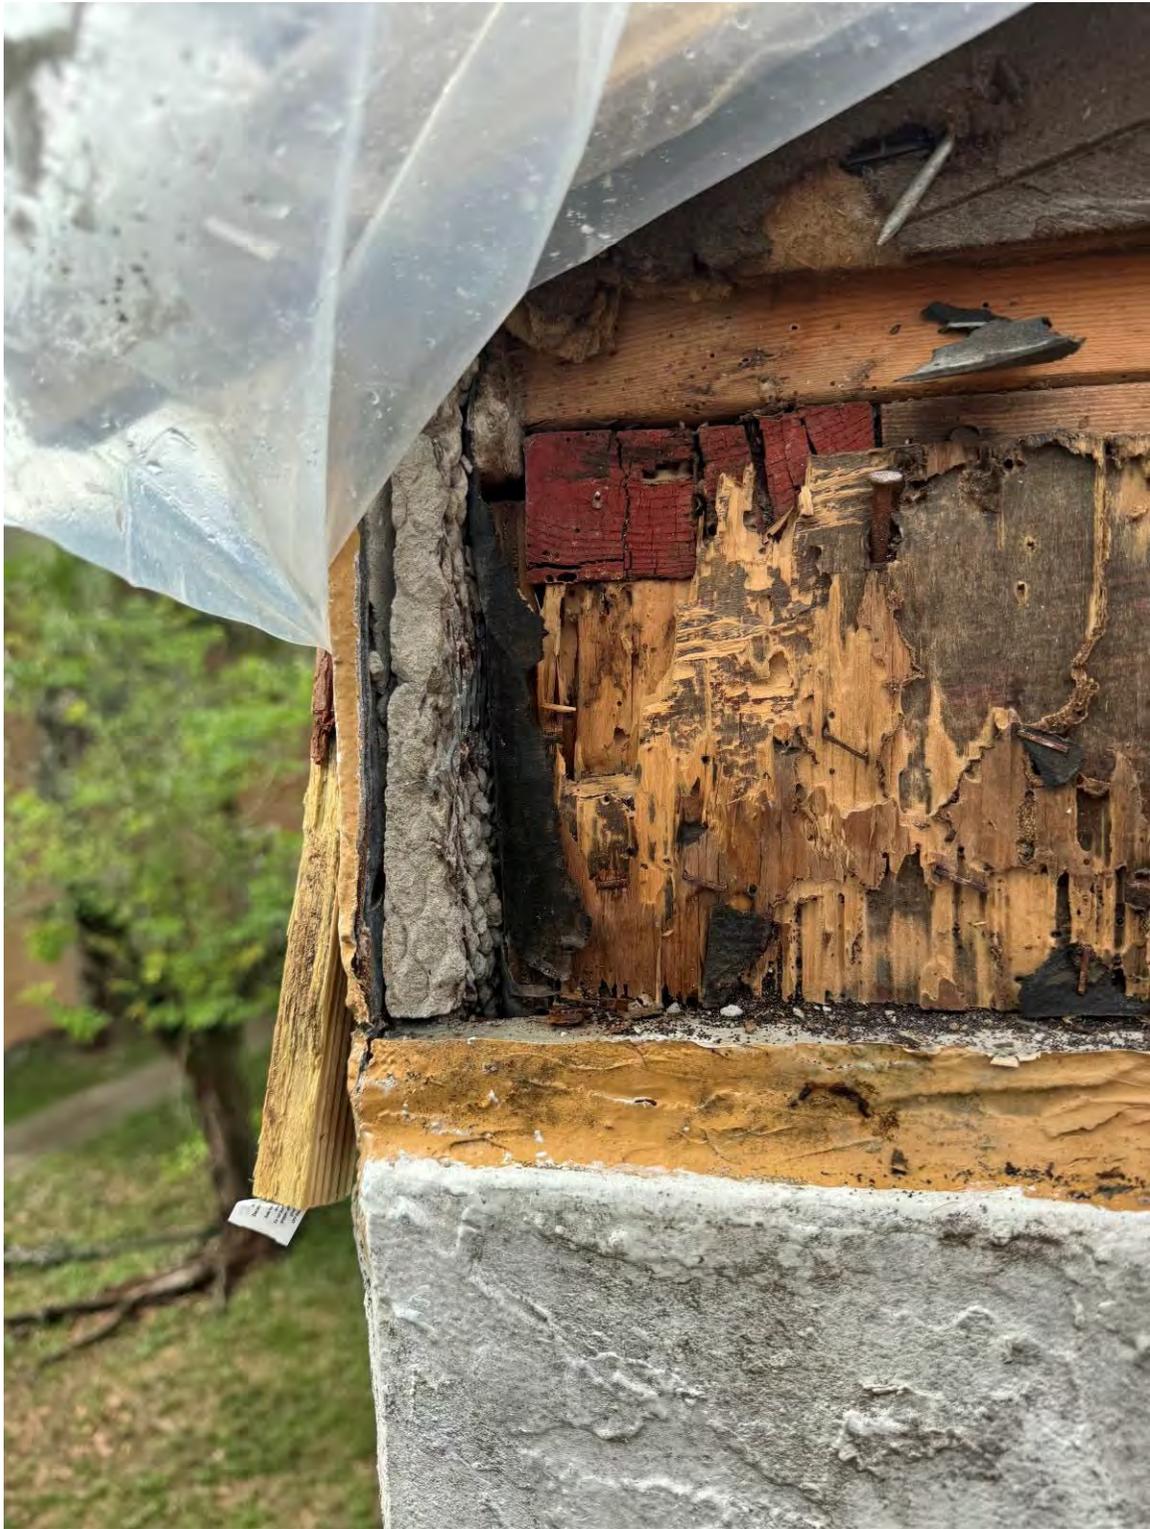
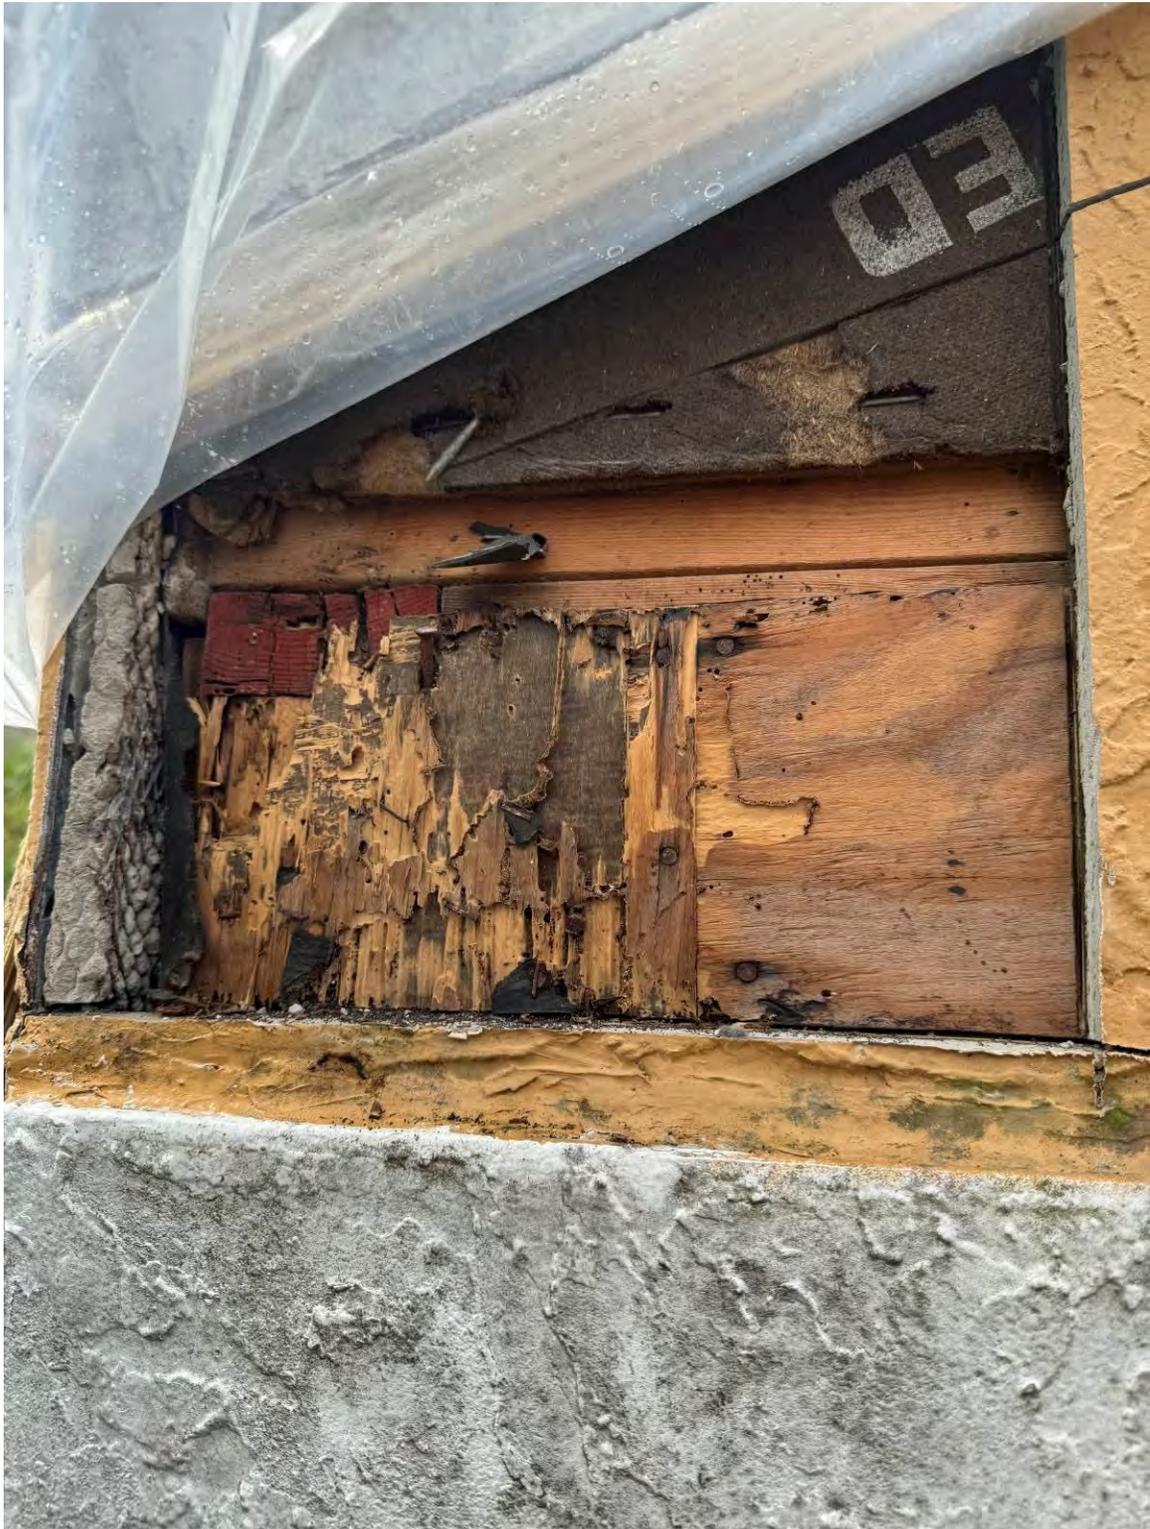
# OPENING #12

- Exterior sheathing has termite damage and water damage
- Floor joist has water damage and termite damage
- Roof has no fascia board
- Feld board faces gabled end
- No visible connector for north 2<sup>nd</sup> floor wall to east 2<sup>nd</sup> floor wall

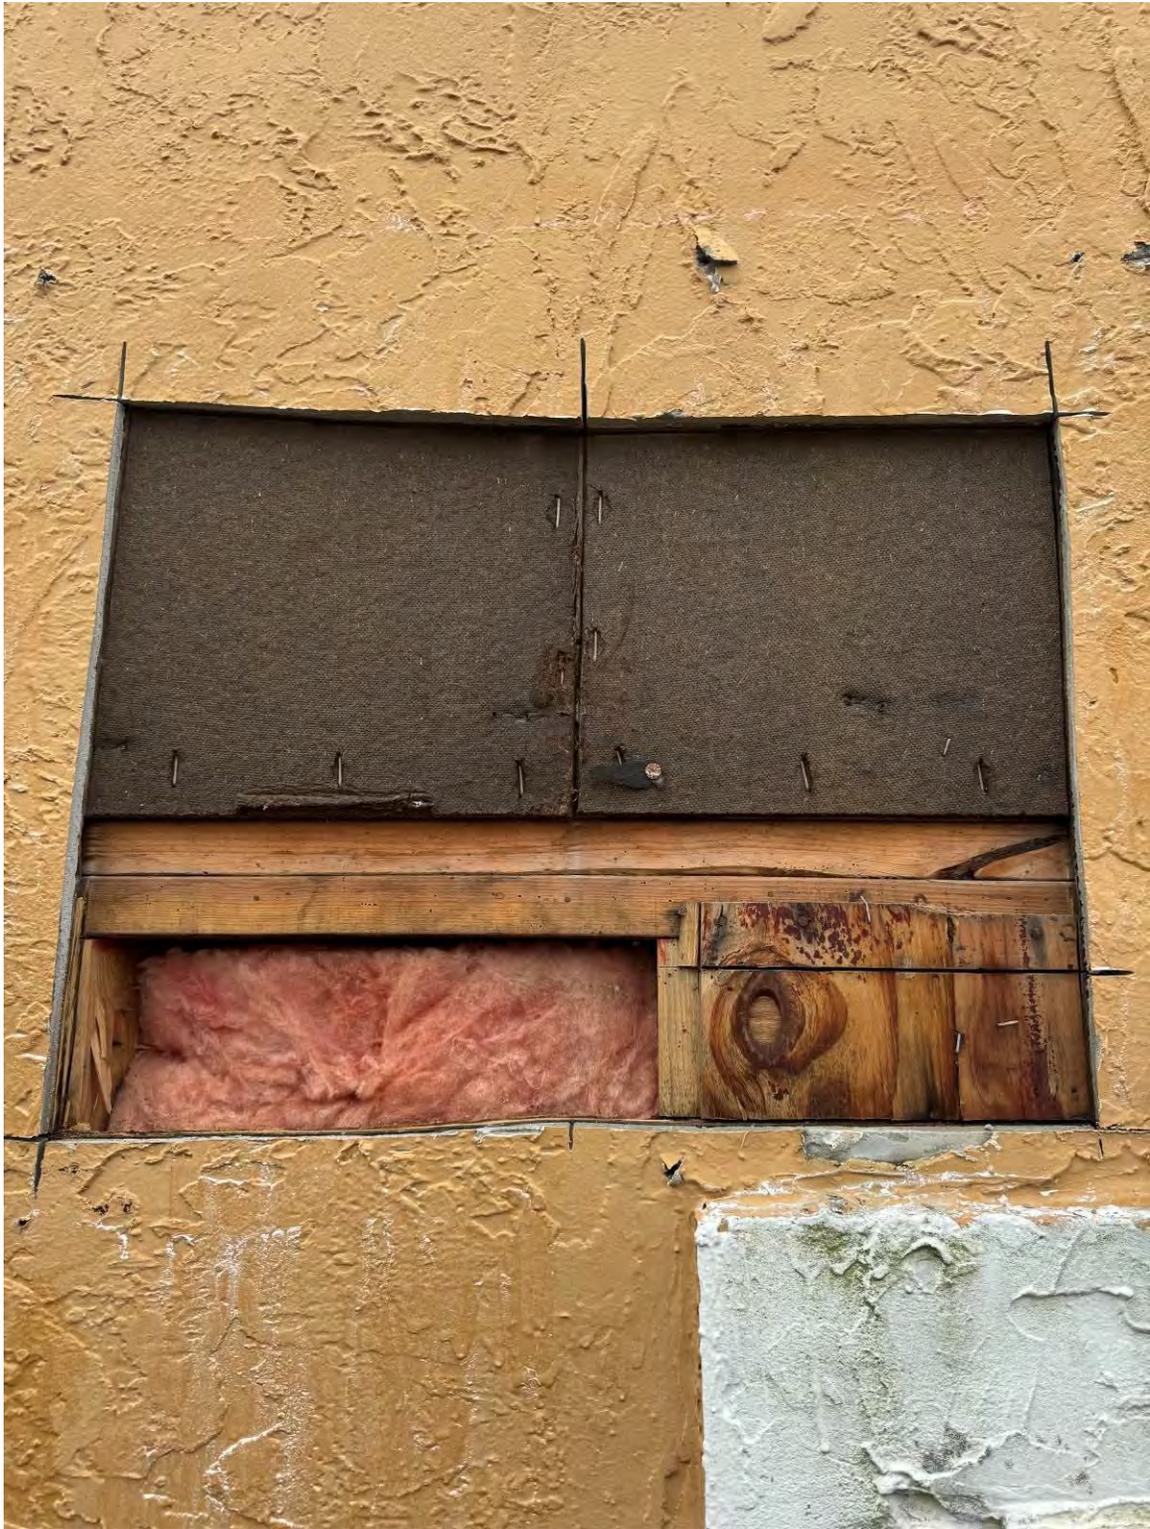
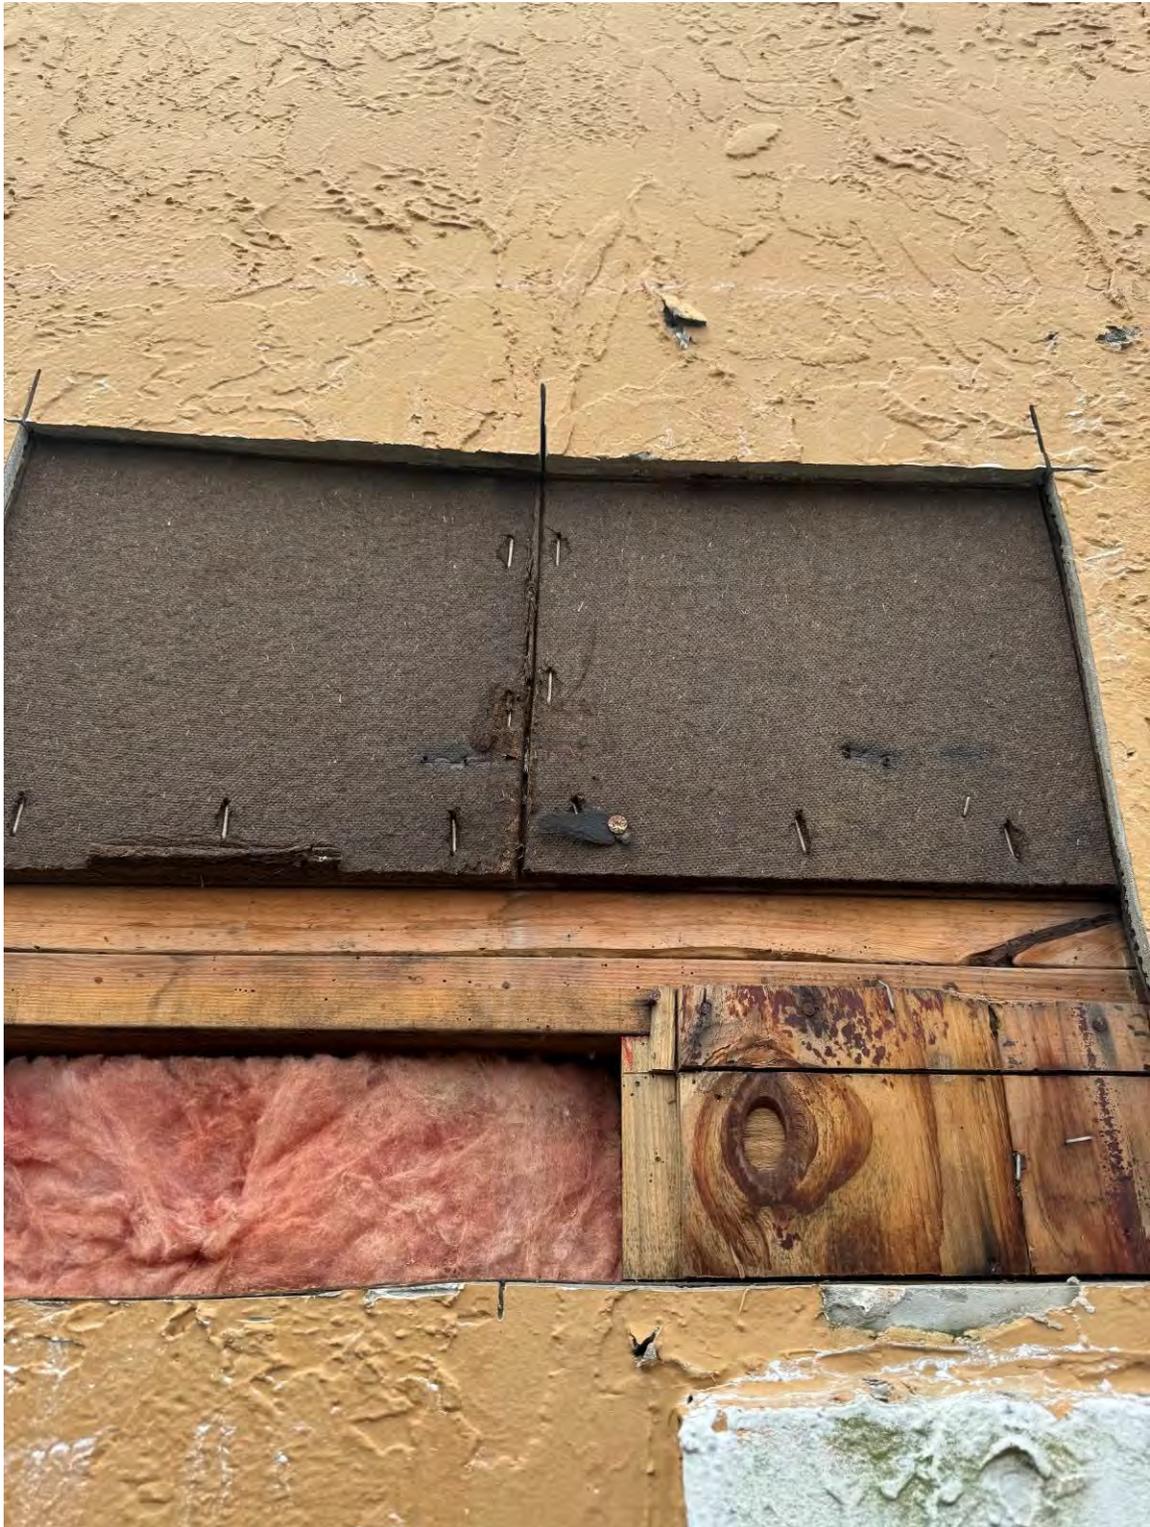
# OPENING #13

- Exterior sheathing has water damage
- Gabled end faced with felt board
