**NOTICE OF FILING PART 1 OF FINAL ENGINEERING REPORT OF SPECIALTY  
ENGINEERING CONSULTANTS, INC. DATED NOVEMBER 5, 2024**

**PROFESSIONAL CONSULTING SERVICES FOR:  
Heron Pond Condominium Association, Inc.**

Building #9  
8343 SW 5<sup>th</sup> Street,  
Pembroke Pines, FL 33025

Re: Investigation and Documentation of Deteriorated and Damaged Structural Items

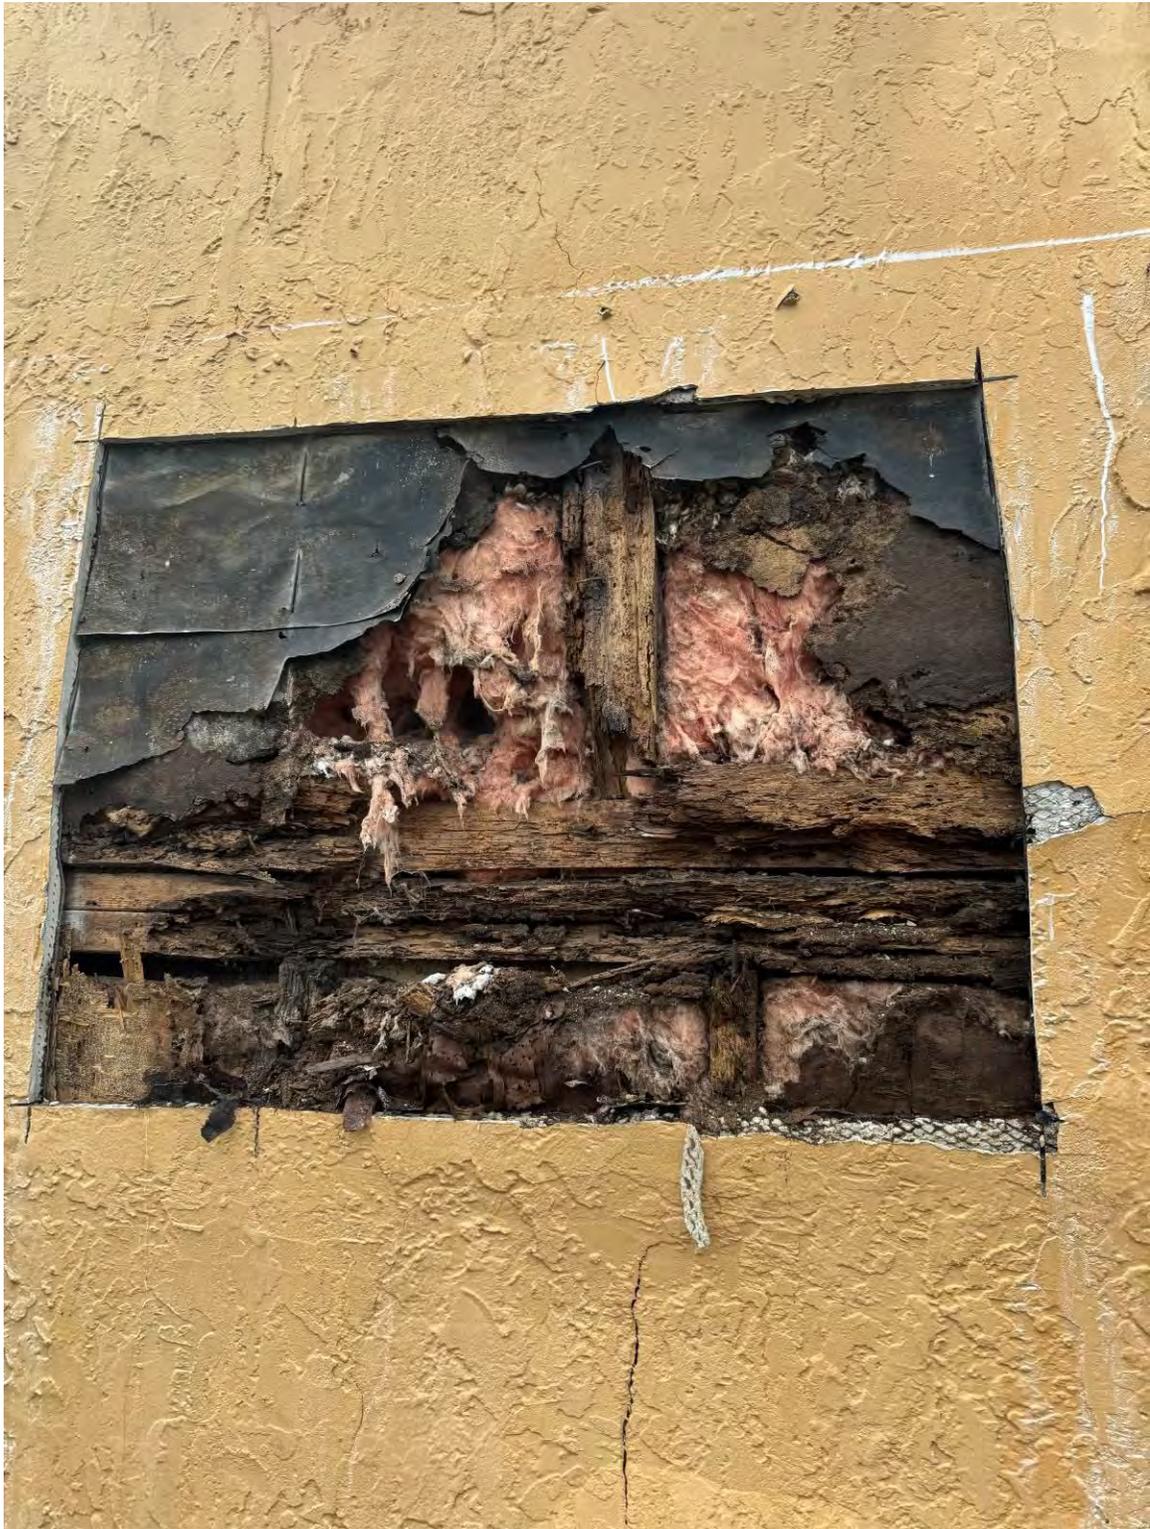
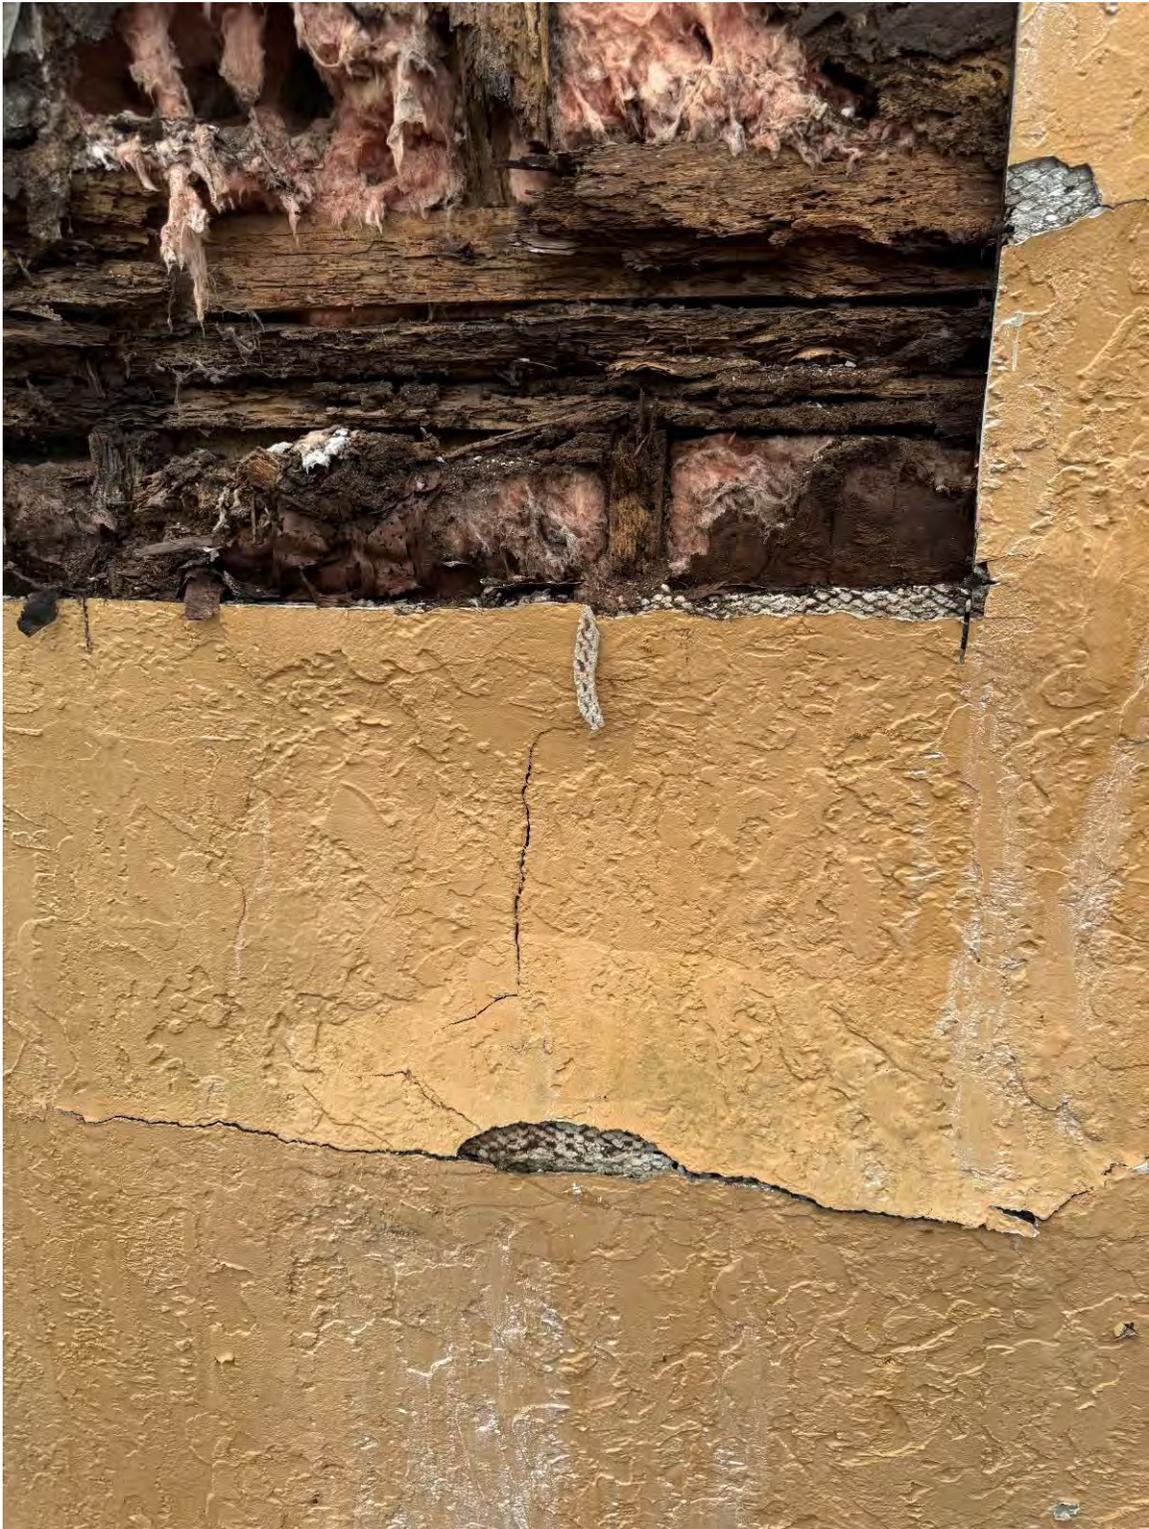
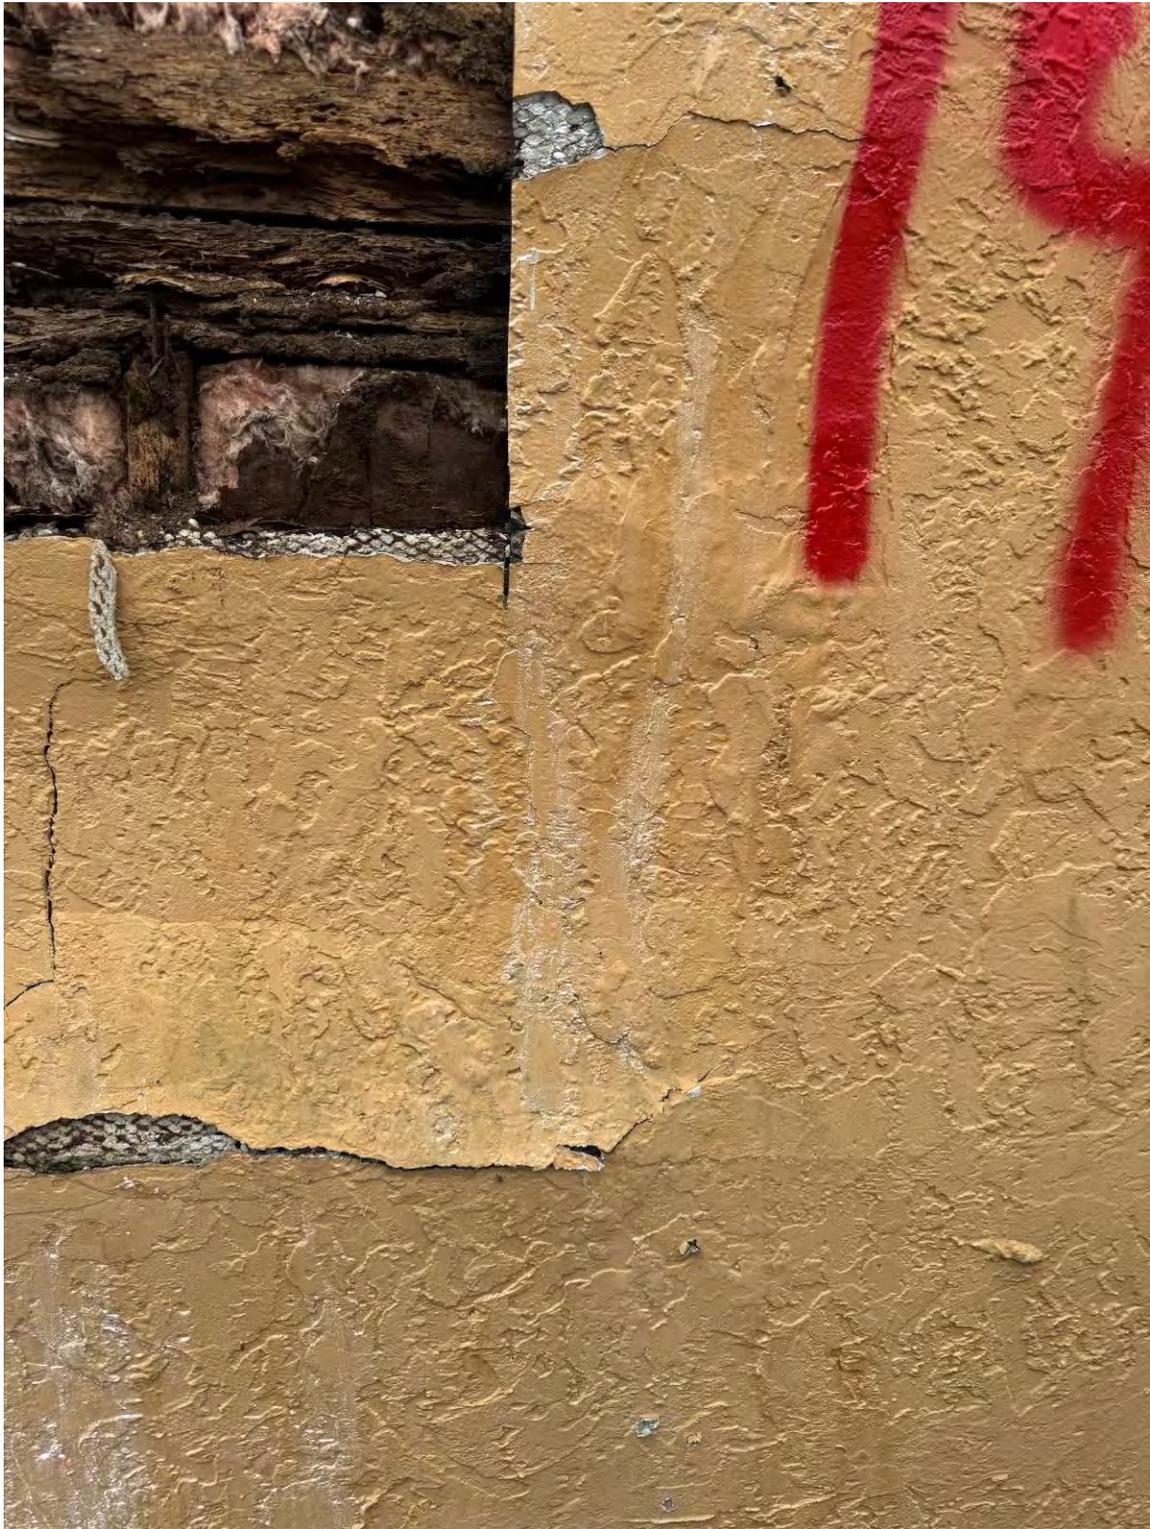
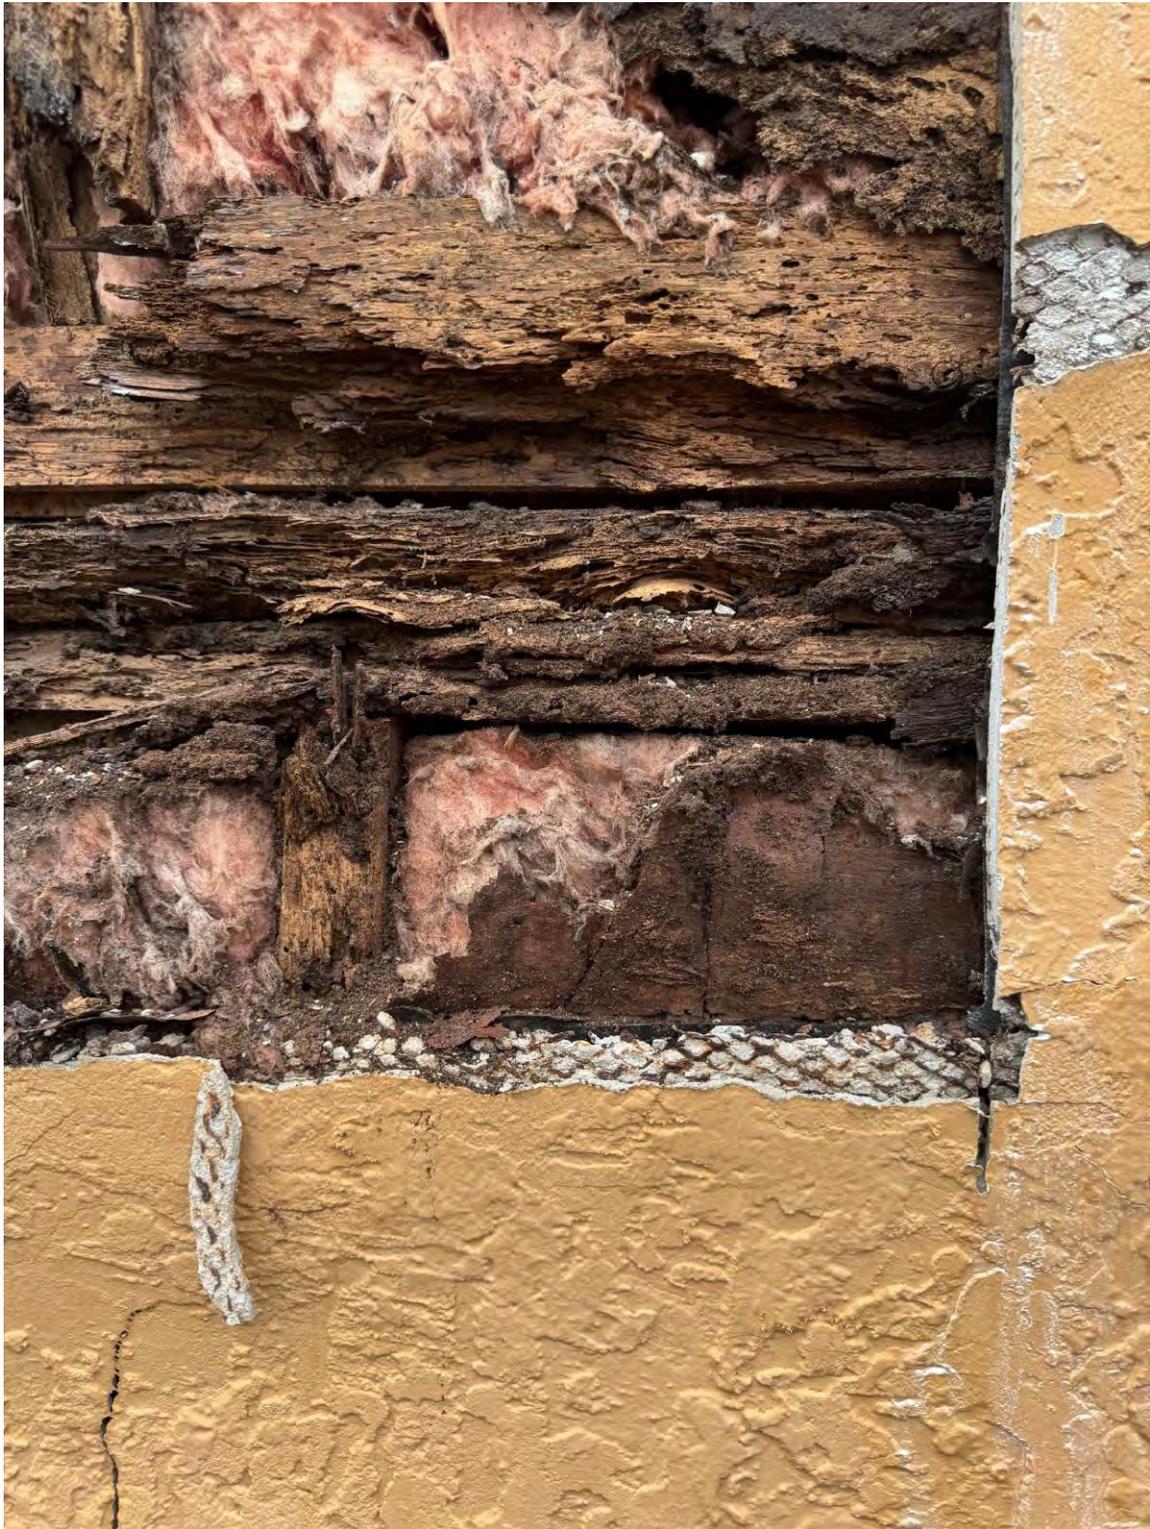
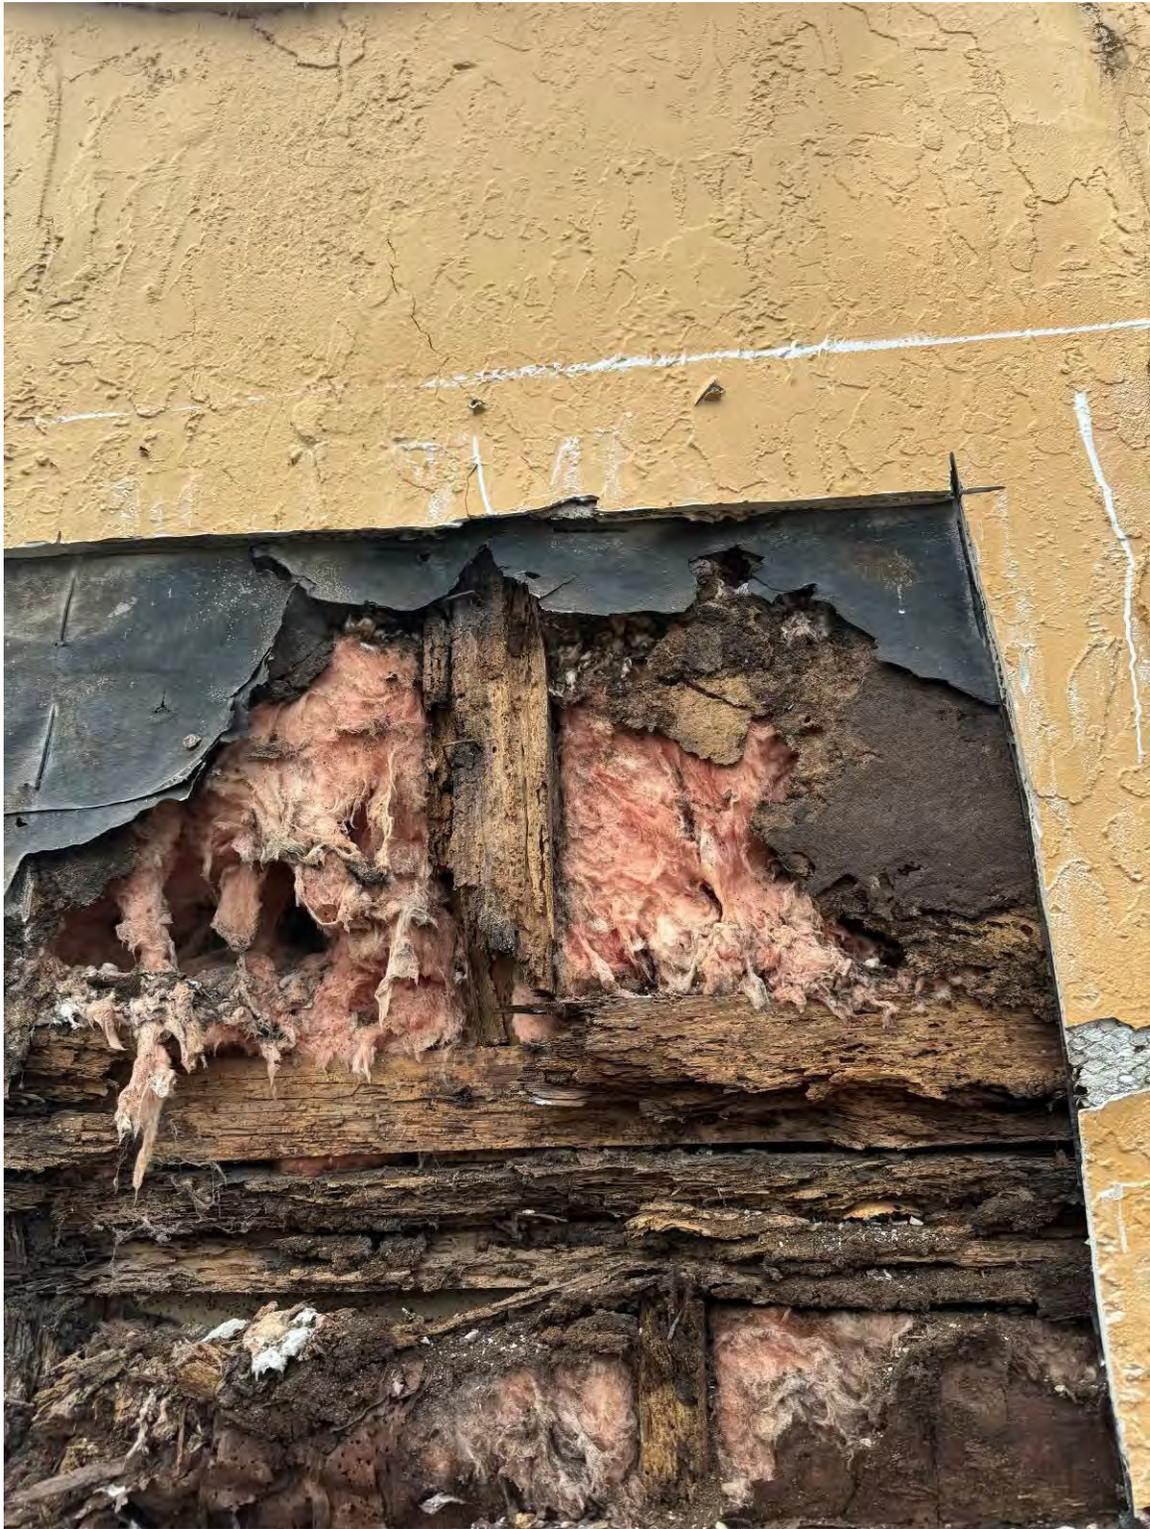
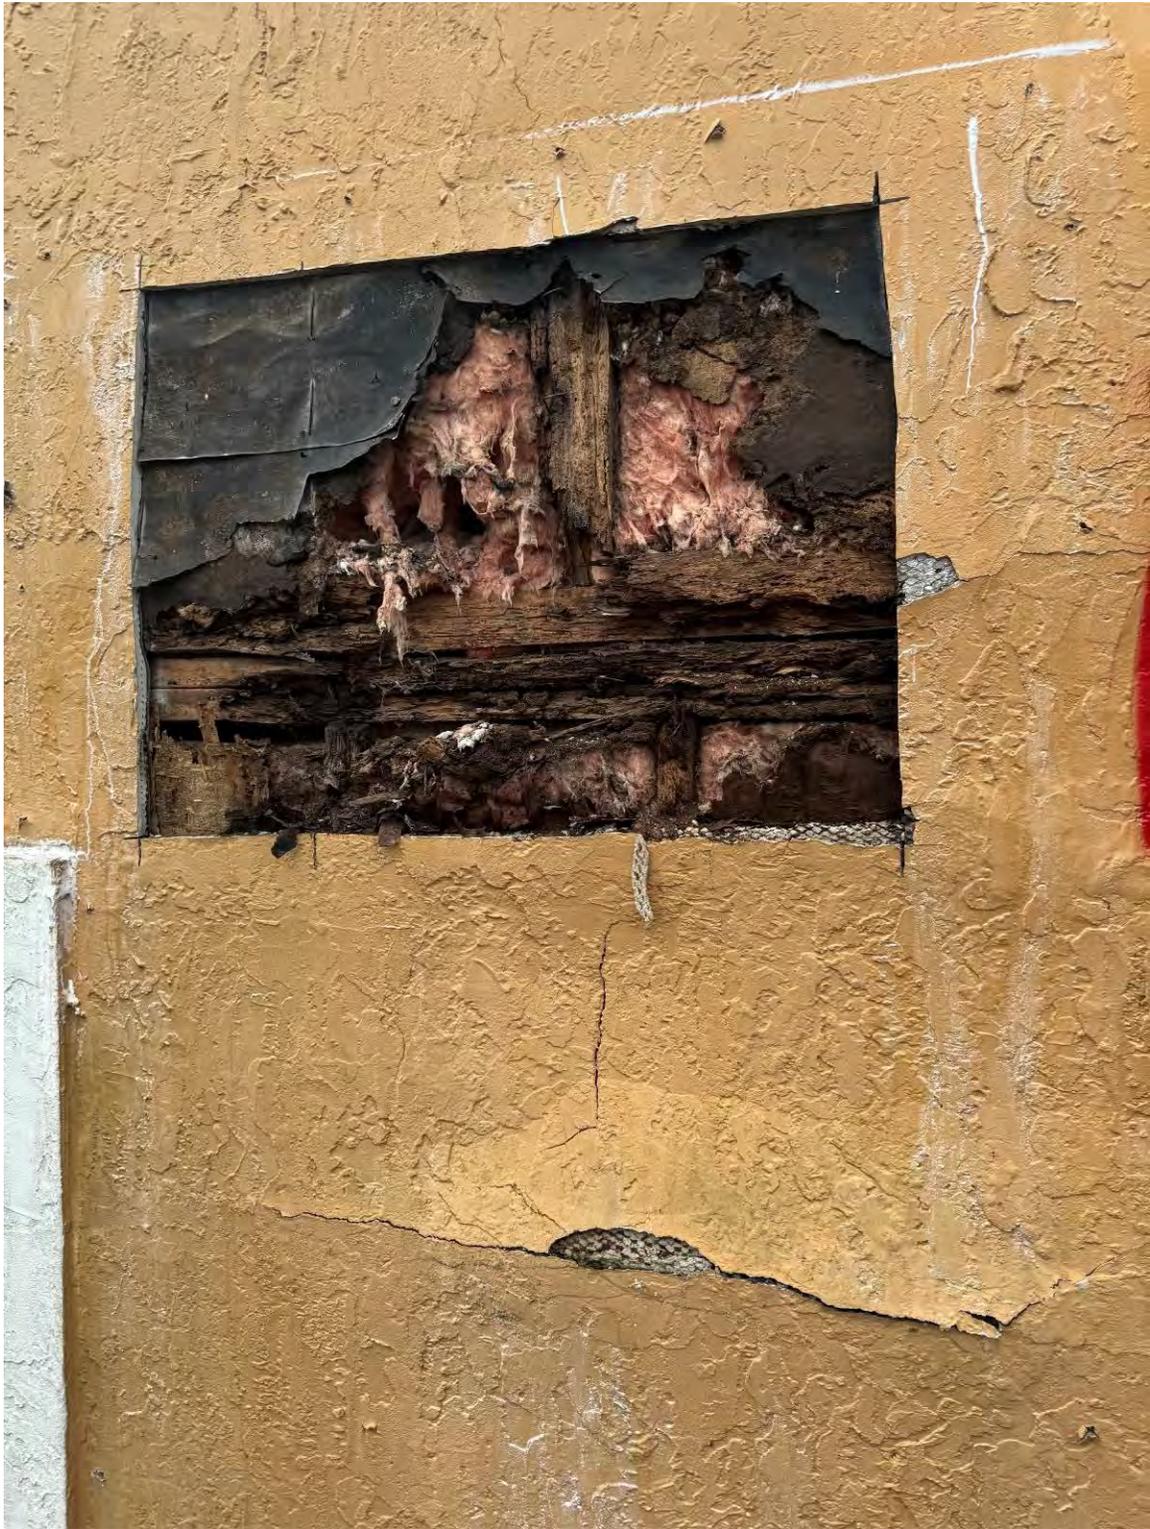
# OPENING #14

- Gabled end roof truss destroyed by water damage and termite damage
- Bearing wall top plate destroyed by water damage and termite damage
- Bearing wall studs destroyed by water damage and termite damage
- Wall sheathing destroyed by water damage and termite damage
- Gabled end faced with felt board
