**NOTICE OF FILING PART 2 OF FINAL ENGINEERING REPORT OF SPECIALTY  
ENGINEERING CONSULTANTS, INC. DATED NOVEMBER 5, 2024**

Daniel J. Stermer, not individually, but solely in his capacity as Court Appointed Receiver (the "Receiver"), over the Heron Pond Condominium Association, Inc., (the "Association") by and through its undersigned counsel, hereby gives notice of filing Part 2 of the attached final Engineering Report of Specialty Engineering Consultants, Inc. dated November 5, 2024, opining on the existing condition of Building 9.

# OPENING #15

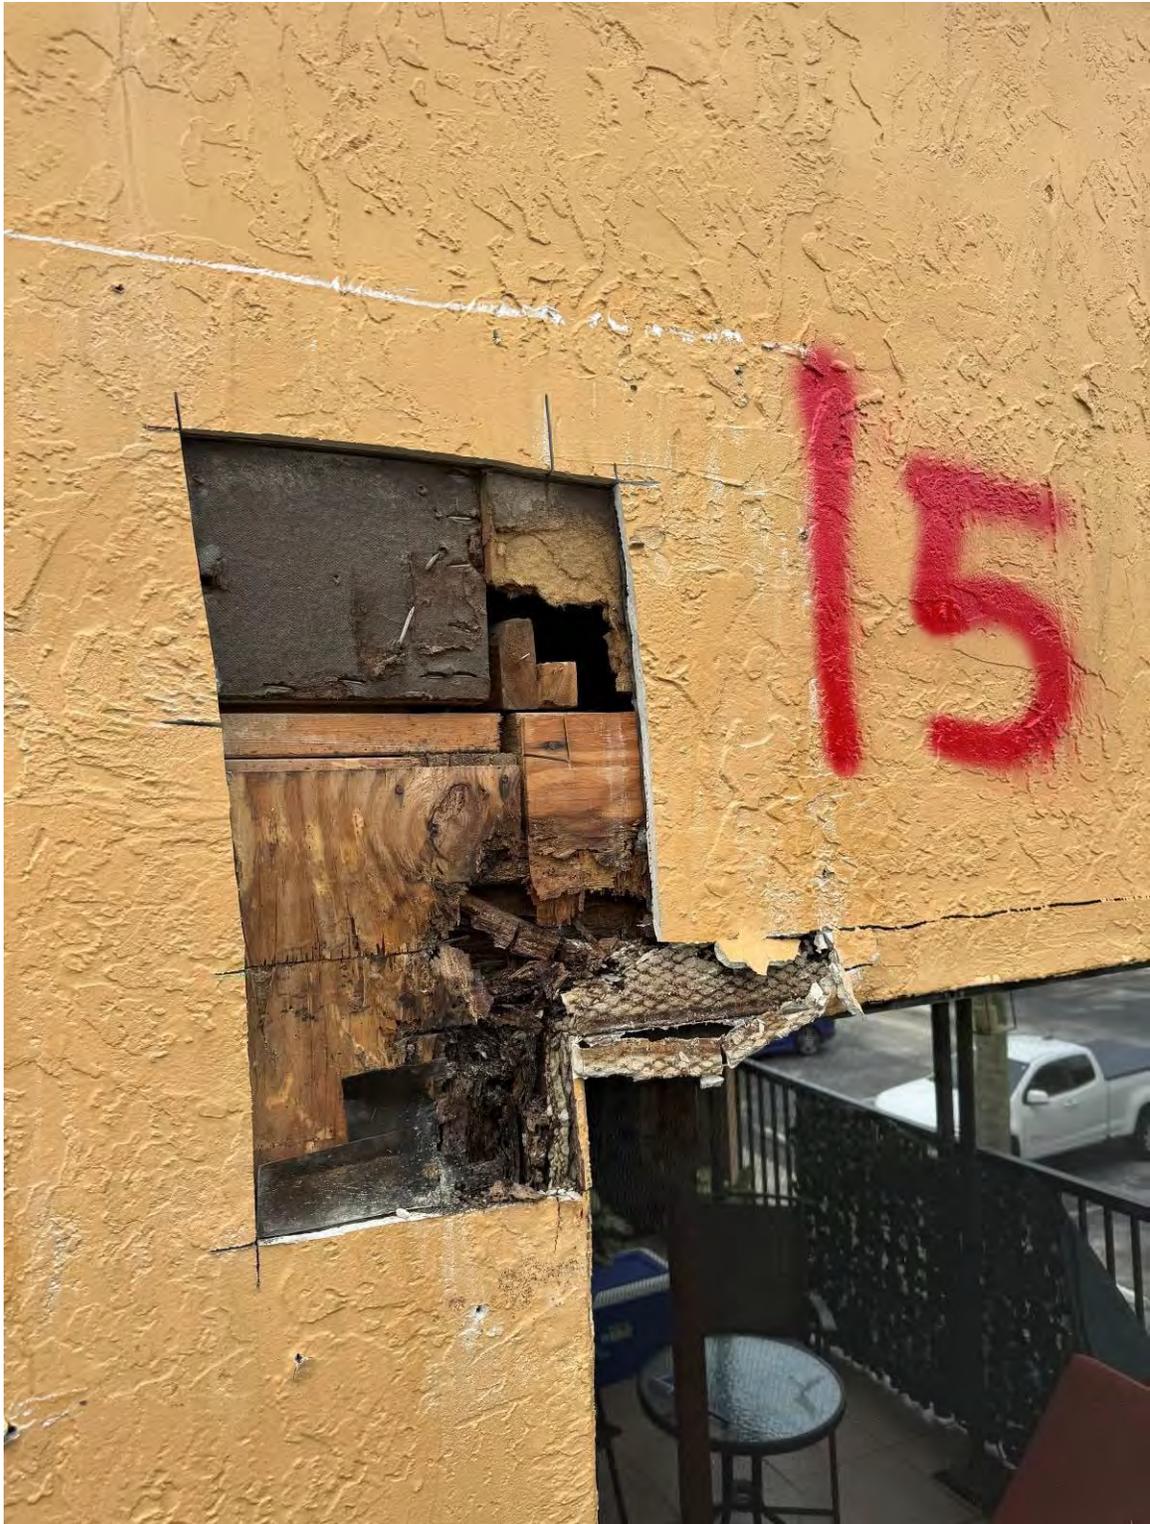
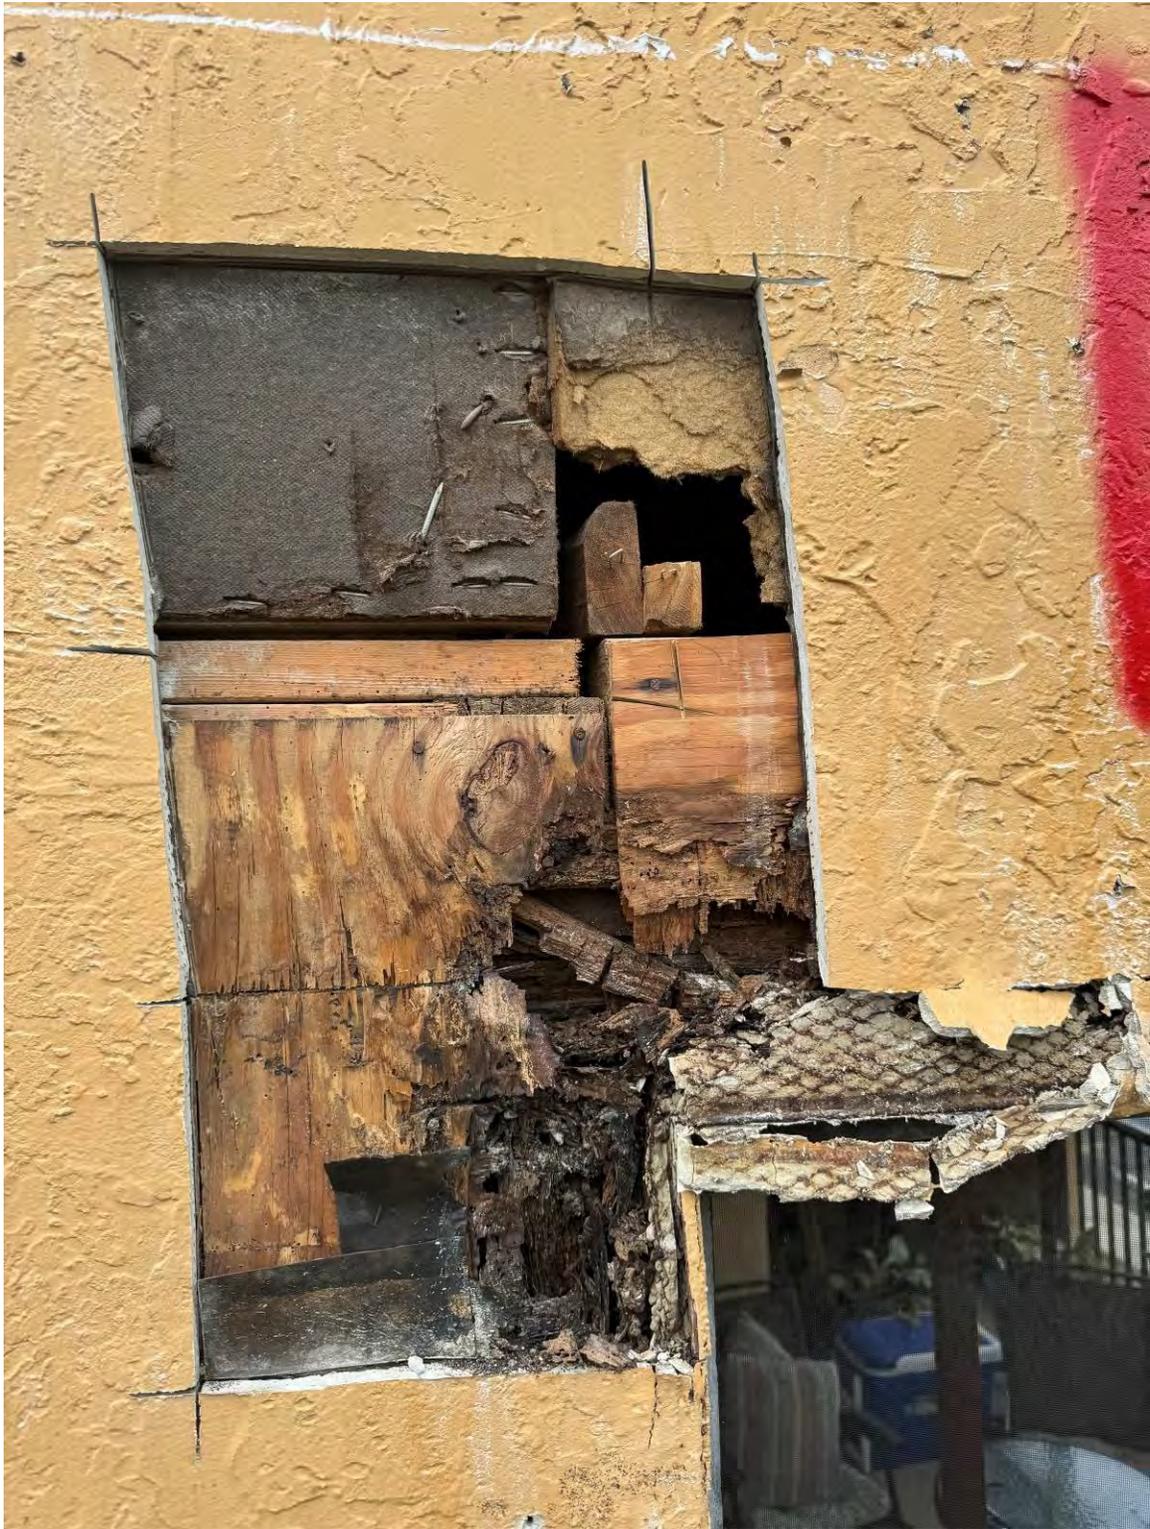
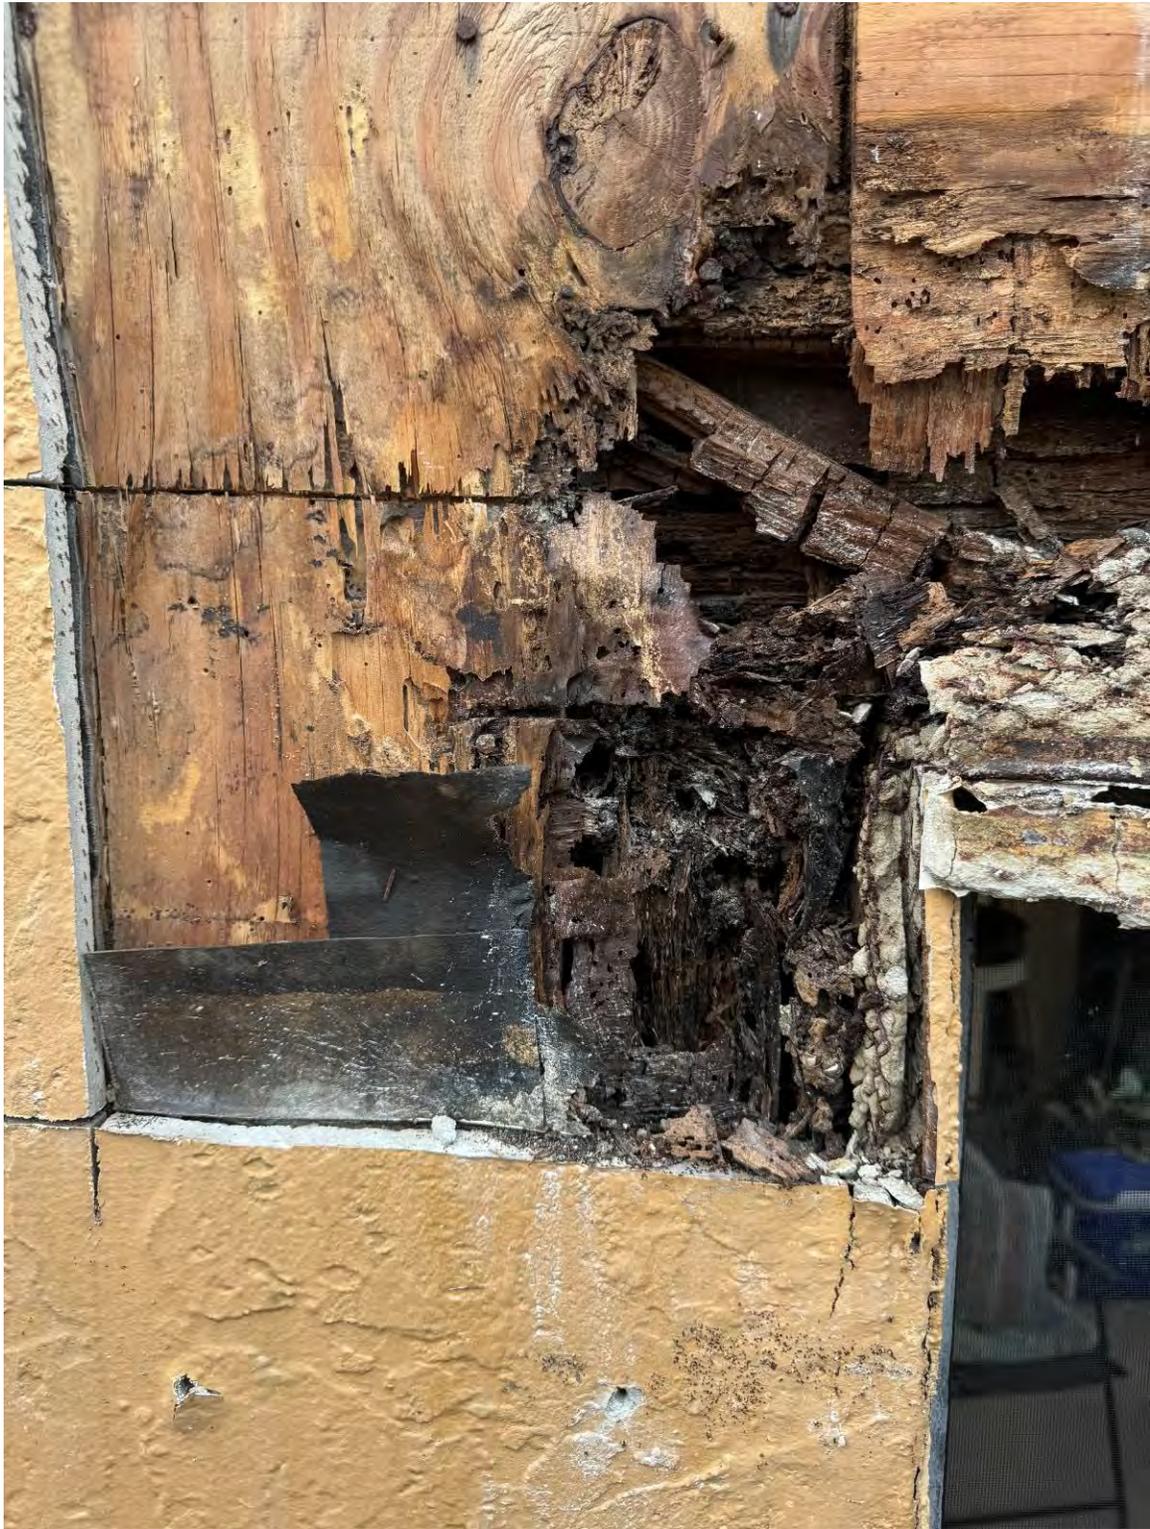
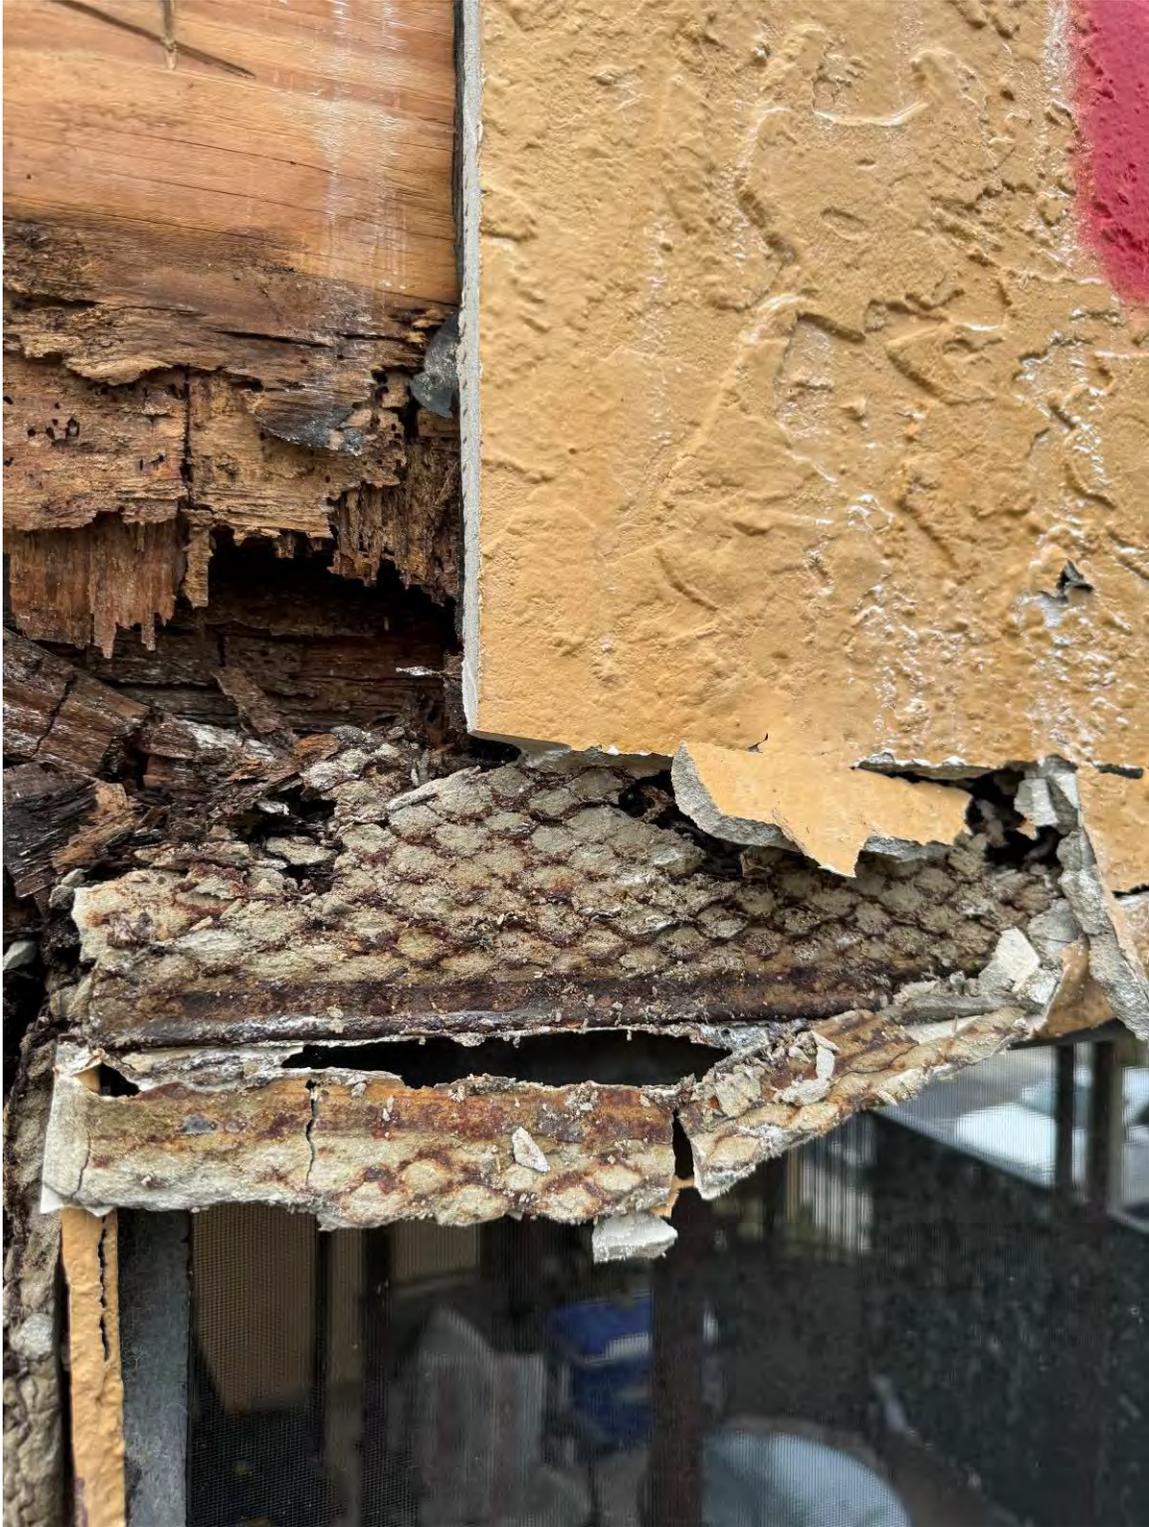
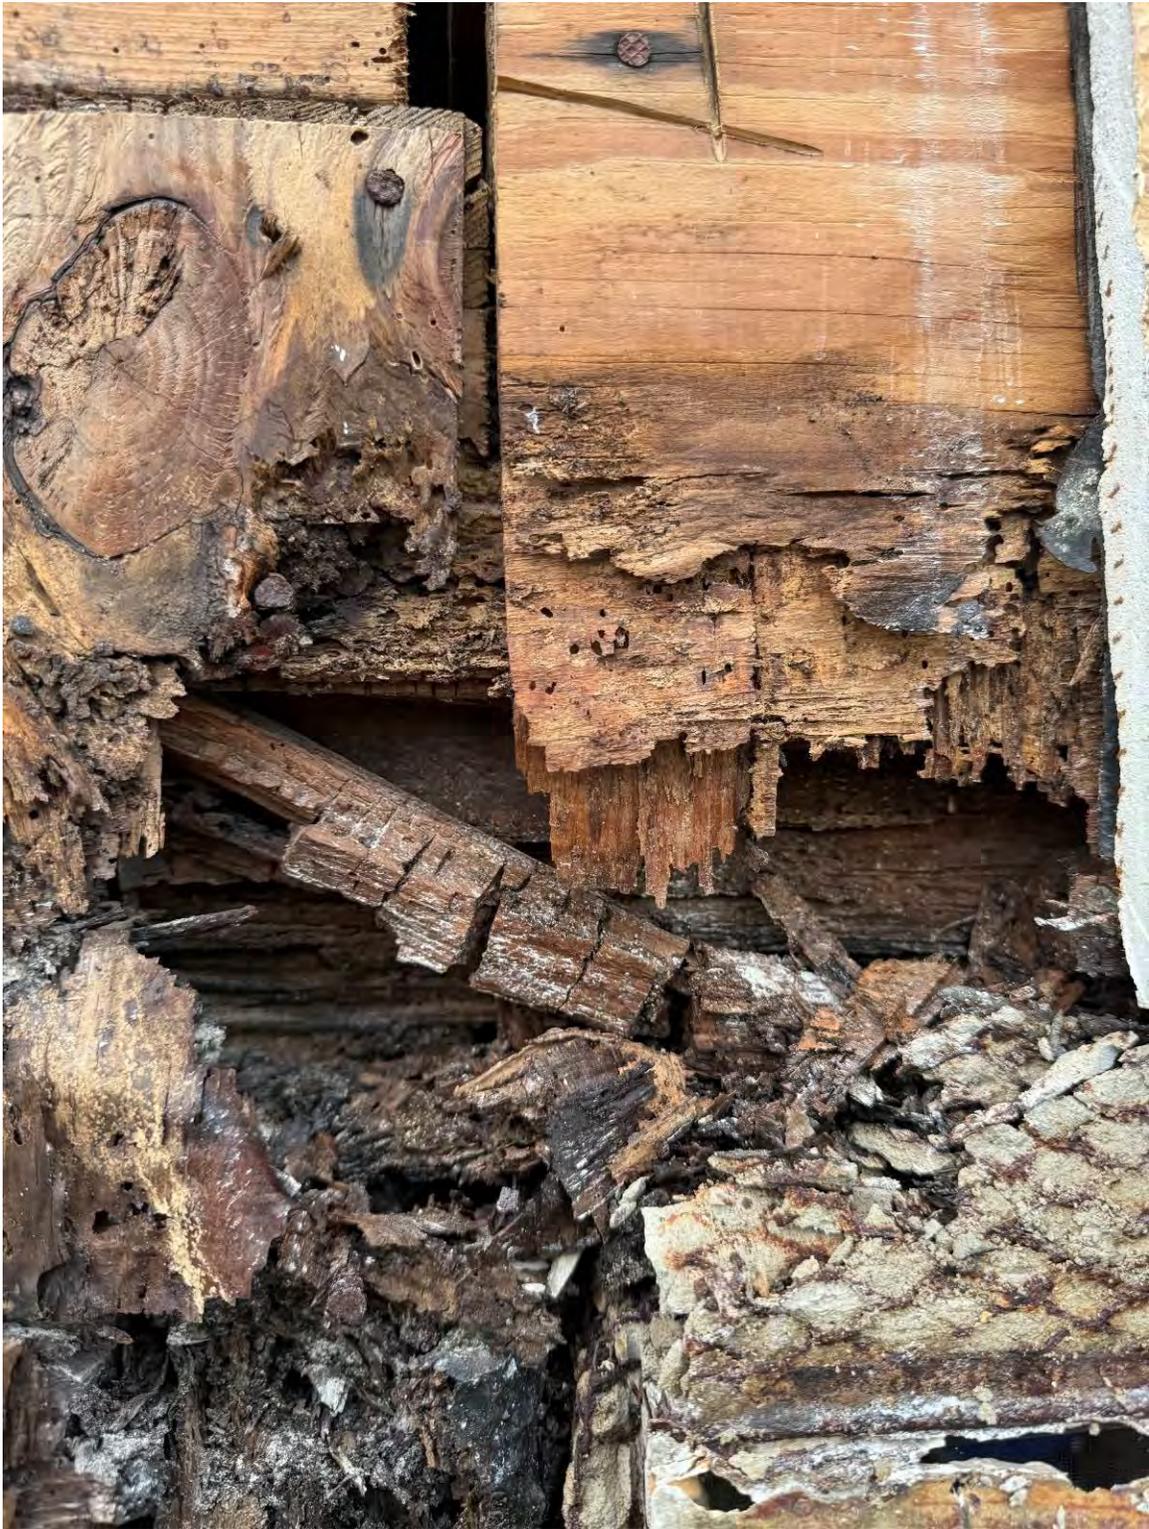
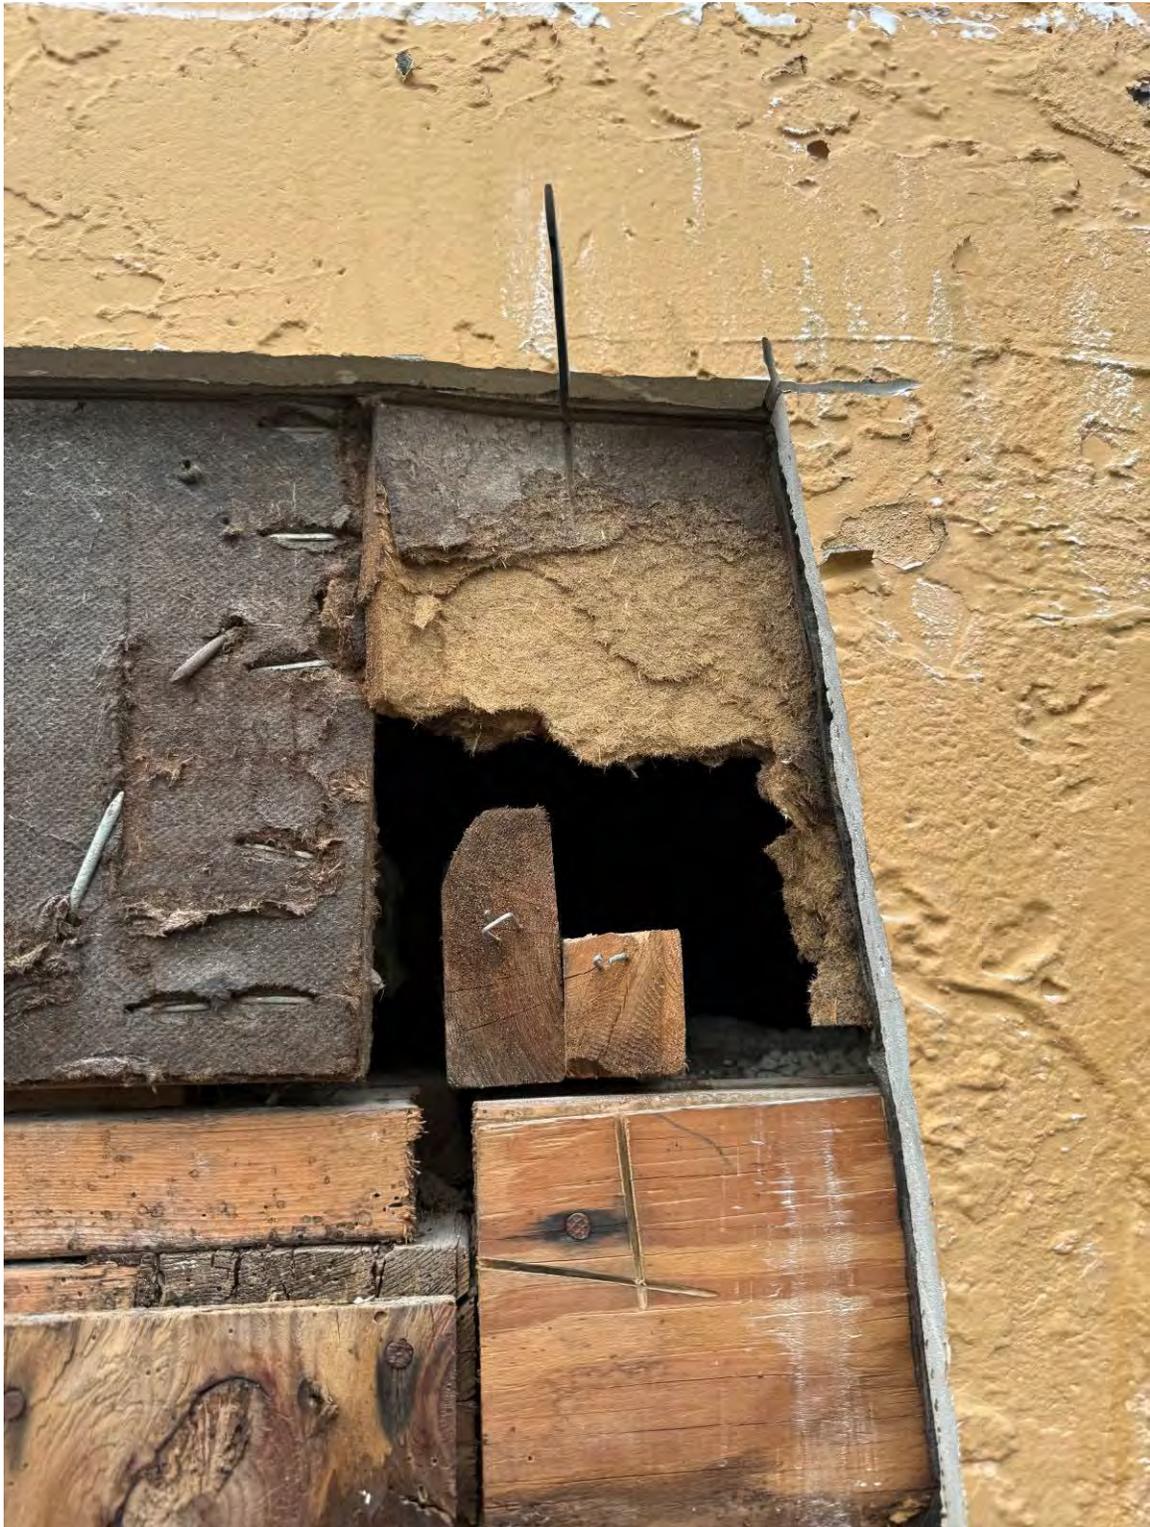
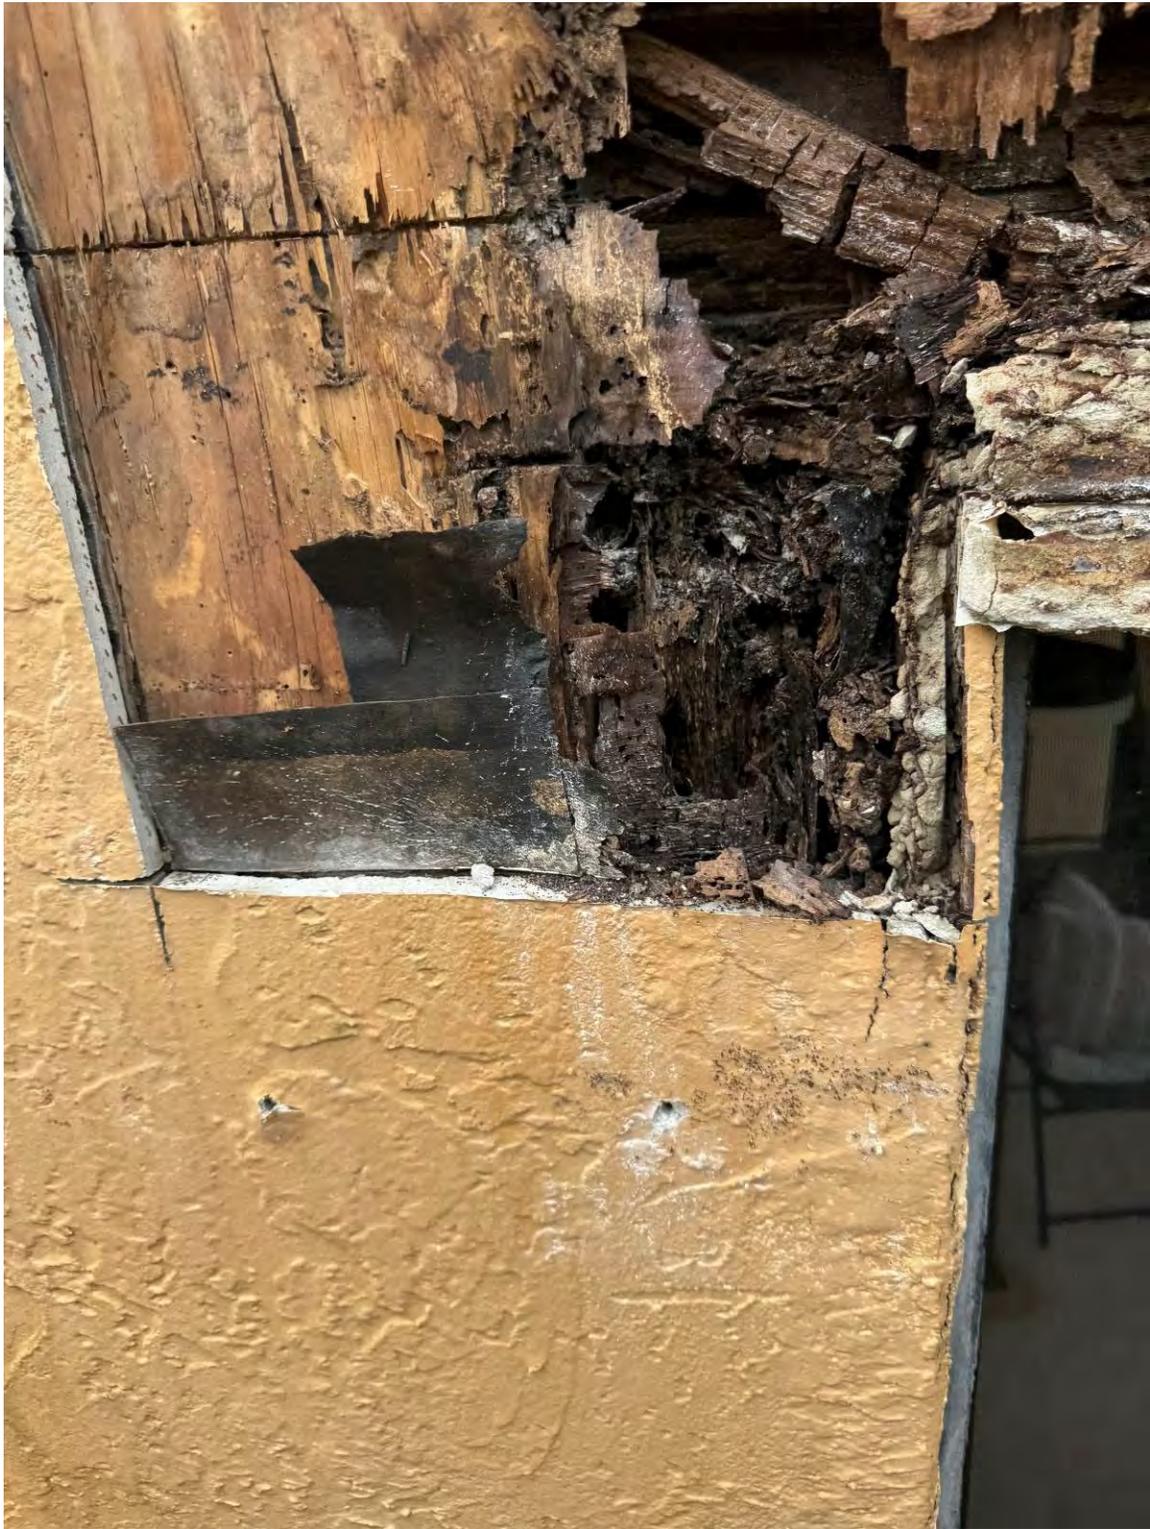
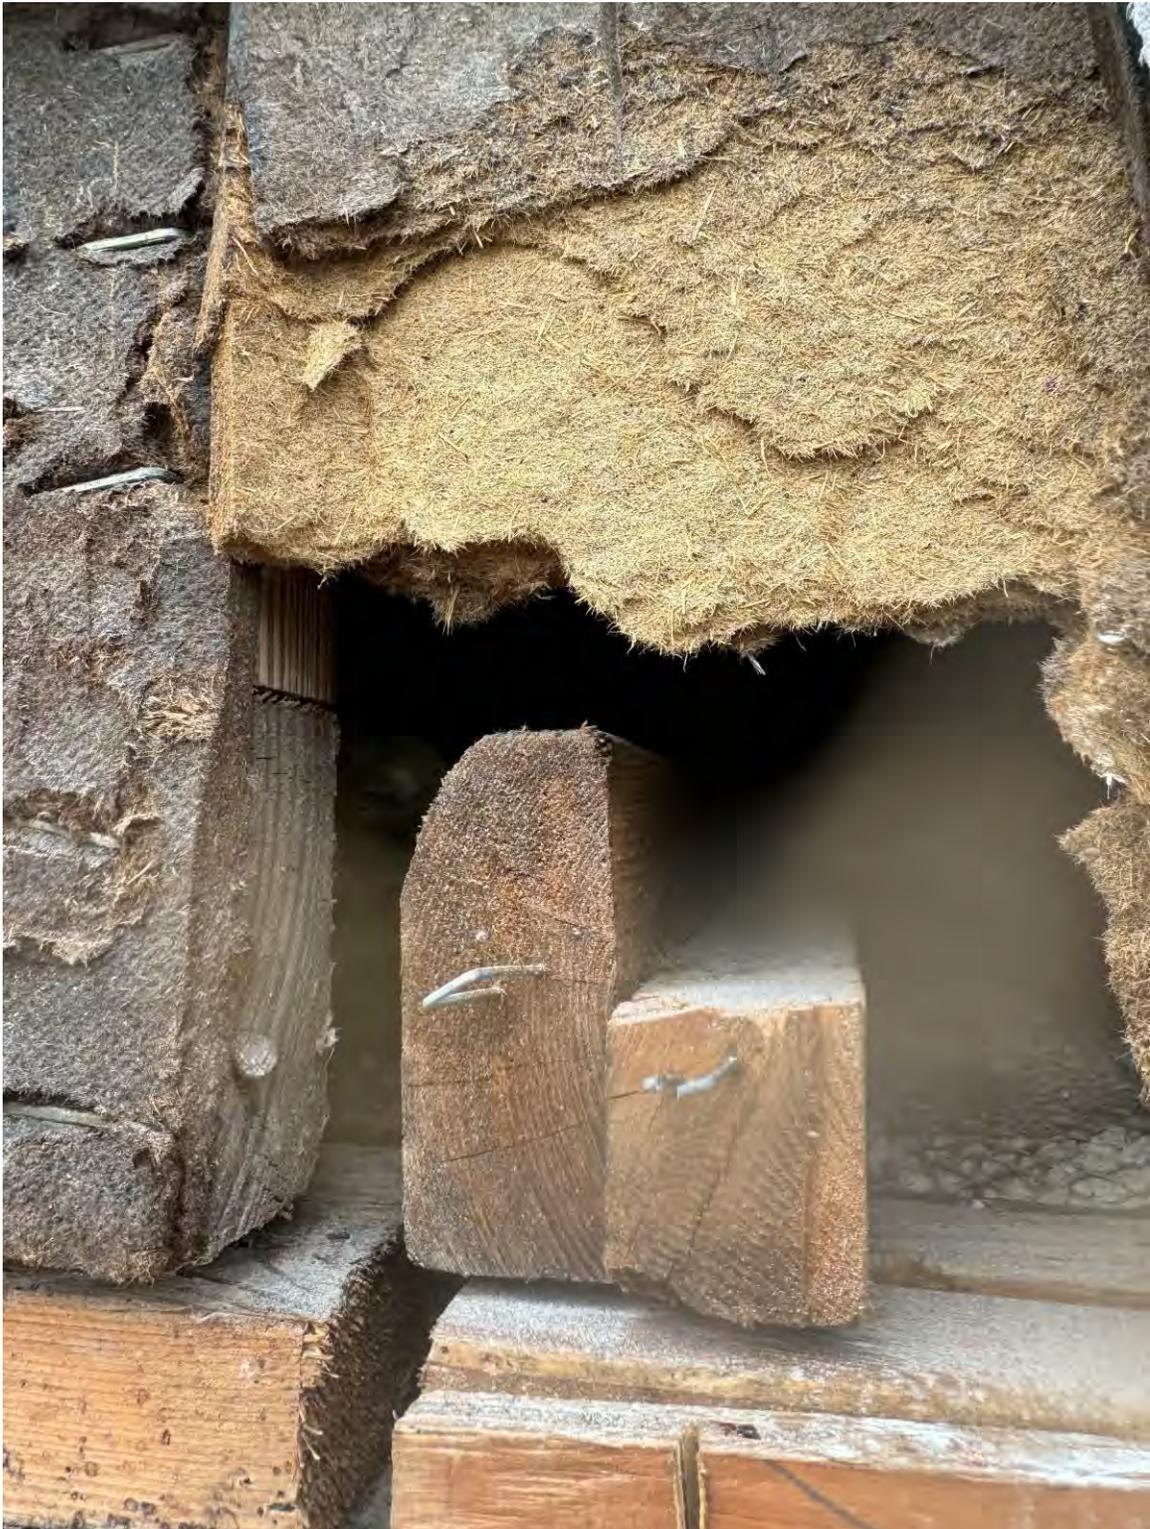
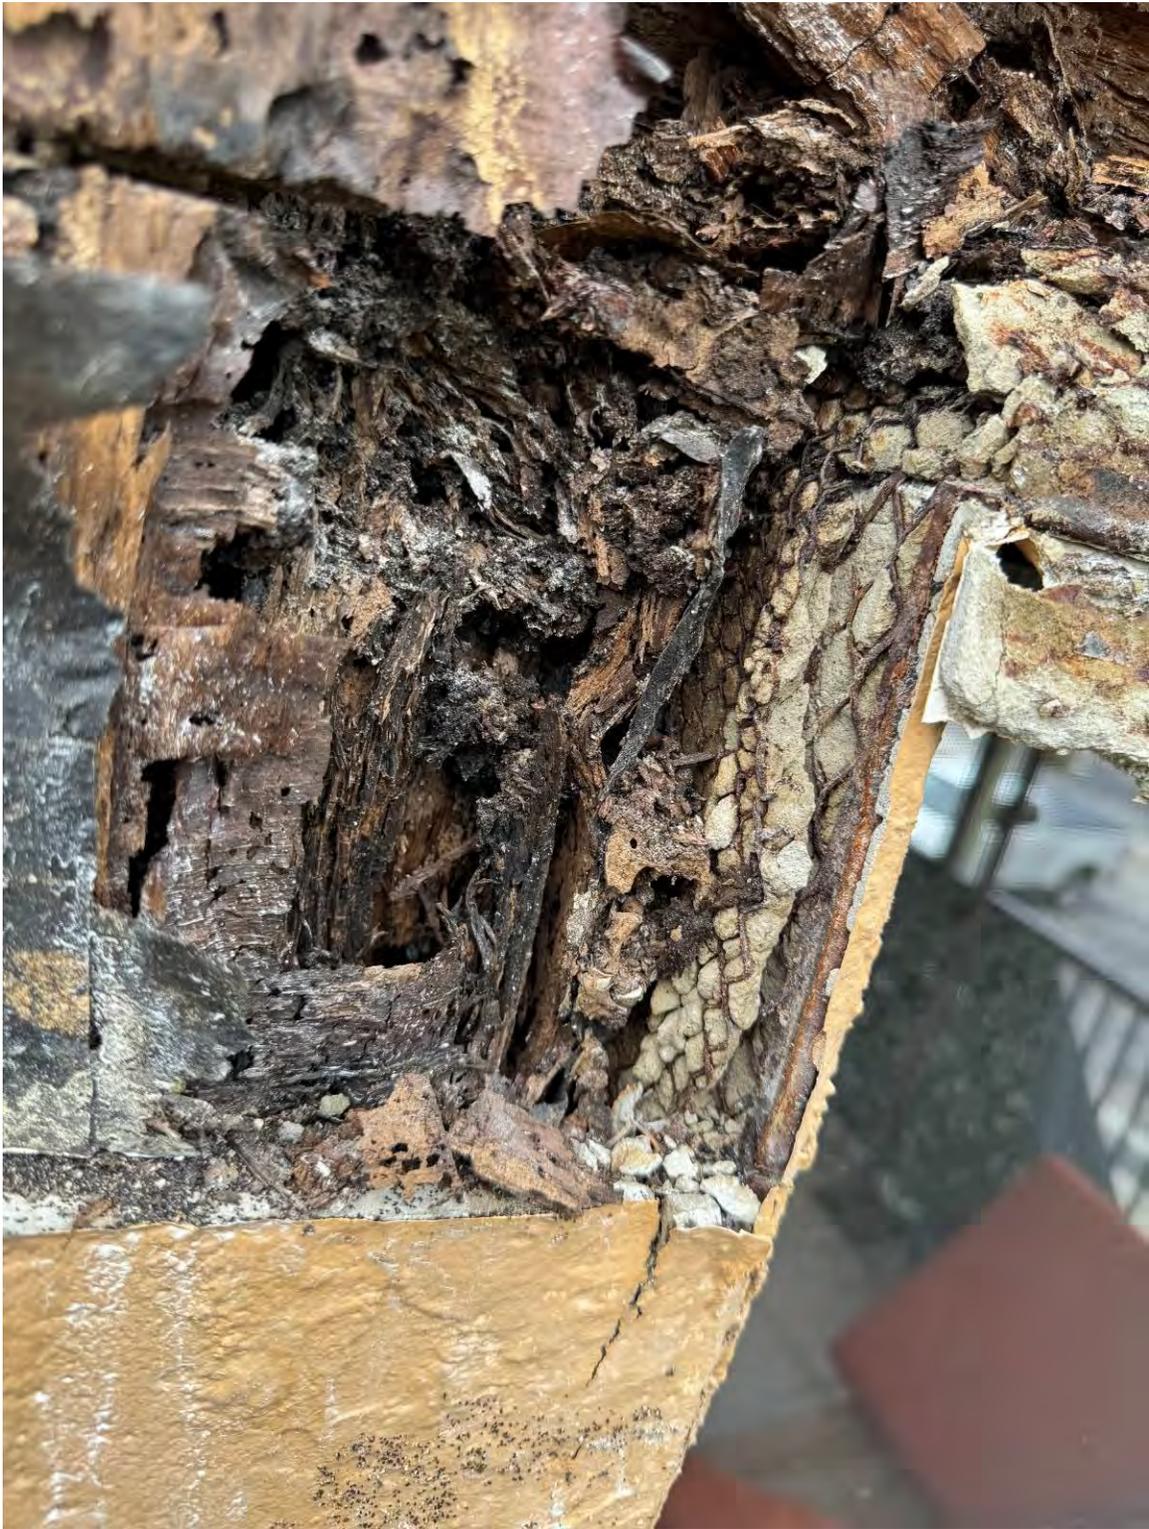
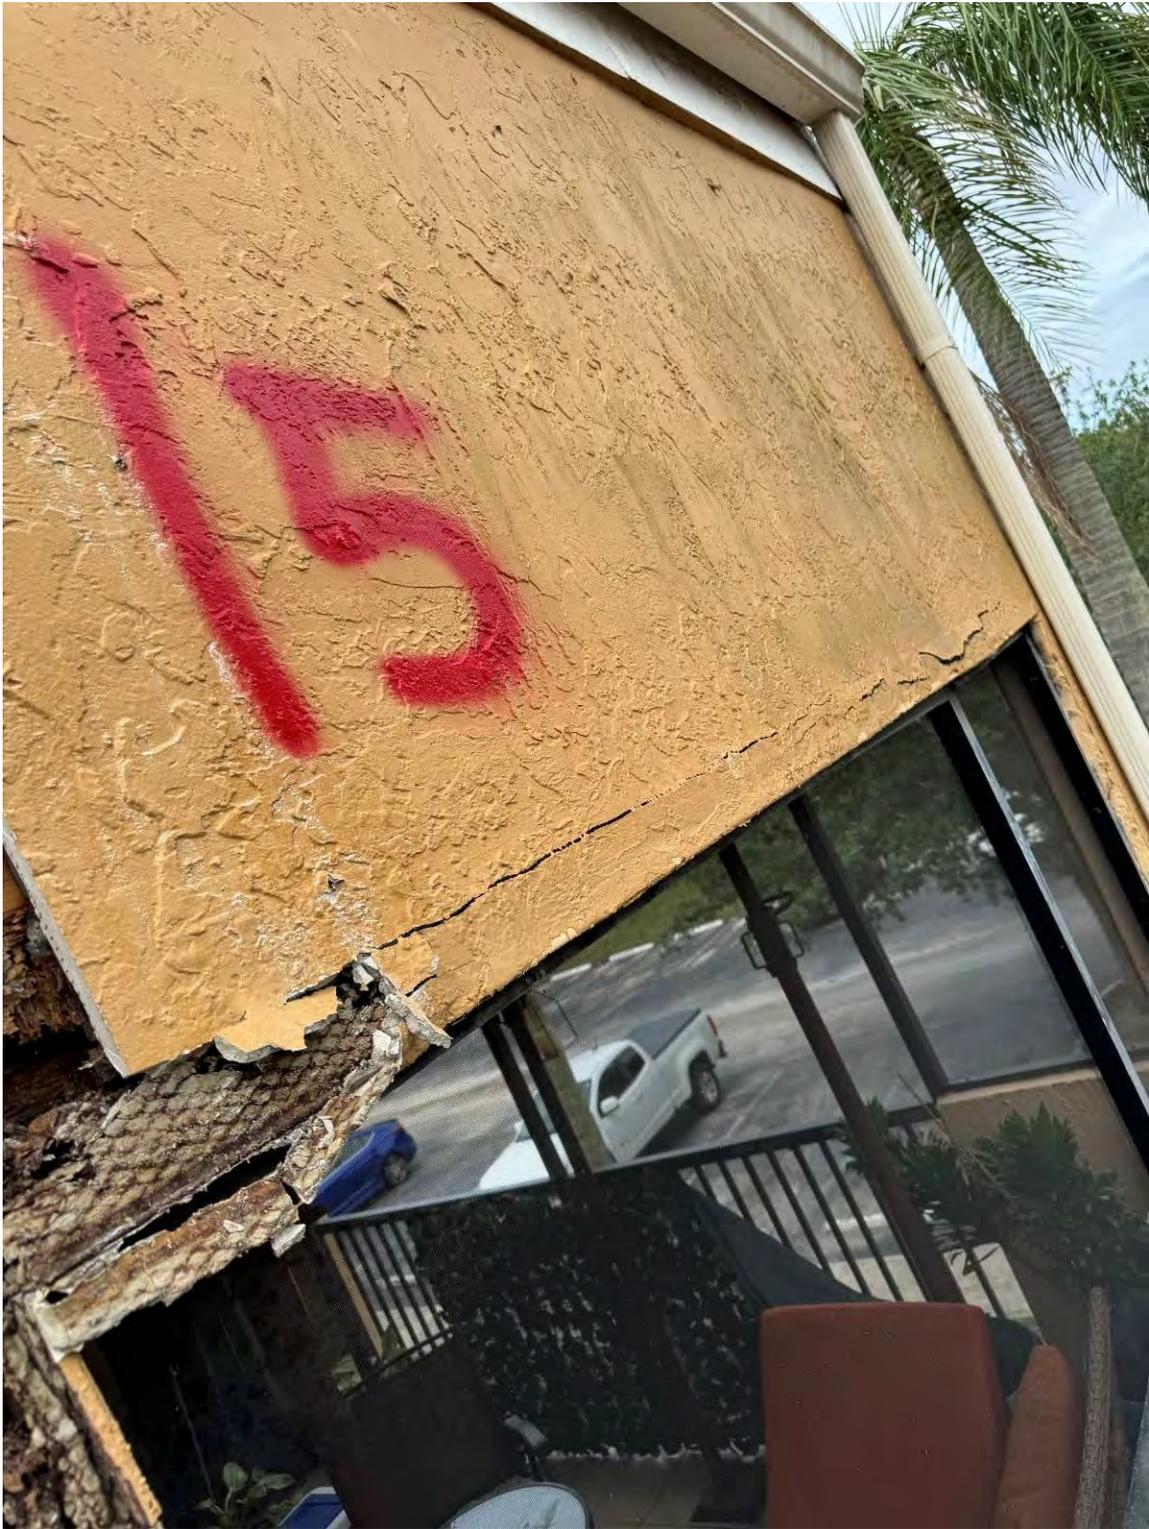
- Wall sheathing has water damage and termite damage
- 2<sup>nd</sup> floor wall stud has water damage and termite damage
- Ceiling joist has water damage and termite damage
- No connections at gabled end to 2<sup>nd</sup> floor bearing wall
- Water damage at the entire length of exterior balcony joist
