**NOTICE OF FILING PART 2 OF FINAL ENGINEERING REPORT OF SPECIALTY  
ENGINEERING CONSULTANTS, INC. DATED NOVEMBER 5, 2024**

Daniel J. Stermer, not individually, but solely in his capacity as Court Appointed Receiver (the "Receiver"), over the Heron Pond Condominium Association, Inc., (the "Association") by and through its undersigned counsel, hereby gives notice of filing Part 2 of the attached final Engineering Report of Specialty Engineering Consultants, Inc. dated November 5, 2024, opining on the existing condition of Building 9.

# OPENING #15

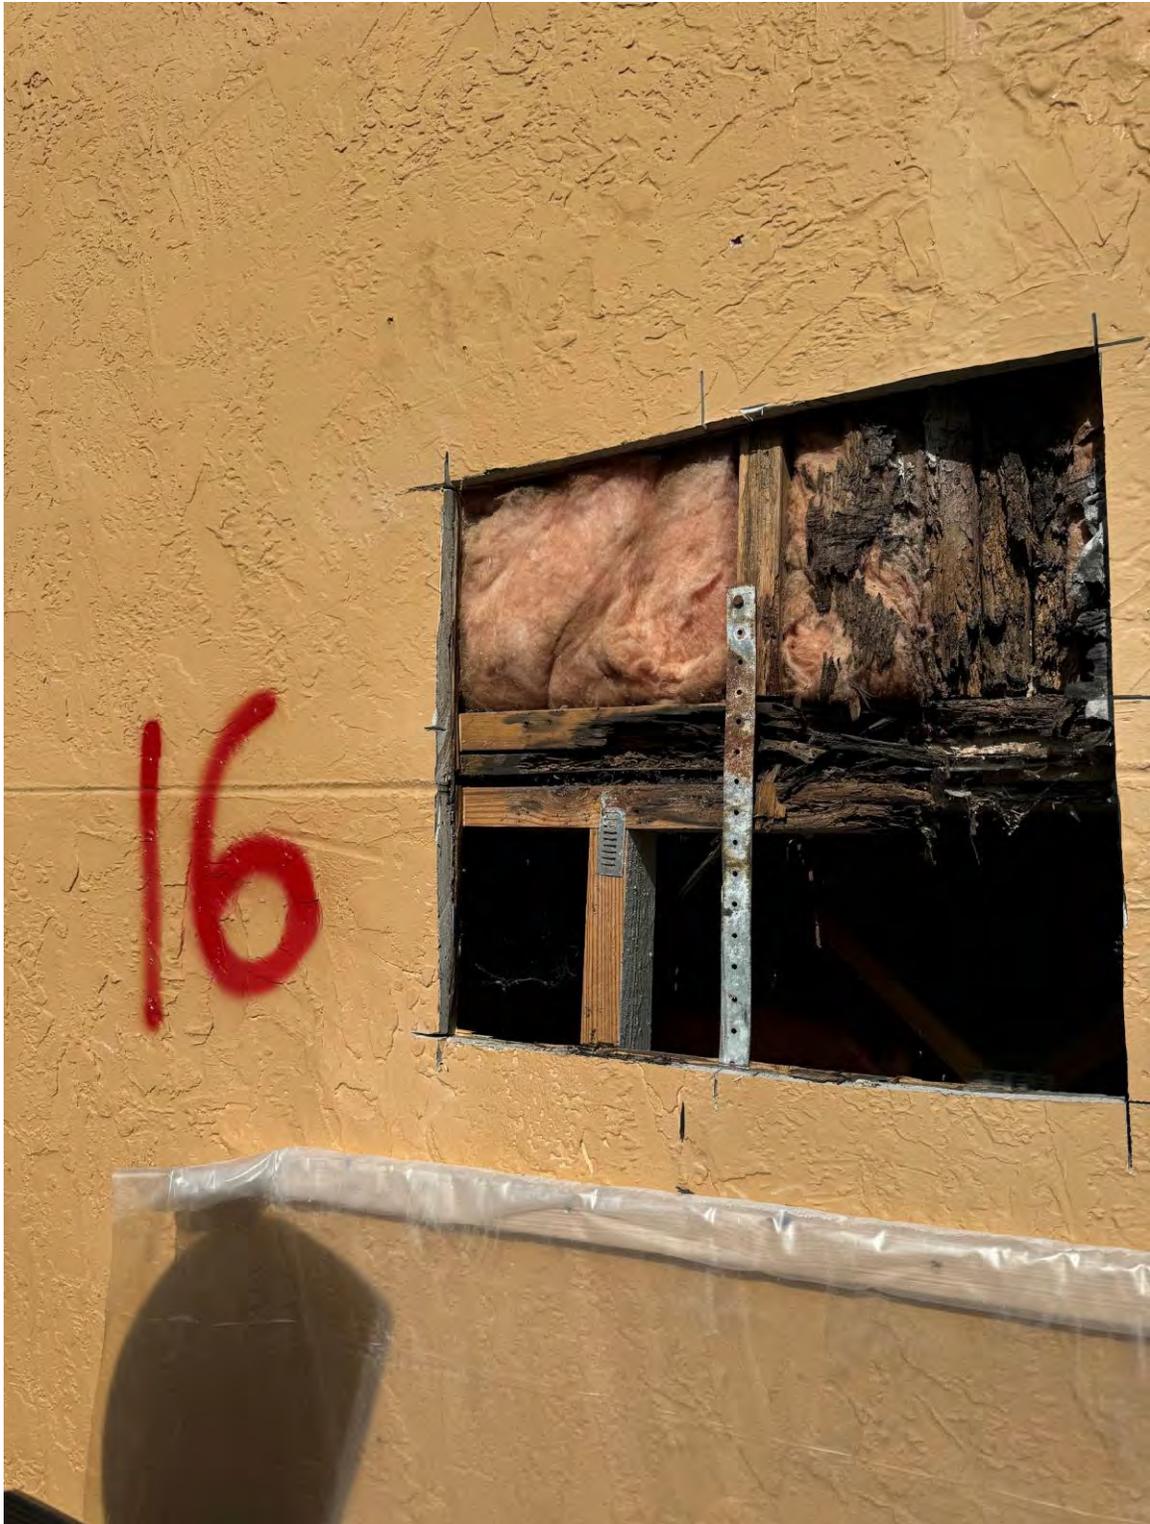
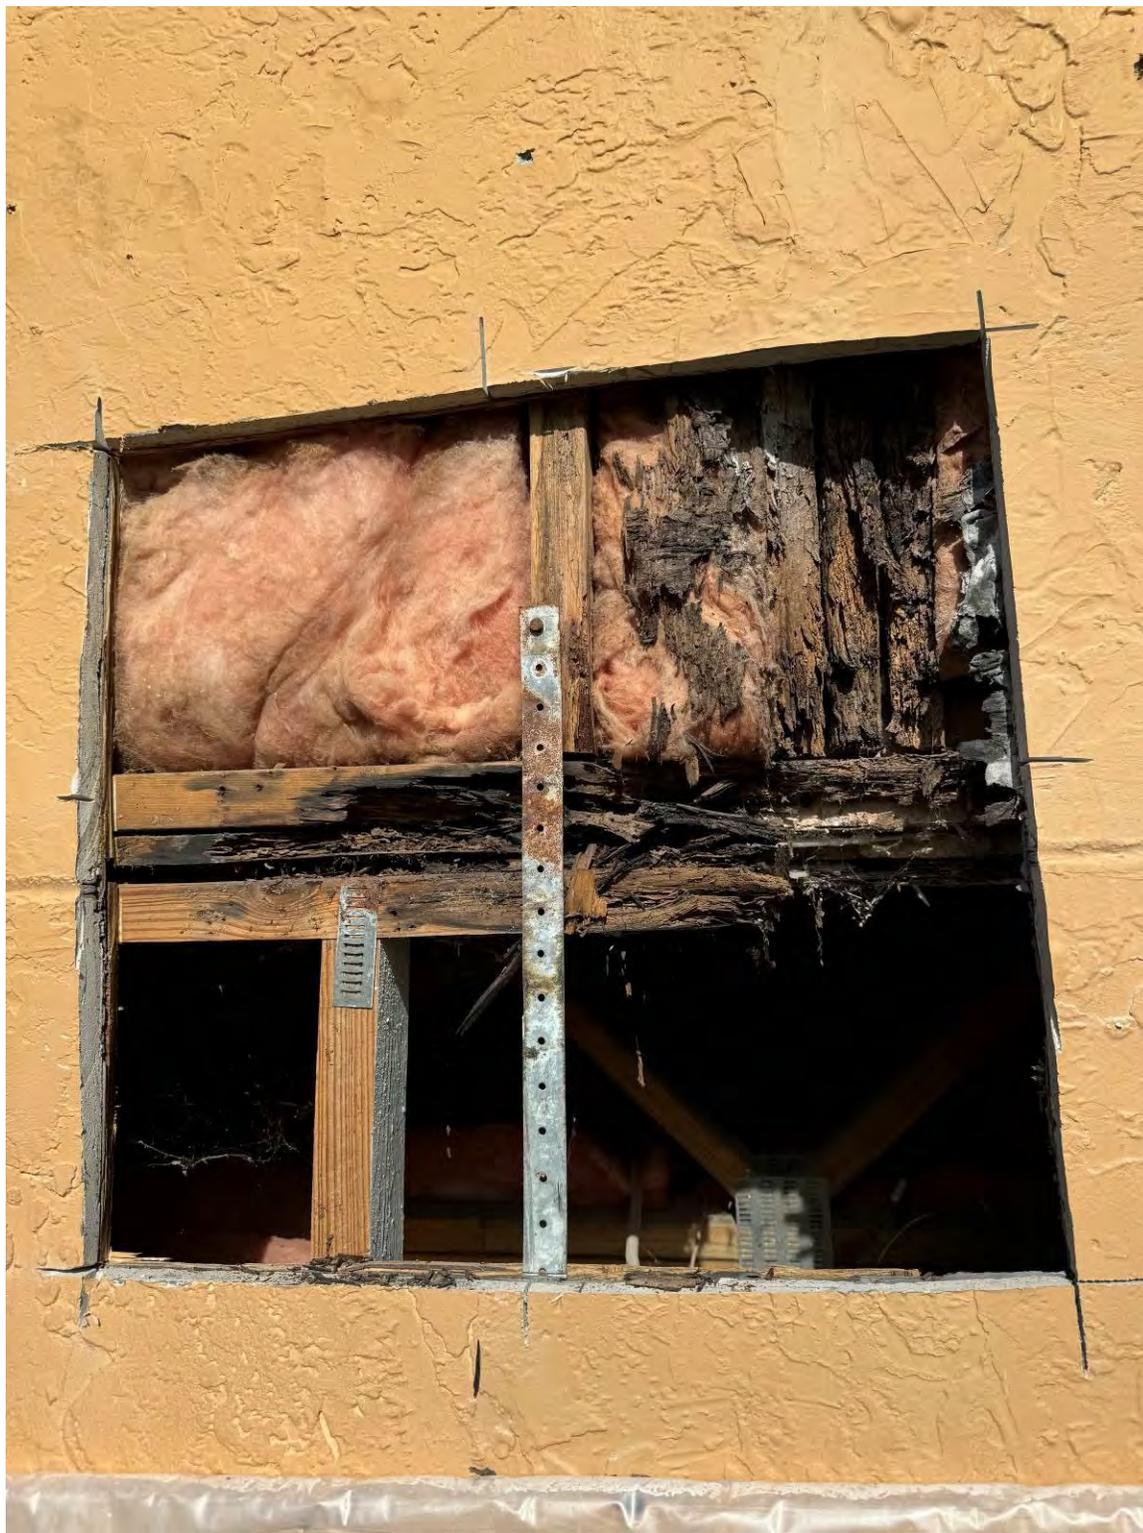
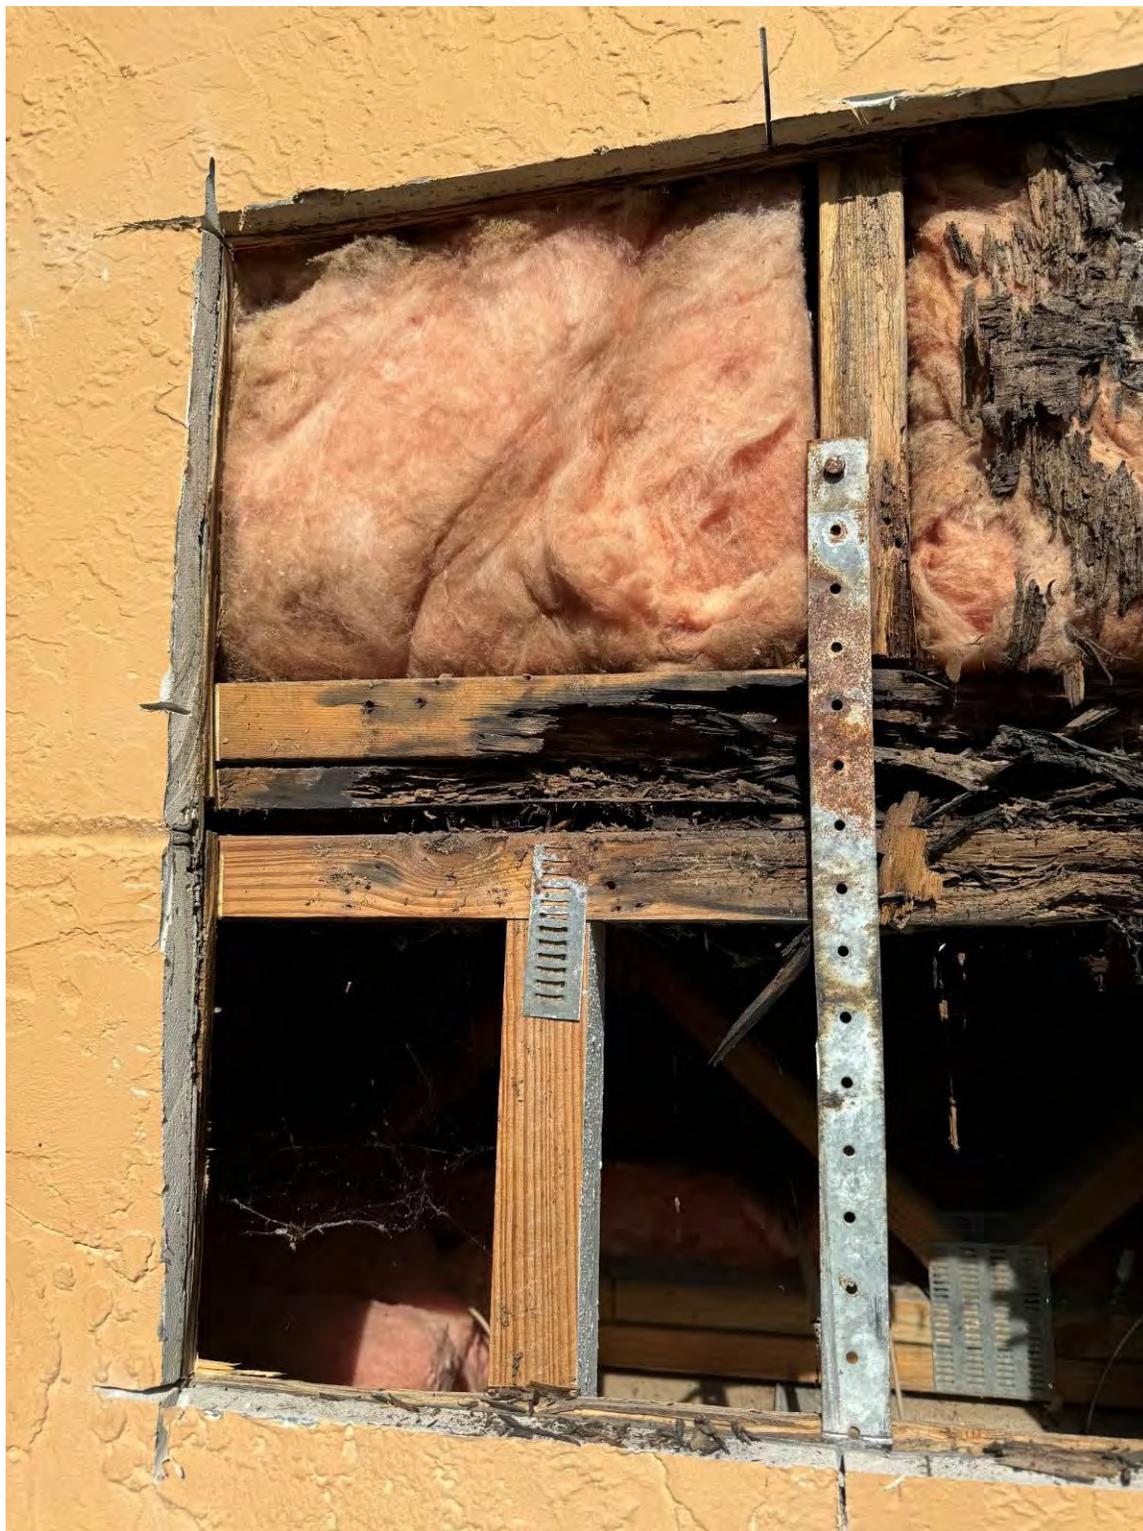
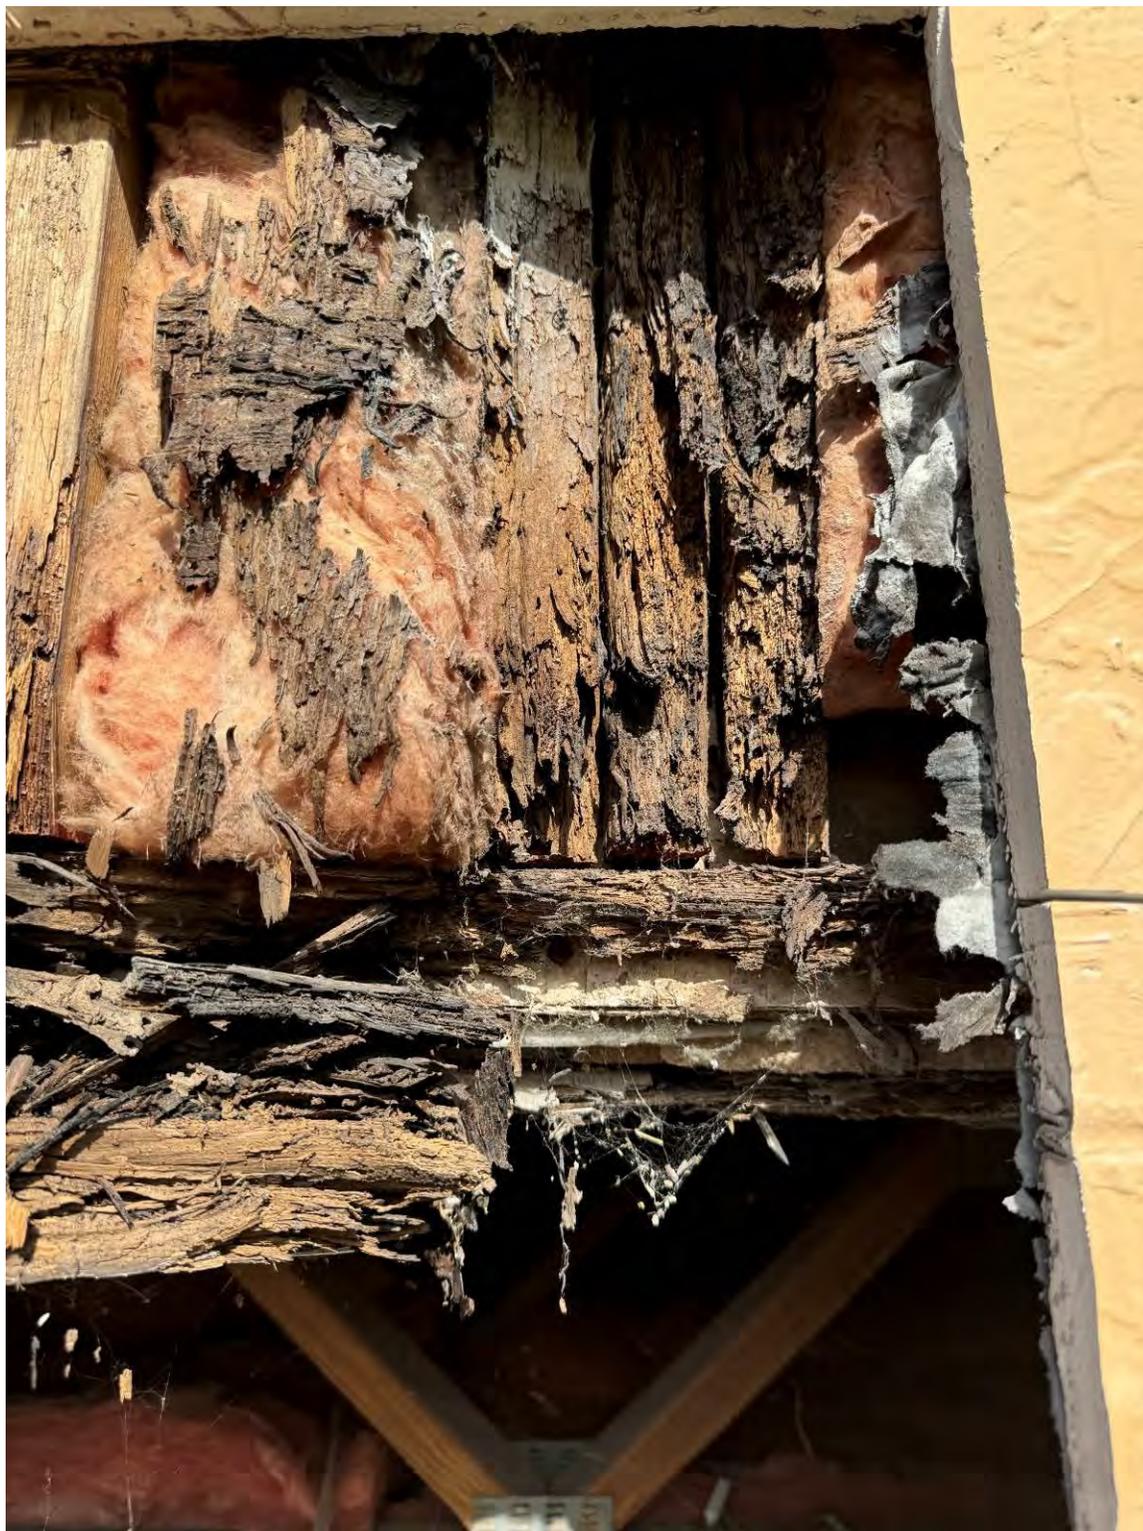
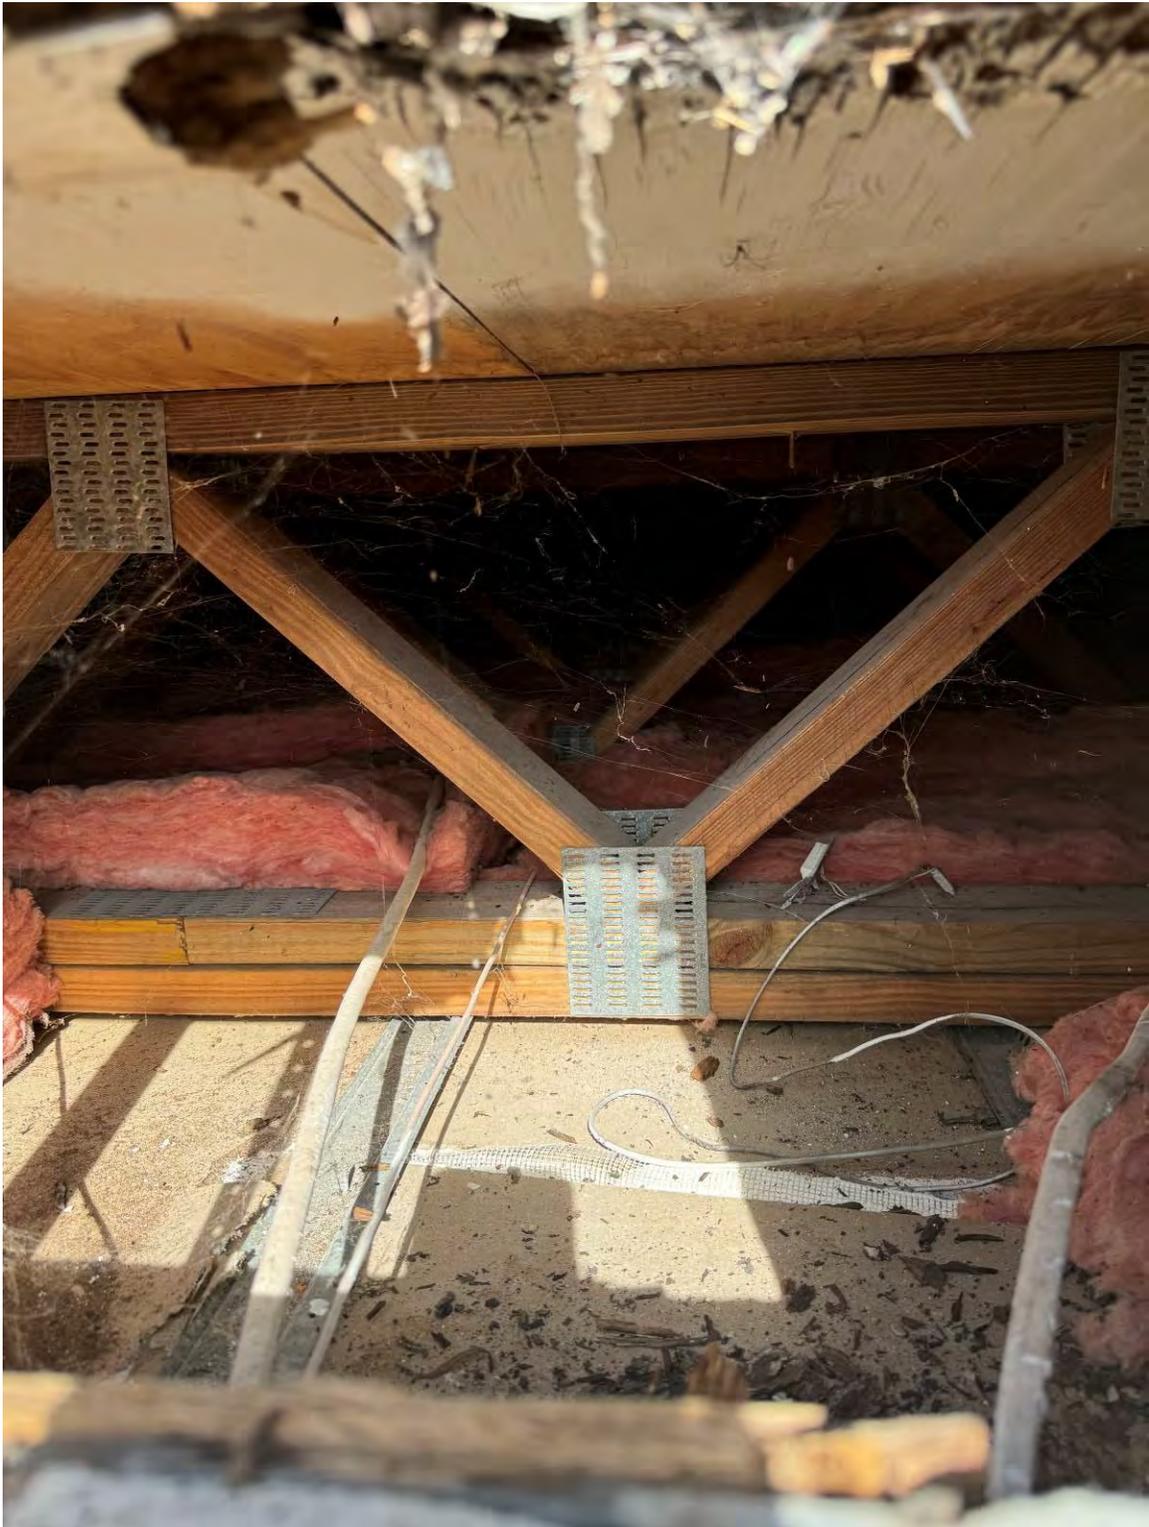
# OPENING #16

- Truss strap has 1 nail
- 2<sup>nd</sup> floor stud has no metal connection to base plate
- Floor sheathing is  $\frac{3}{4}$ " thick
- Floor truss completely disintegrated – water damage and termite damage
- 3 member column completely deteriorated

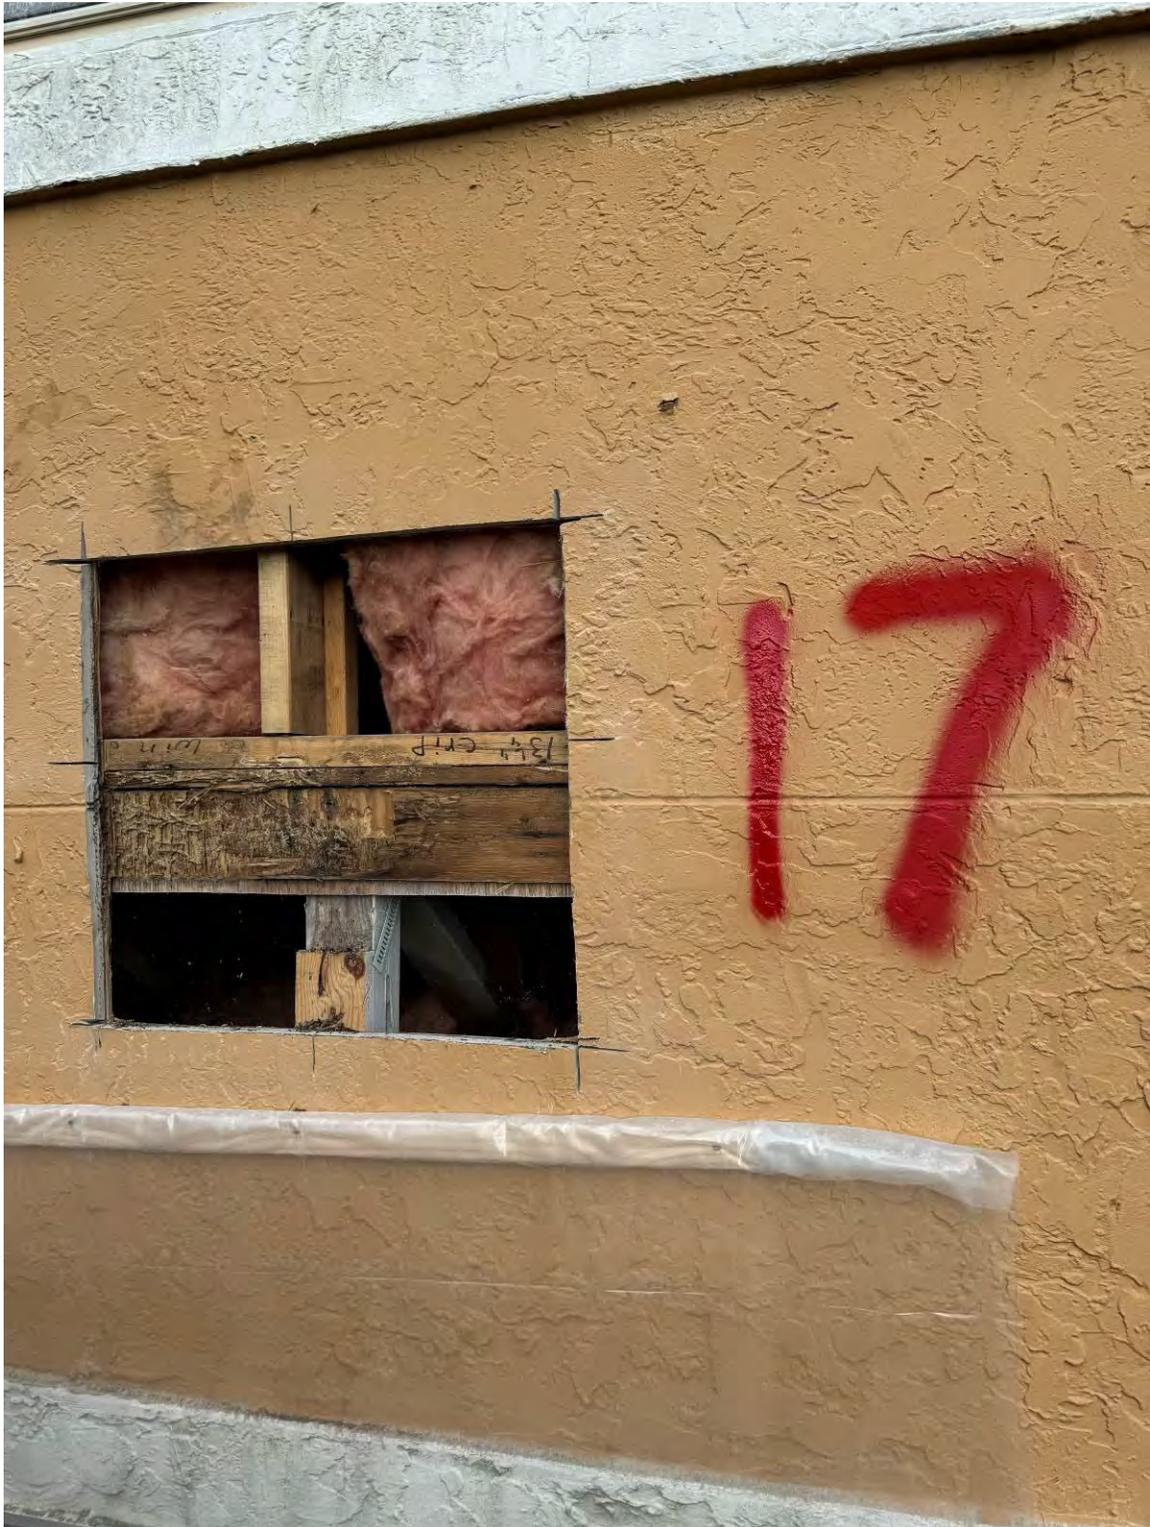
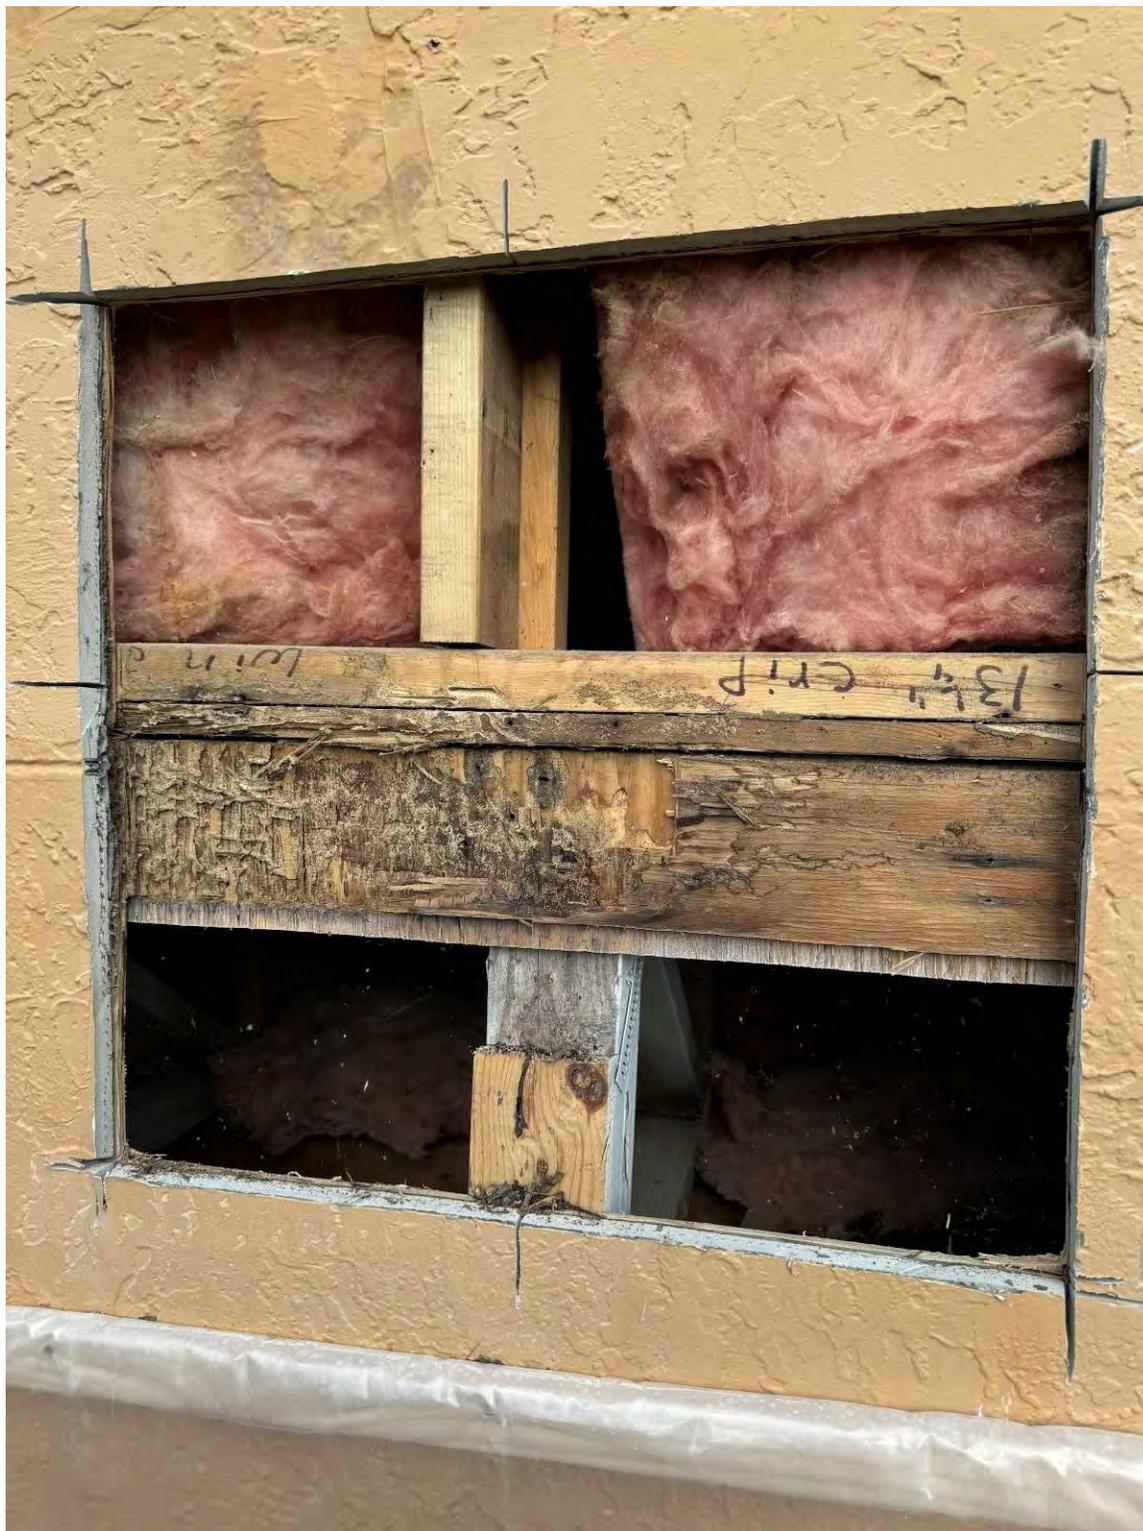
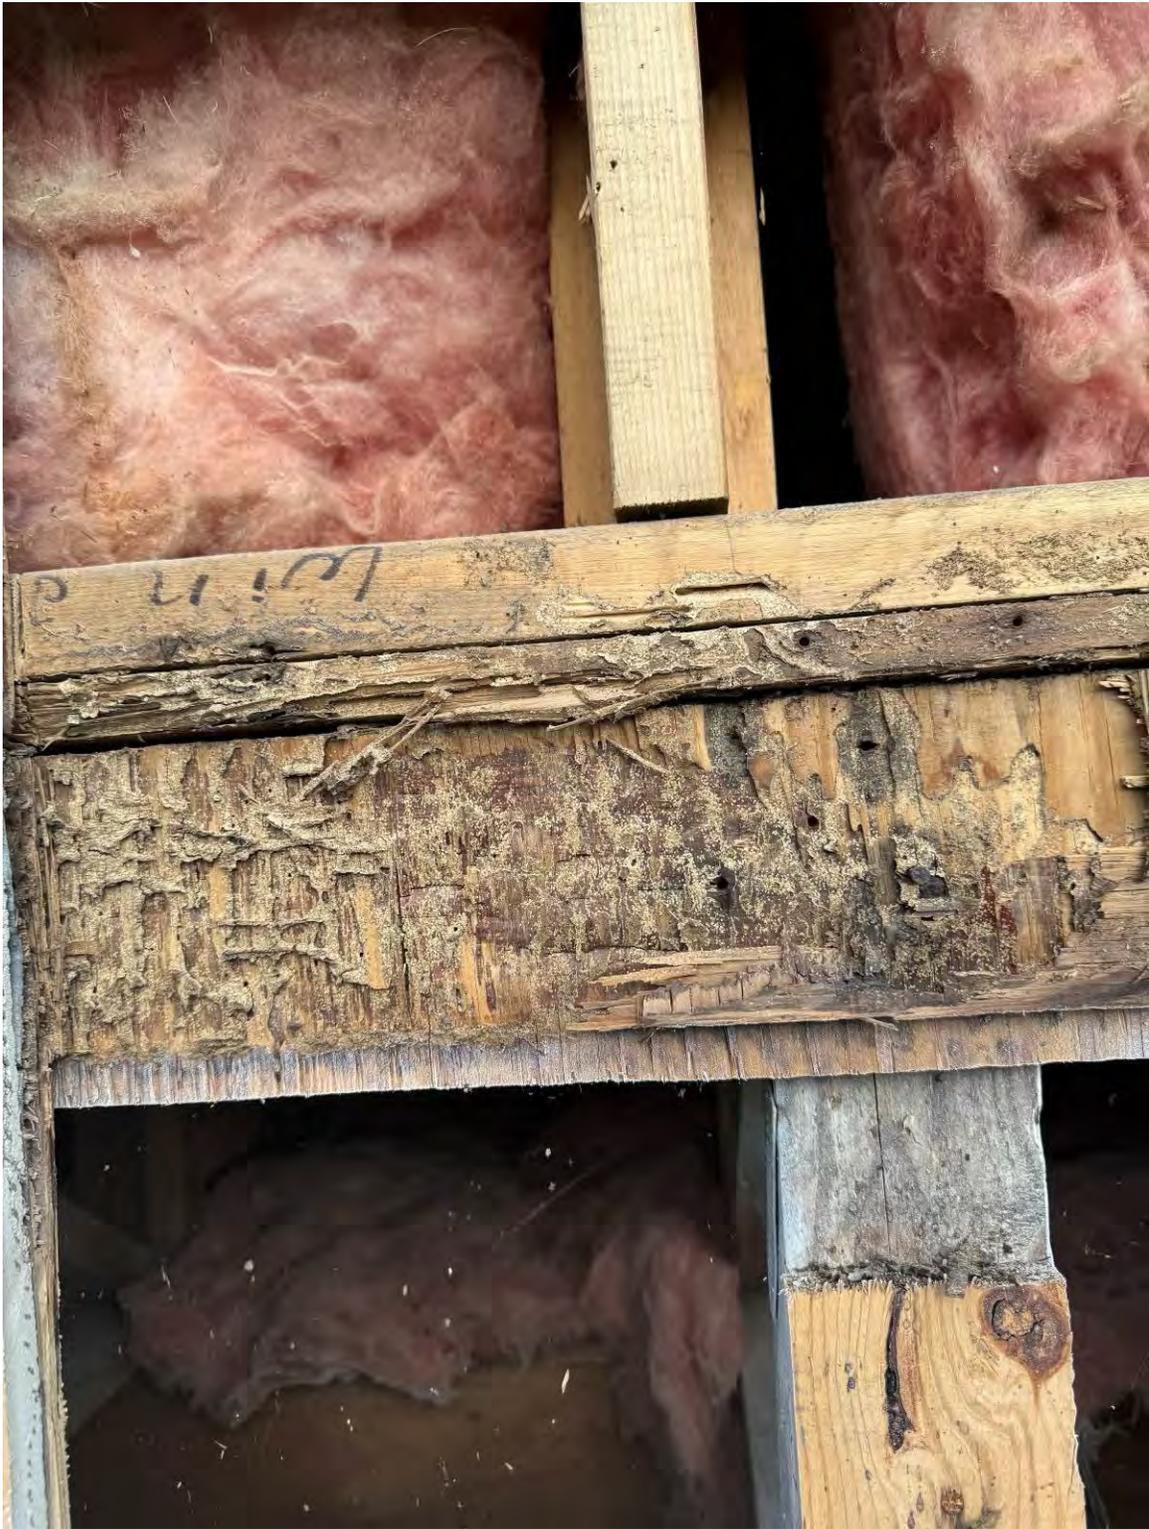
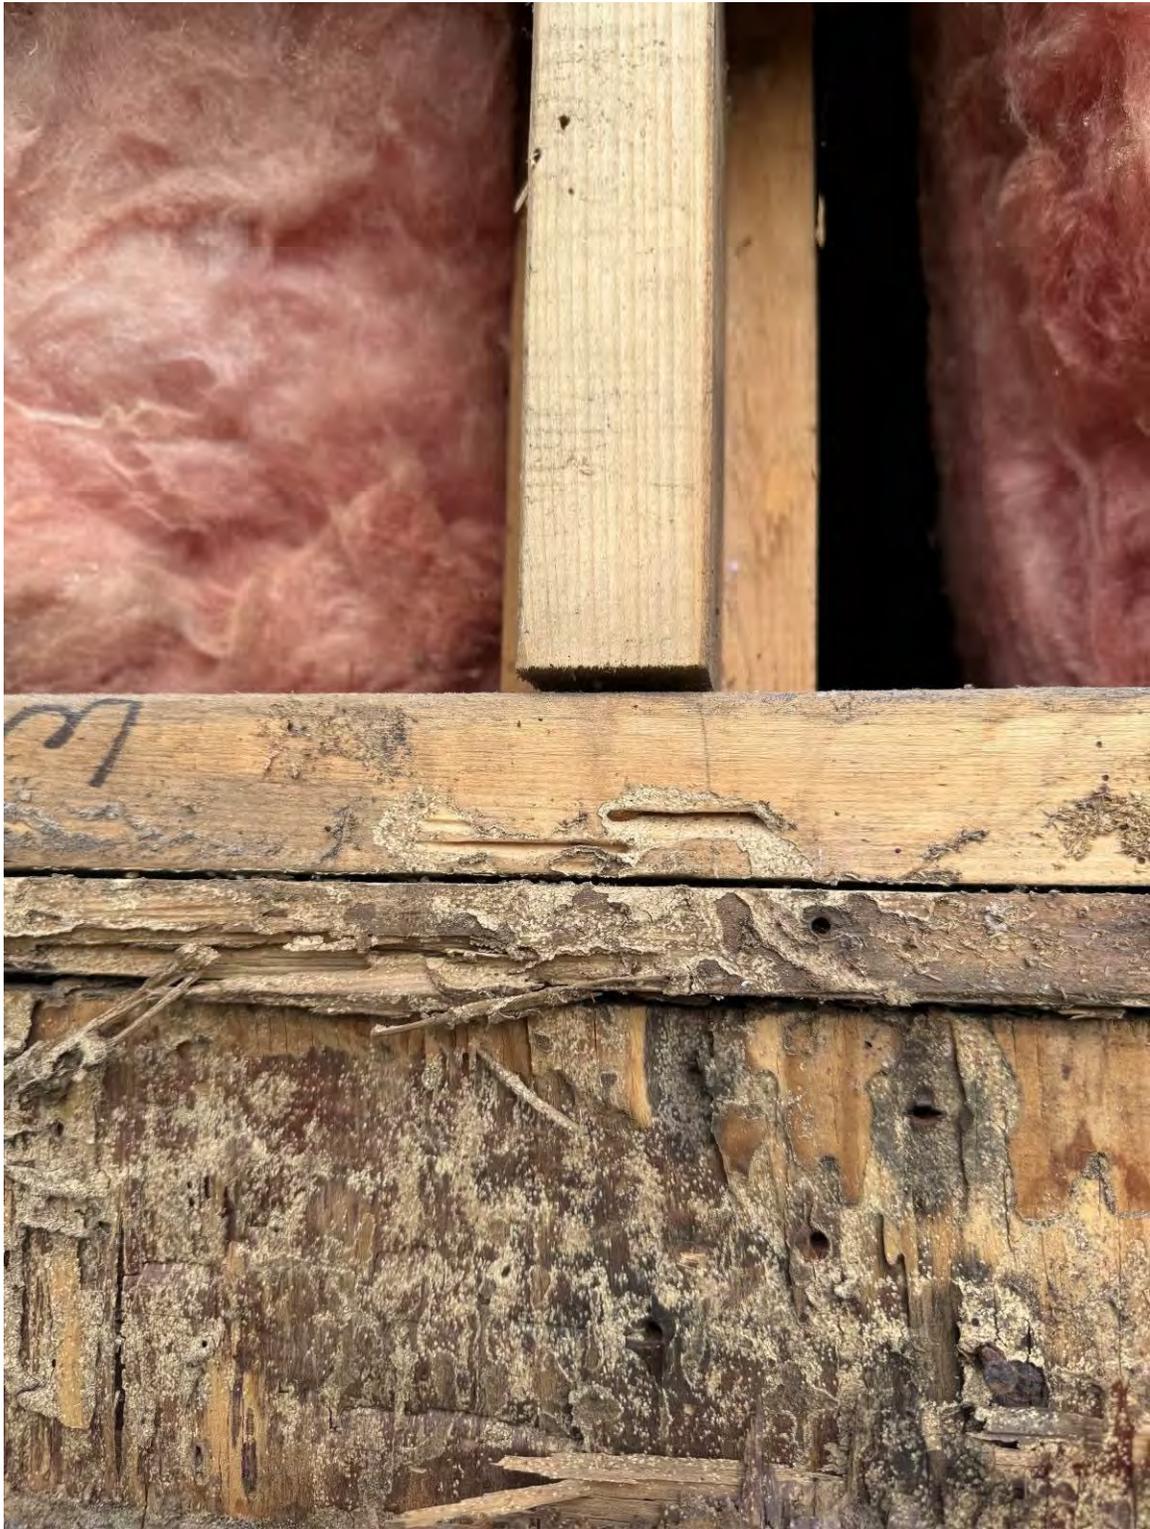
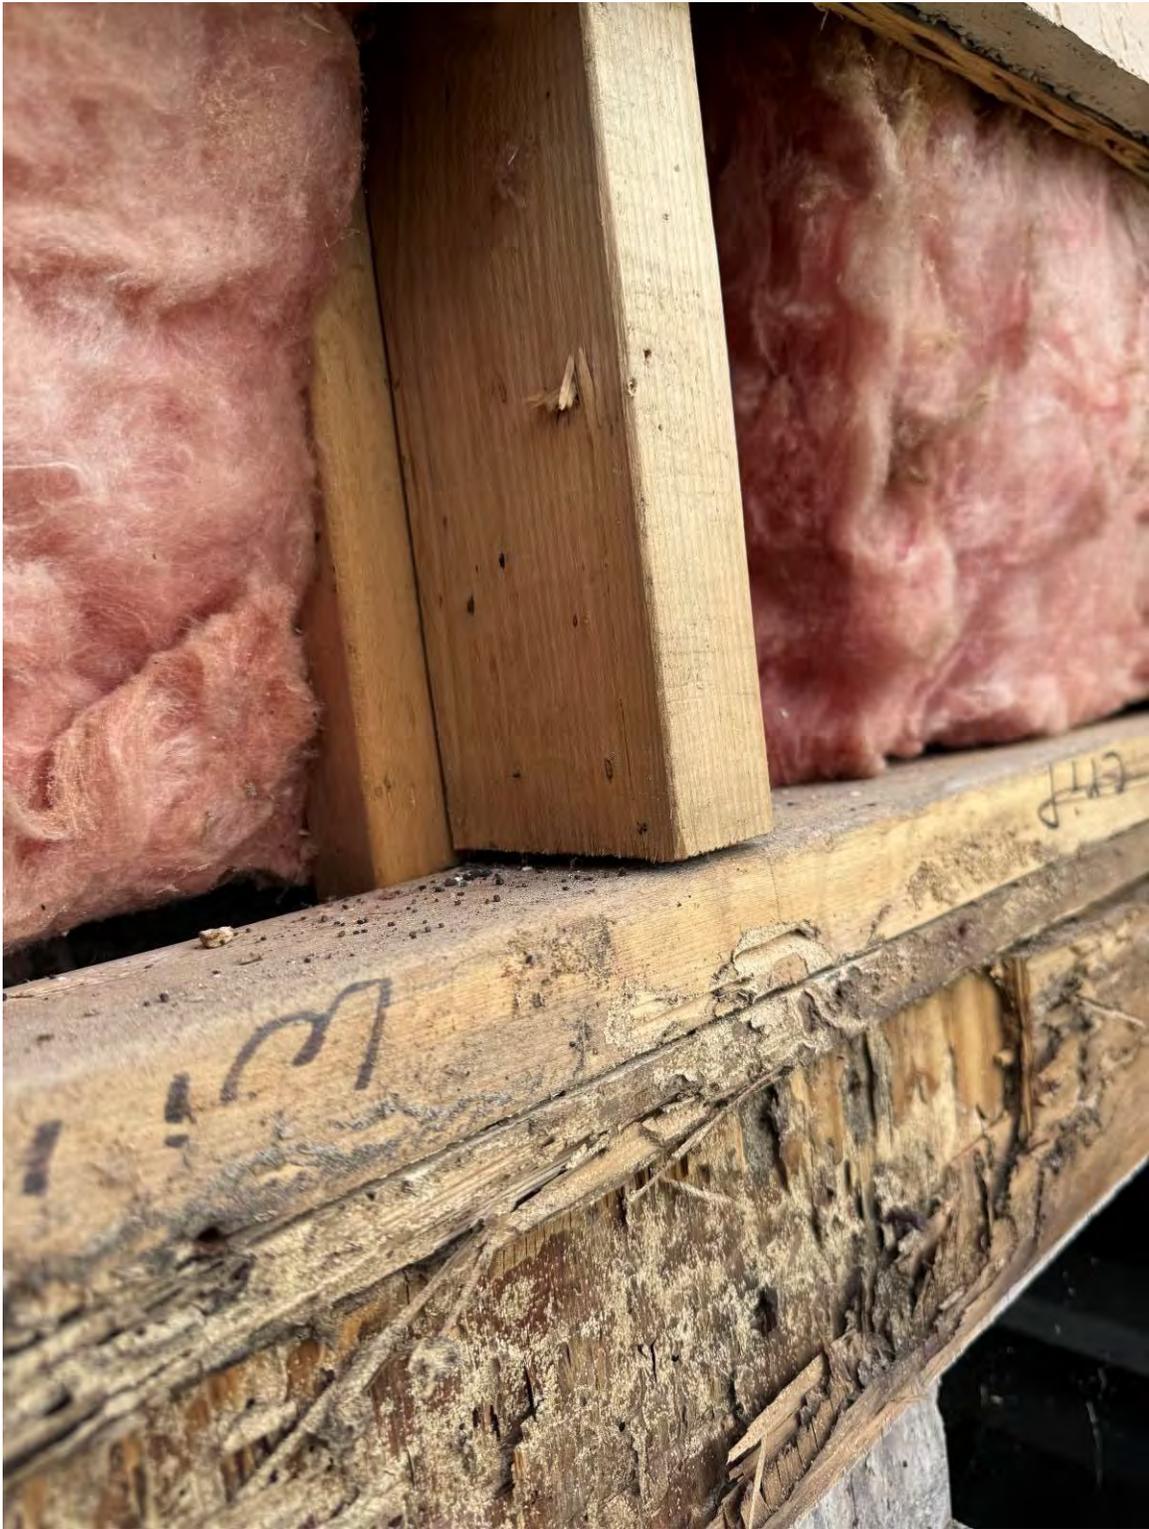
# OPENING #17

- Termite damage to sheathing
- Termite damage to bottom plate
- Wall stud not bearing on bottom plate
- No connection to stud to bottom plate
