**NOTICE OF FILING PART 2 OF FINAL ENGINEERING REPORT OF SPECIALTY  
ENGINEERING CONSULTANTS, INC. DATED NOVEMBER 5, 2024**

Daniel J. Stermer, not individually, but solely in his capacity as Court Appointed Receiver (the "Receiver"), over the Heron Pond Condominium Association, Inc., (the "Association") by and through its undersigned counsel, hereby gives notice of filing Part 2 of the attached final Engineering Report of Specialty Engineering Consultants, Inc. dated November 5, 2024, opining on the existing condition of Building 9.

# OPENING #15

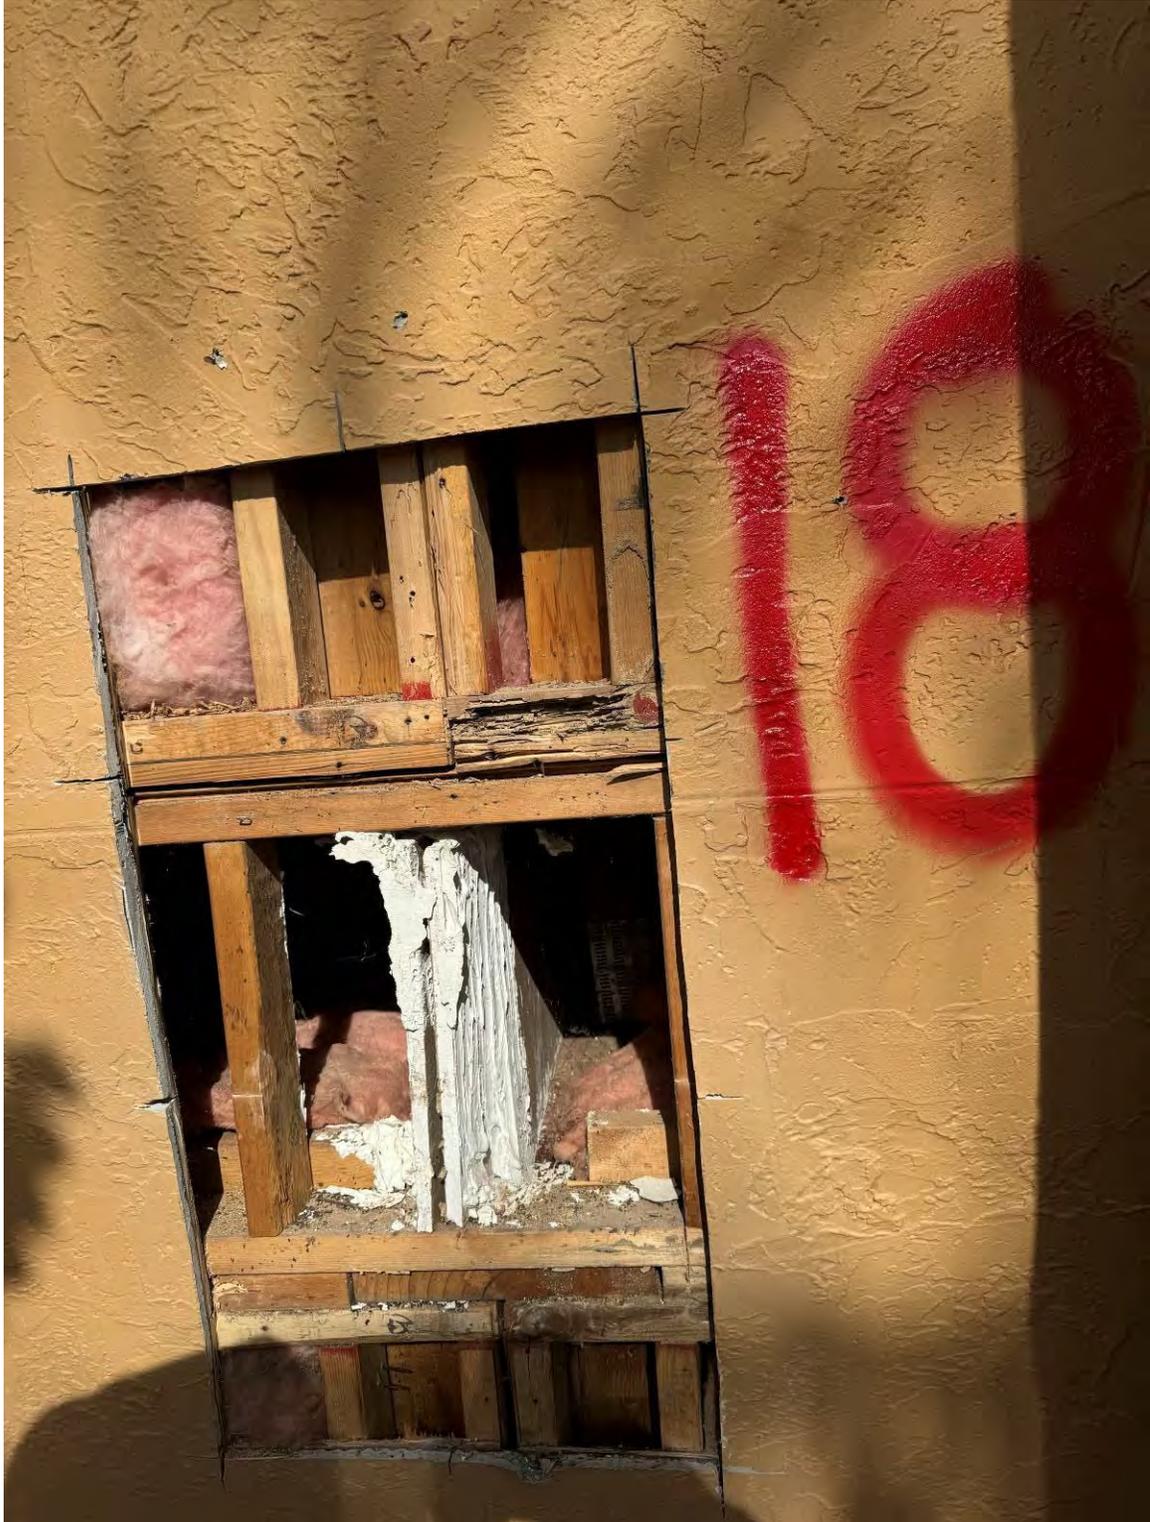
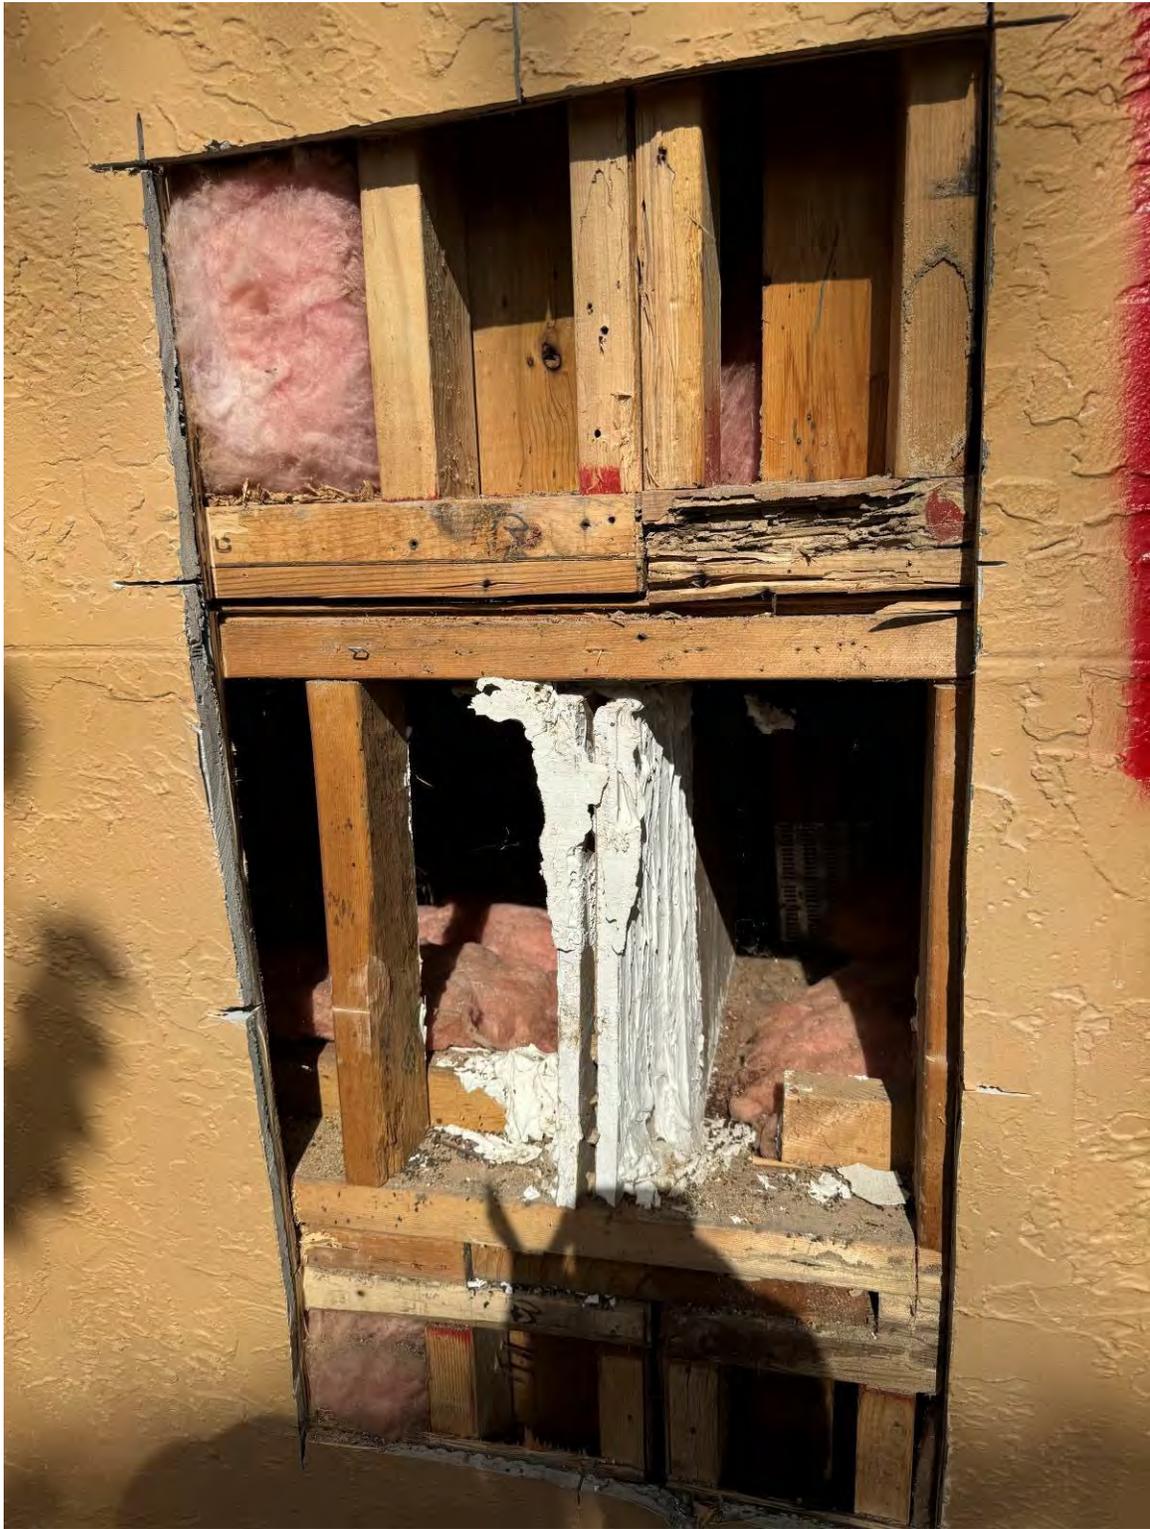
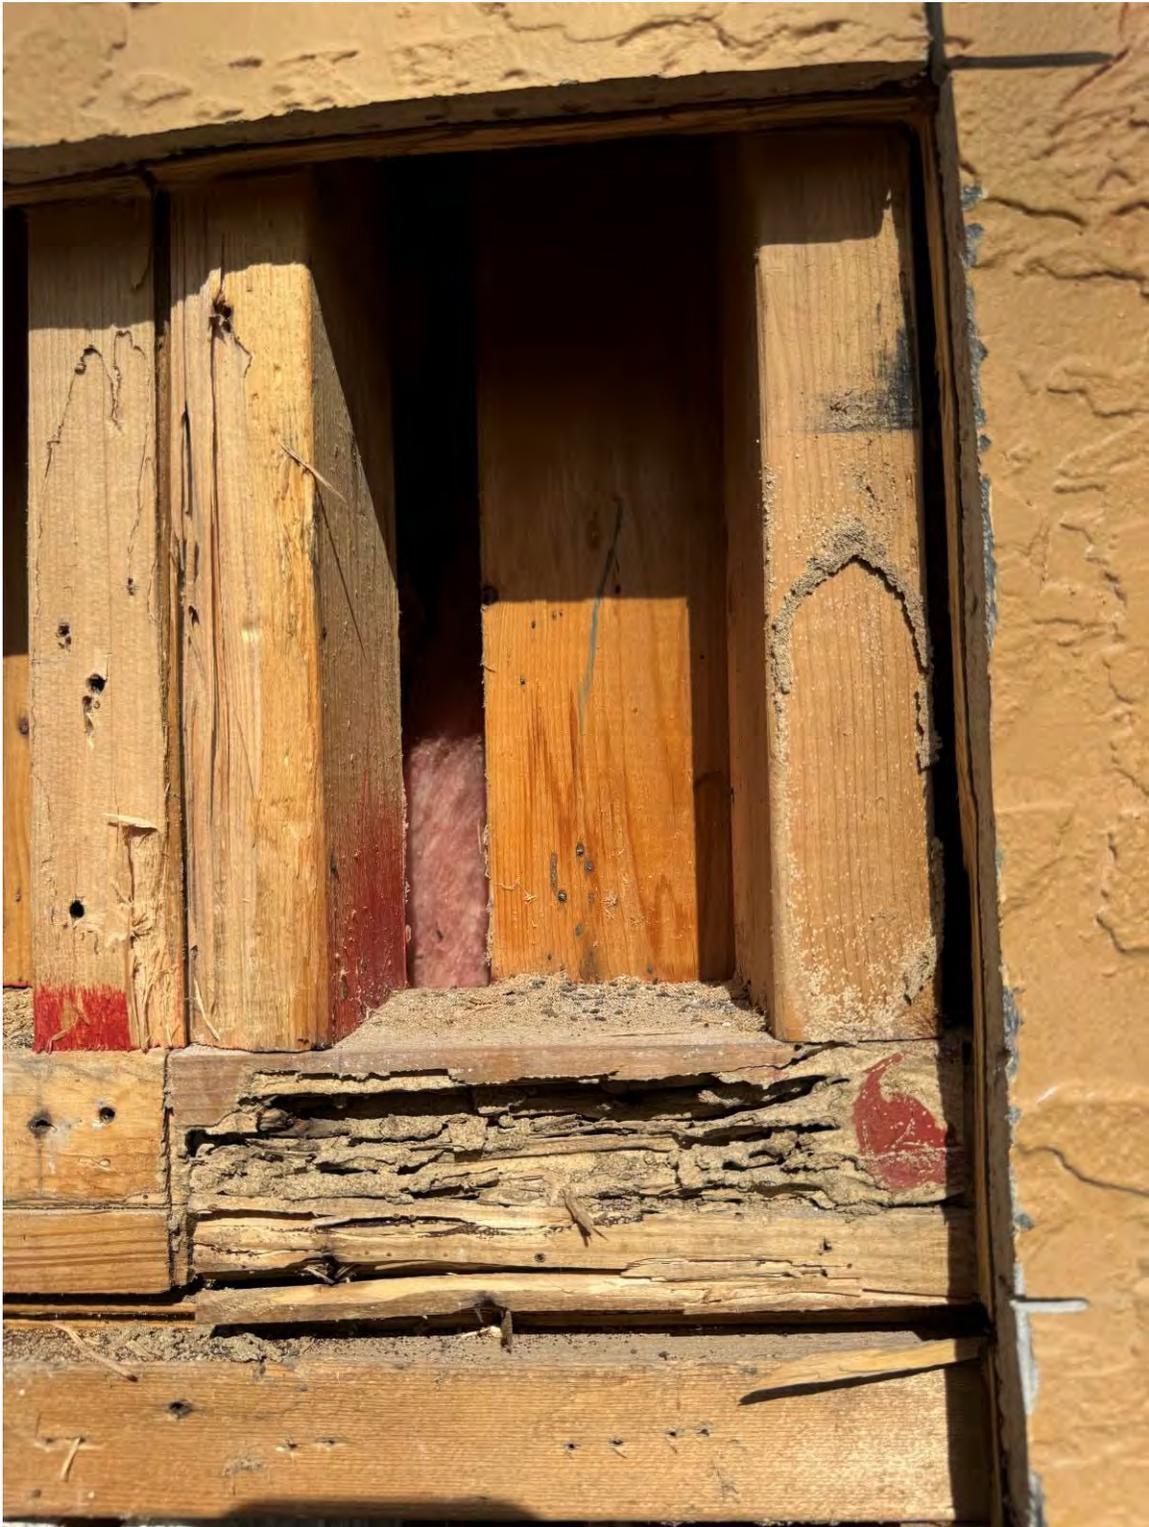
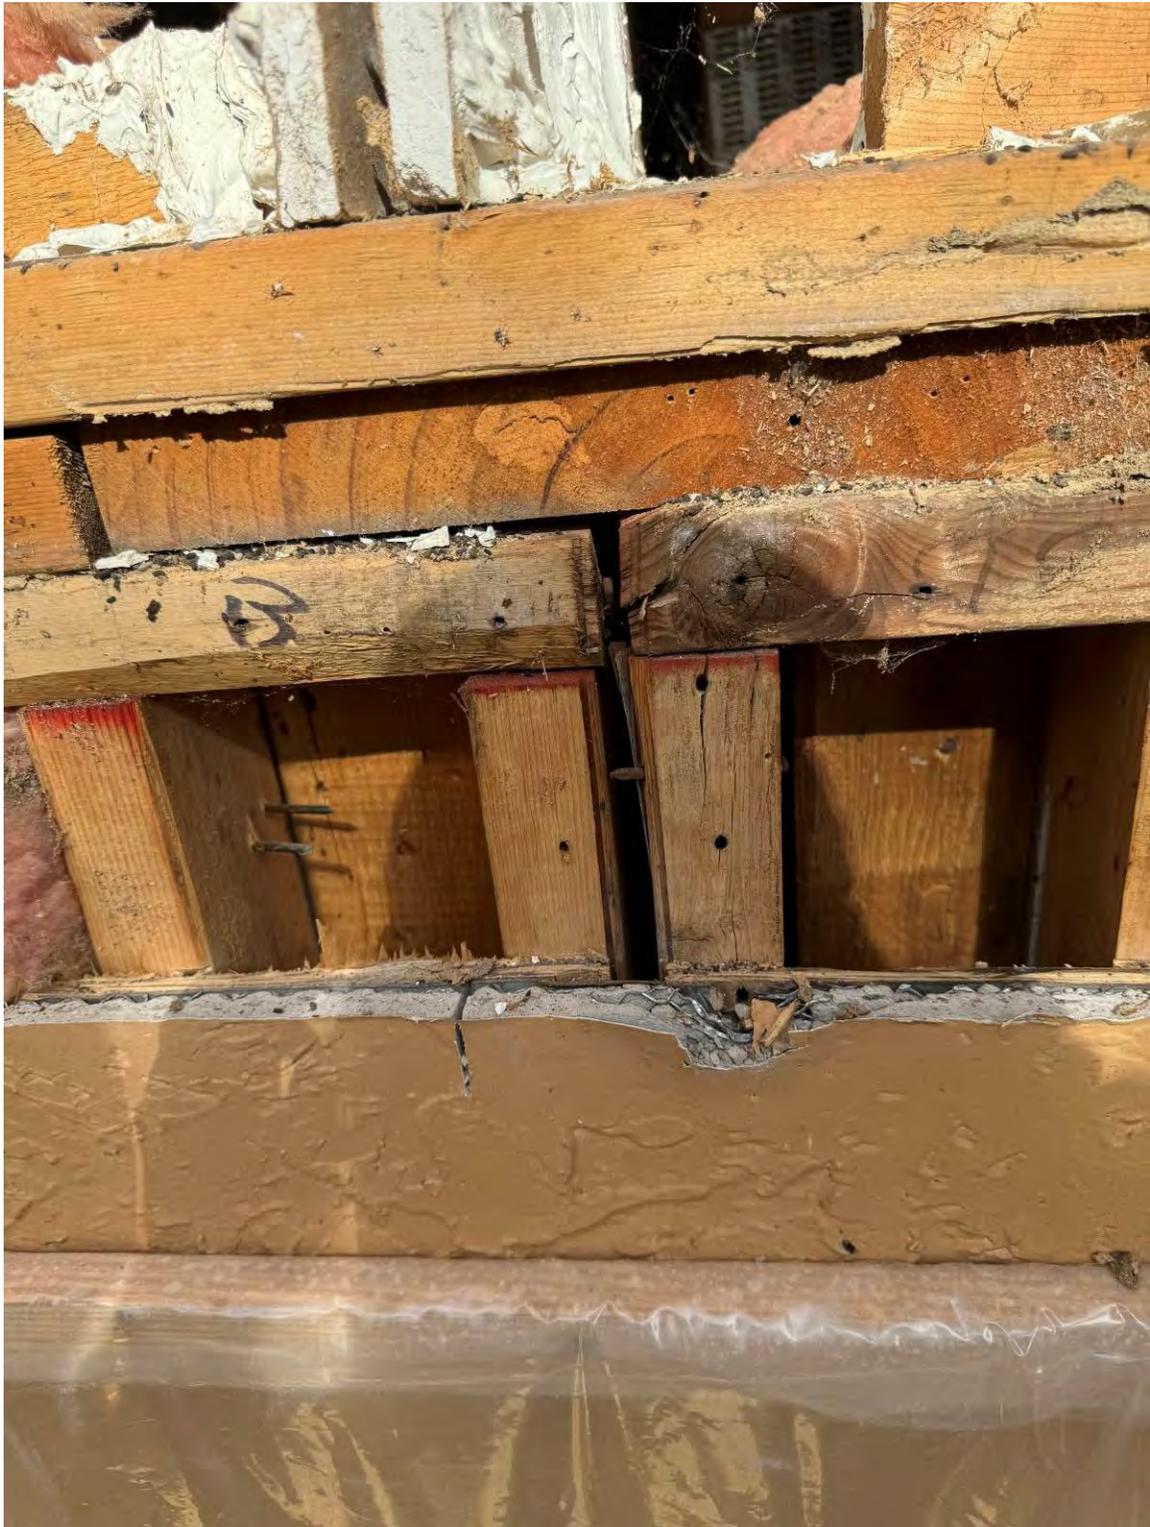
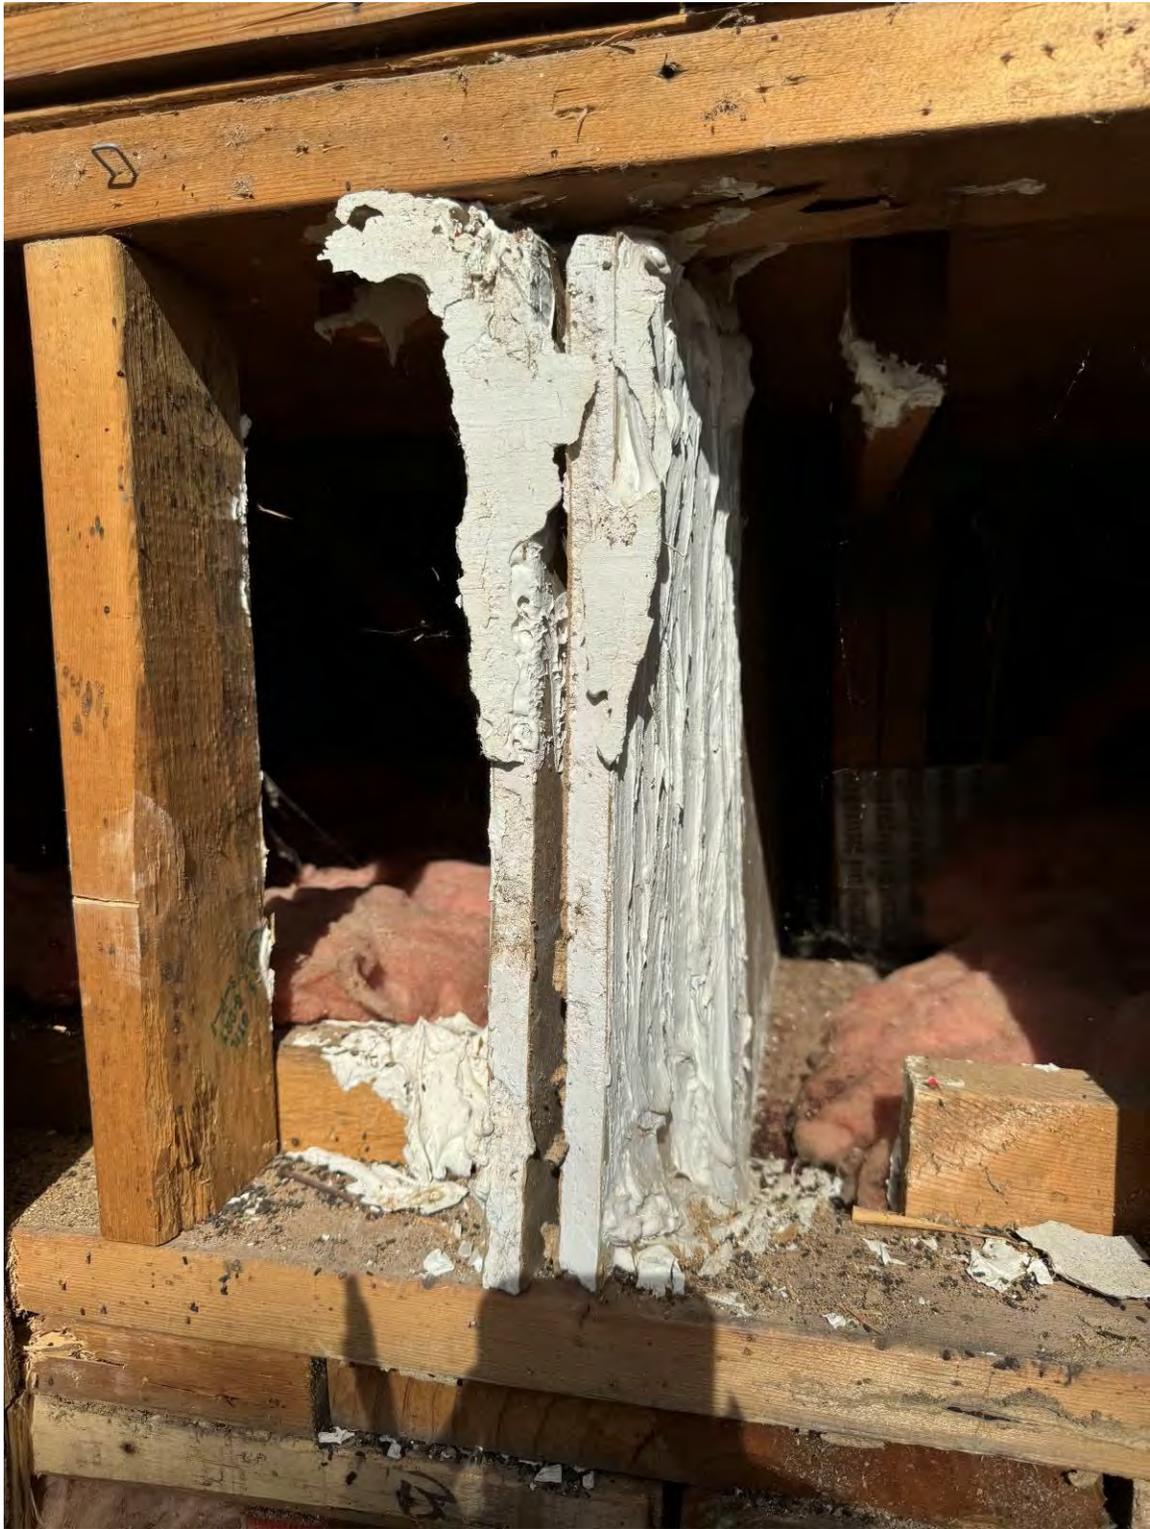
# OPENING #18

- No metal connections from studs to top or bottom plate
- Termite damage to studs, bottom plate and top plate
- Termite damage to floor truss
- 2<sup>nd</sup> layer of top plate topped with 2x12
- No fire separation 1<sup>st</sup> floor visible

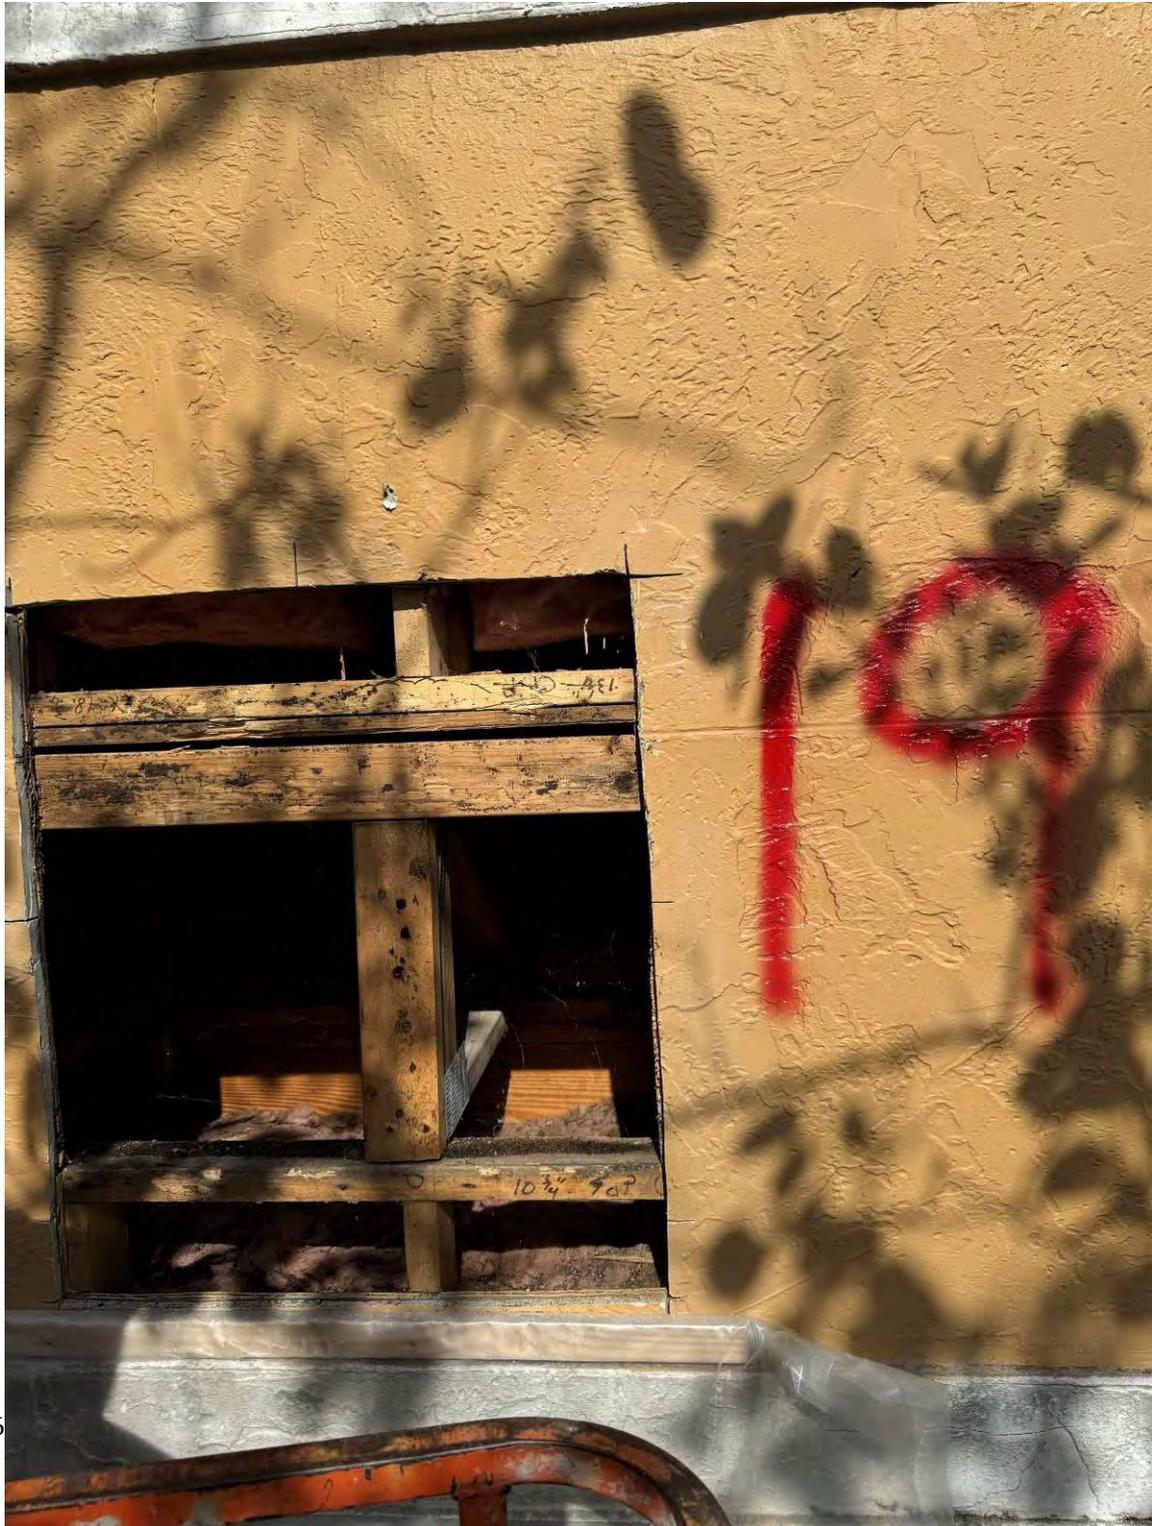
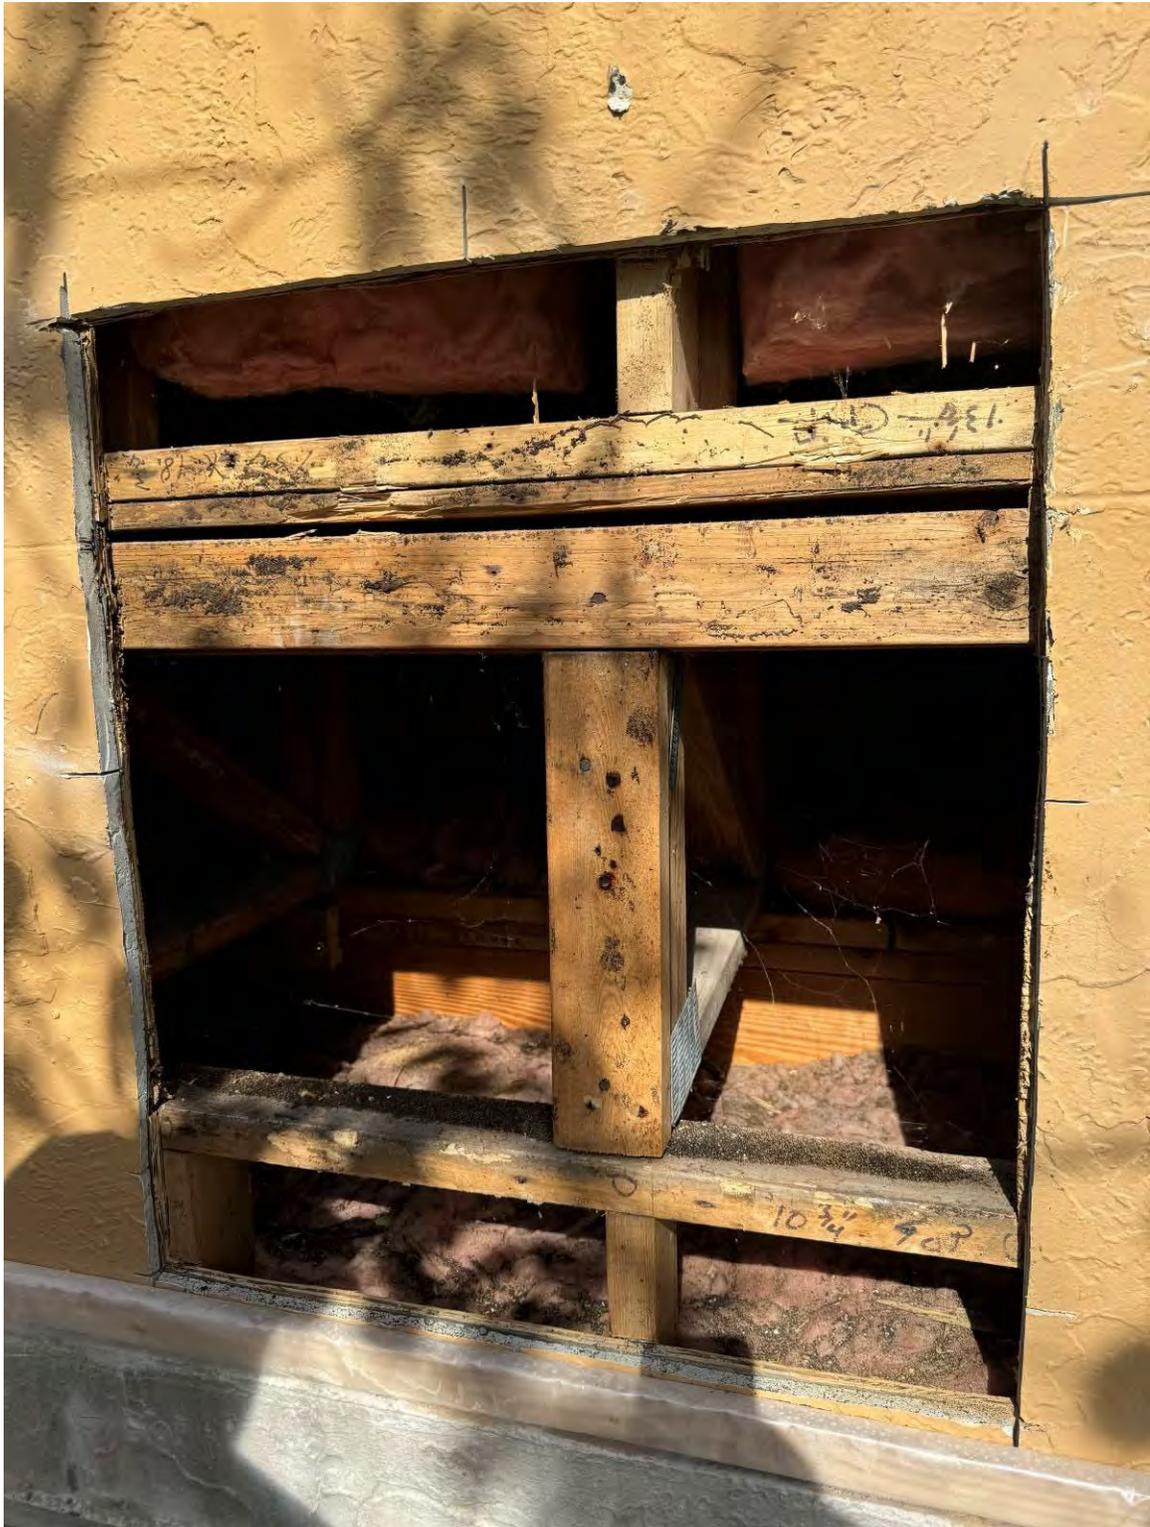
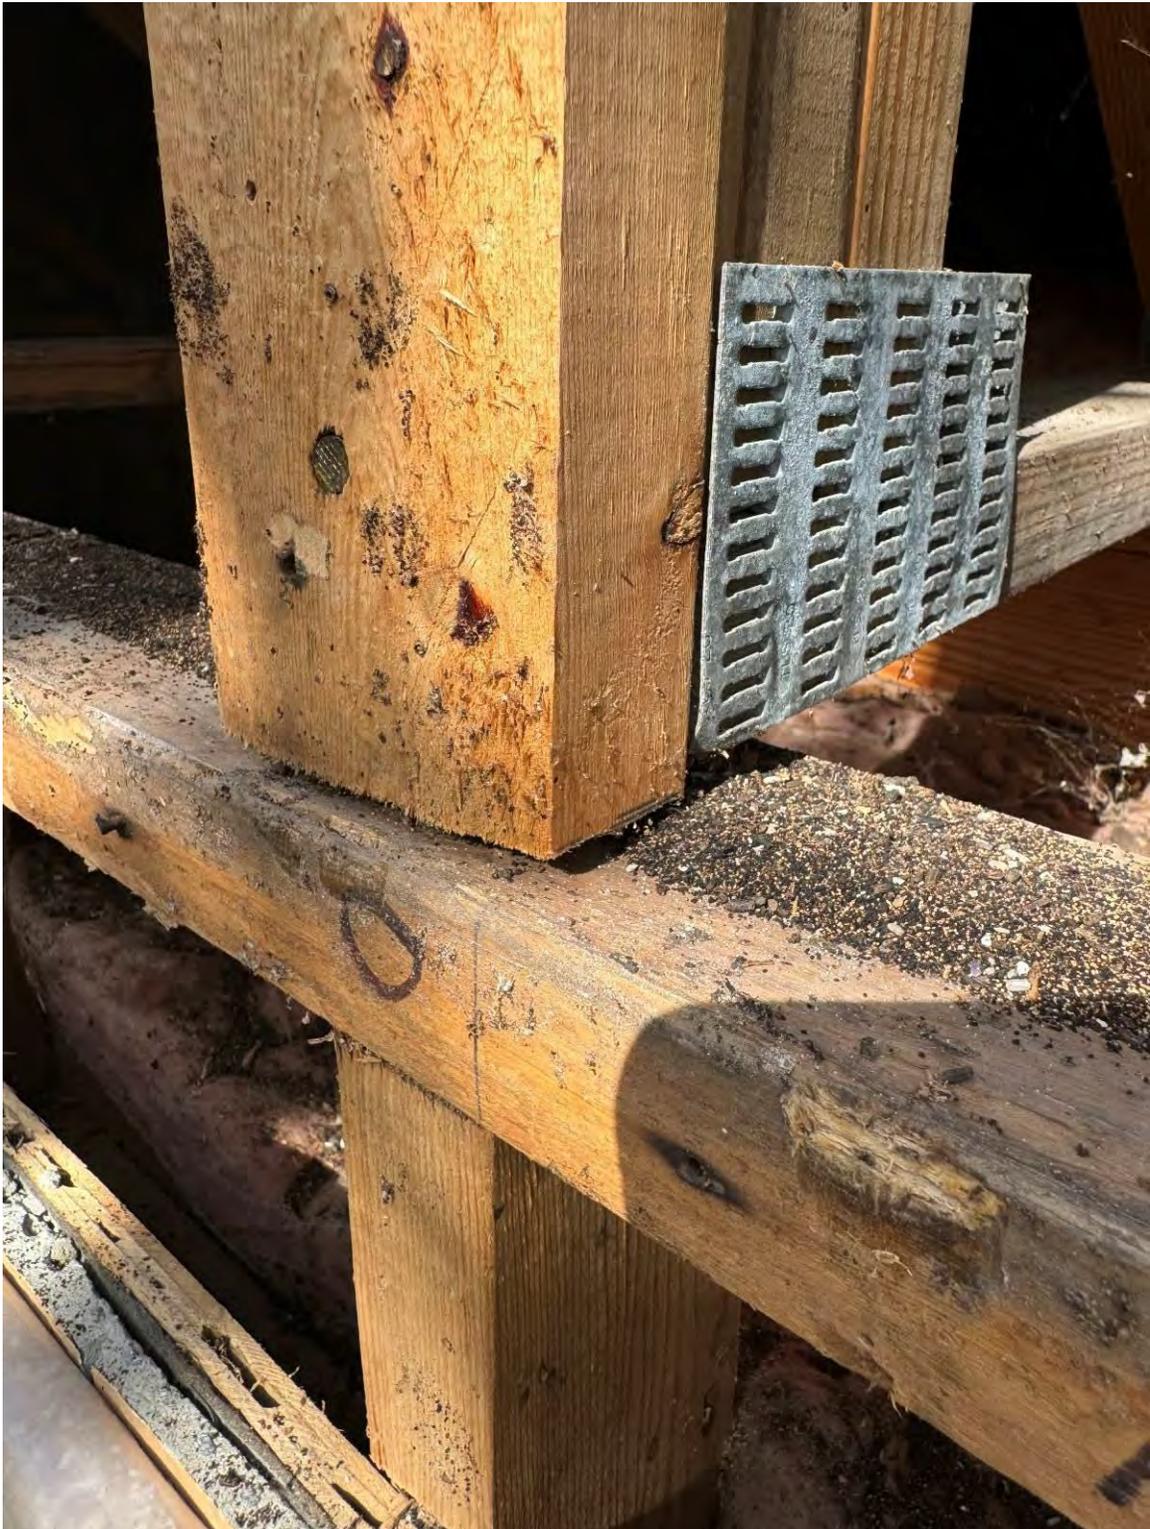
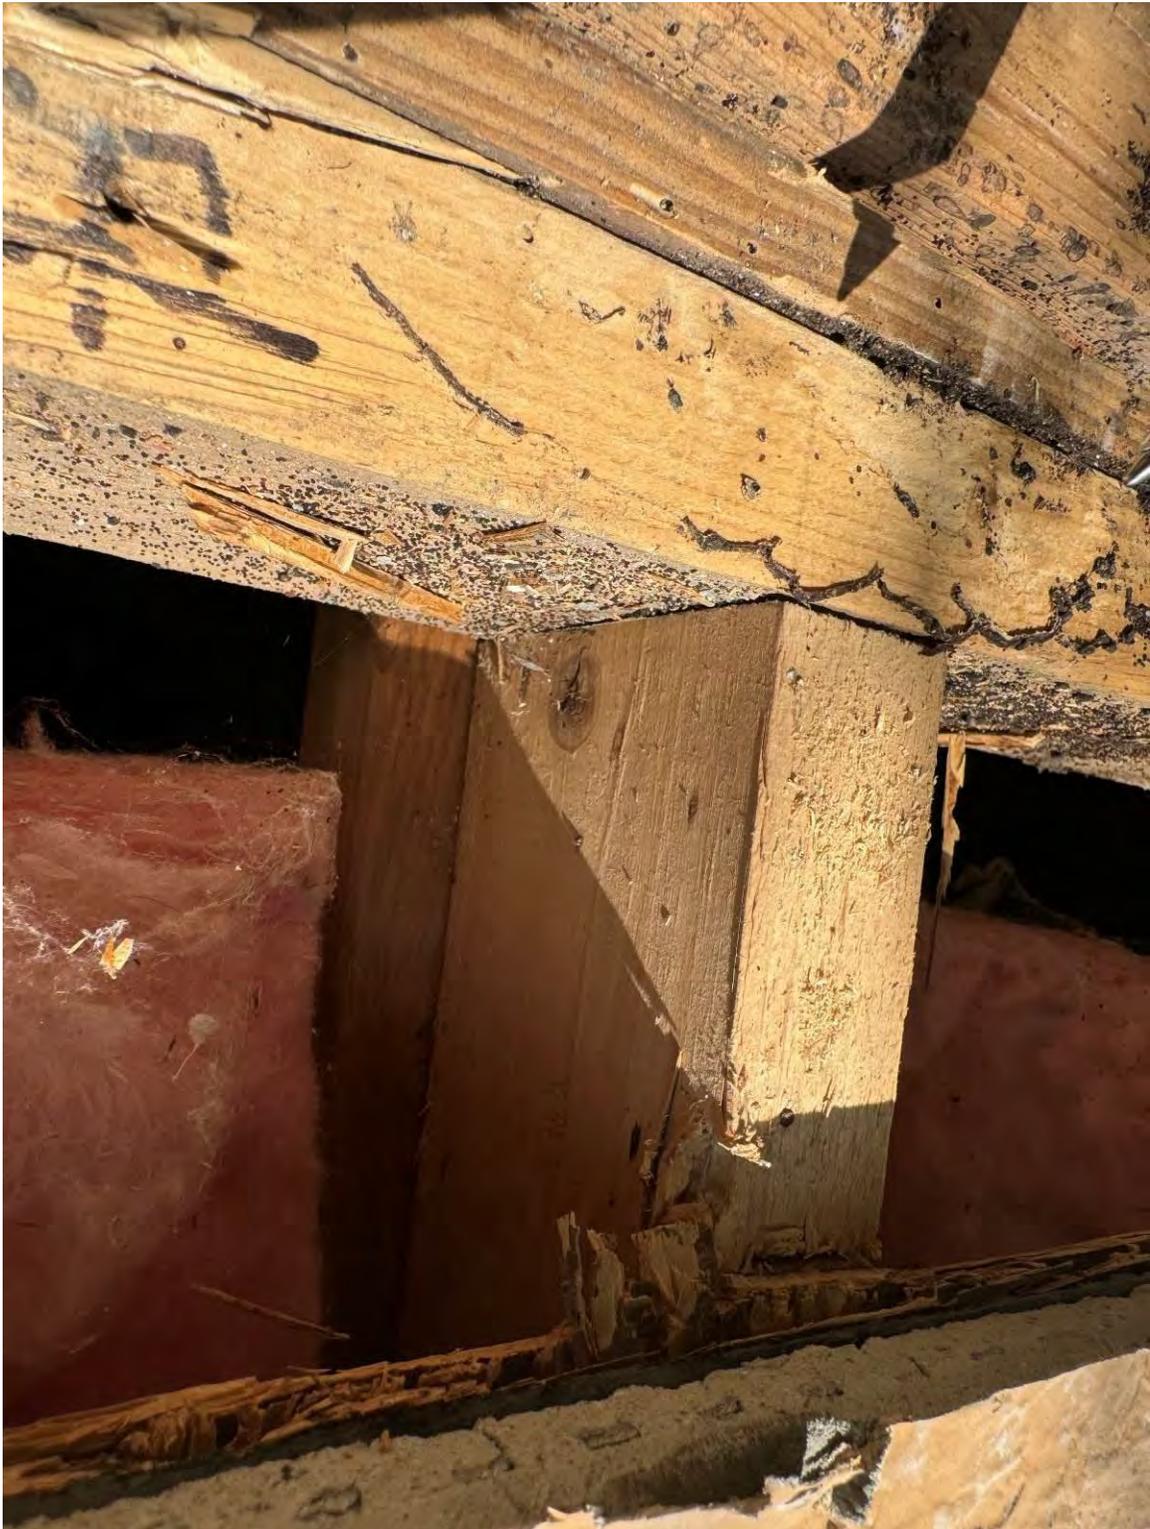
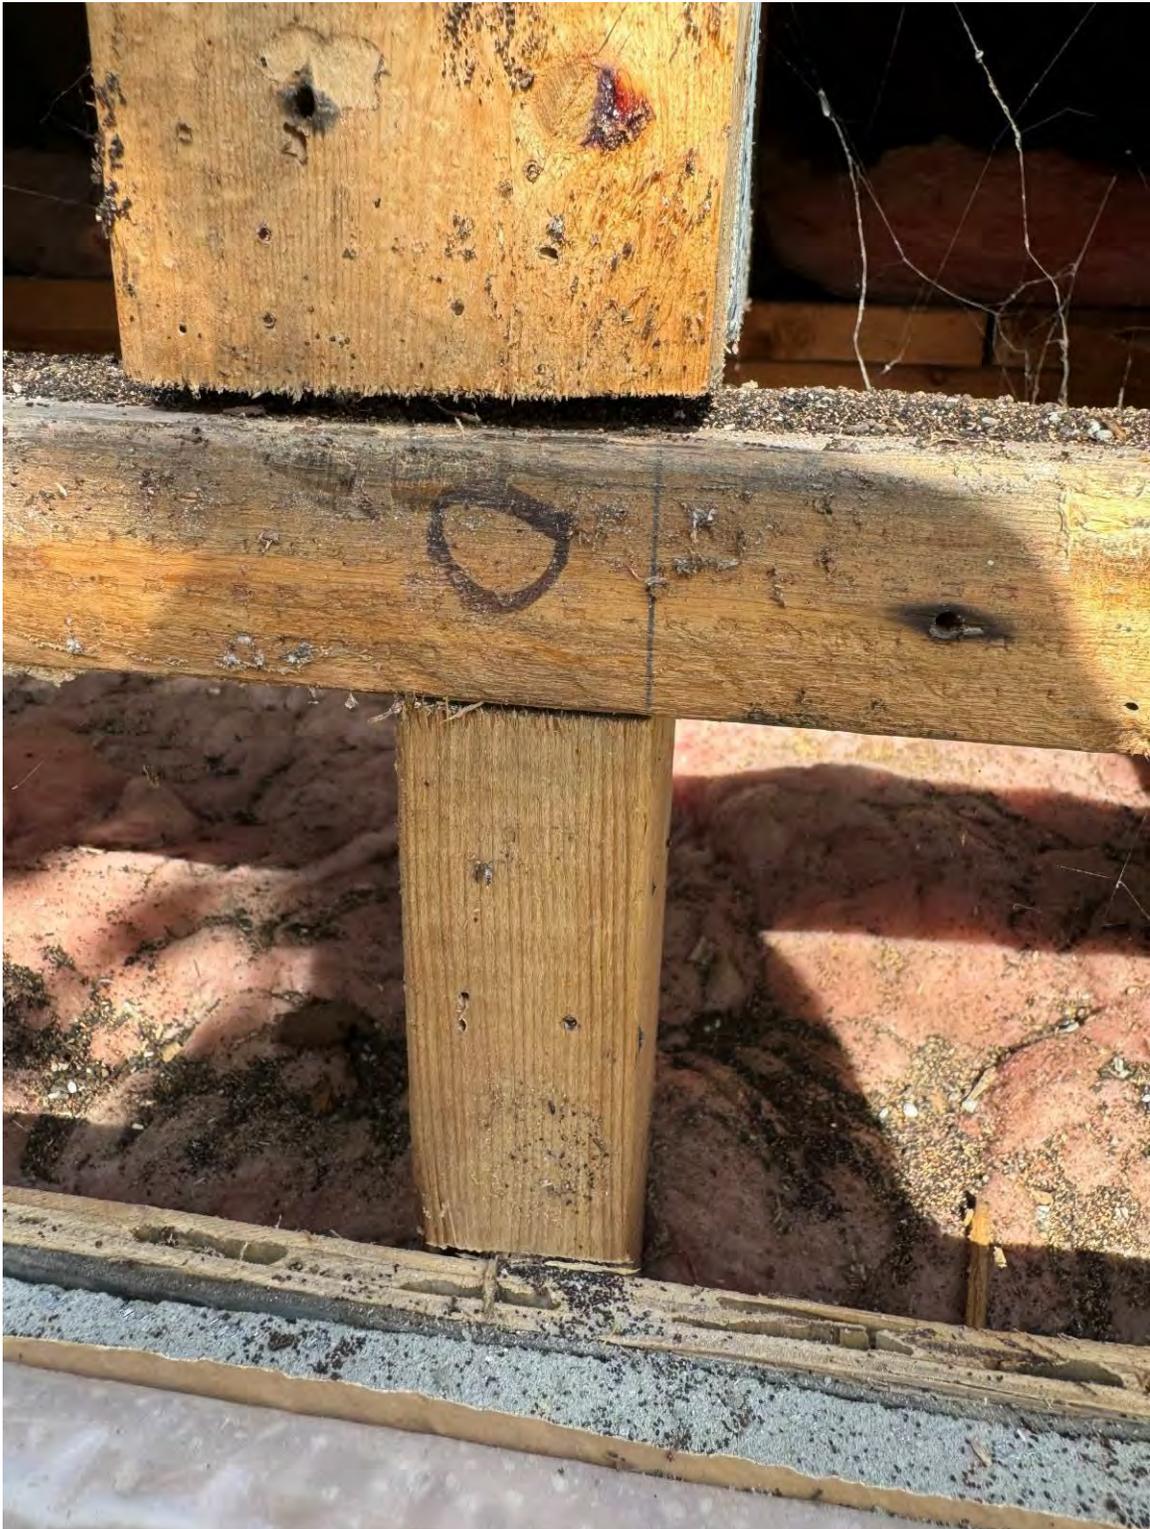
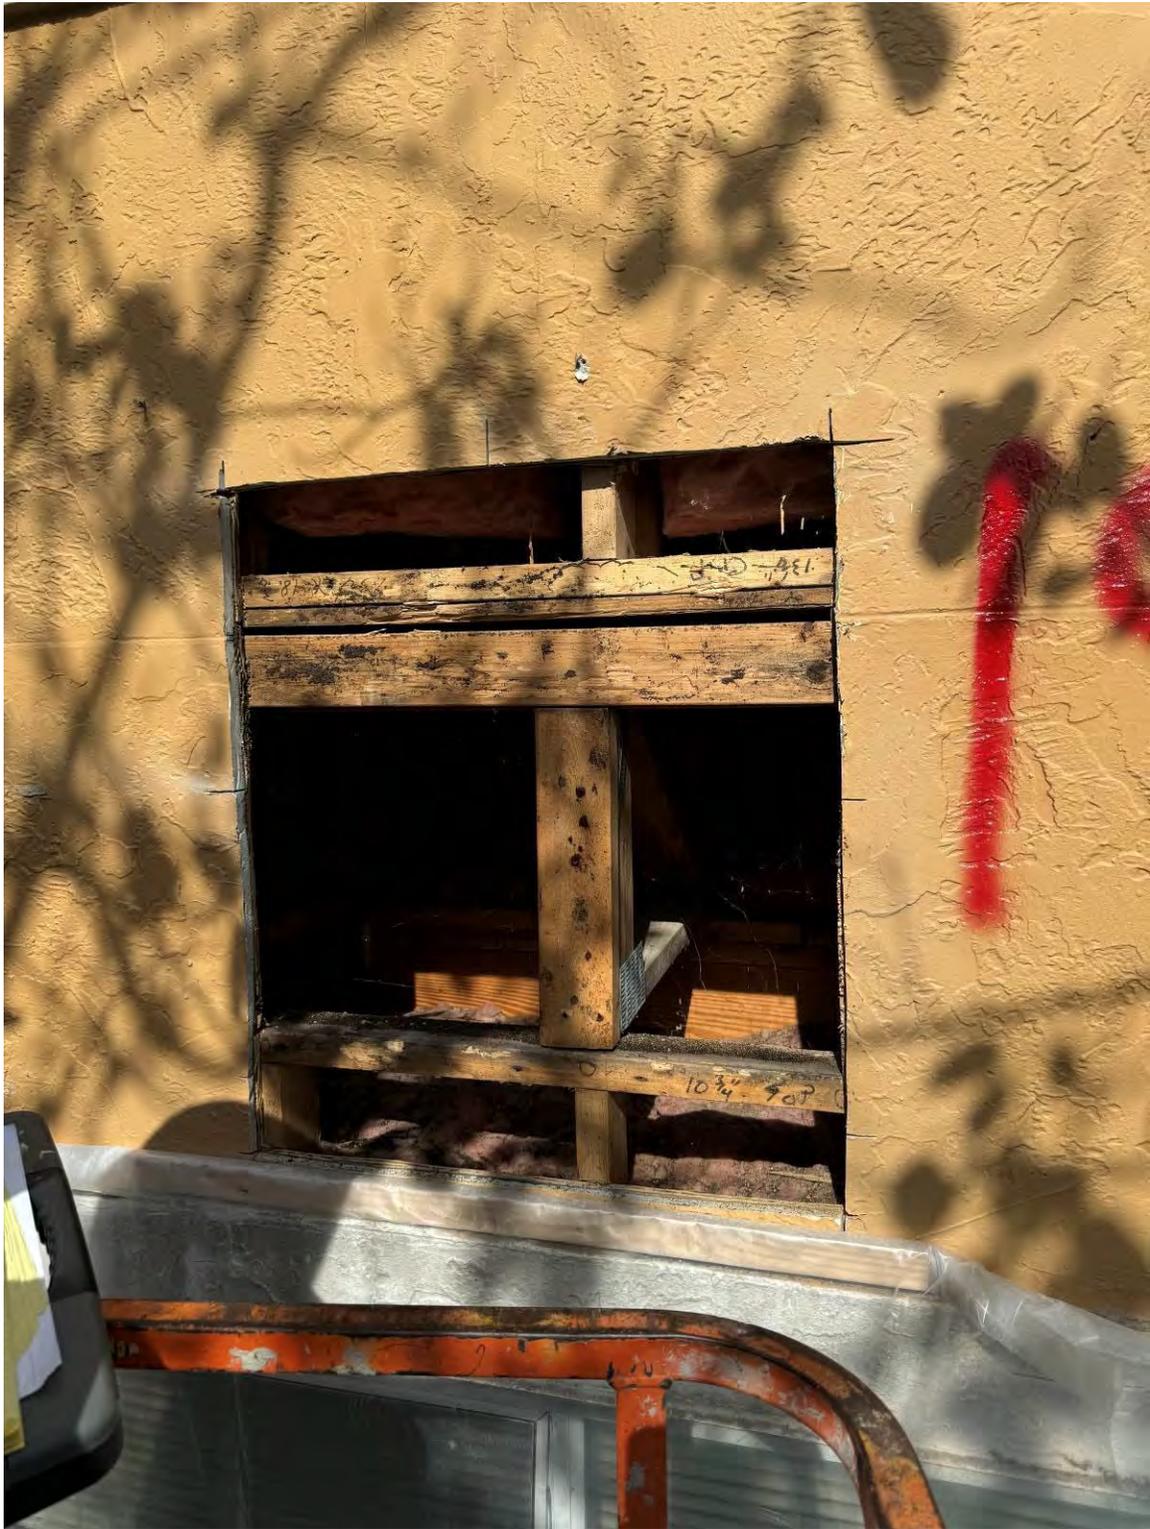
# OPENING #19

- No connection from 1<sup>st</sup> floor vertical to top plate
- Single top plate no connection from floor truss to 1<sup>st</sup> floor wall
- Single member sill plate for 2<sup>nd</sup> floor
- No connection 2<sup>nd</sup> floor stud to sill plate
- 2<sup>nd</sup> floor sheathing has no nail connection where the 2<sup>nd</sup> top plate member should be
- 2<sup>nd</sup> floor sheathing not nailed along bottom edge
