**NOTICE OF FILING PART 2 OF FINAL ENGINEERING REPORT OF SPECIALTY  
ENGINEERING CONSULTANTS, INC. DATED NOVEMBER 5, 2024**

Daniel J. Stermer, not individually, but solely in his capacity as Court Appointed Receiver (the "Receiver"), over the Heron Pond Condominium Association, Inc., (the "Association") by and through its undersigned counsel, hereby gives notice of filing Part 2 of the attached final Engineering Report of Specialty Engineering Consultants, Inc. dated November 5, 2024, opining on the existing condition of Building 9.

# OPENING #15

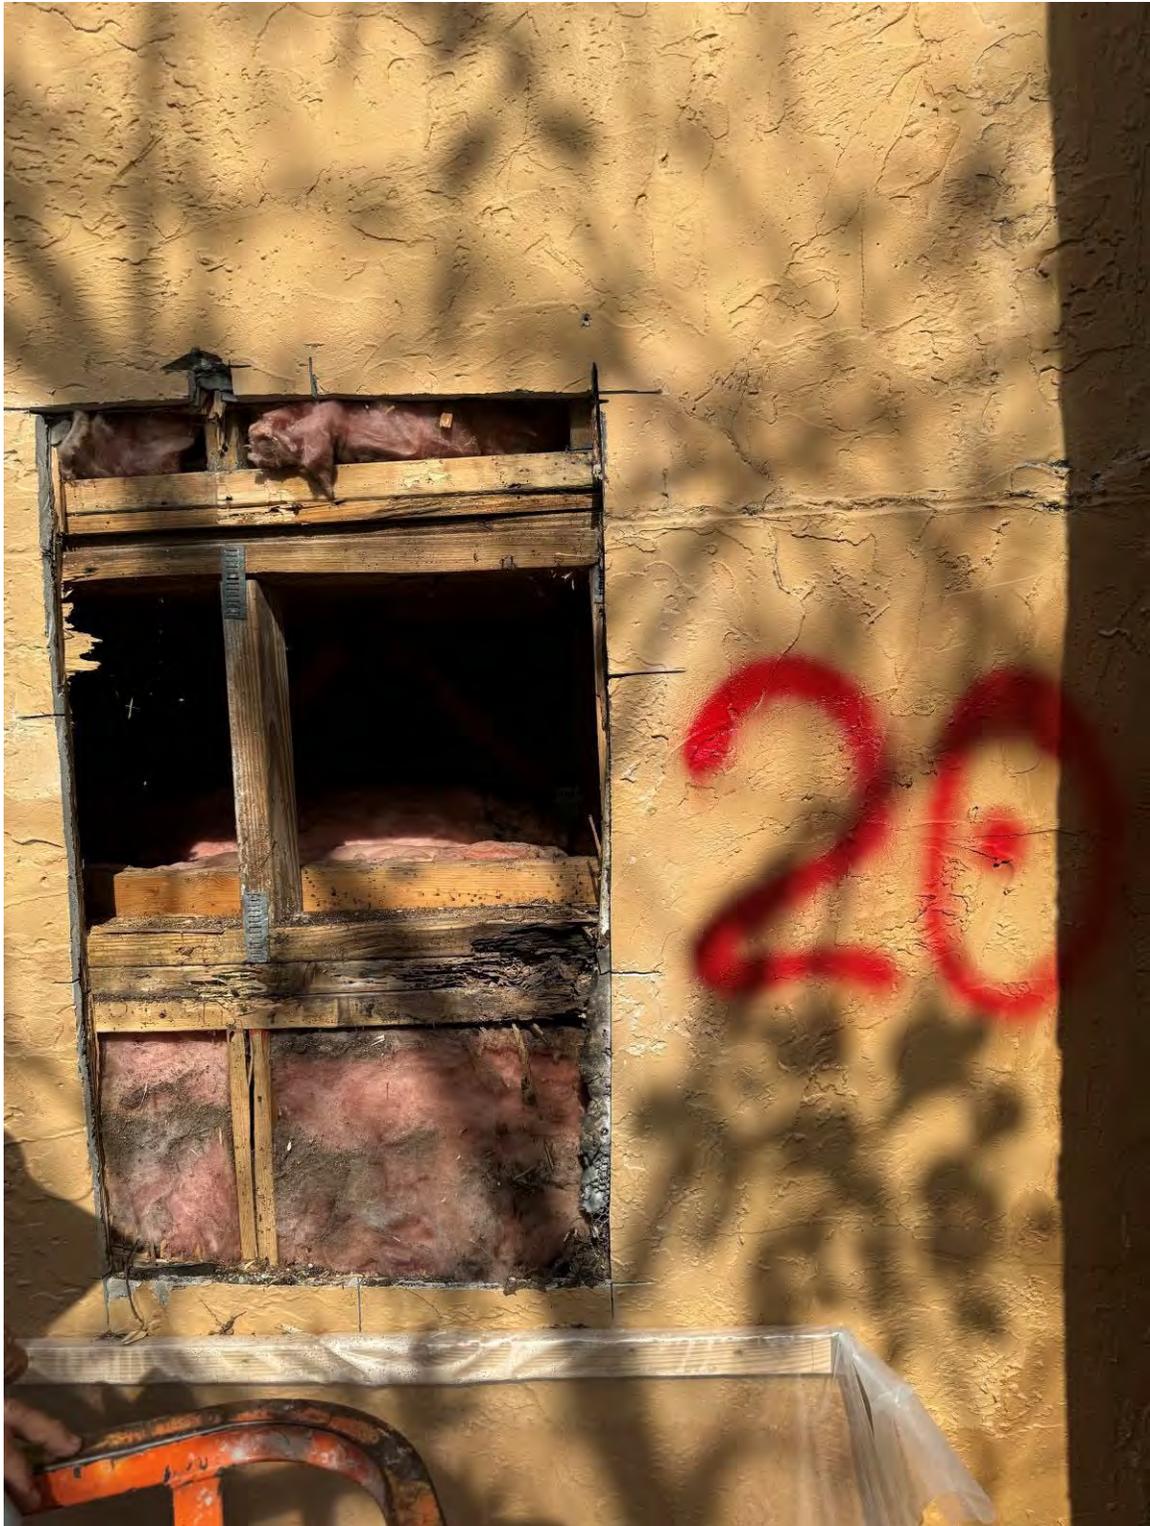
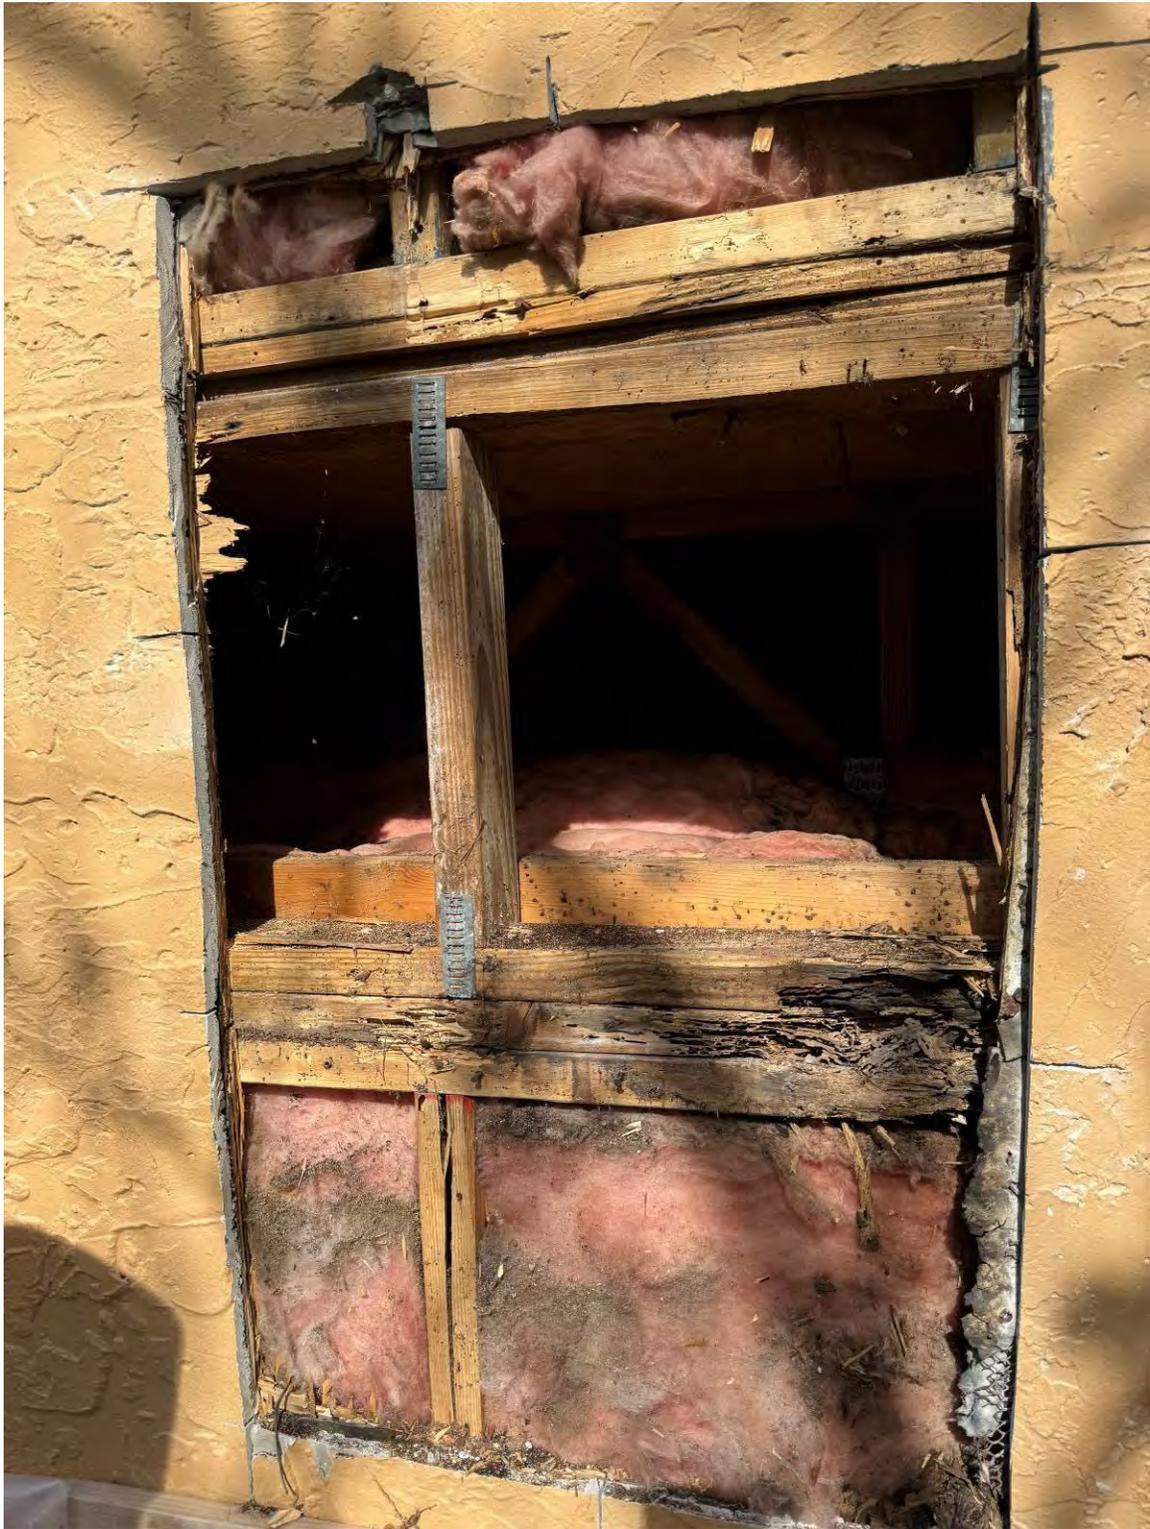
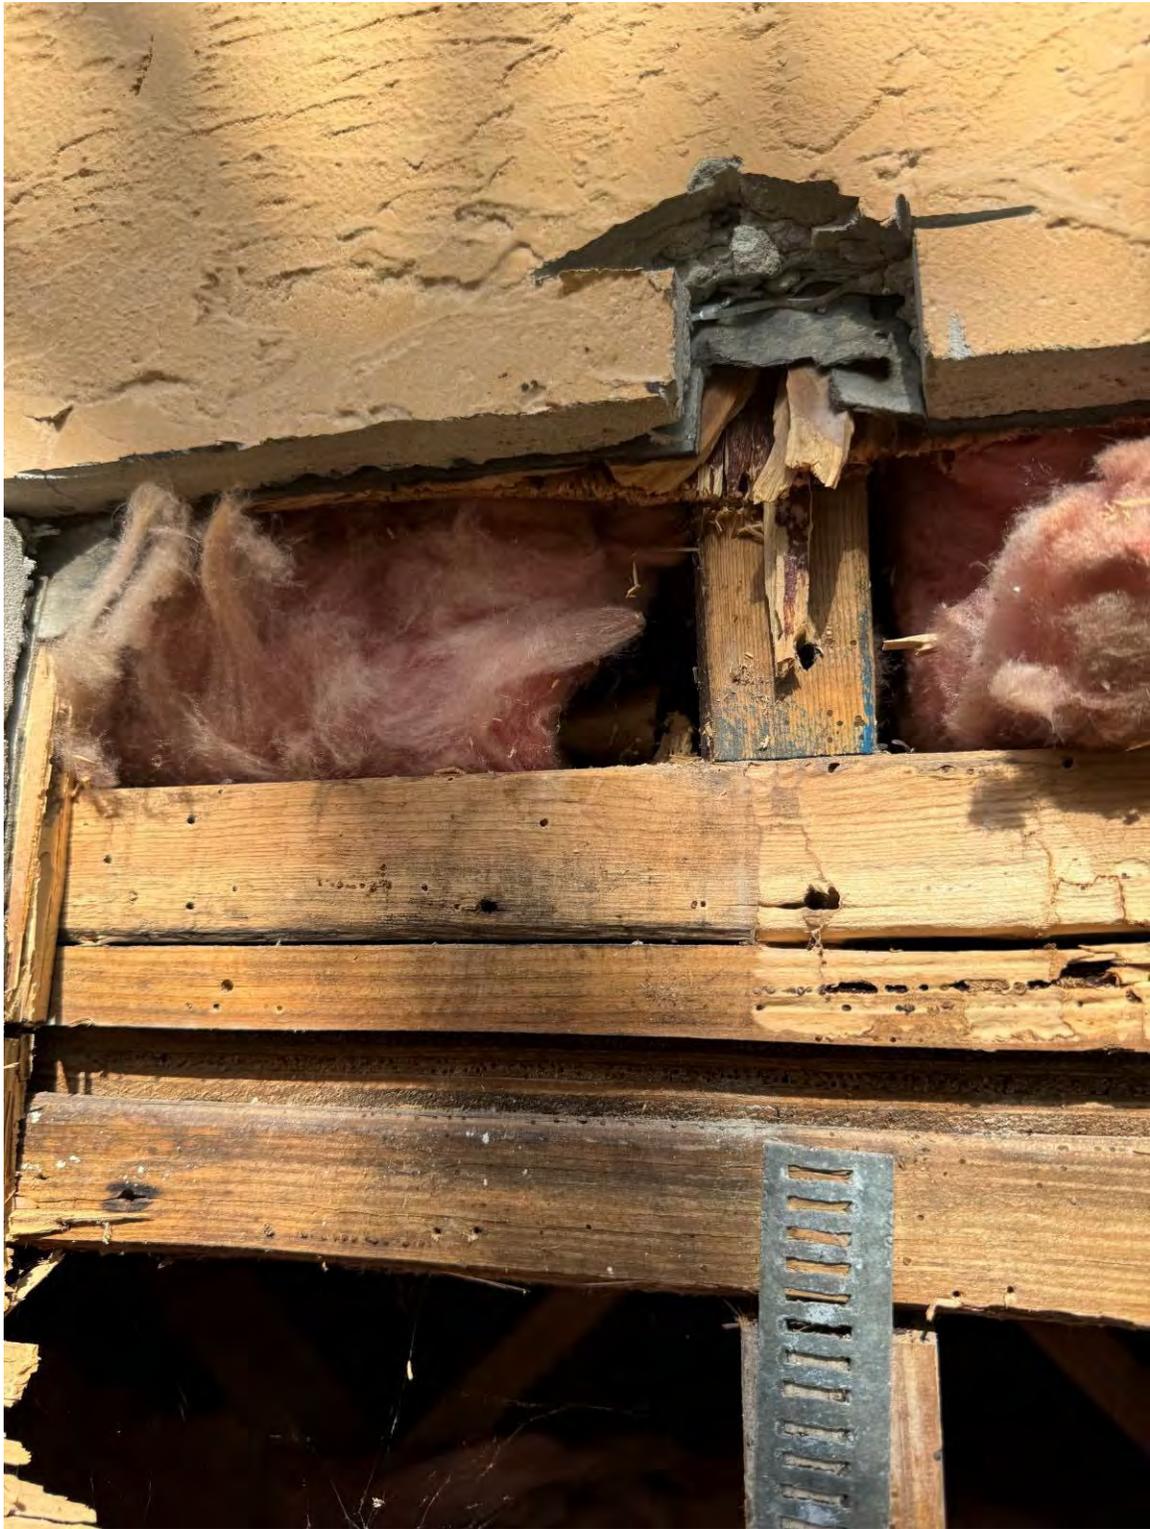
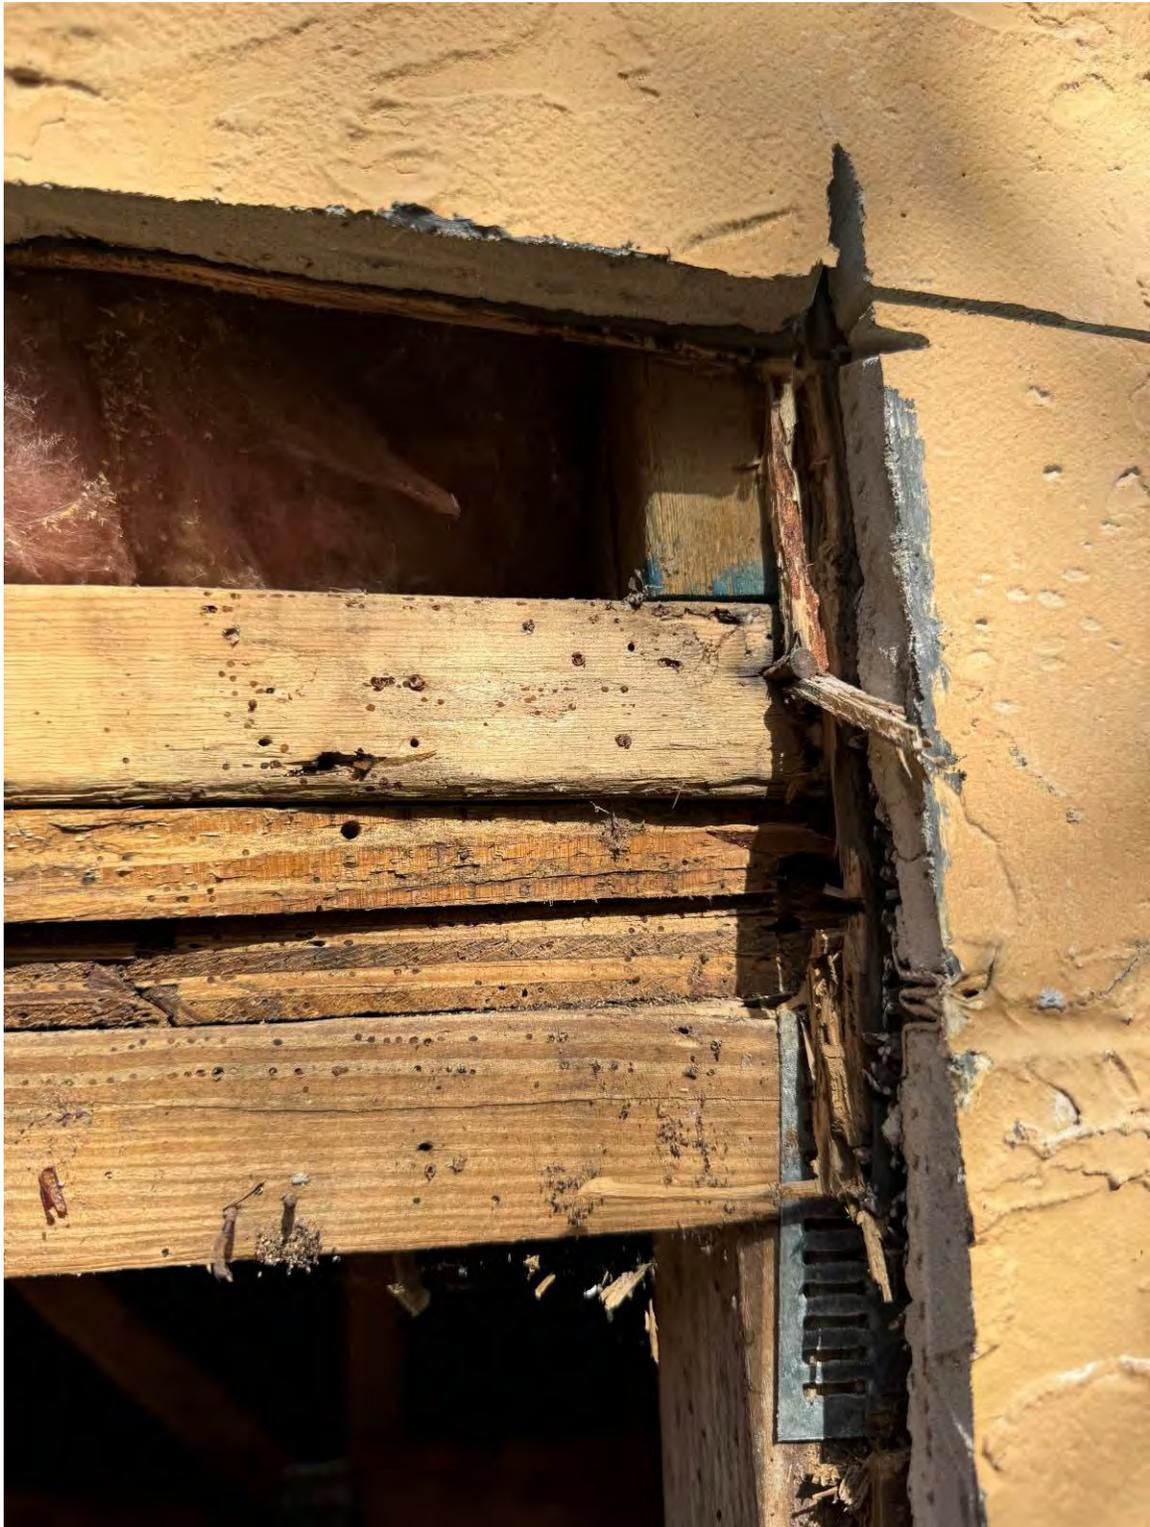
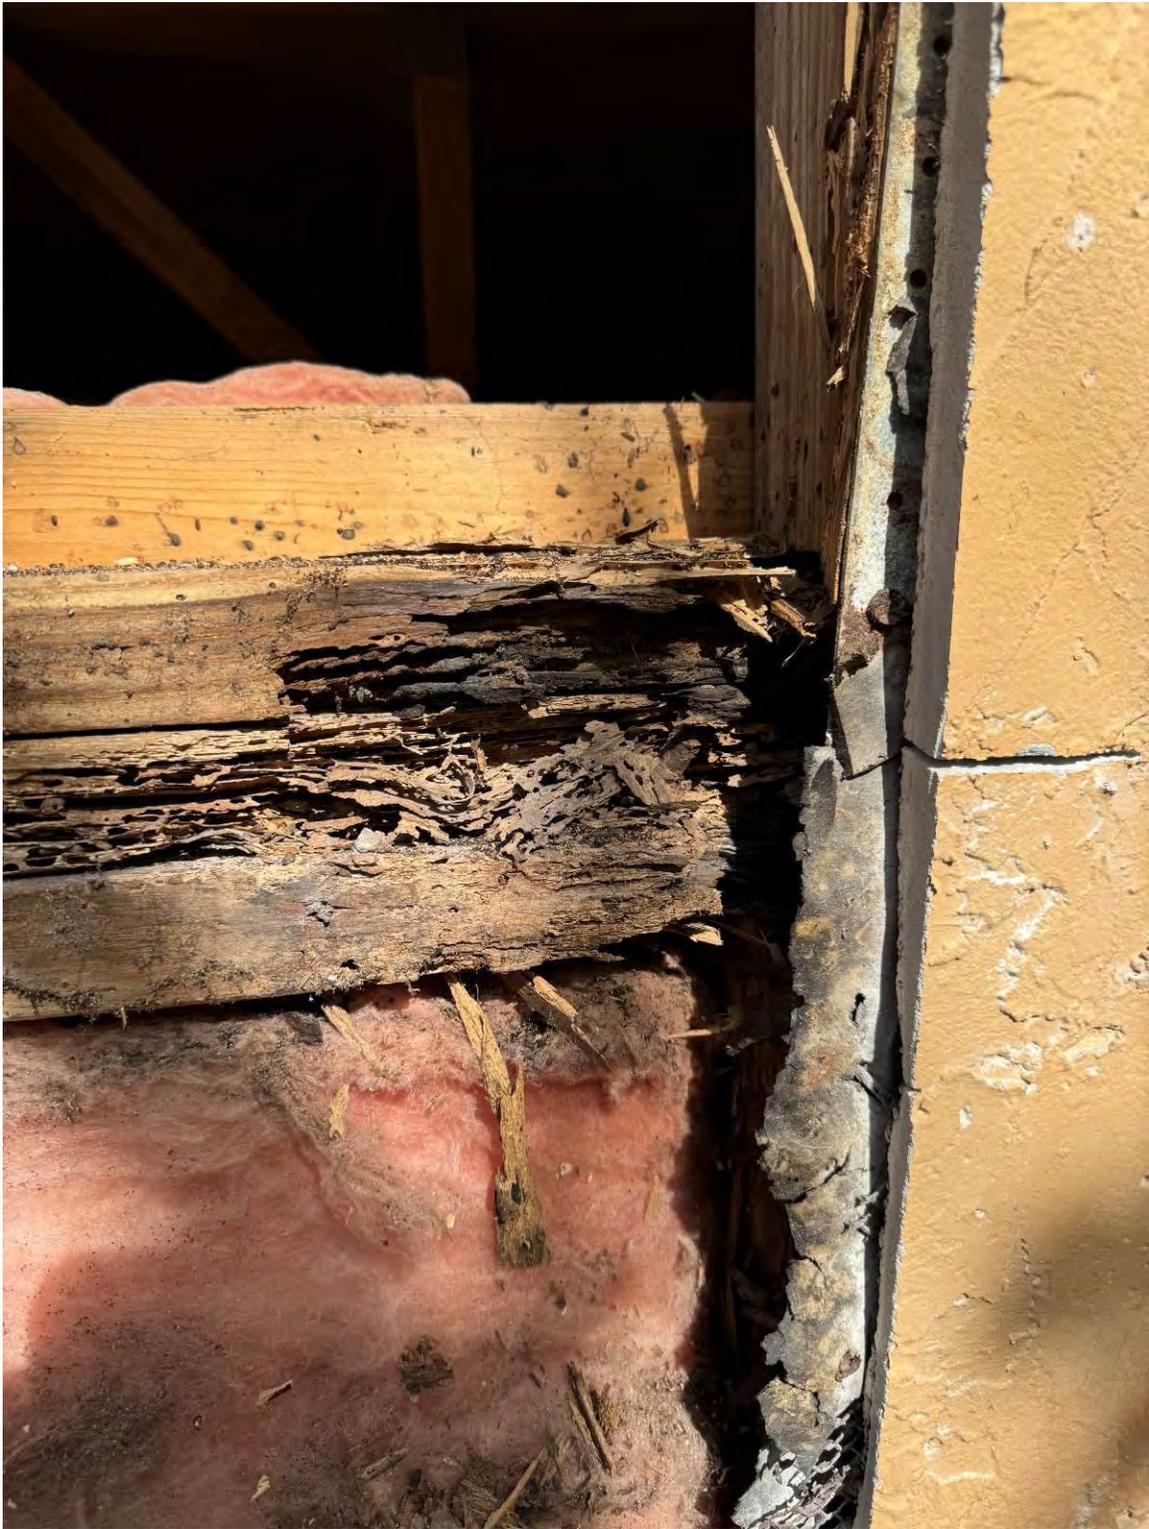
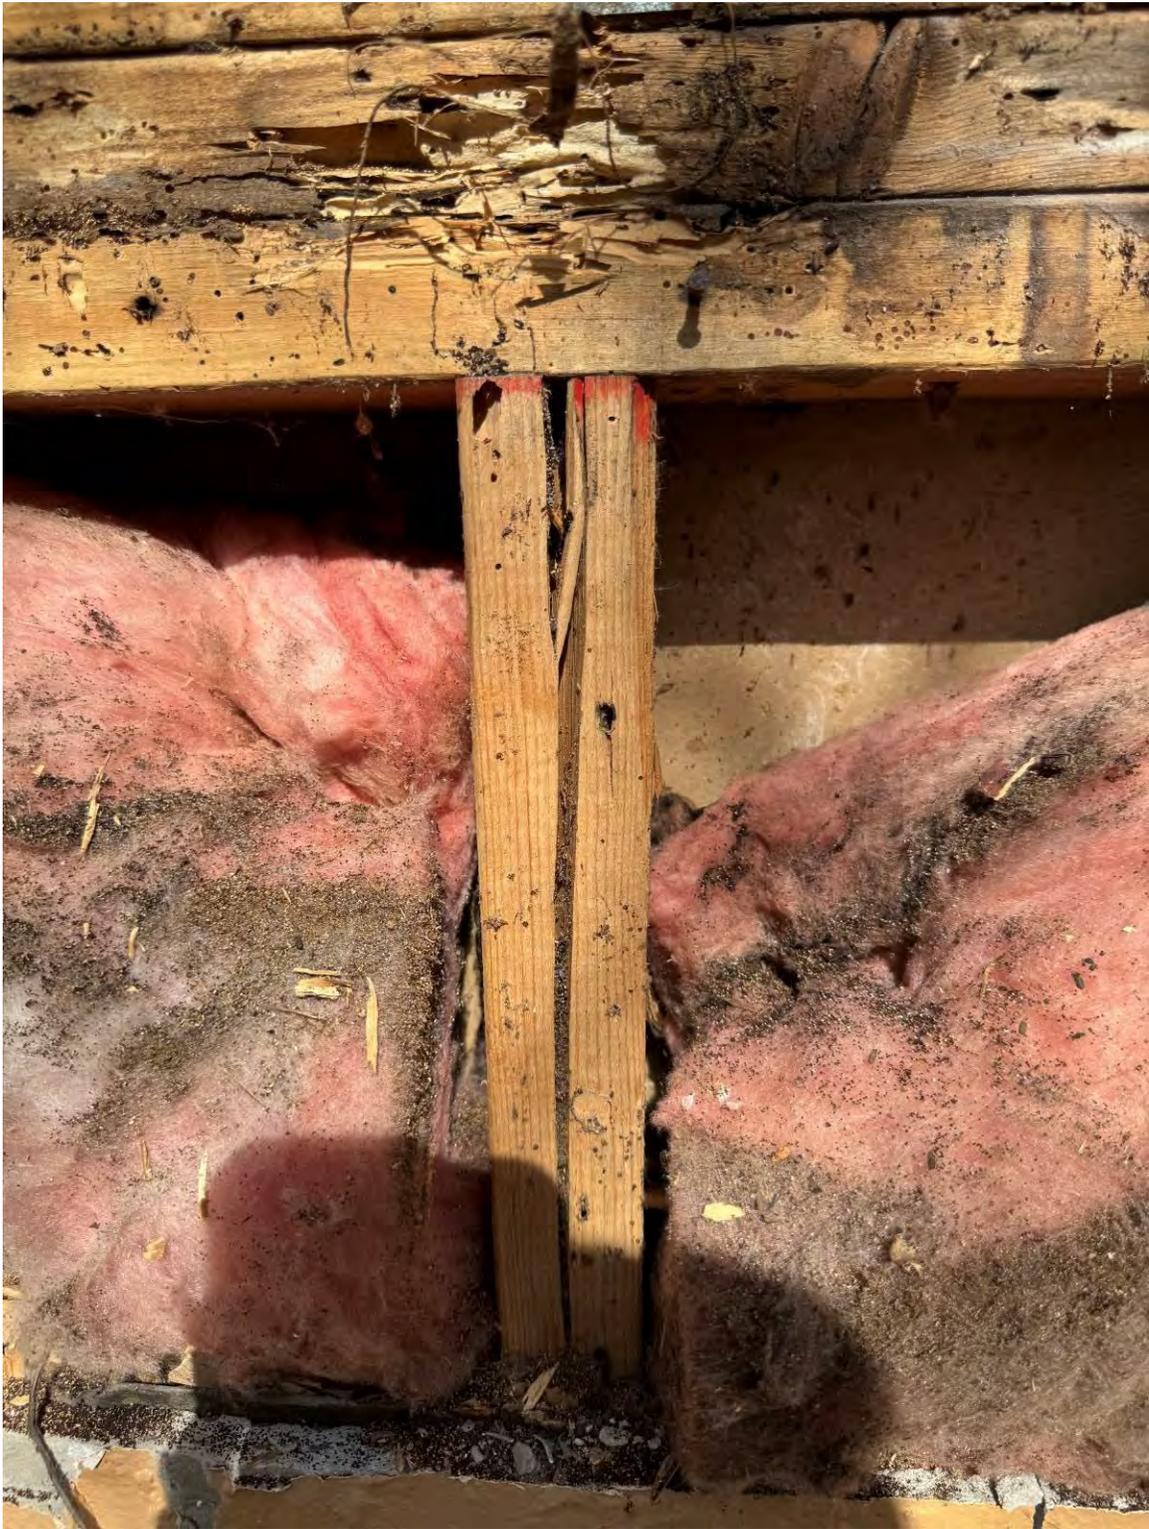
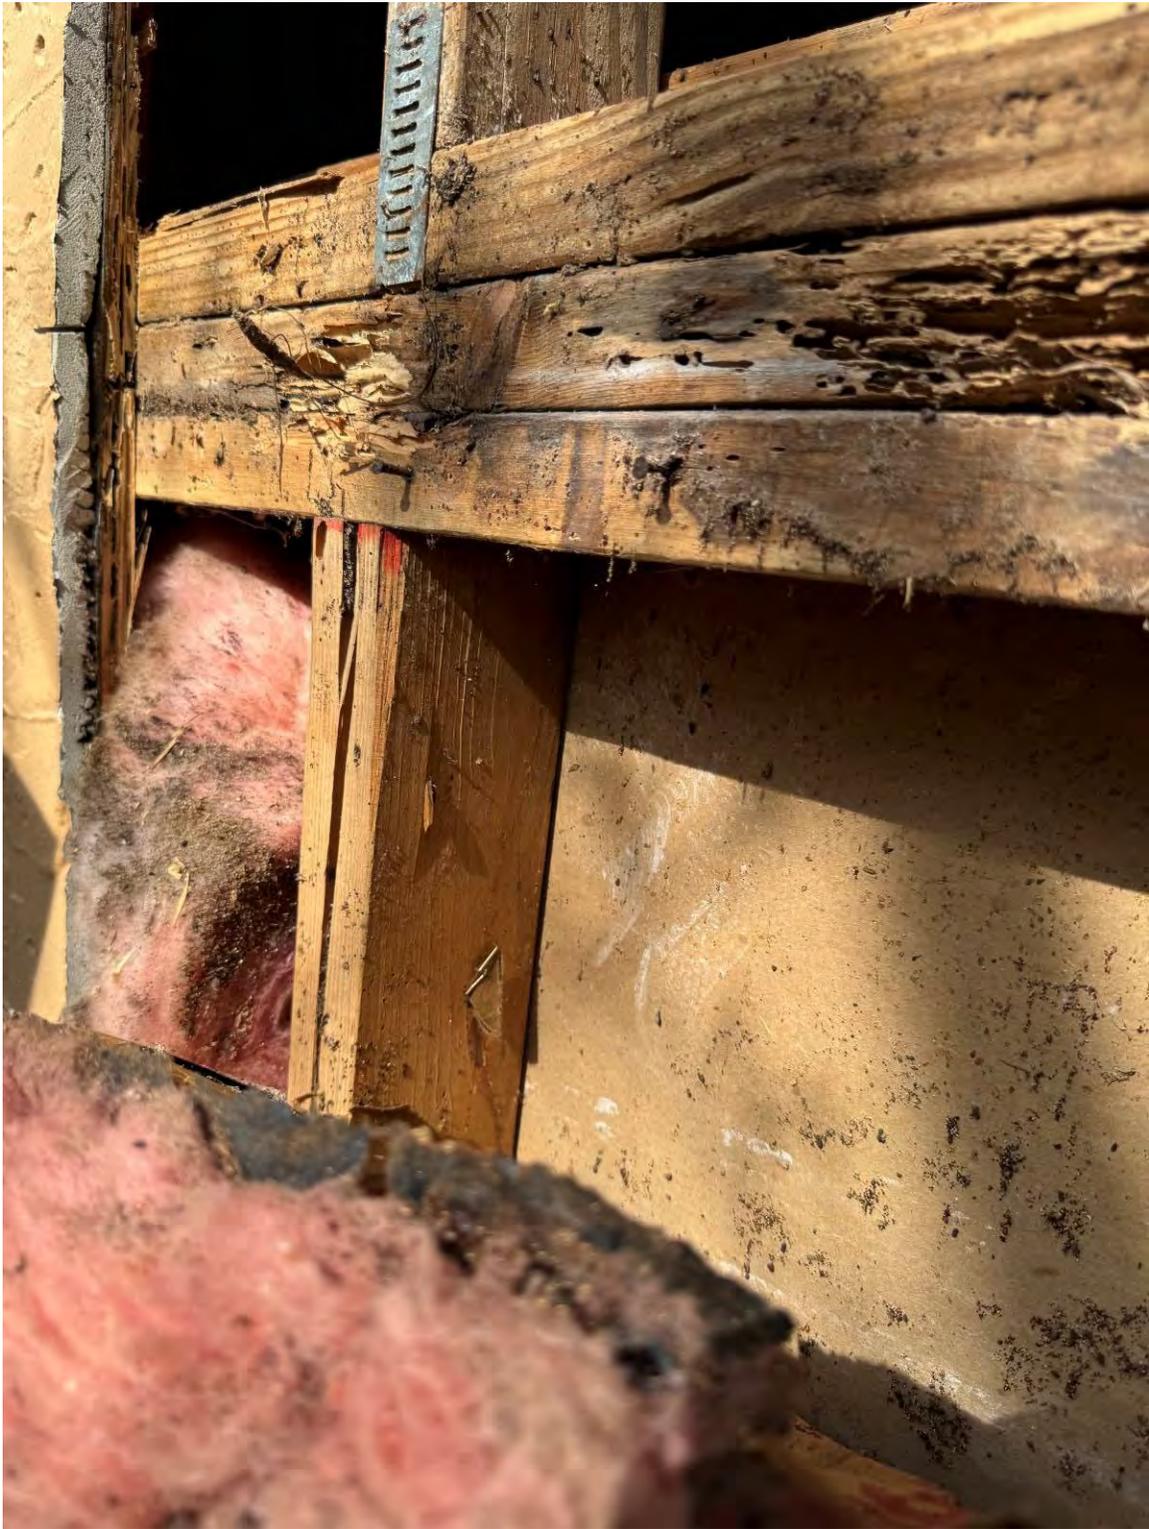
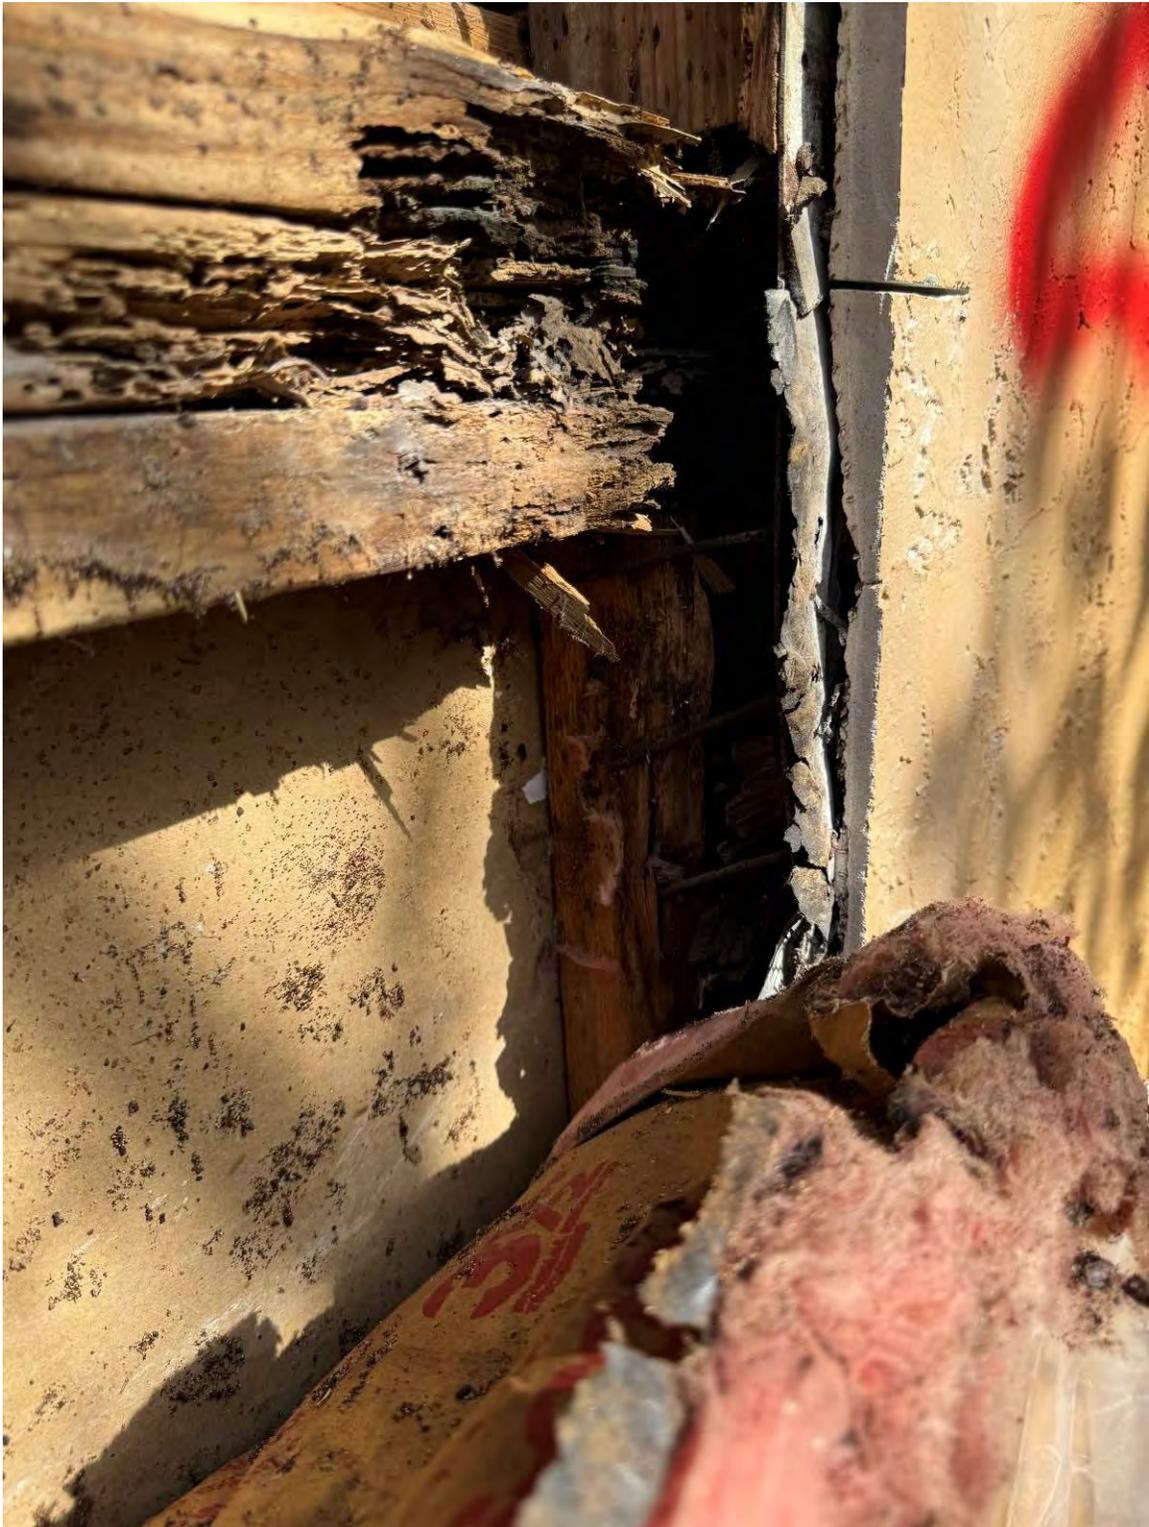
# OPENING #20

- 1<sup>st</sup> floor stud split
- 1<sup>st</sup> floor stud not connected to bearing wall
- Drywall present 1<sup>st</sup> floor
- Double top plate present
- Double top plate termite damage and water damage
- 1<sup>st</sup> floor wall termite damage and water damage
- Floor truss termite damage and water damage
- 2<sup>nd</sup> floor bearing wall single bottom plate?
- No connections 2<sup>nd</sup> floor bearing wall to bottom plate
- Termite damage to bottom plate and plywood flooring
