**NOTICE OF FILING PART 2 OF FINAL ENGINEERING REPORT OF SPECIALTY  
ENGINEERING CONSULTANTS, INC. DATED NOVEMBER 5, 2024**

Daniel J. Stermer, not individually, but solely in his capacity as Court Appointed Receiver (the "Receiver"), over the Heron Pond Condominium Association, Inc., (the "Association") by and through its undersigned counsel, hereby gives notice of filing Part 2 of the attached final Engineering Report of Specialty Engineering Consultants, Inc. dated November 5, 2024, opining on the existing condition of Building 9.

# OPENING #15

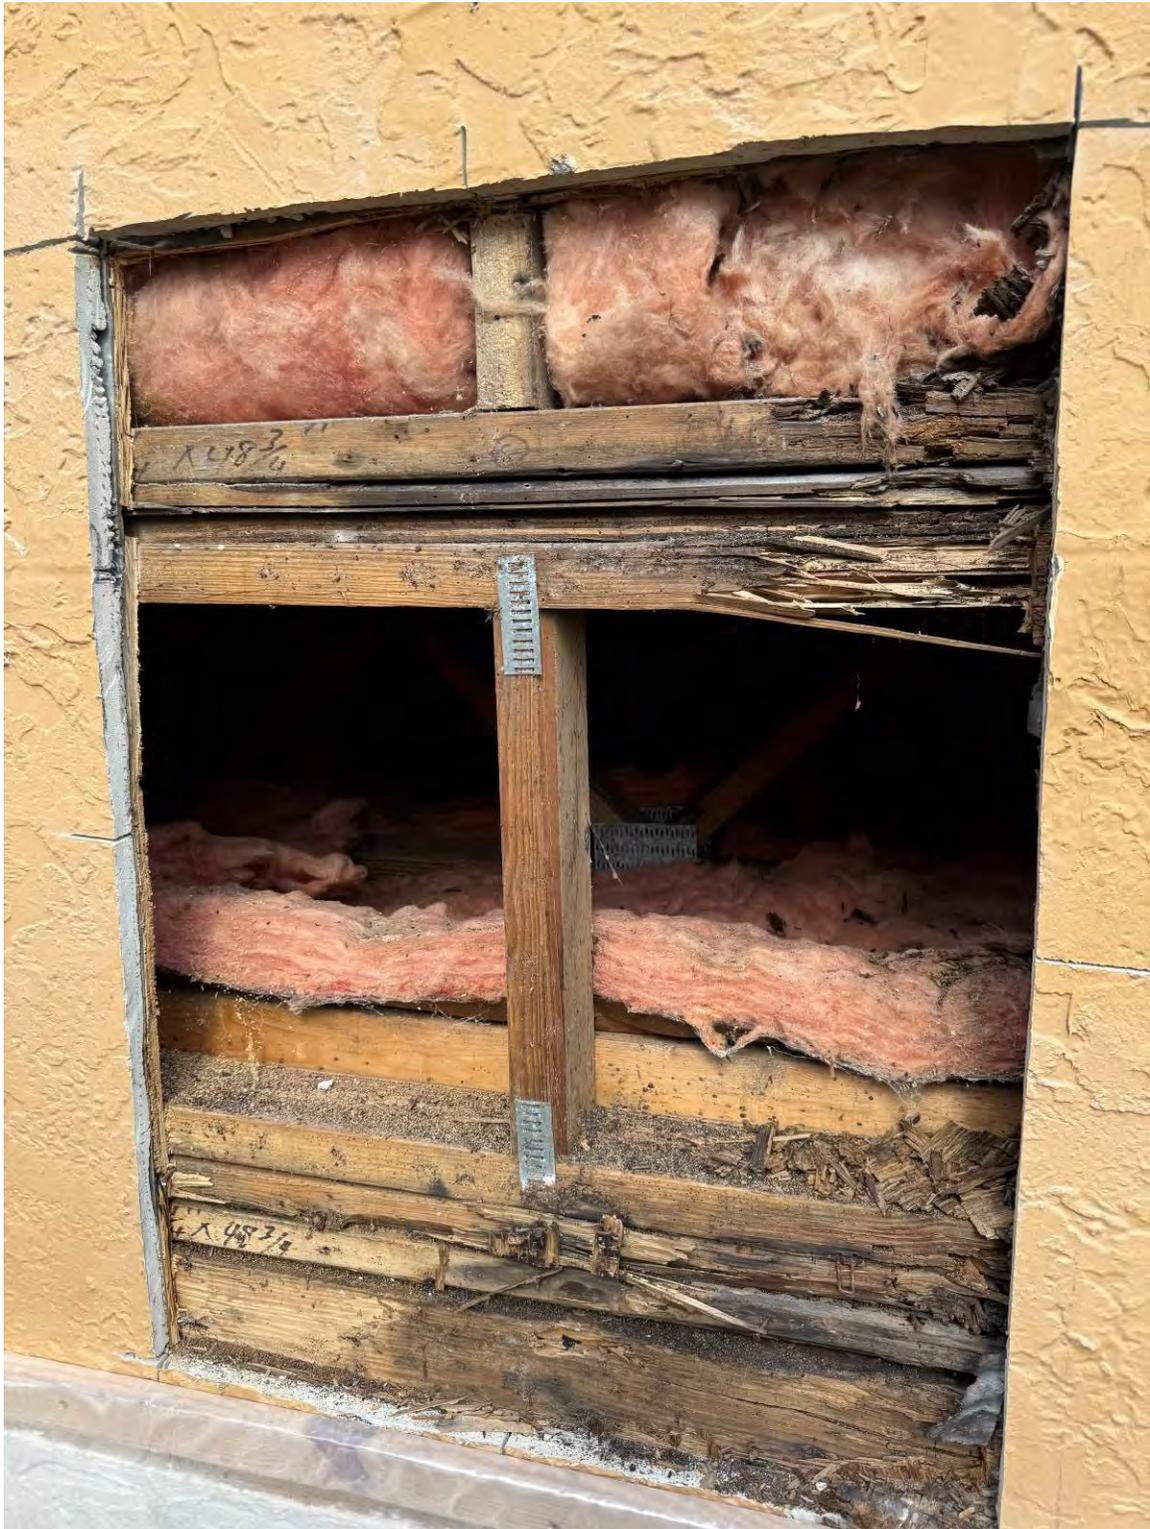
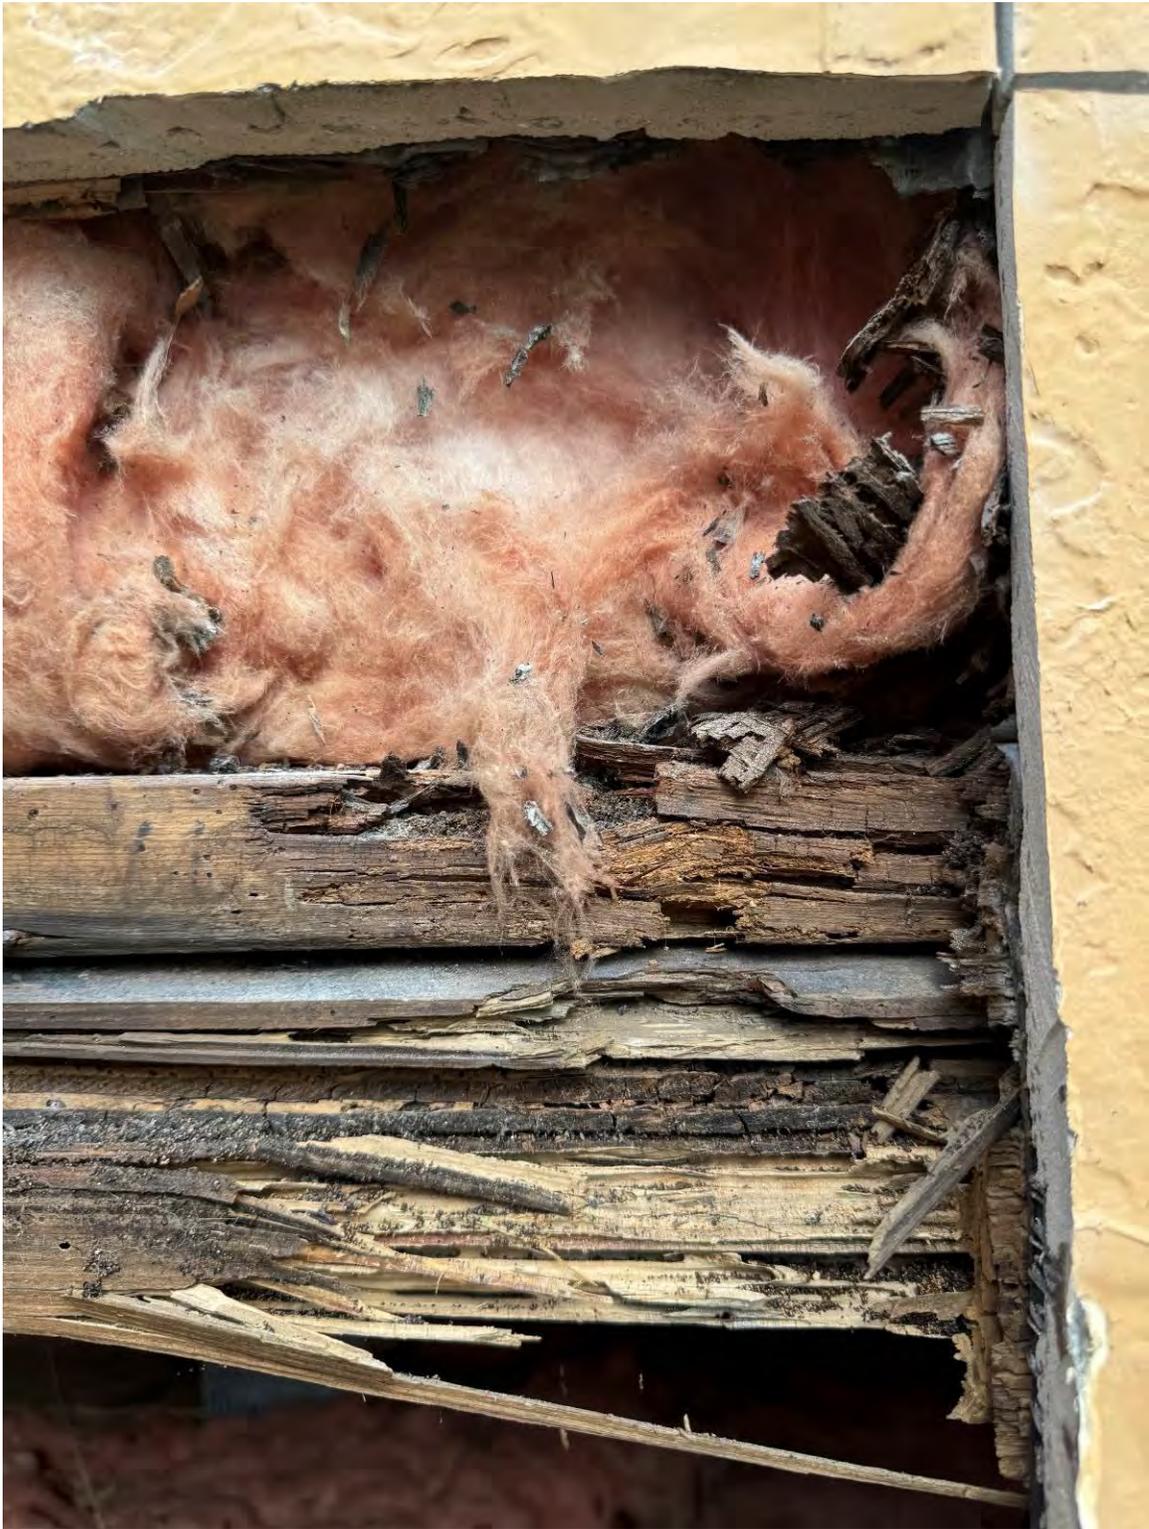
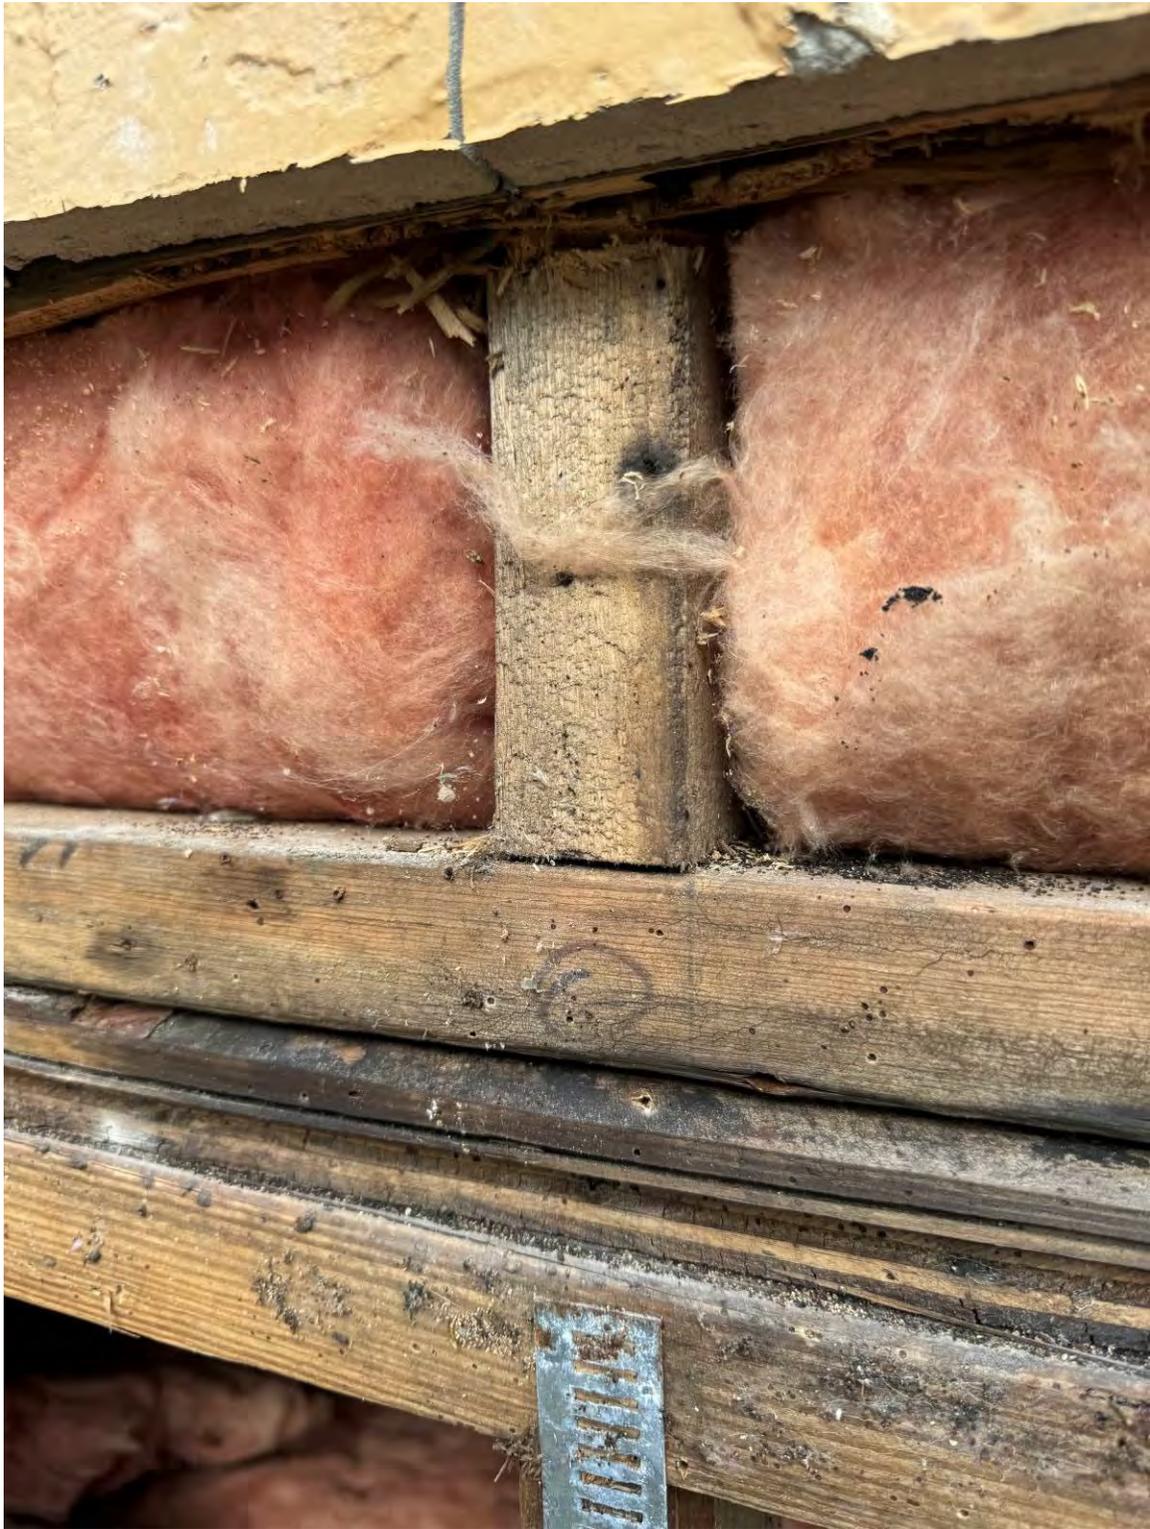
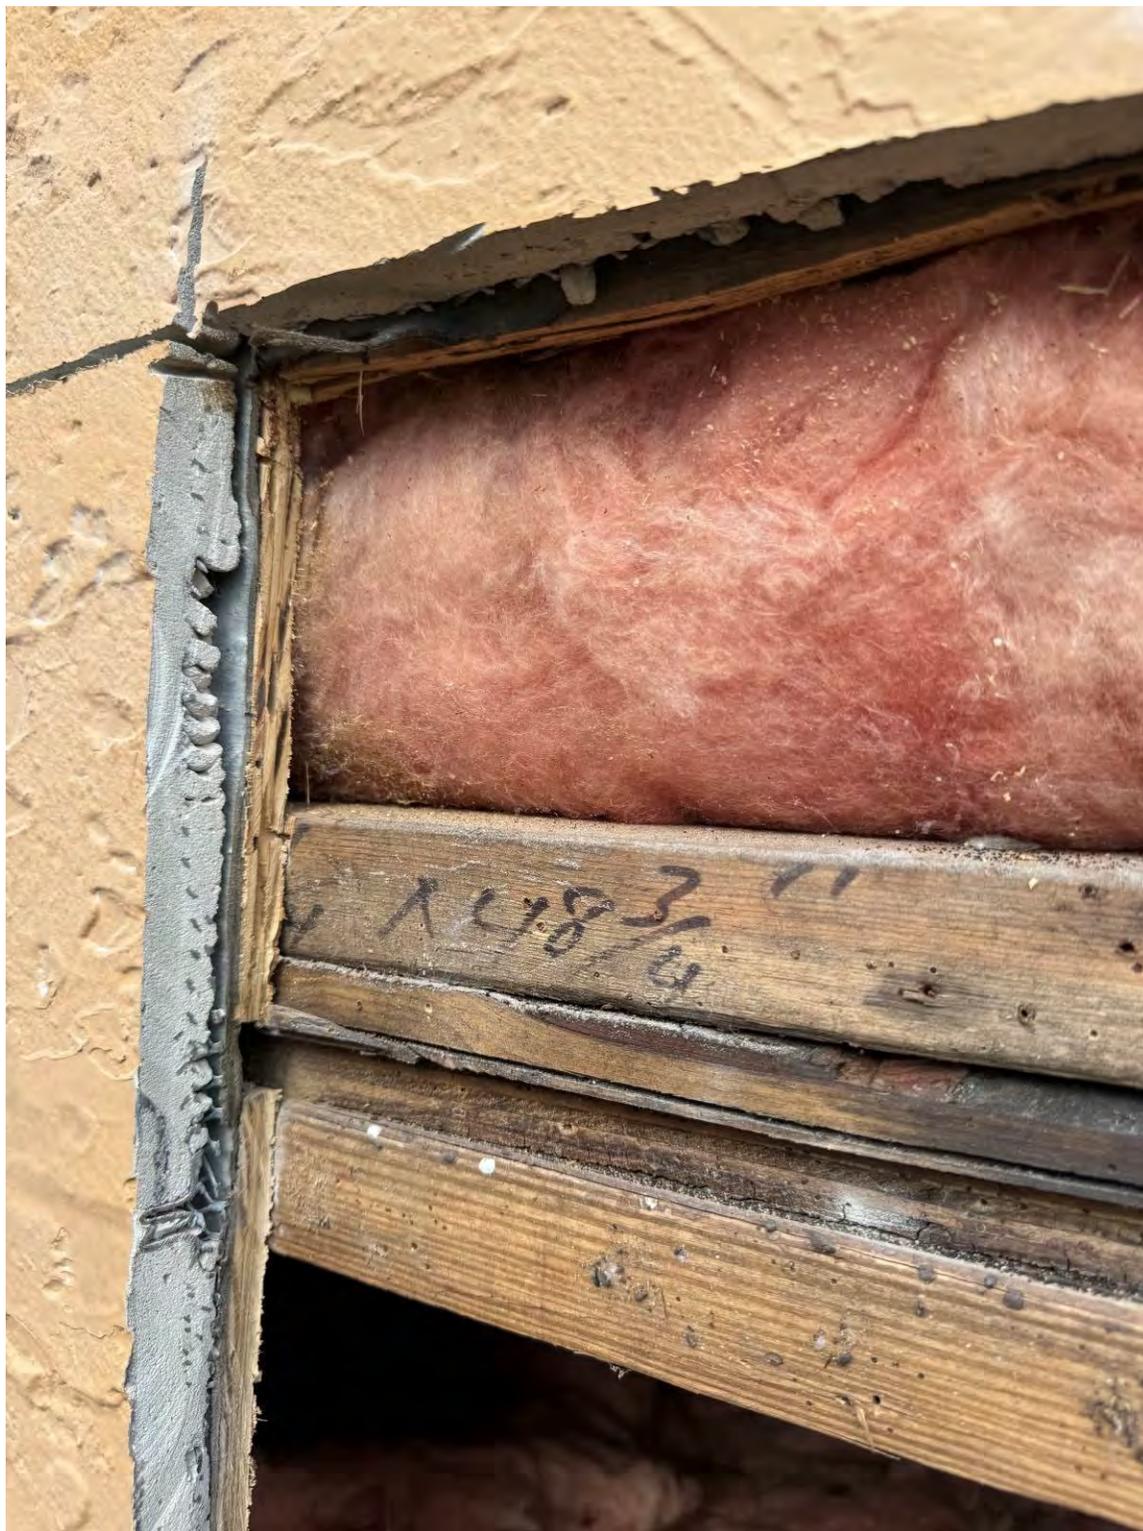
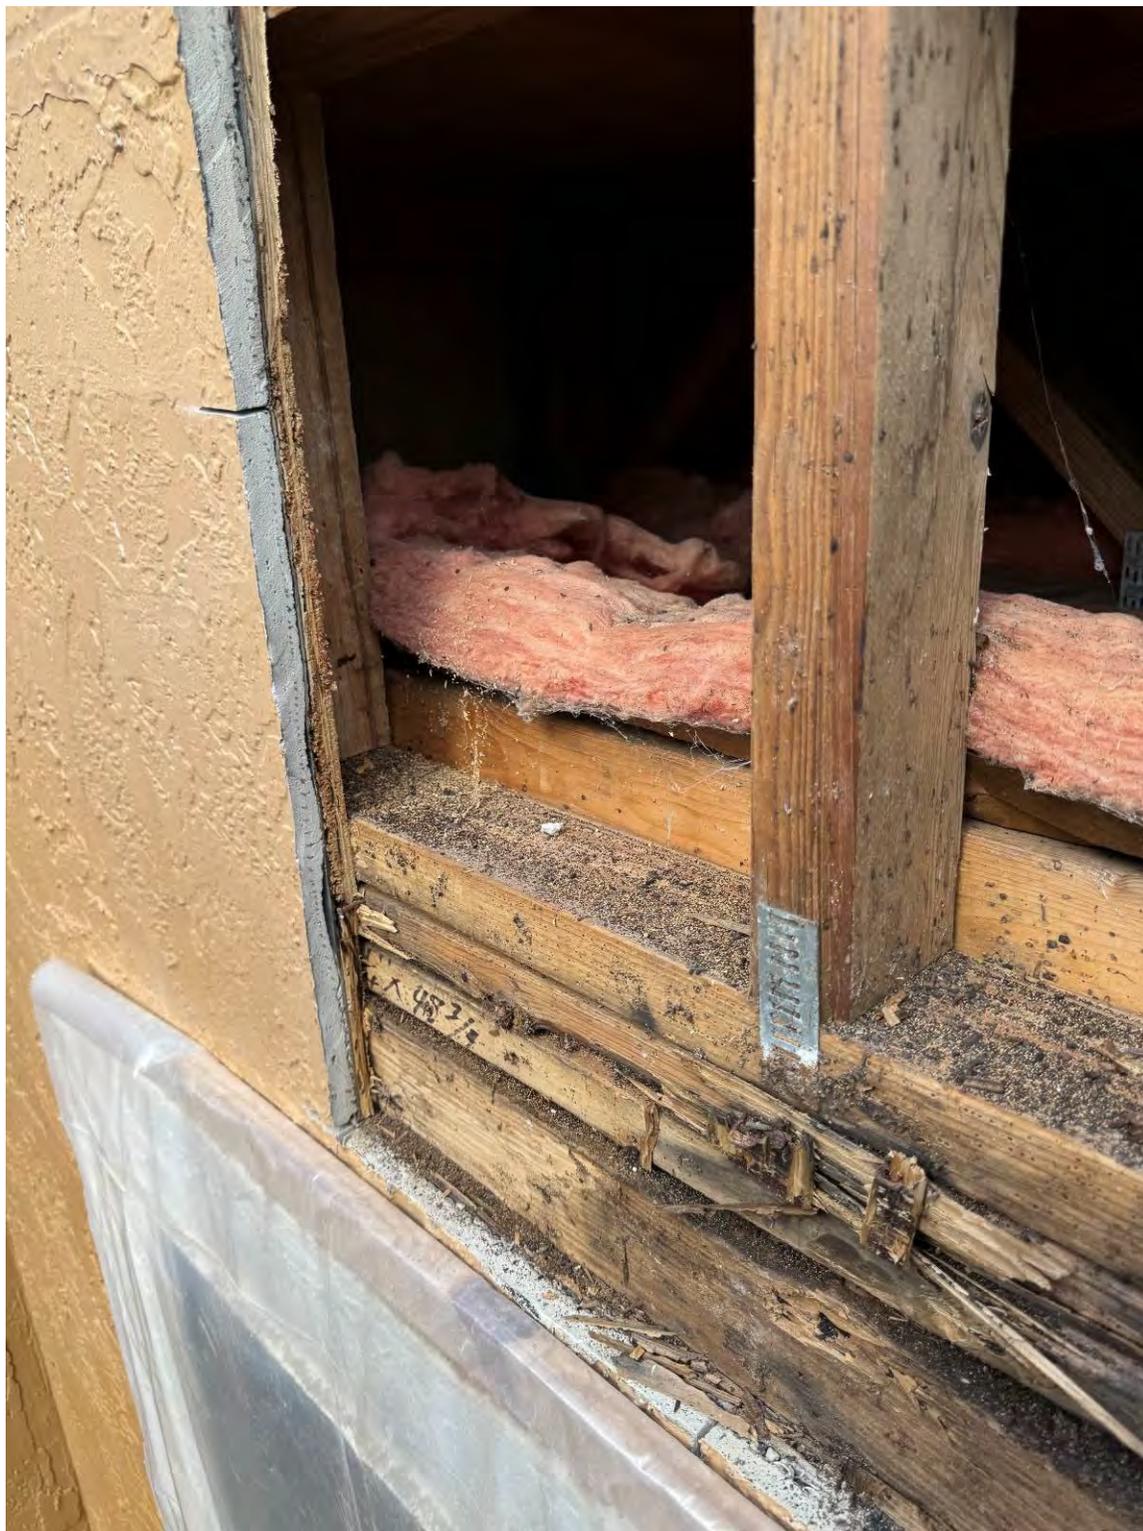
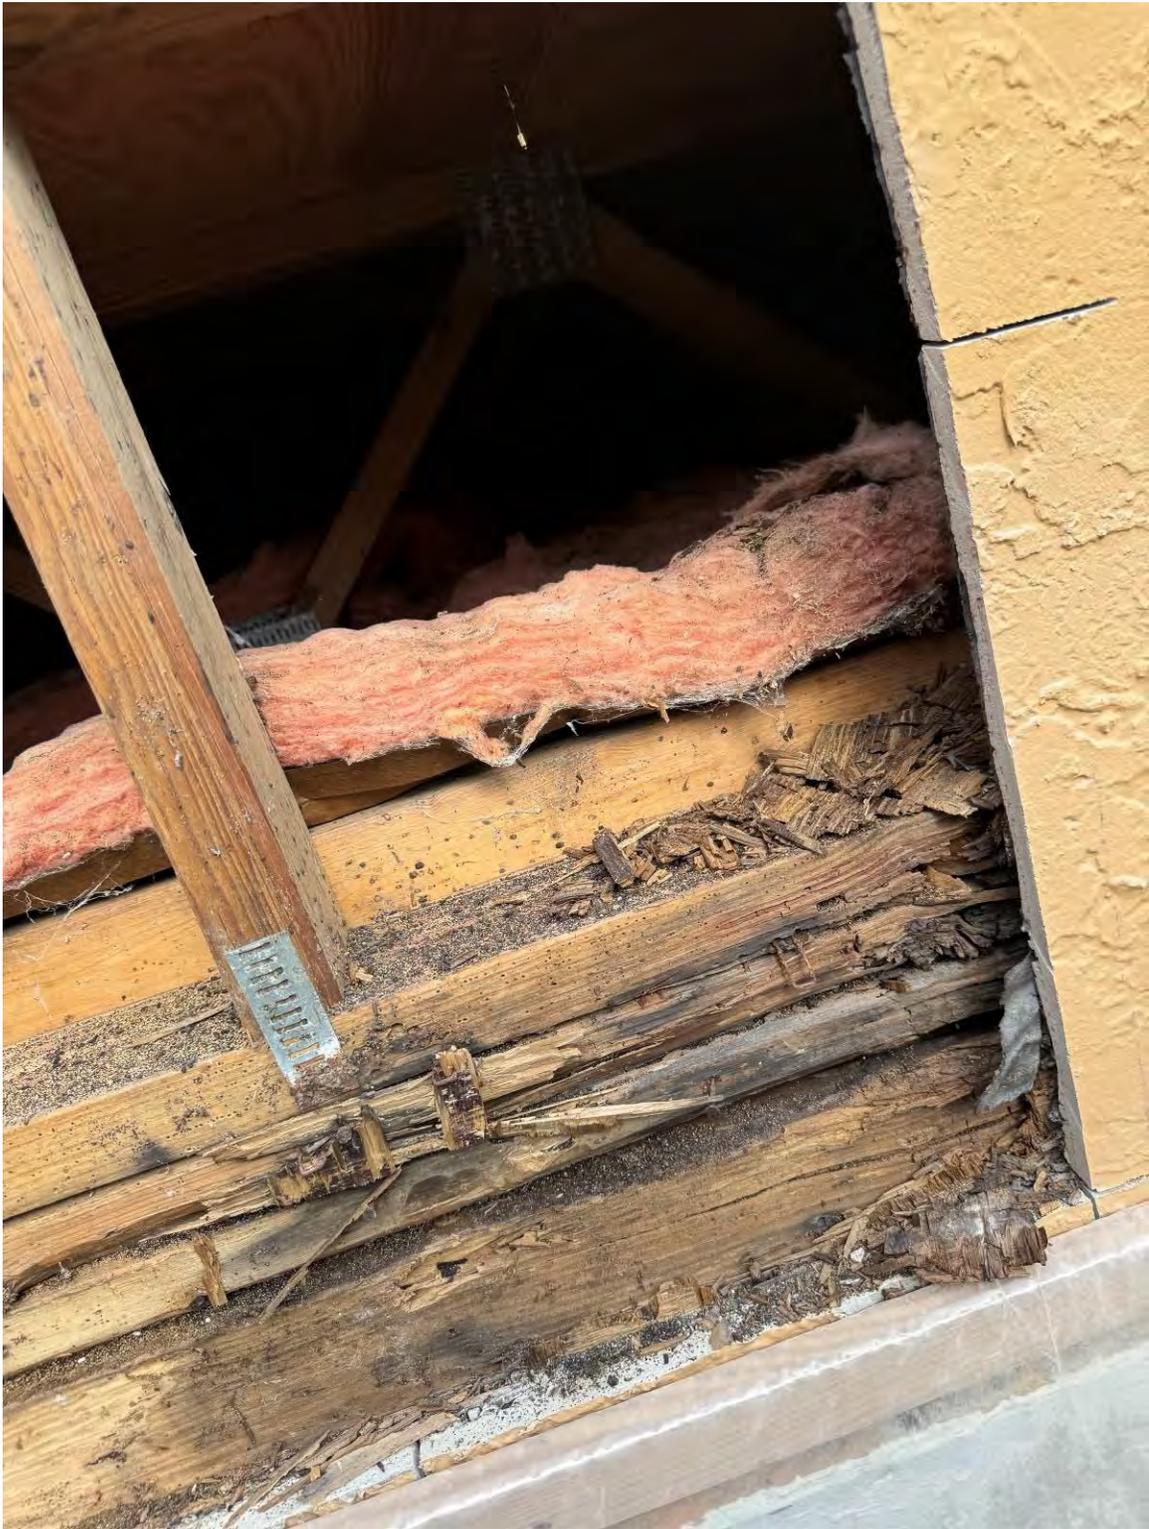
# OPENING #21

- Window header termite damage and water damage
- 1<sup>st</sup> floor top plate termite damage and water damage
- Floor truss termite damage and water damage – top and bottom
- 2<sup>nd</sup> floor floor sheathing water damage and termite damage
- Single member bottom plate termite damage and water damage
- 2<sup>nd</sup> floor wall stud not connected to bottom plate

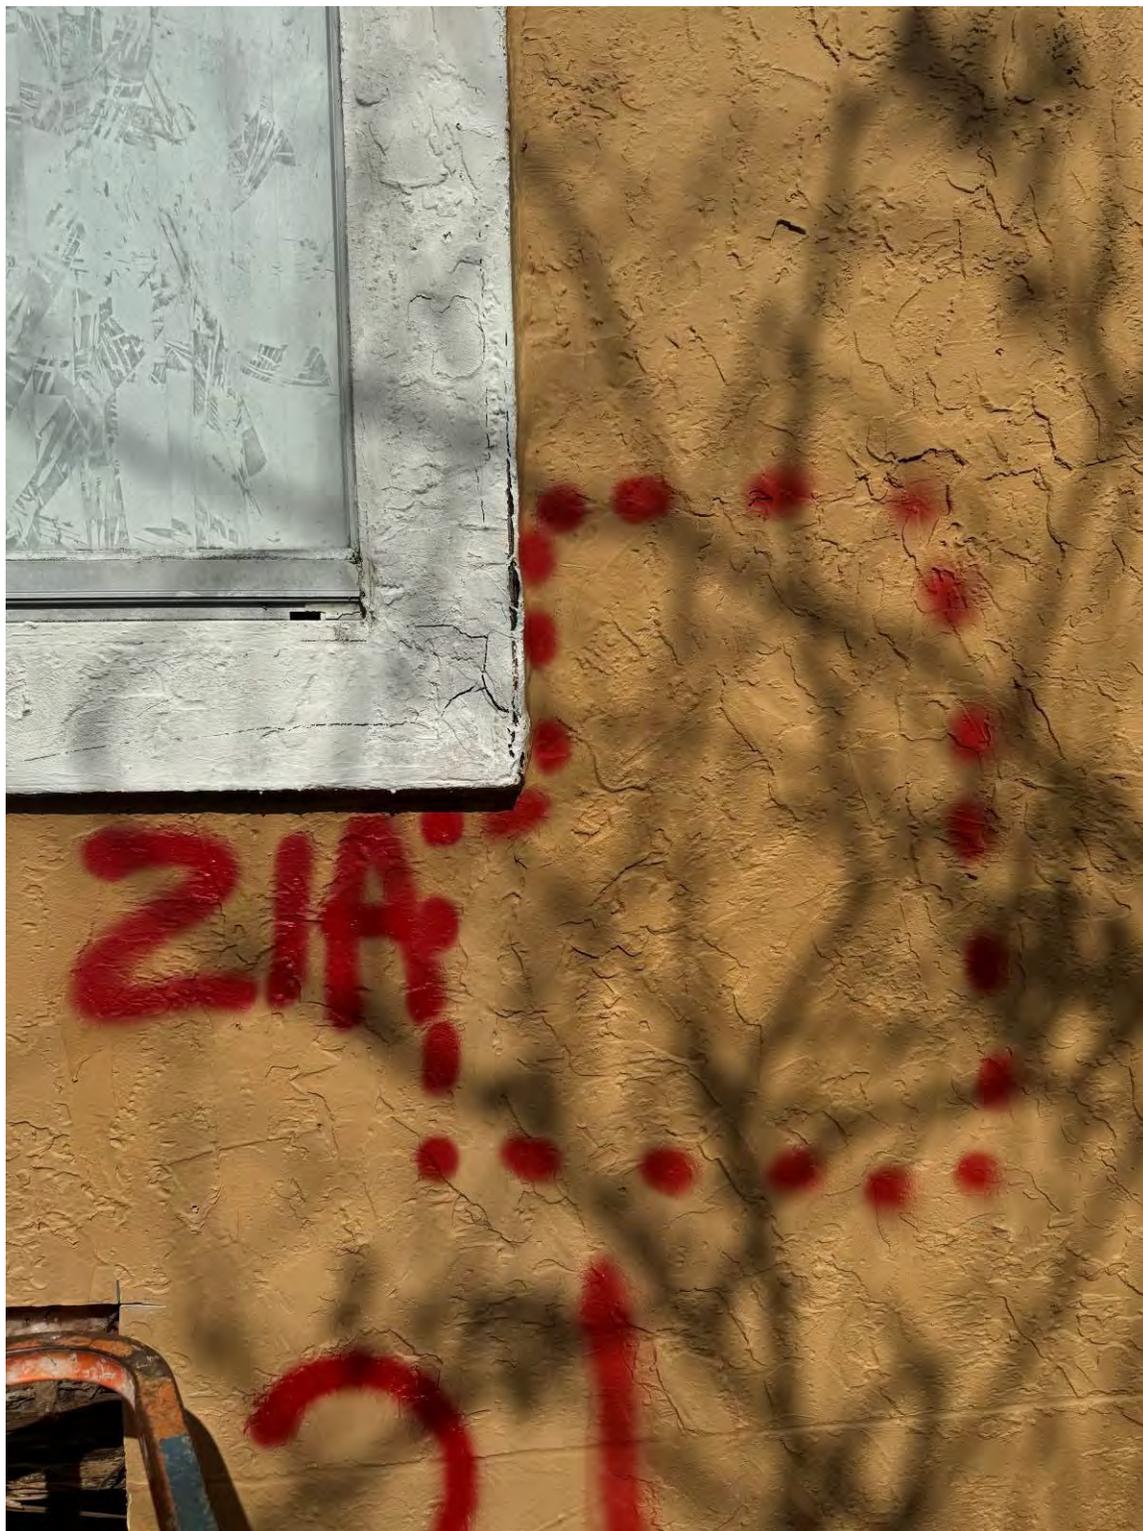
# OPENING #21A

- 2<sup>nd</sup> floor wall stud water damage and termite damage
- Water intrusion around window

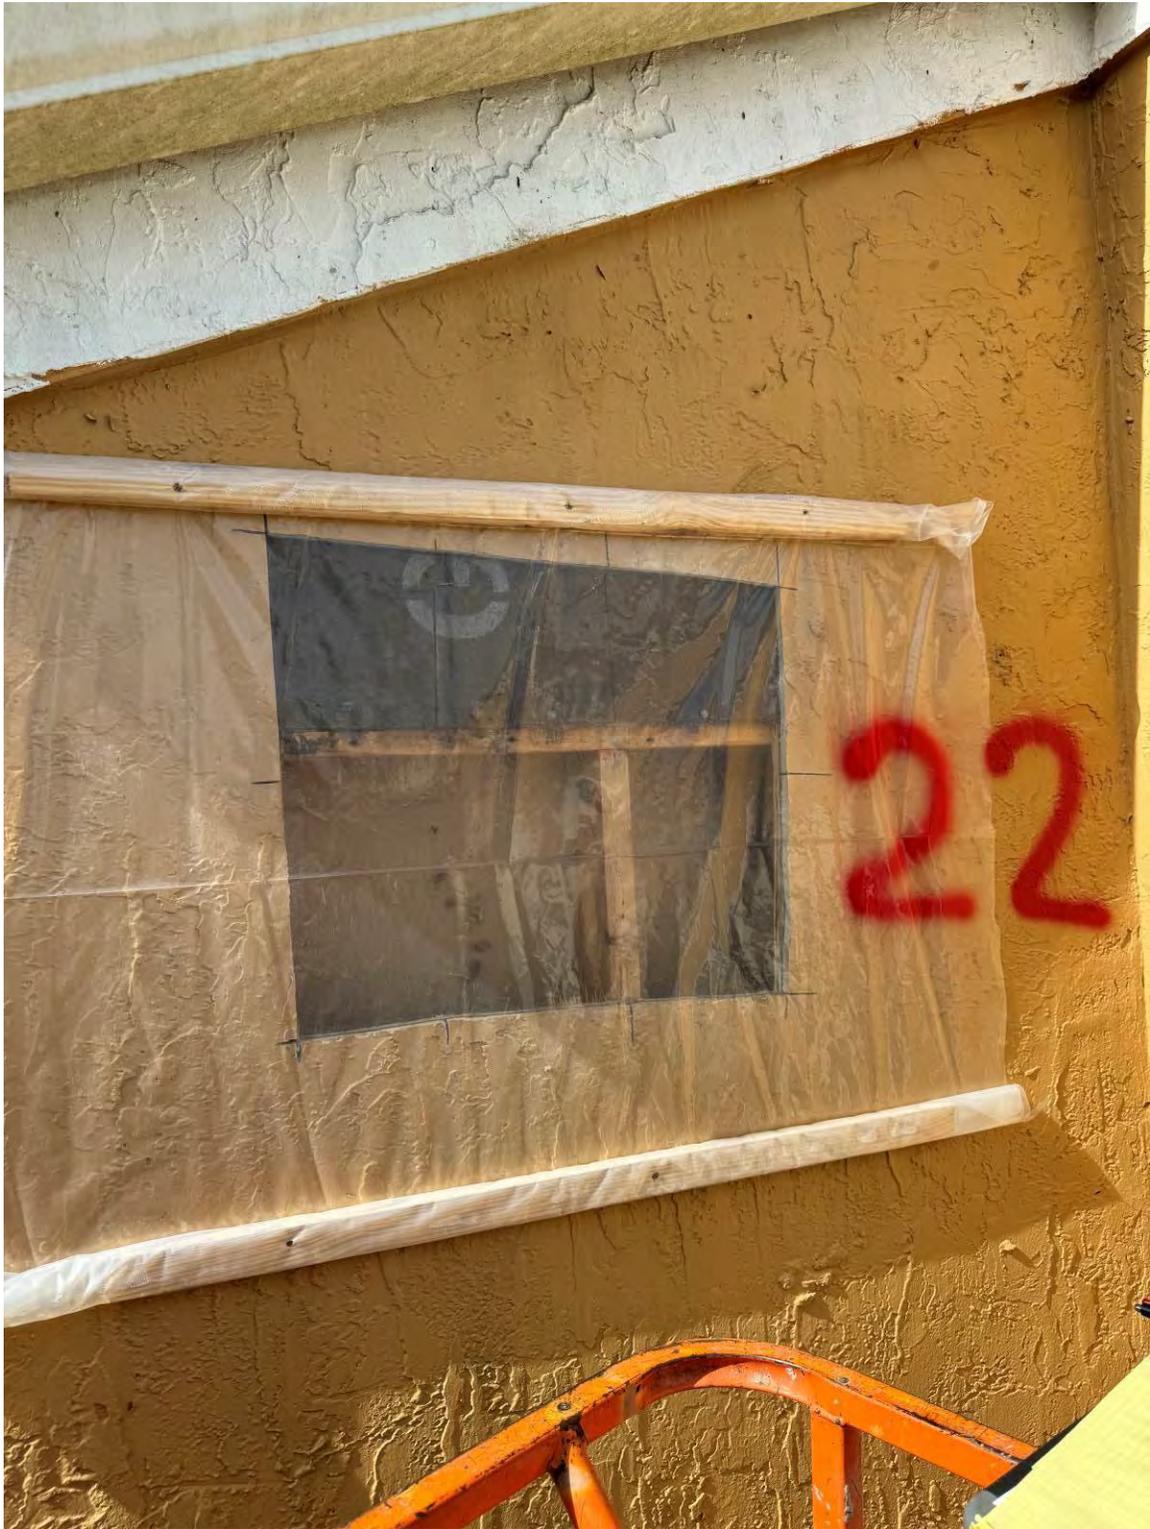
# OPENING #22

- Gabled end sheathing felt-board not plywood
- 2<sup>nd</sup> floor wall stud connected to top plate with 1 clip
