**NOTICE OF FILING PART 2 OF FINAL ENGINEERING REPORT OF SPECIALTY  
ENGINEERING CONSULTANTS, INC. DATED NOVEMBER 5, 2024**

Daniel J. Stermer, not individually, but solely in his capacity as Court Appointed Receiver (the "Receiver"), over the Heron Pond Condominium Association, Inc., (the "Association") by and through its undersigned counsel, hereby gives notice of filing Part 2 of the attached final Engineering Report of Specialty Engineering Consultants, Inc. dated November 5, 2024, opining on the existing condition of Building 9.

# OPENING #15

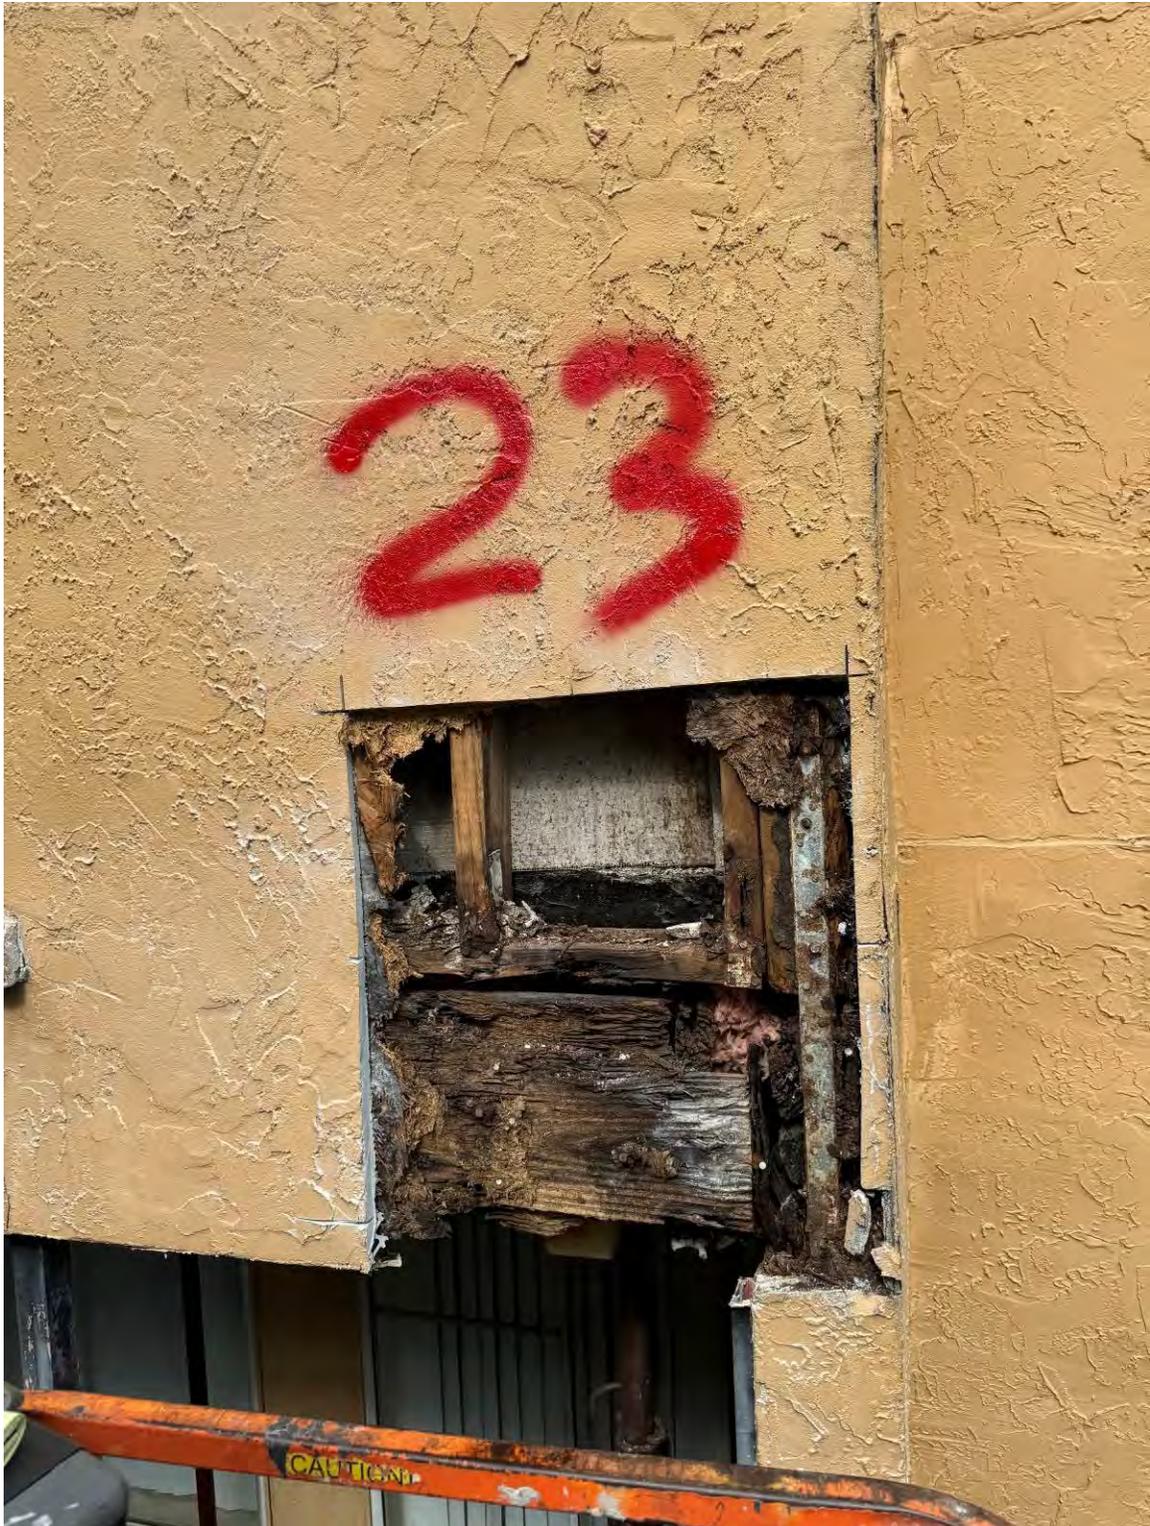
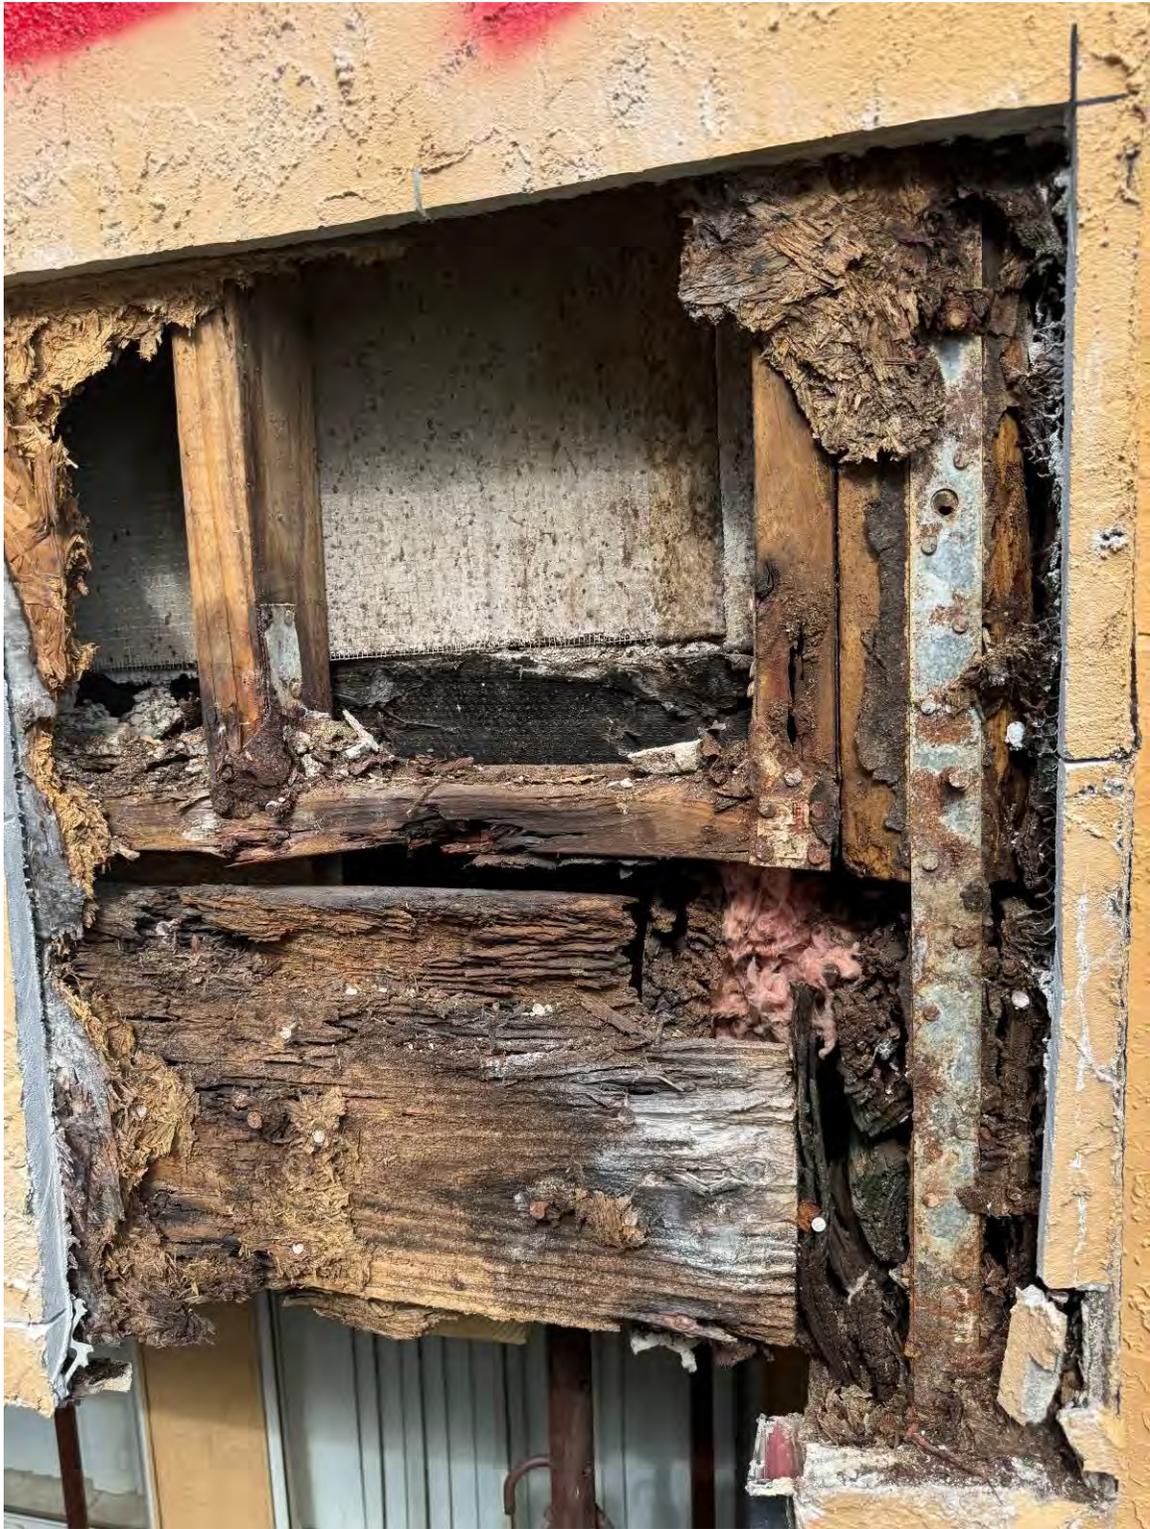
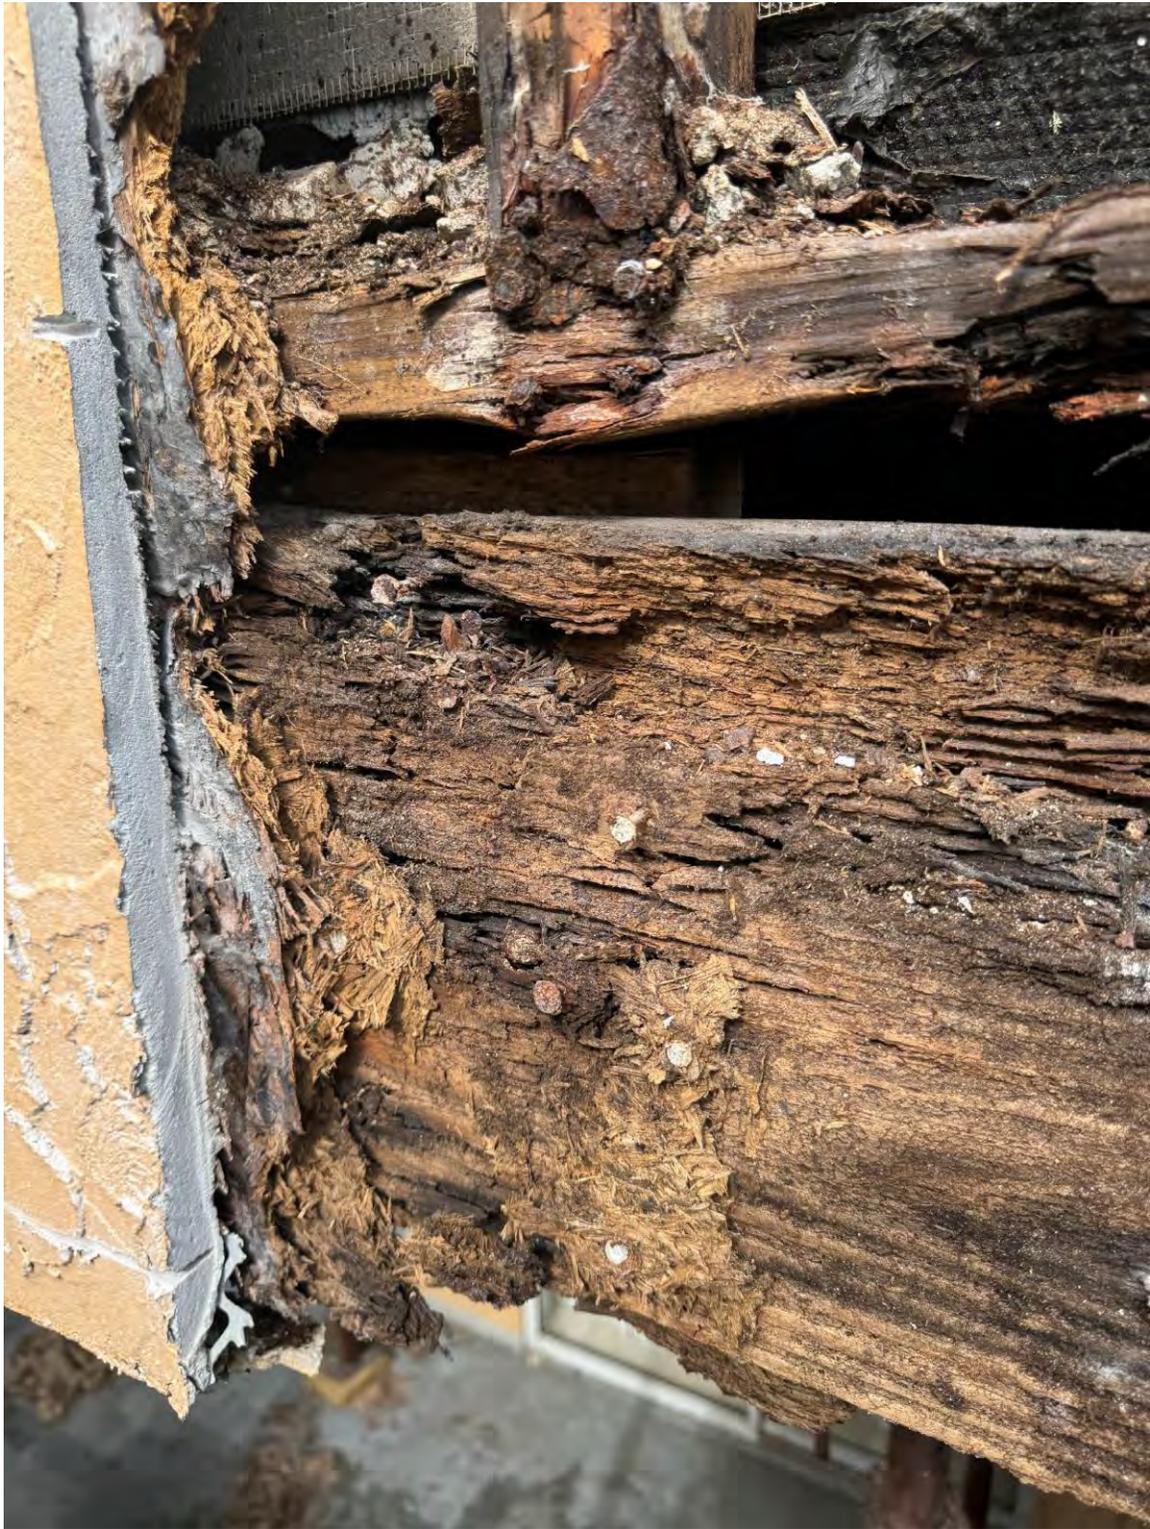
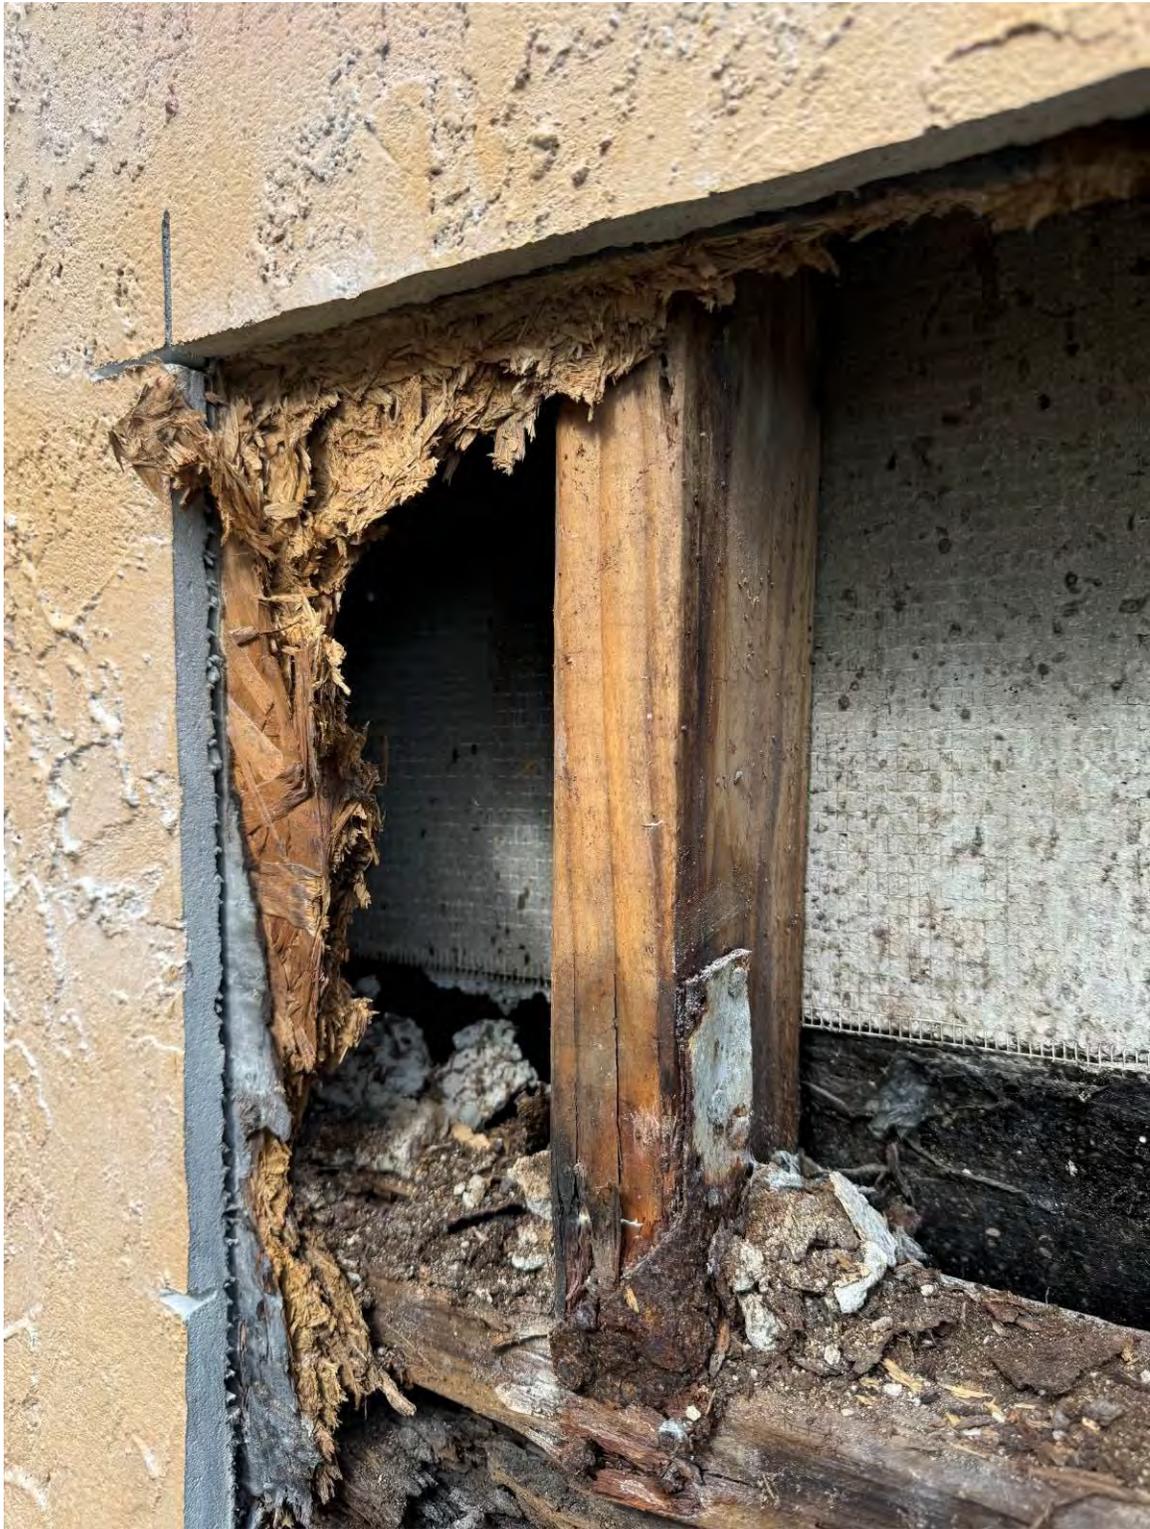
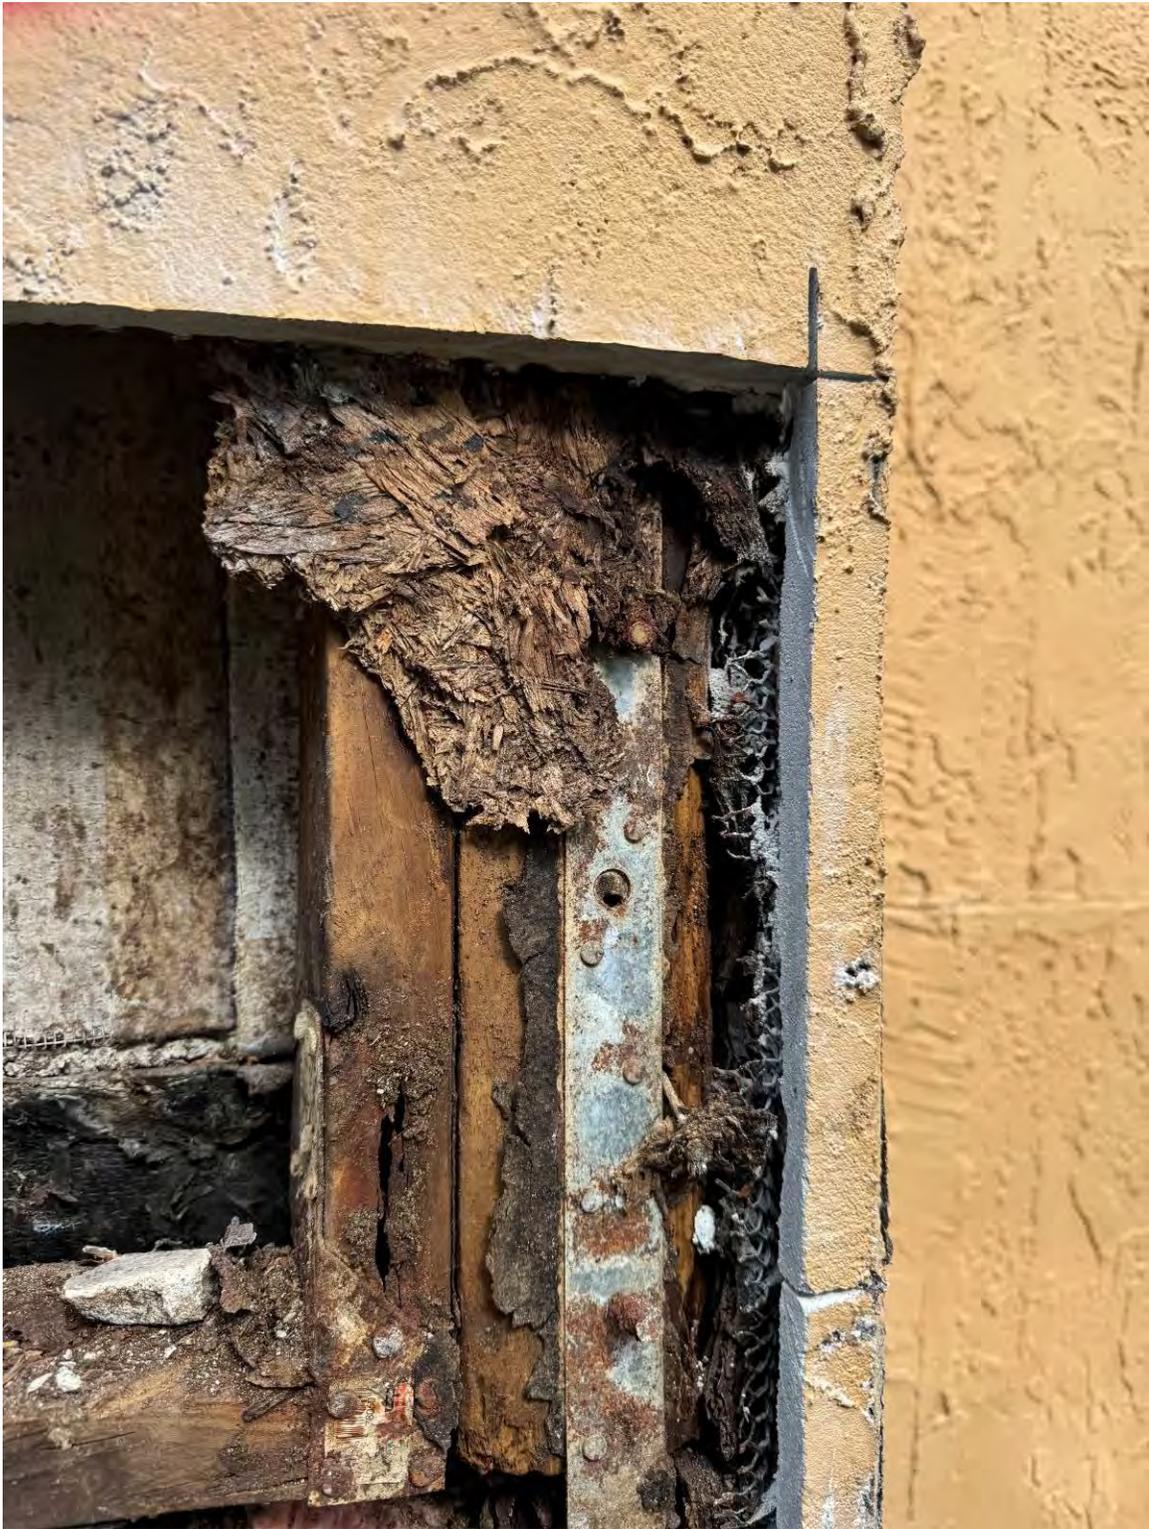
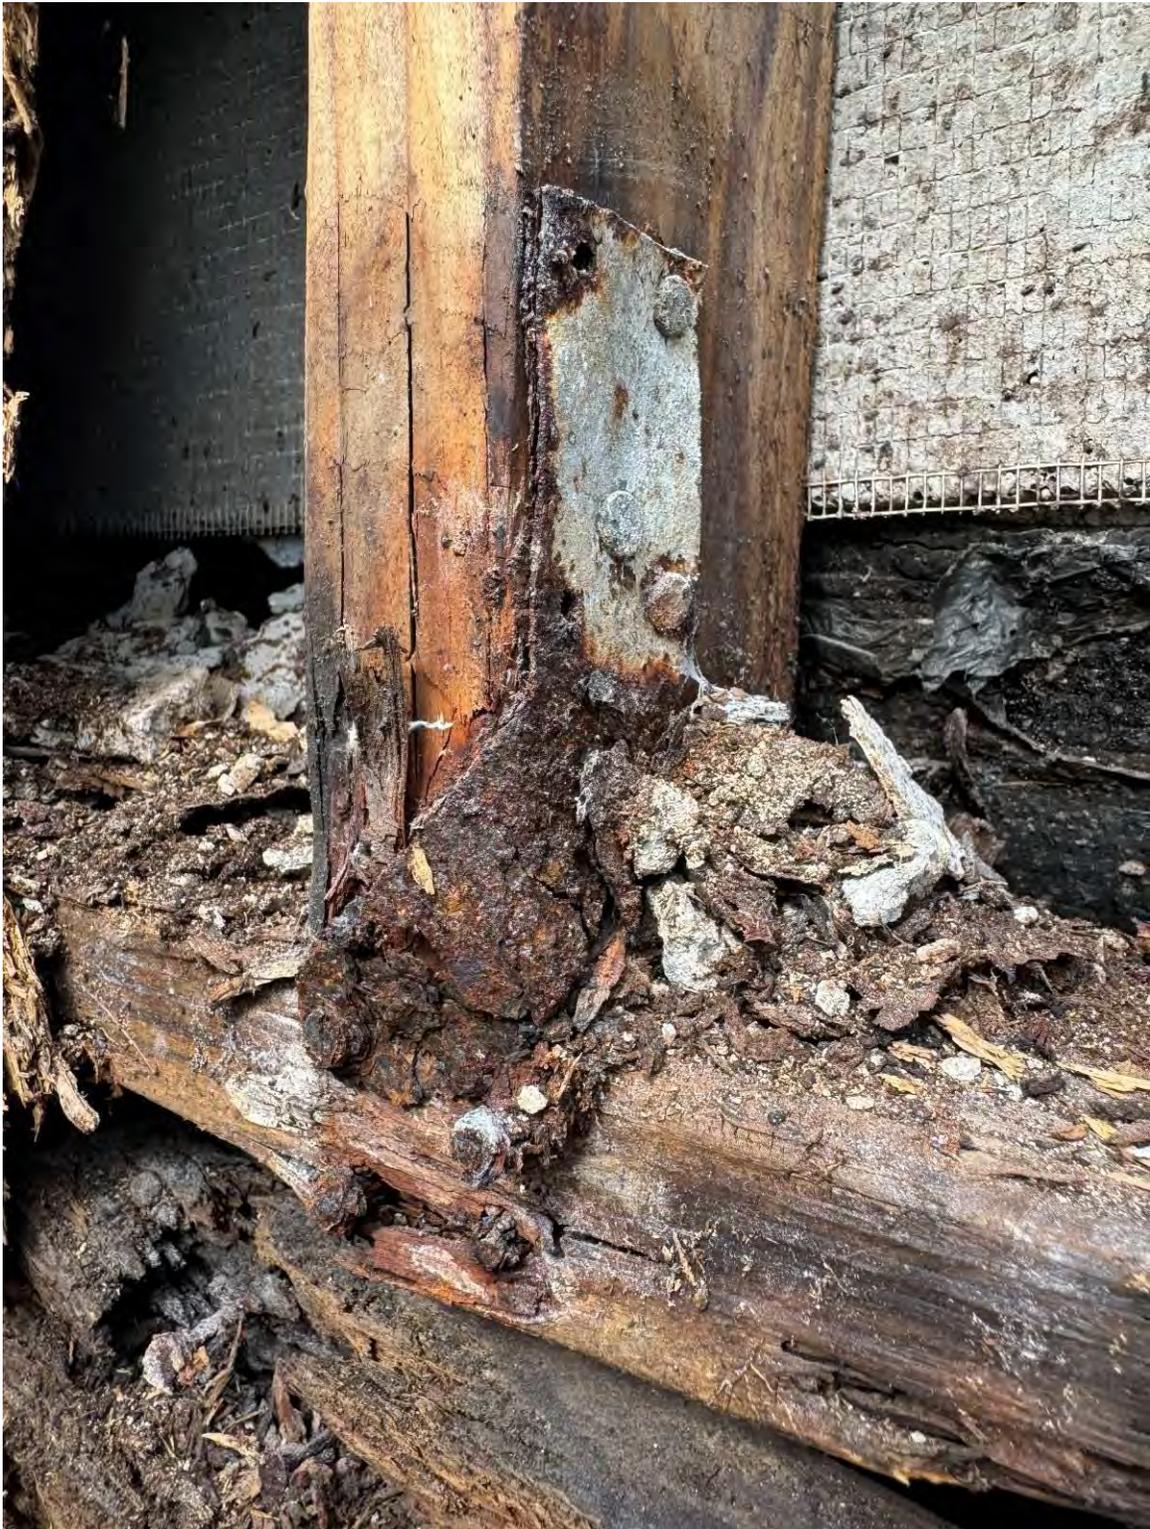
# OPENING #23

- Balcony 2x12 destroyed
- Beam at north edge destroyed
- Bottom sill plate for 2<sup>nd</sup> floor wall destroyed
- Wall studs and bottom plate water damage and termite damage
- Metal connectors present and nailed, but compromised by corrosion
- Wall sheathing pressed wood OSB not plywood

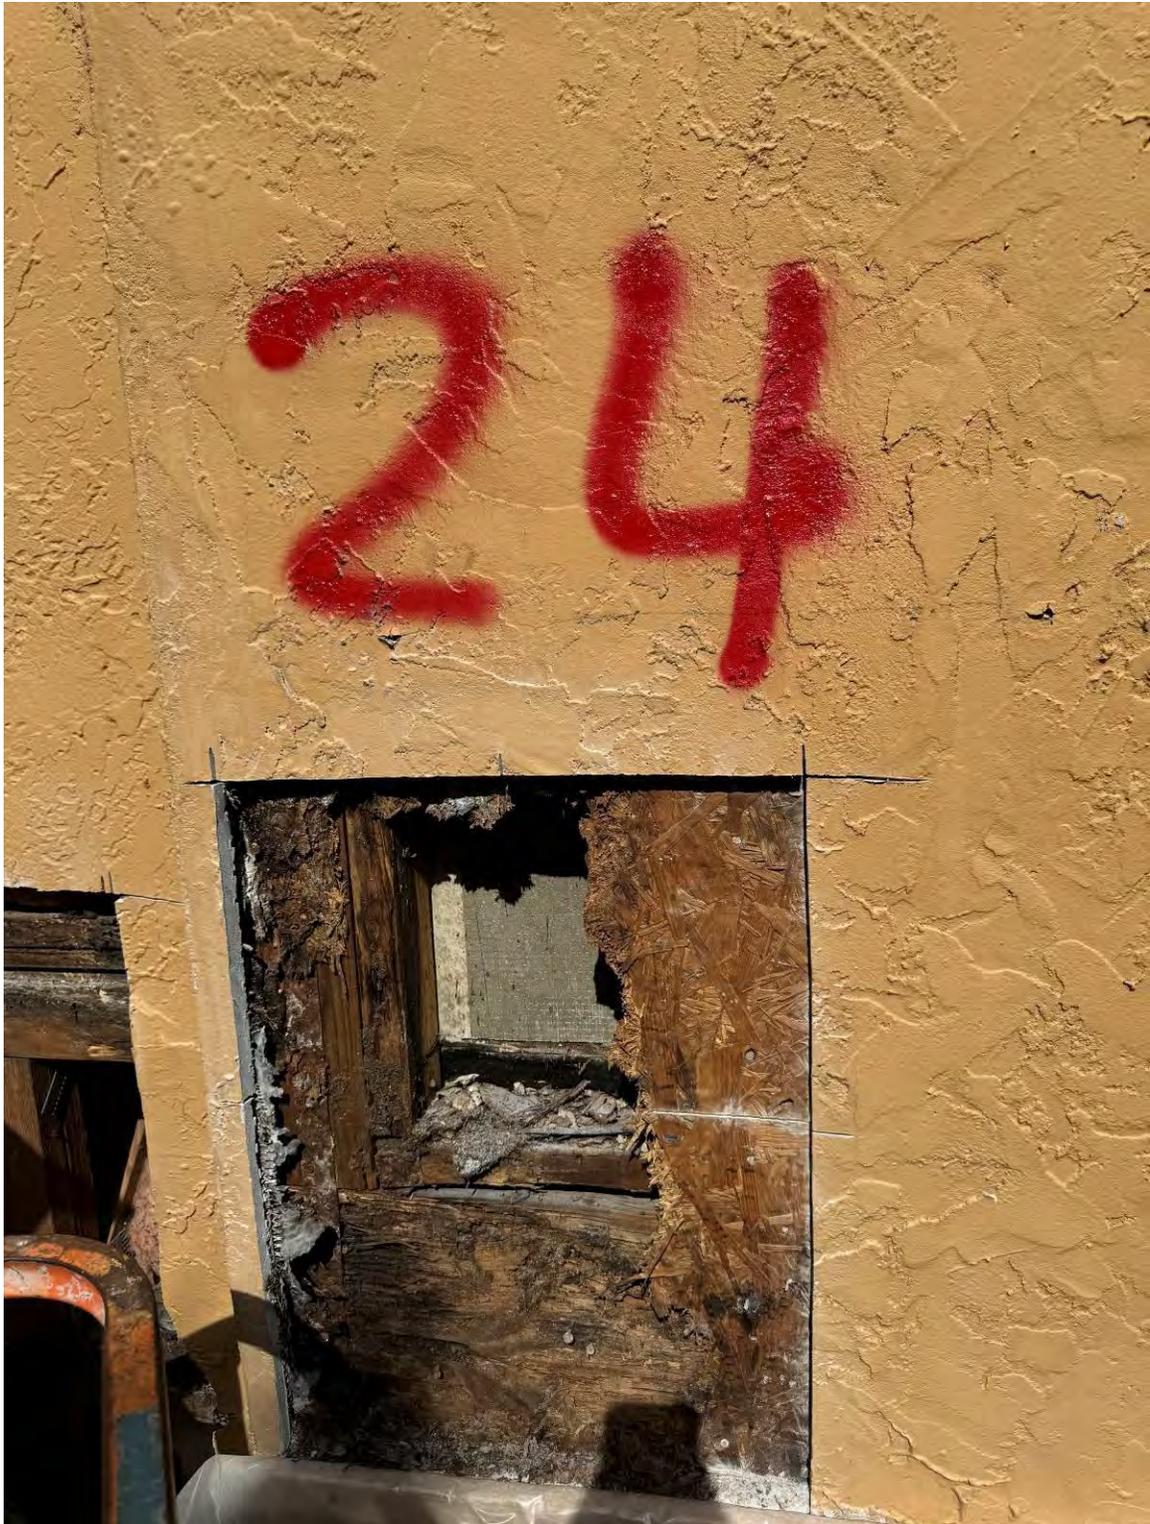
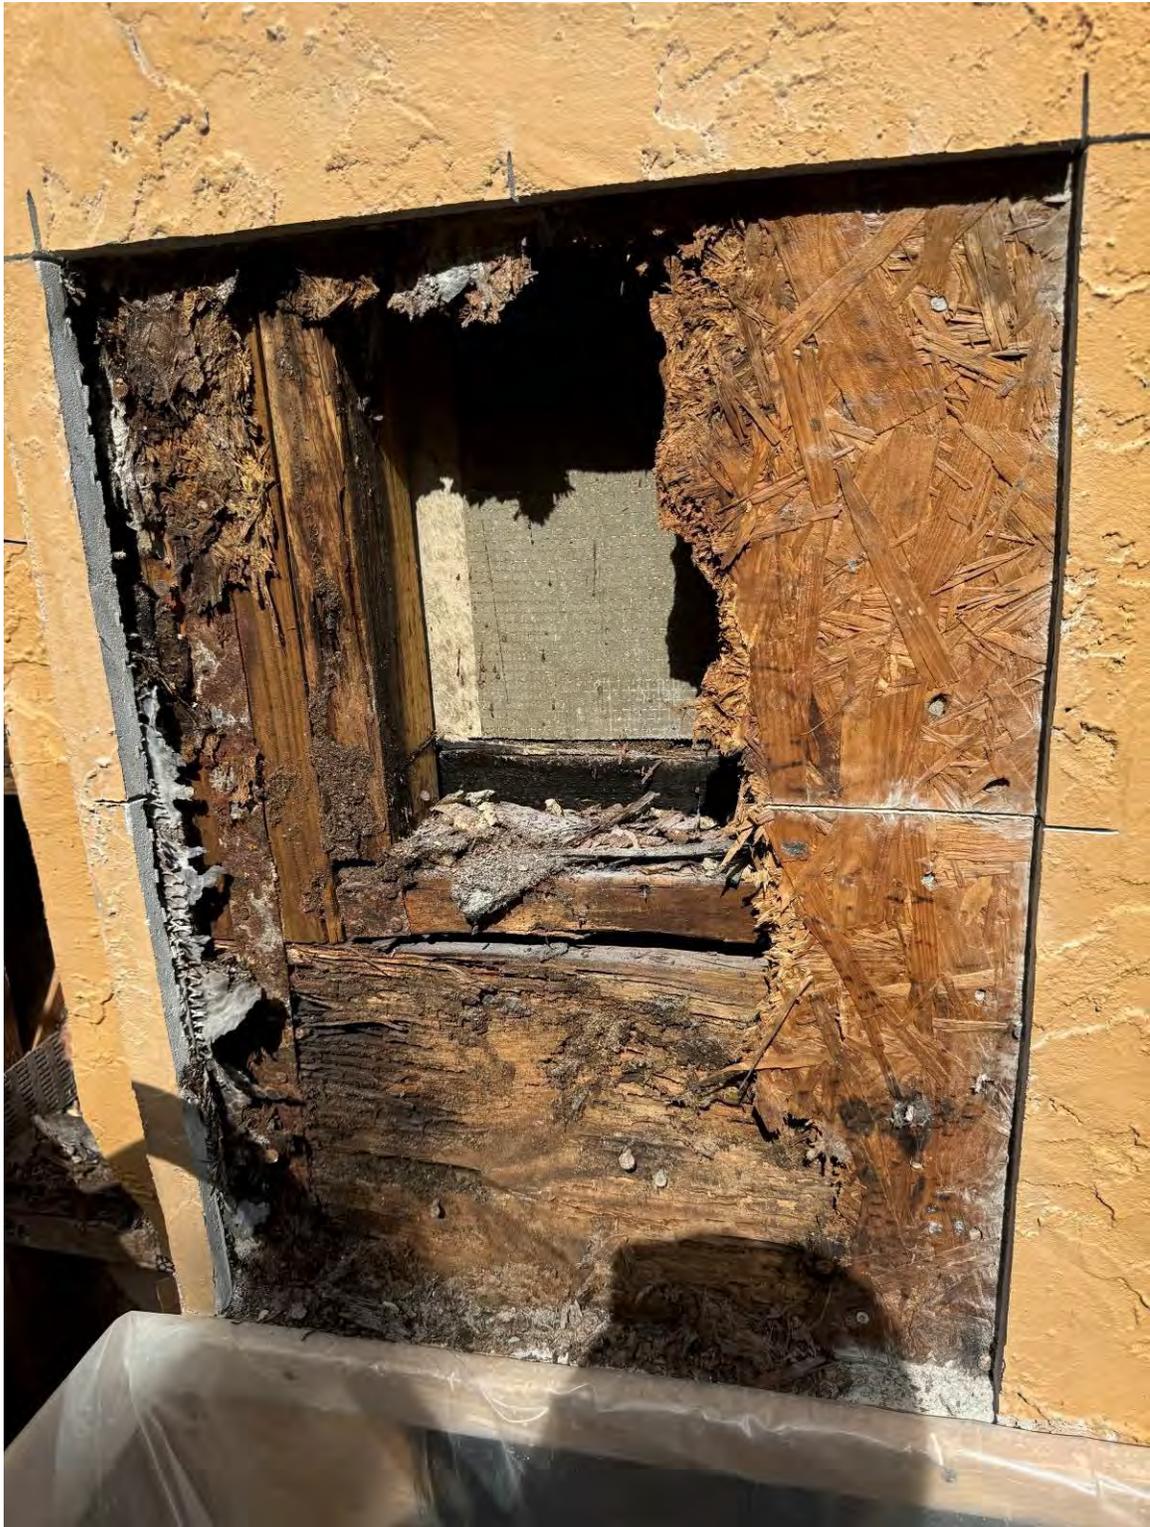
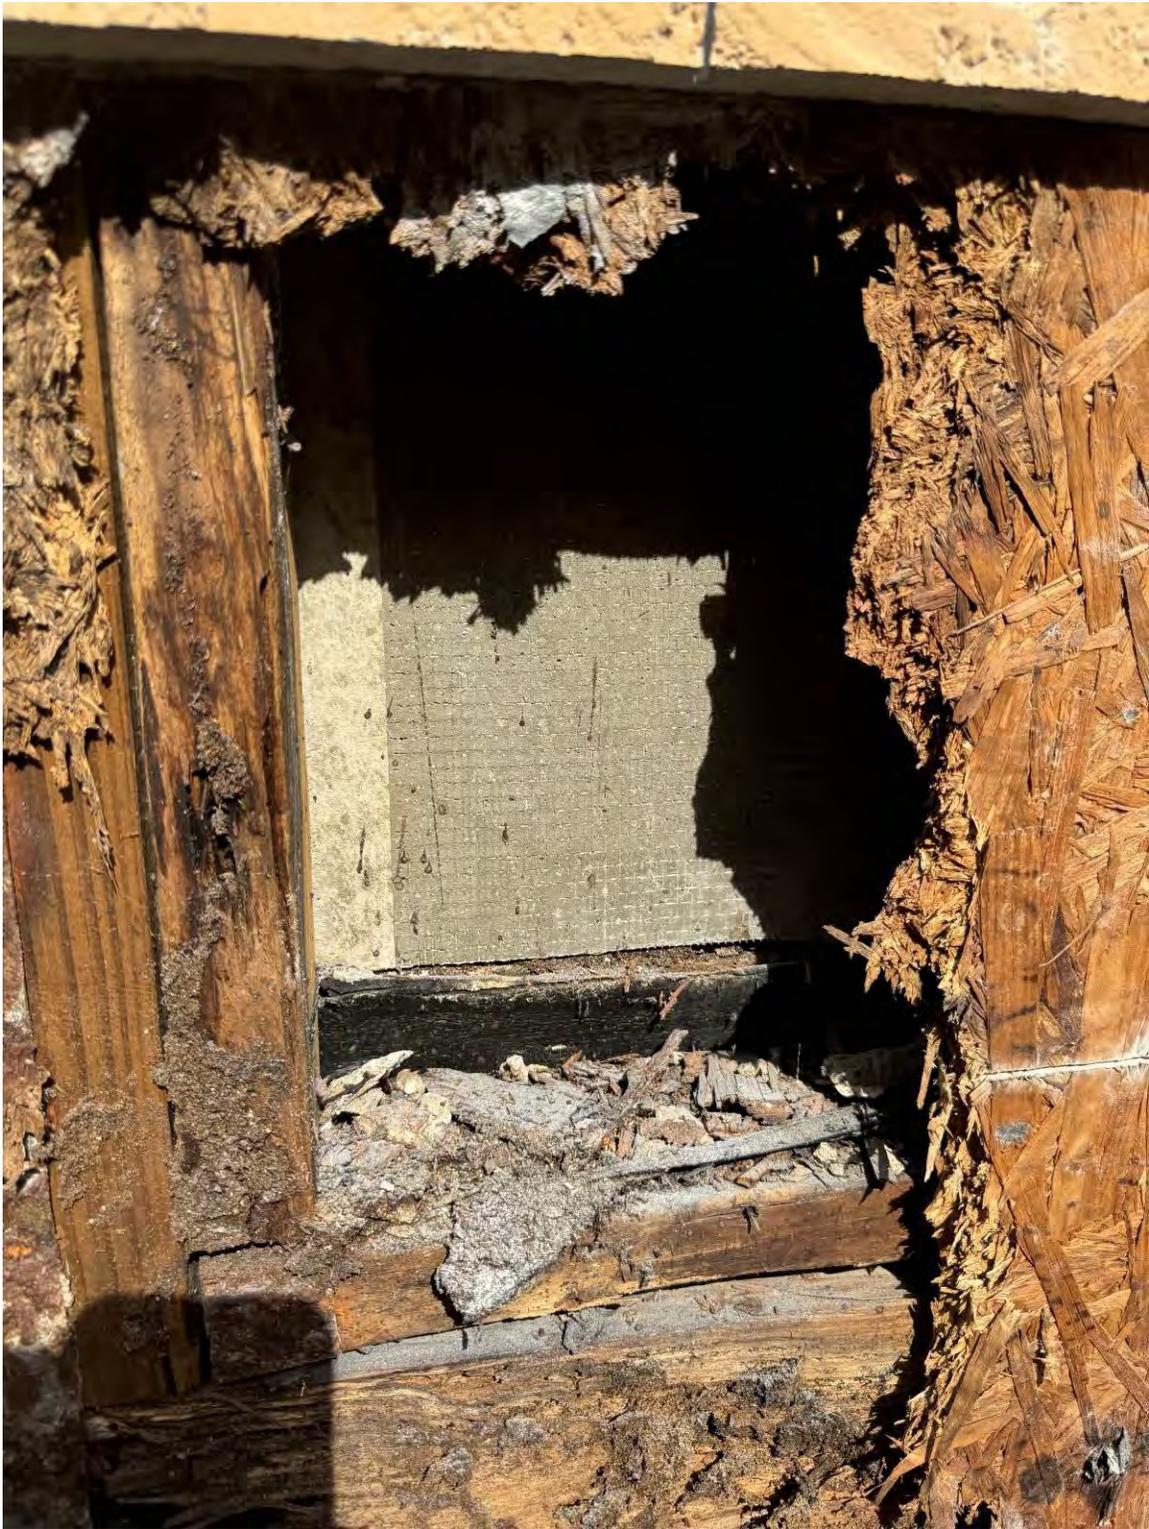
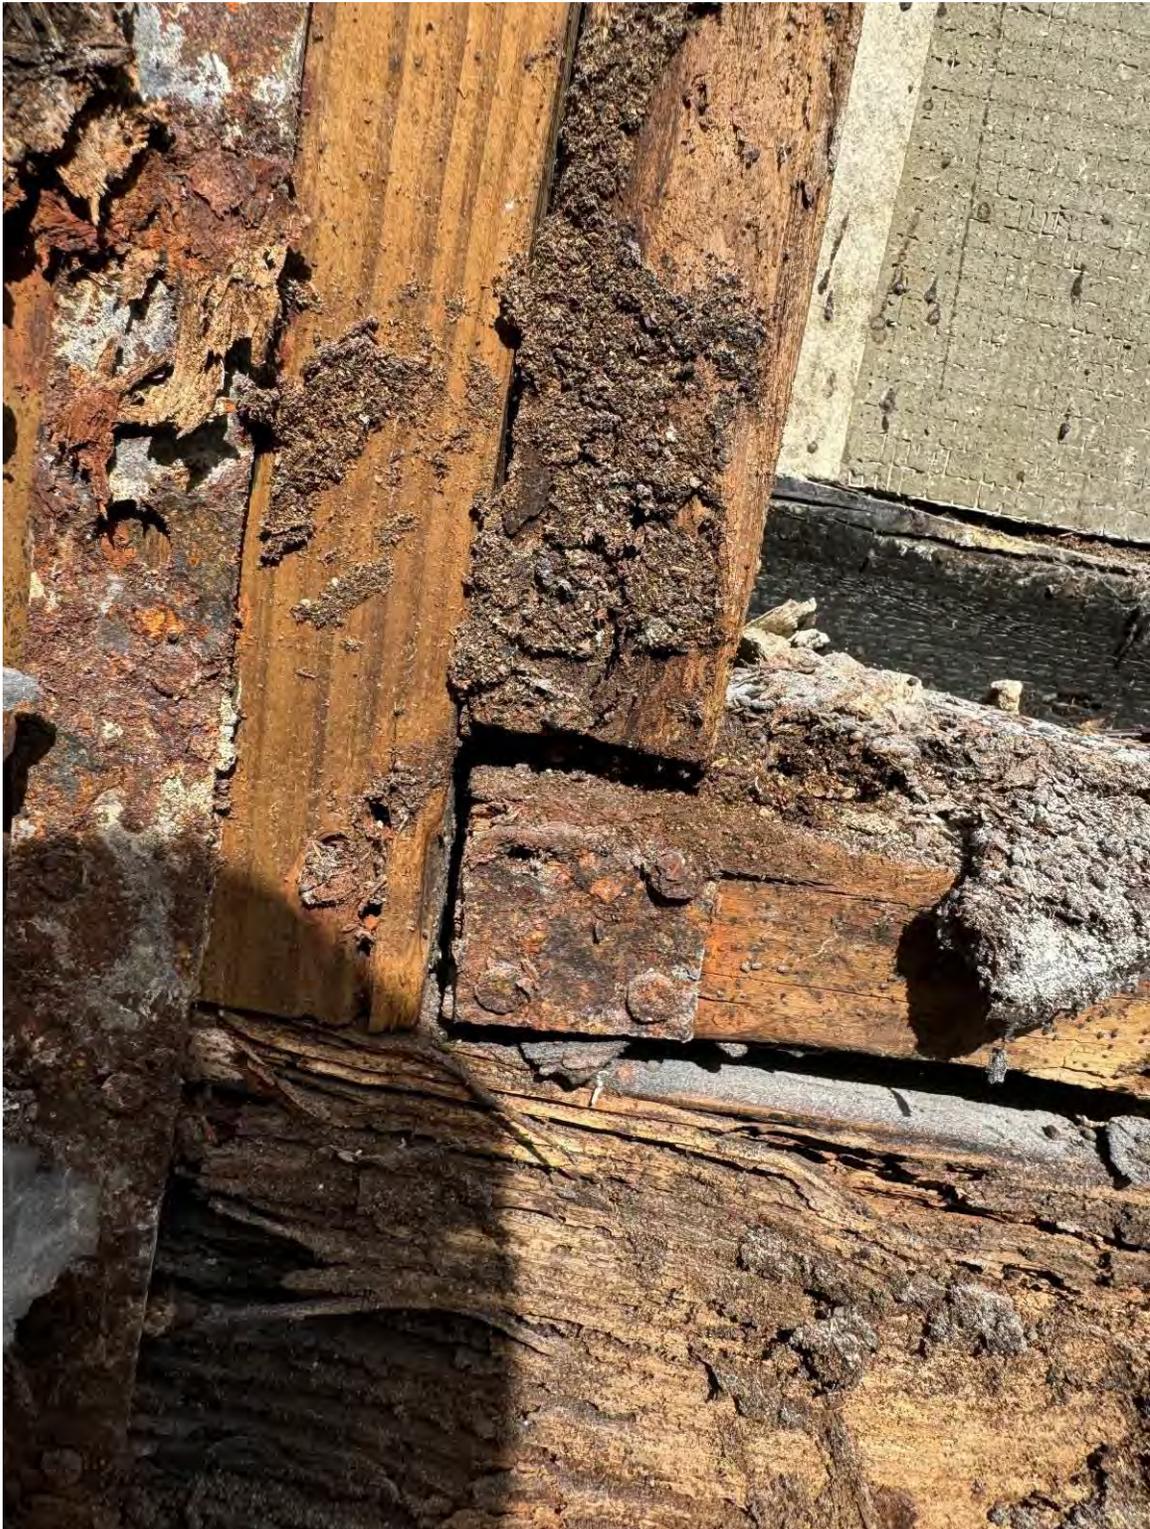
# OPENING #24

- 2x12 floor joist termite damage and water damage
- 2<sup>nd</sup> floor wall studs termite damage and water damage
- Evidence of a metal connecting plate at 1 wall stud to bottom plate completely deteriorated
- Wall sheathing OSB
- 3/4" gap between floor joist and sill plate indicating deflection of floor joist
- At end of cut, the gap is 3/4"
- At start of cut, gap is 3/8"
- Metal strap deteriorated = comprised
