**NOTICE OF FILING PART 2 OF FINAL ENGINEERING REPORT OF SPECIALTY  
ENGINEERING CONSULTANTS, INC. DATED NOVEMBER 5, 2024**

Daniel J. Stermer, not individually, but solely in his capacity as Court Appointed Receiver (the "Receiver"), over the Heron Pond Condominium Association, Inc., (the "Association") by and through its undersigned counsel, hereby gives notice of filing Part 2 of the attached final Engineering Report of Specialty Engineering Consultants, Inc. dated November 5, 2024, opining on the existing condition of Building 9.

# OPENING #15

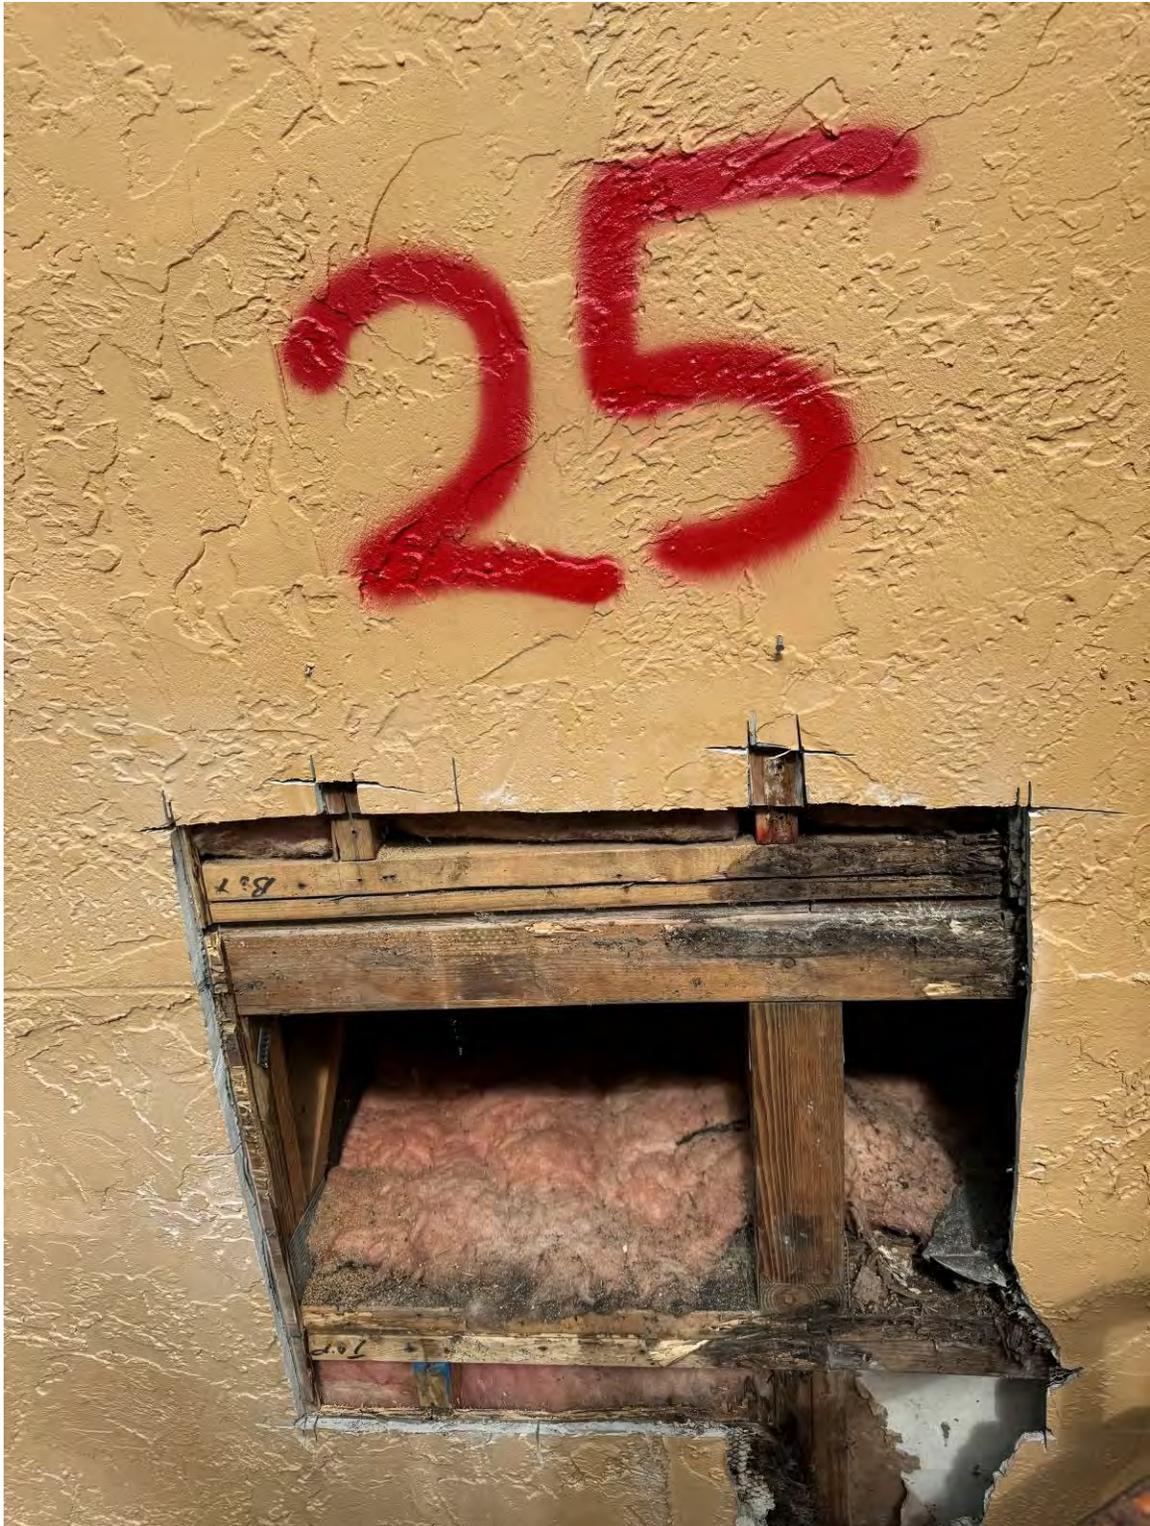
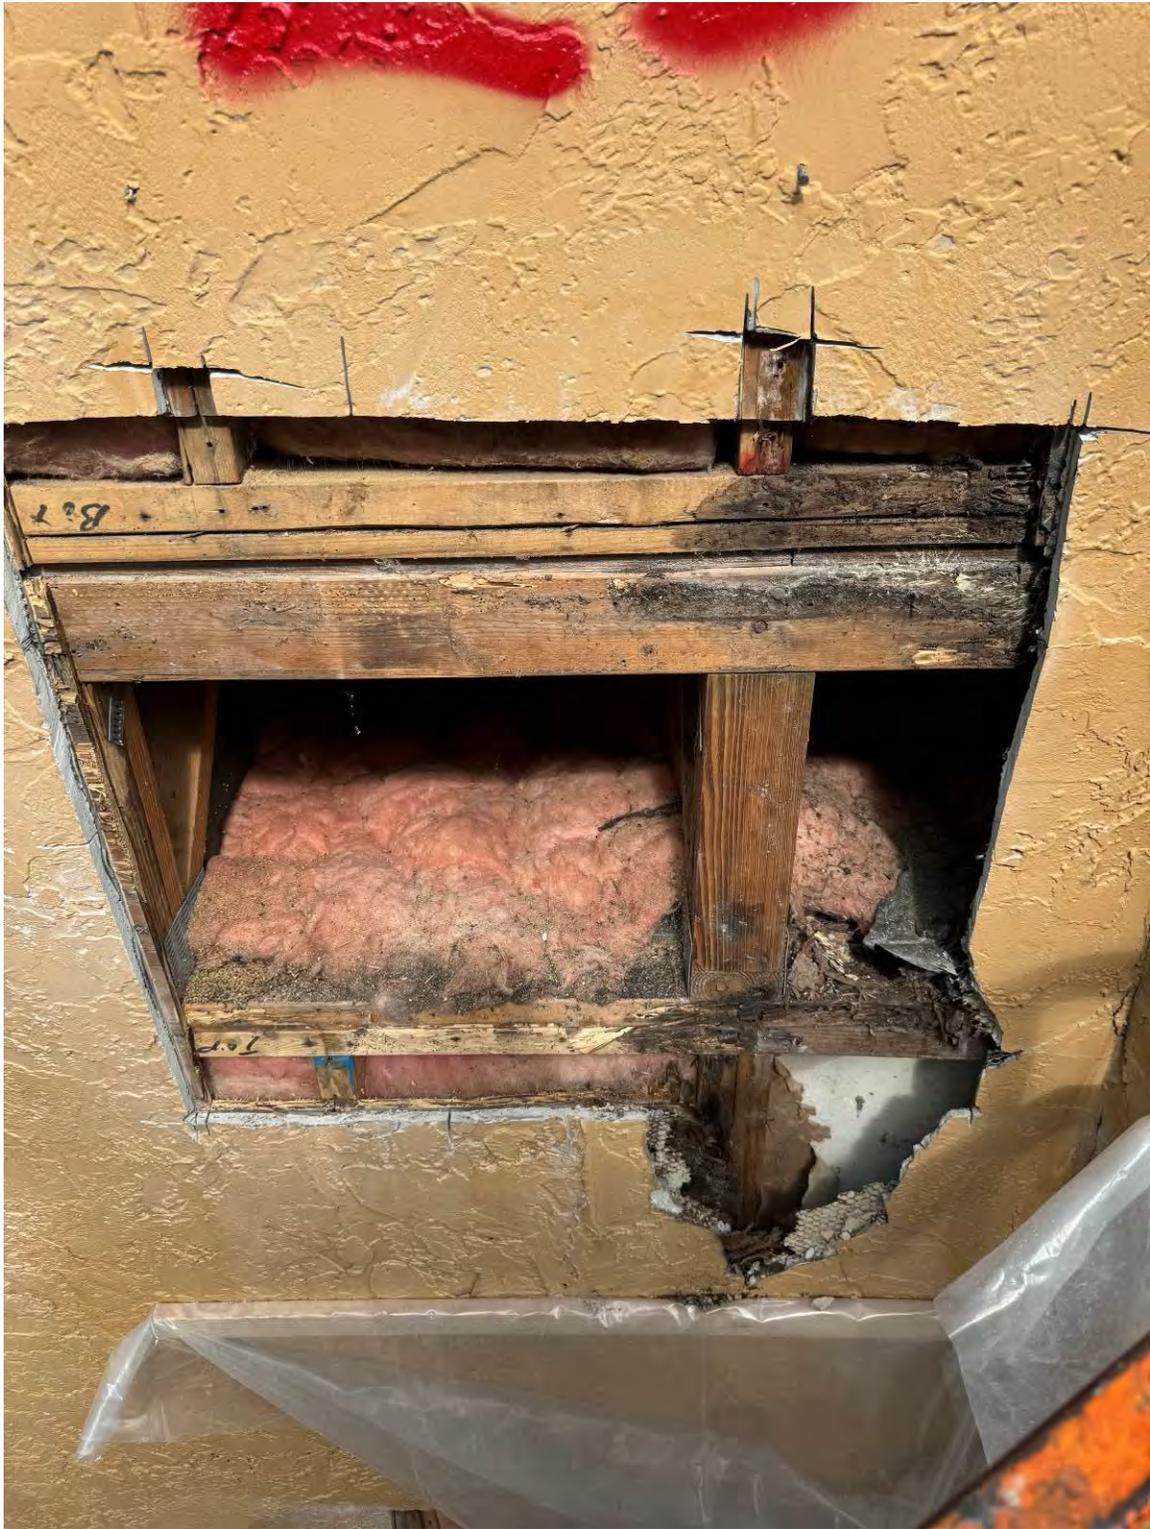
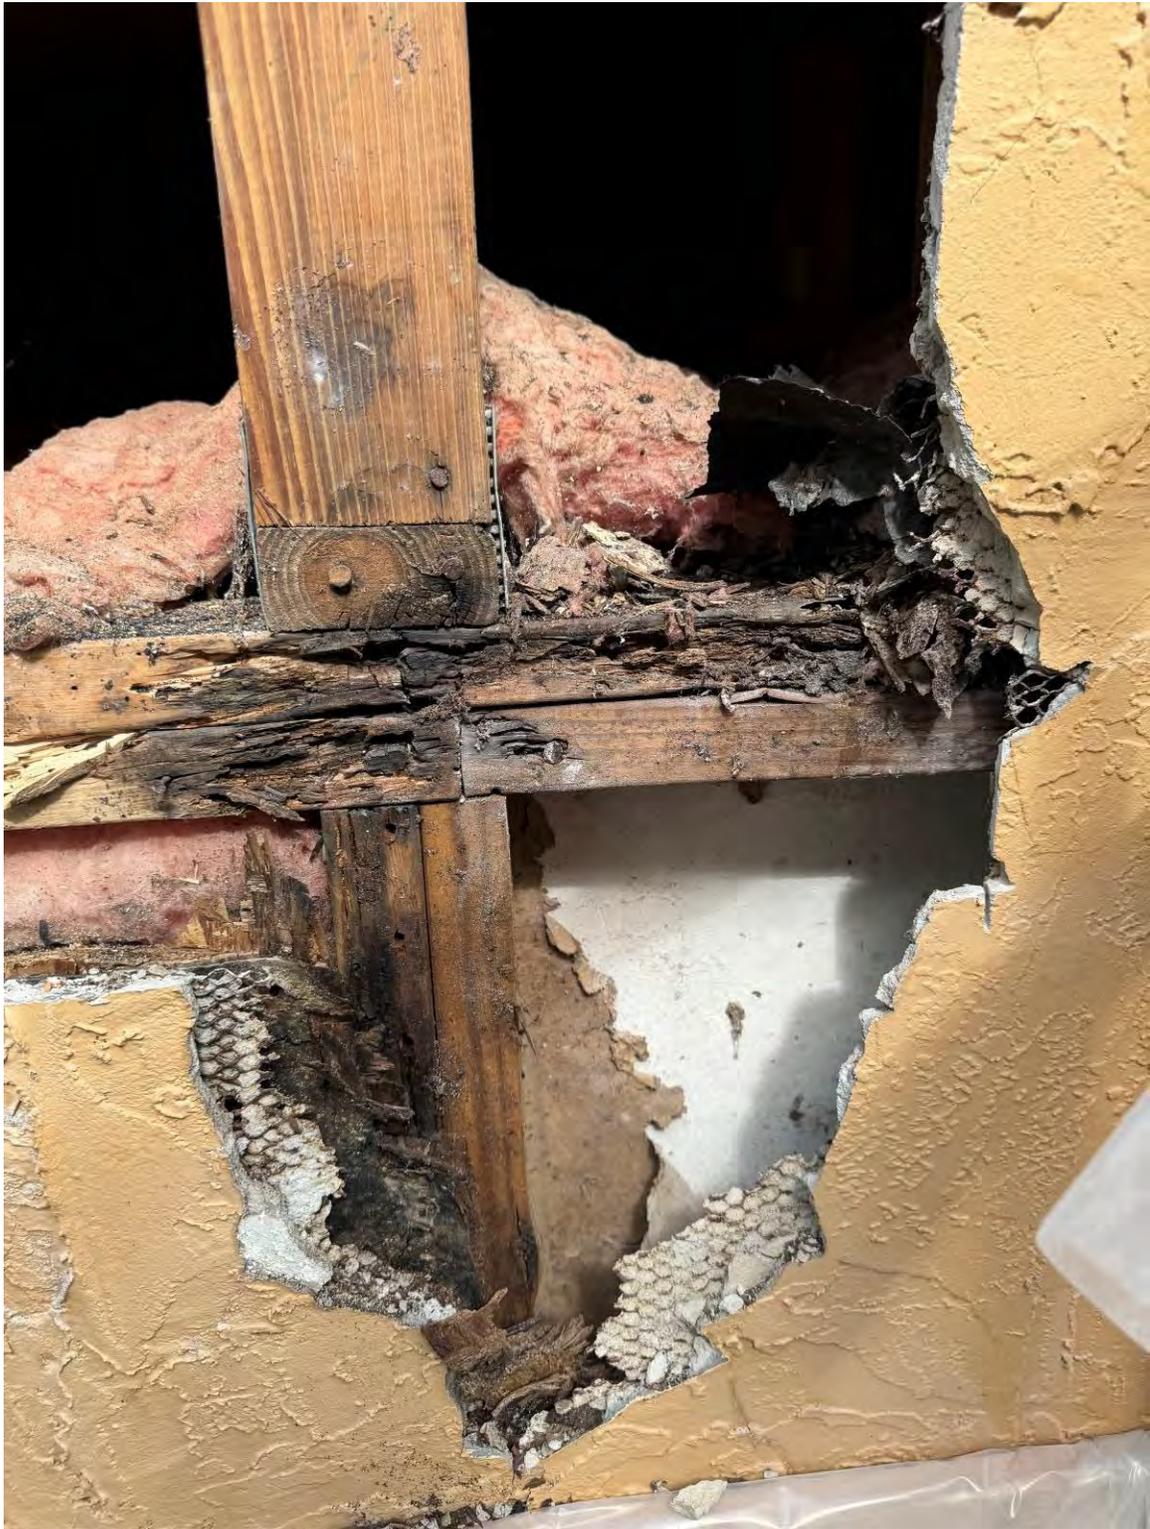
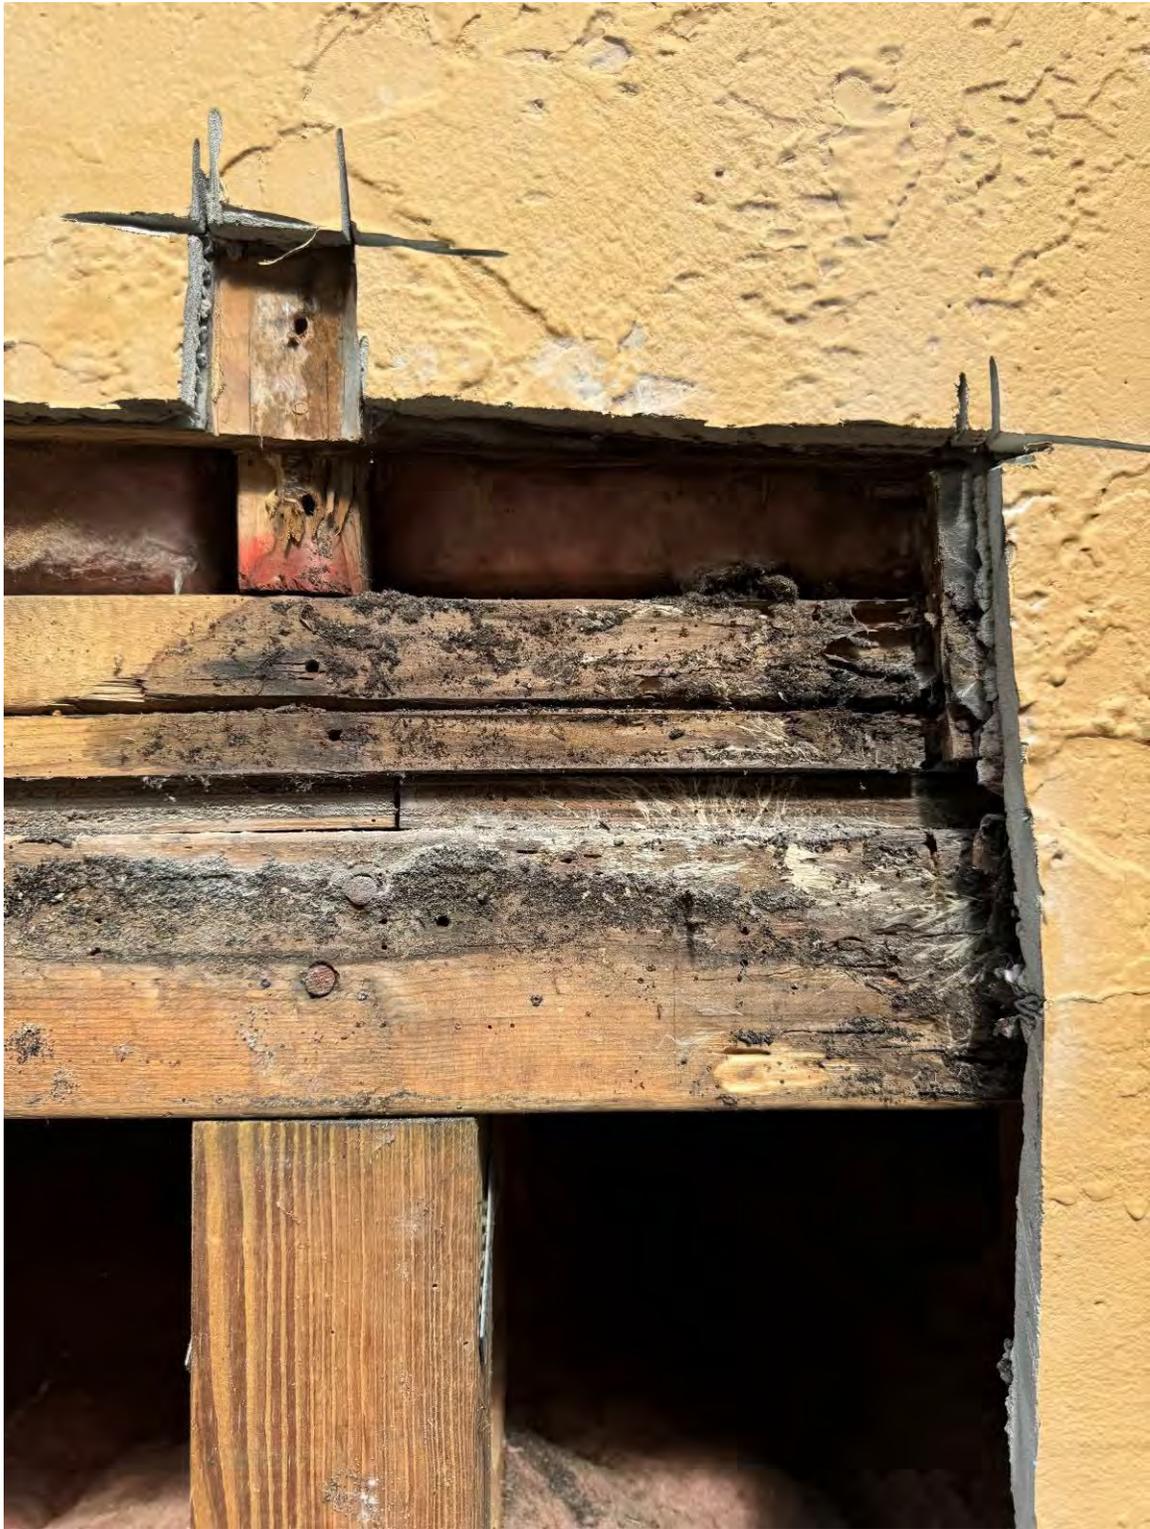
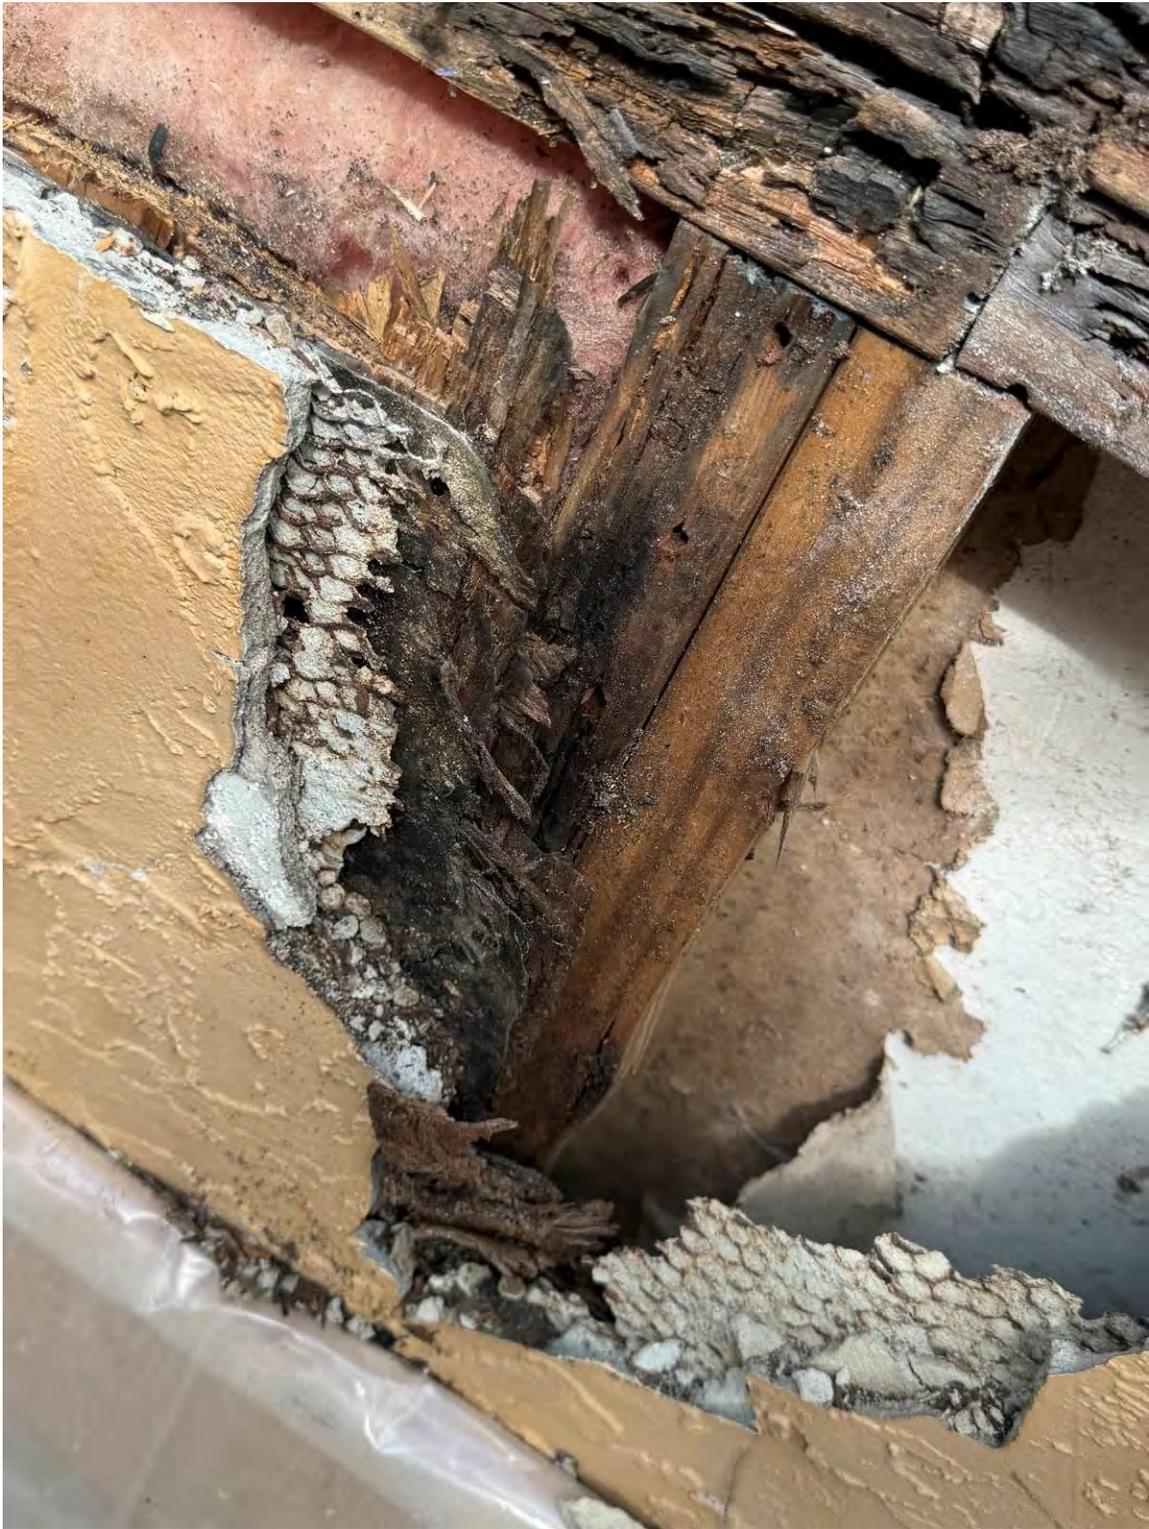
# OPENING #25

- 1<sup>st</sup> floor wall studs not connected to top plate
- 1<sup>st</sup> floor wall studs water damage and termite damage
- Top plate layer joint not staggered
- Floor joist no clips to bearing wall
- 2<sup>nd</sup> floor sill plate termite damage and water damage
- 2<sup>nd</sup> floor wall stud not connected to sill plate

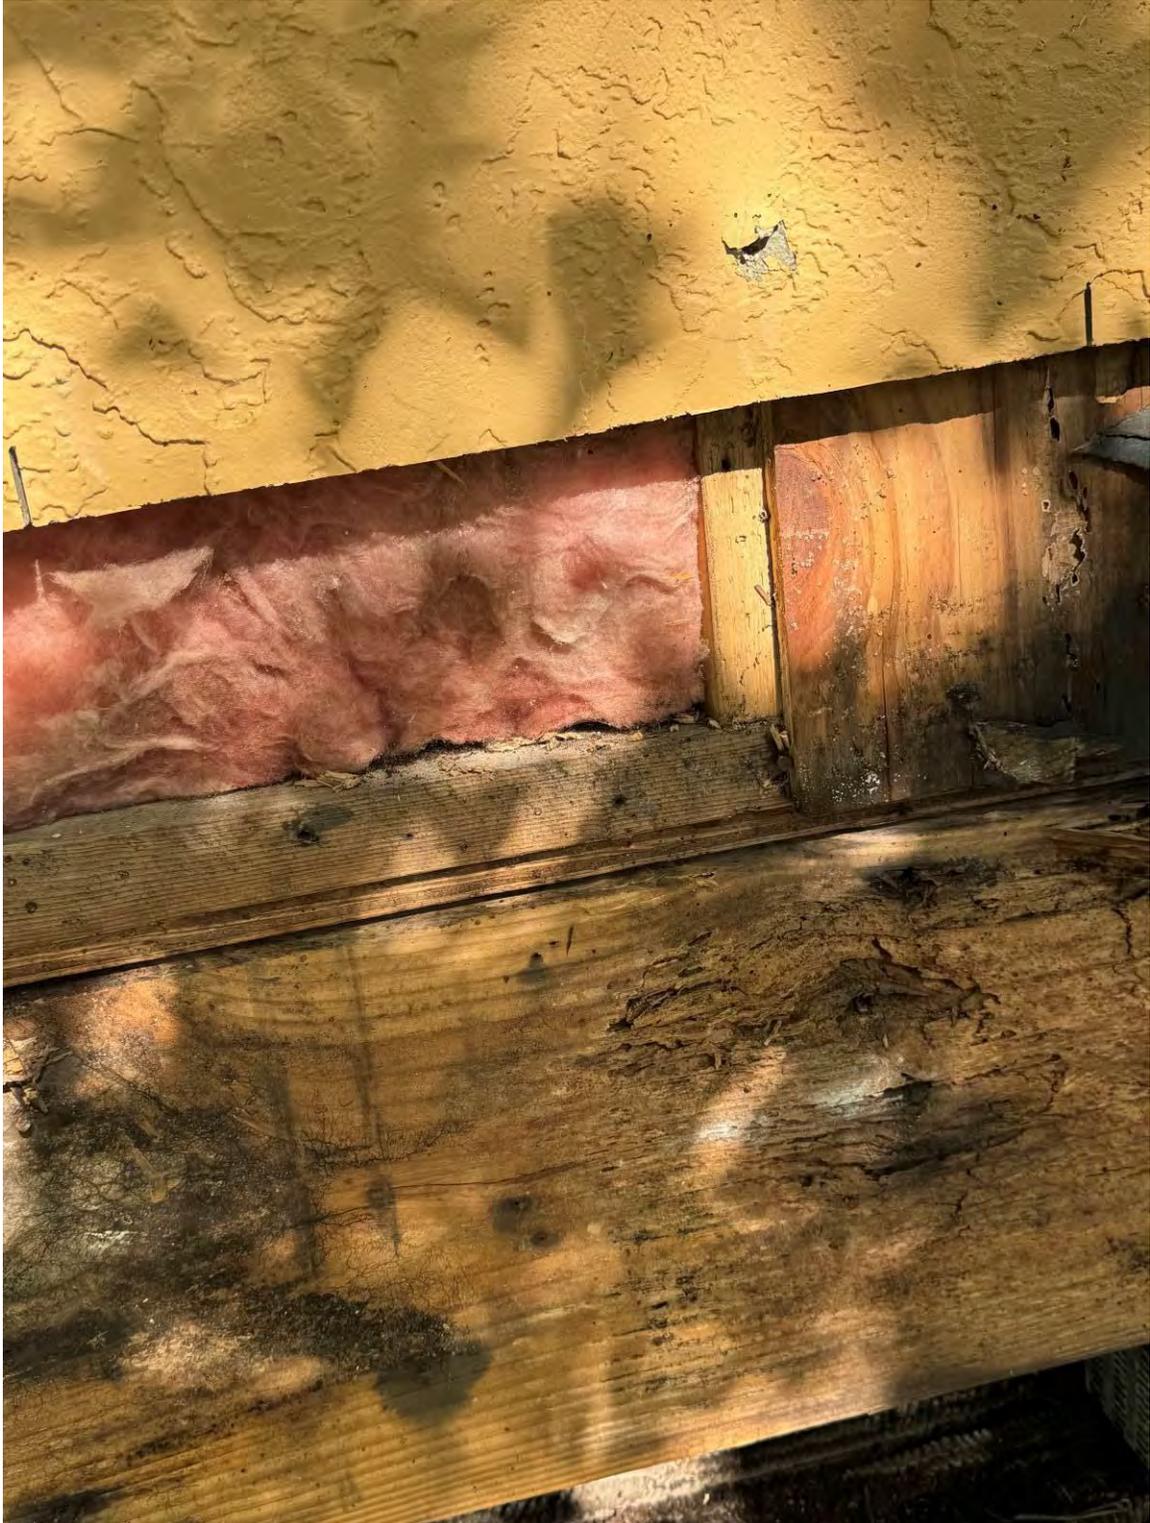
# OPENING #29

- Floor joists water damage and termite damage
- 2x12 bearing member water damage, termite damage, not strapped to floor joists
- 2<sup>nd</sup> floor wall studs not strapped to bottom plate
- Bottom plate destroyed
- Floor sheathing destroyed
- Wall sheathing destroyed

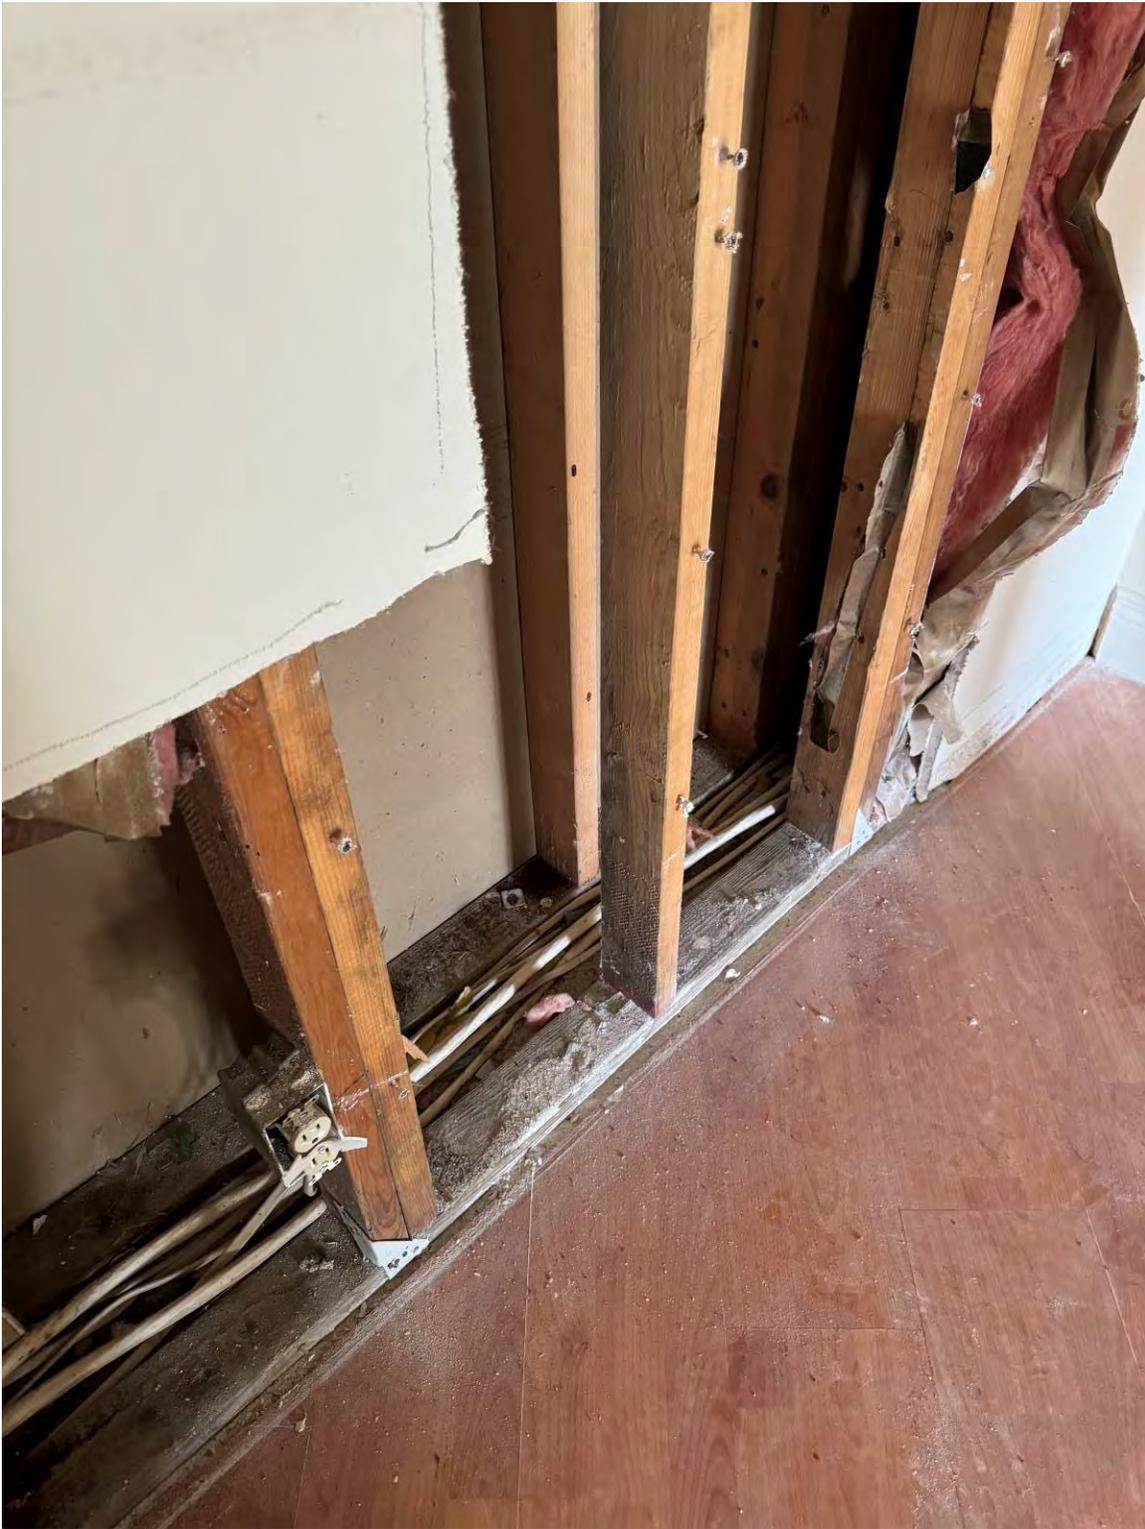
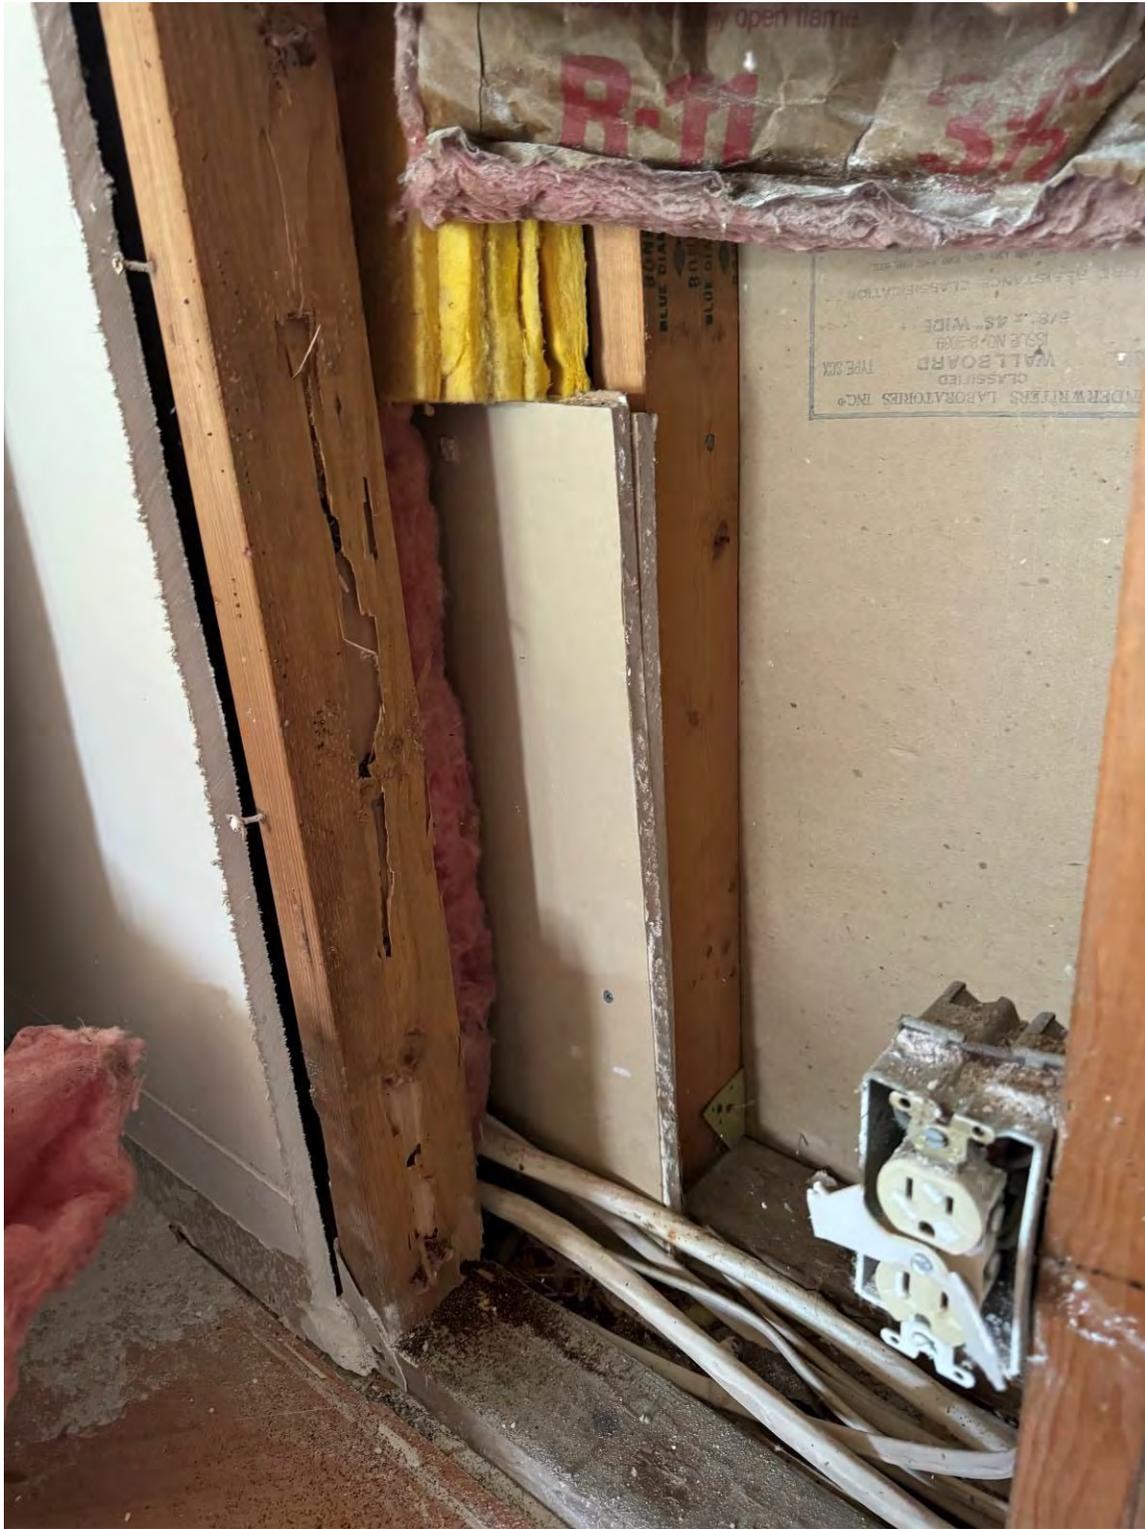
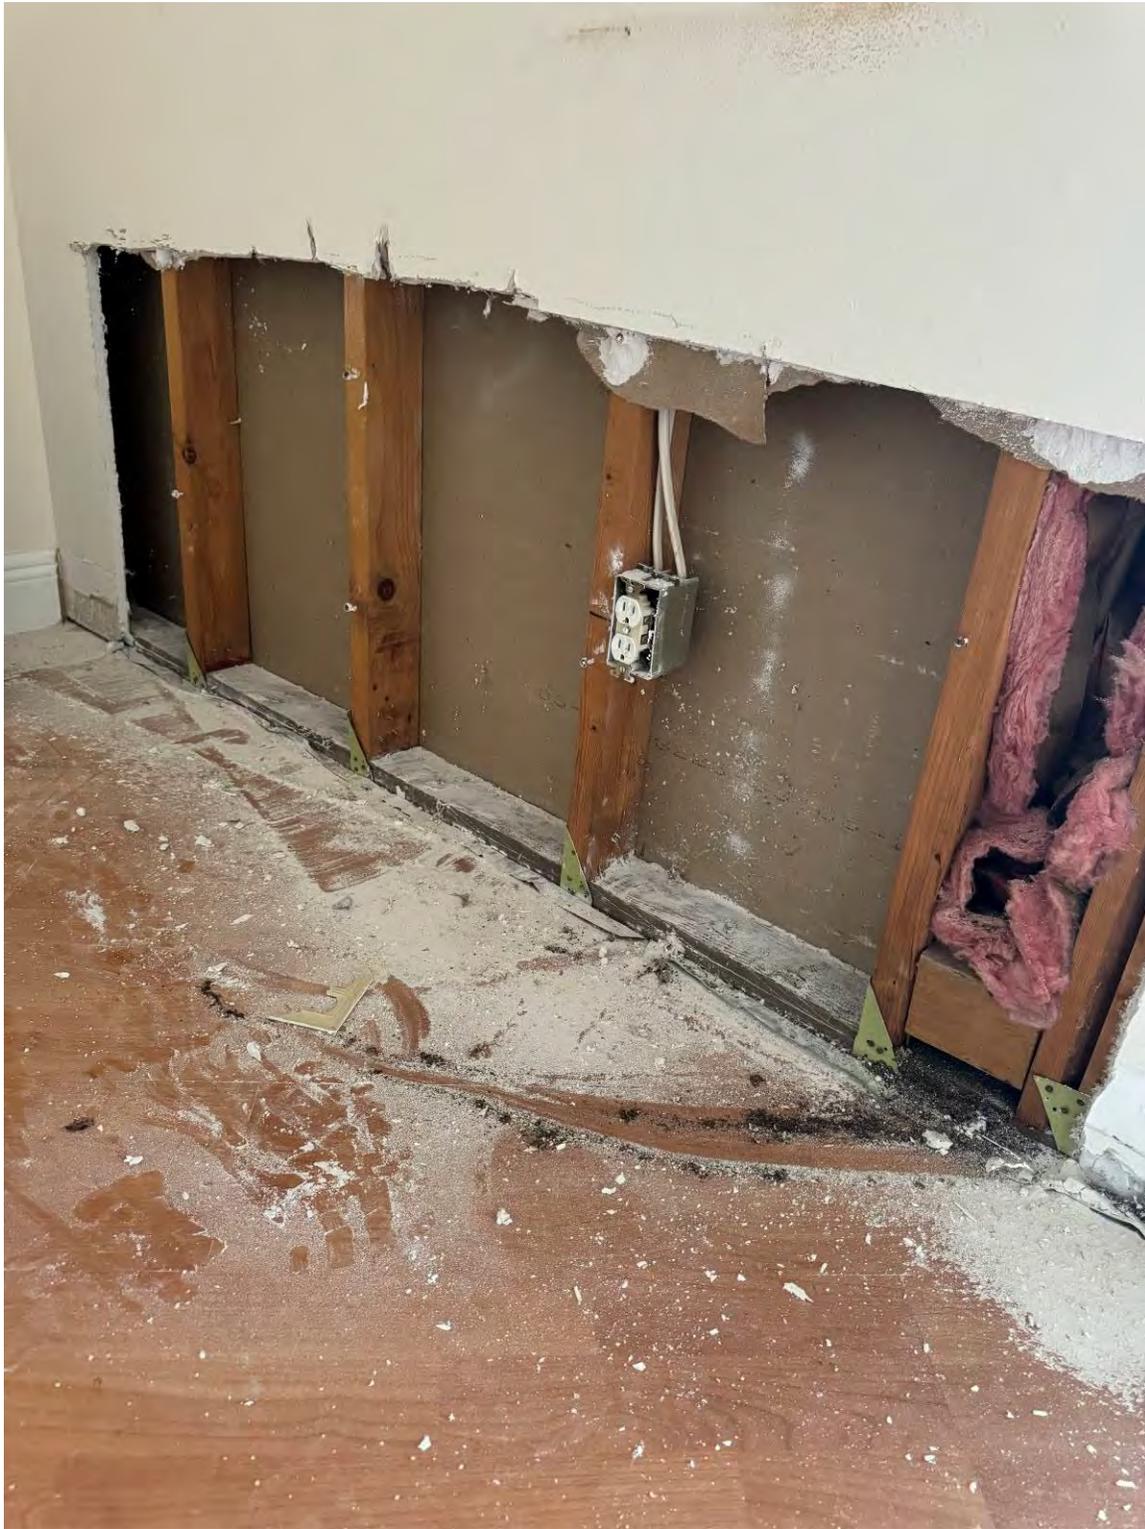
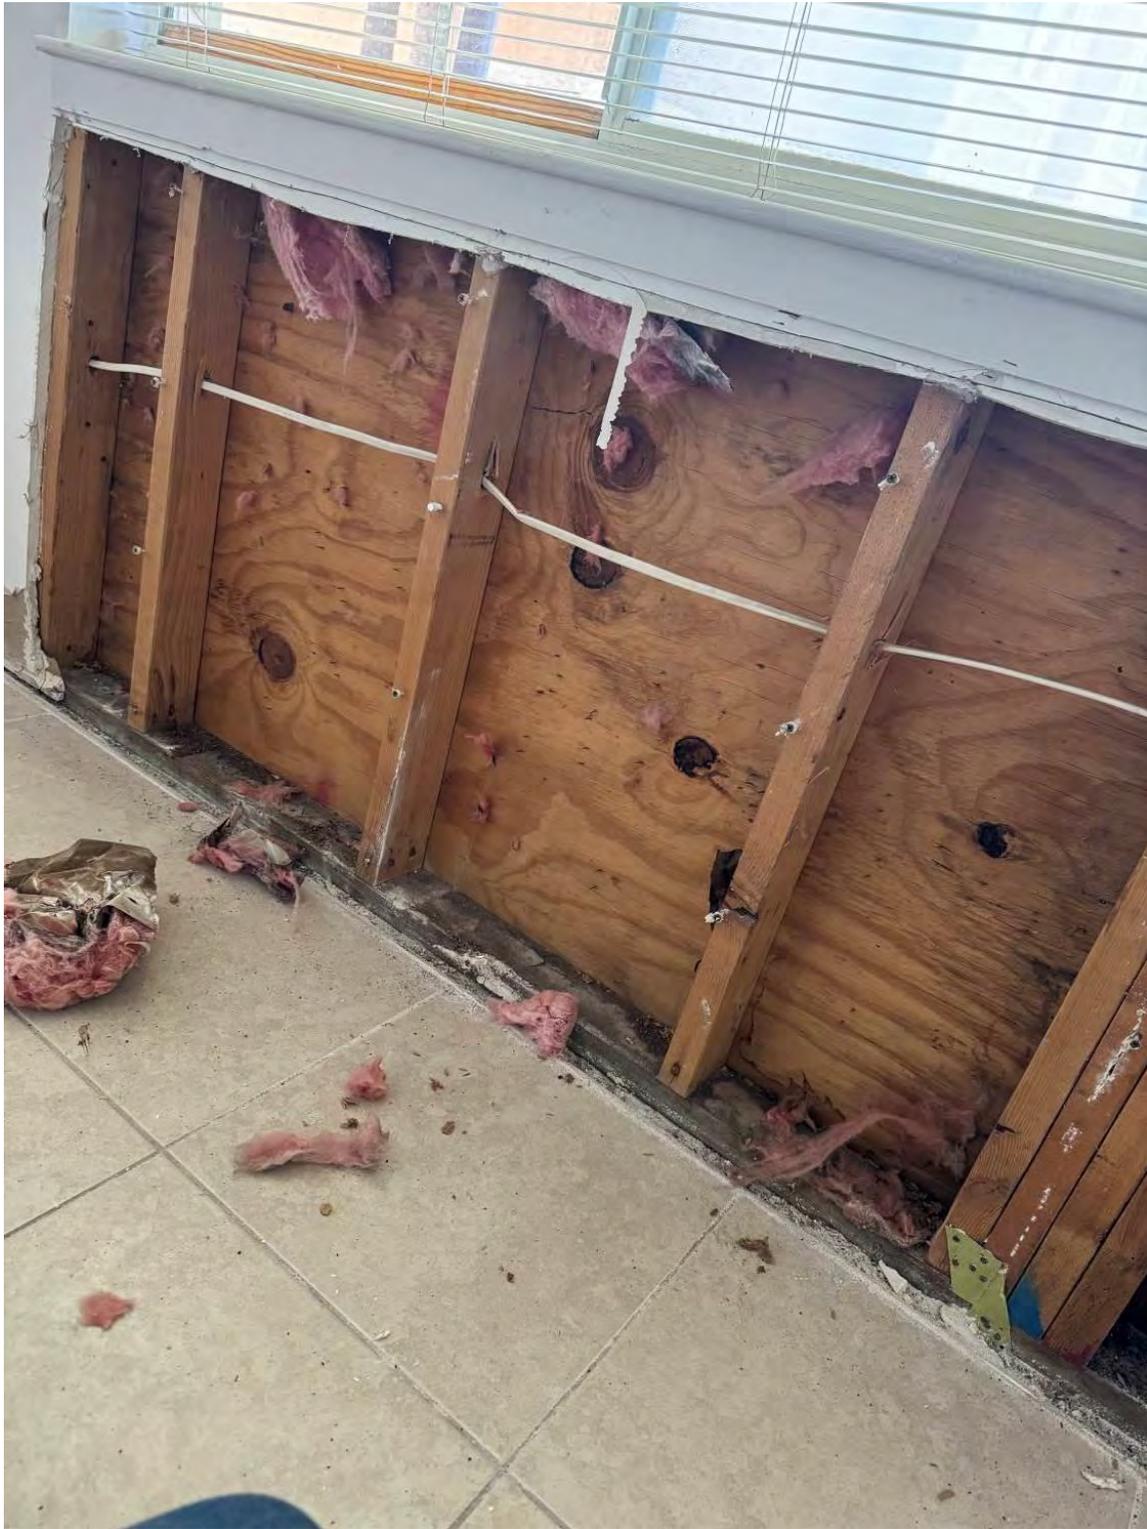
# UNIT #107 INTERIOR

- 2<sup>nd</sup> wall shows signs of 2 layers of drywall in part of the cut away
- No anchor bolts from bearing wall to slab on grade
- Many studs not clipped to the sill plate or to the top plate
- Exterior wall at patio no anchor bolts
- Bedroom exterior wall water damage and termite damage
- Bedroom exterior wall no anchor bolts, no stud clips
- Bedroom closet water damage, missing draft stop
