IN THE CIRCUIT COURT OF THE SEVENTEENTH JUDICIAL CIRCUIT  
IN AND FOR BROWARD COUNTY, FLORIDA

HERON POND CONDOMINIUM  
ASSOCIATION, INC.

**VERIFIED PETITION FOR APPOINTMENT OF A RECEIVER**

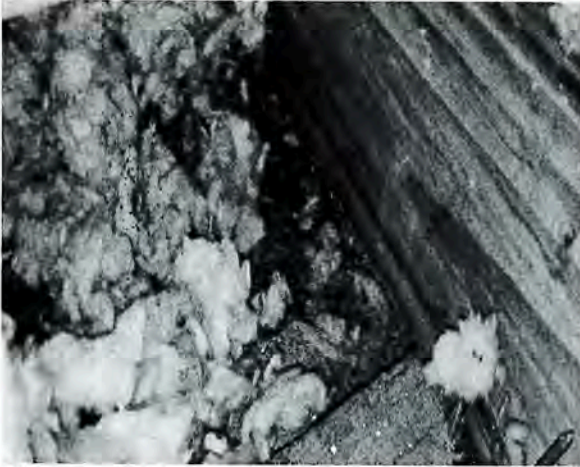
**Photograph 13: Unit 208. Termites infestation**

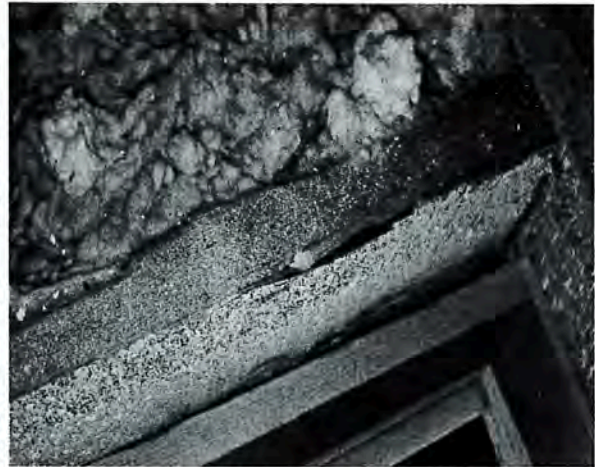
**Photograph 14: Unit 206. Termites infestation**

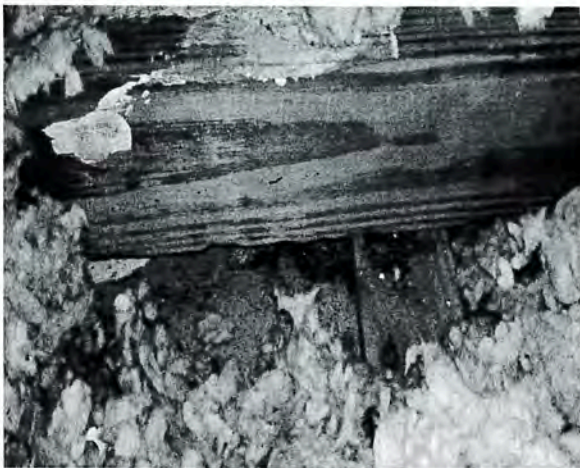
**Photograph 9: Unit 201. Termites infestation**

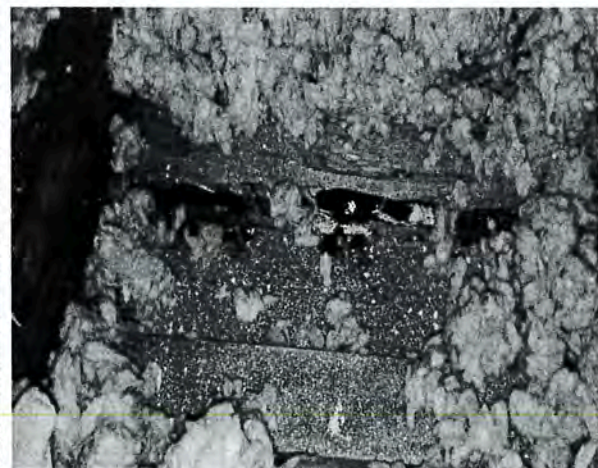
**Photograph 12: Unit 208. Termites infestation**

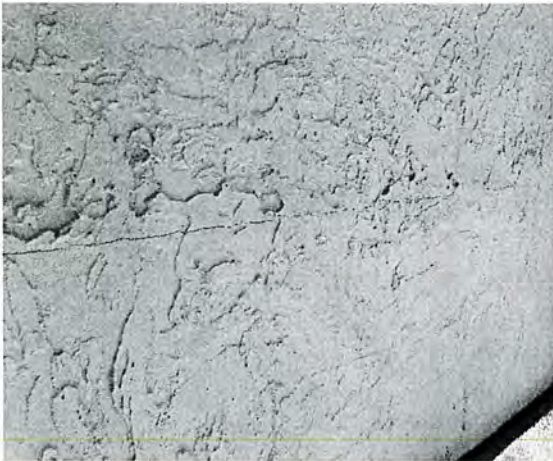
**Photograph 11: Cracks on balcony ceiling Unit 104**

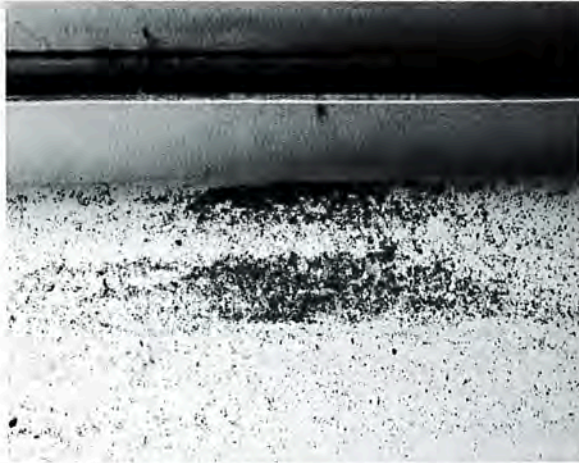
**Photograph 13: Unit 208. Termites infestation**

8. The entire building must be treated for termites prior to the repairs and inspected again for termites following the repairs. If termites persist, the building must be treated again.

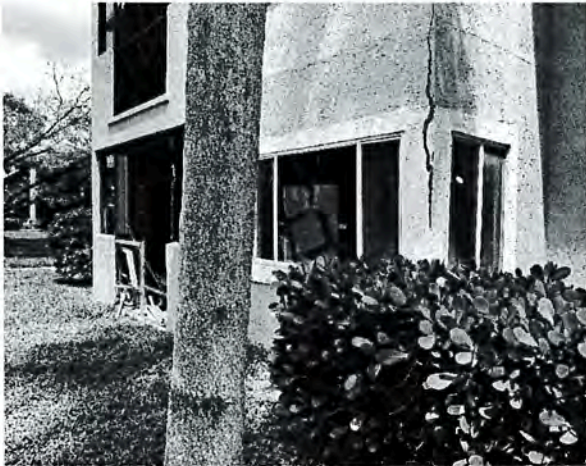
**Photograph 1: Building elevation Blue Tarp required**

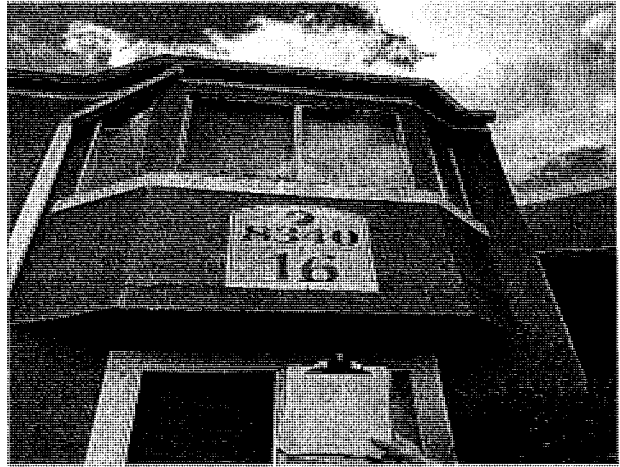
*Photograph 8: Unit 107. Shoring required*

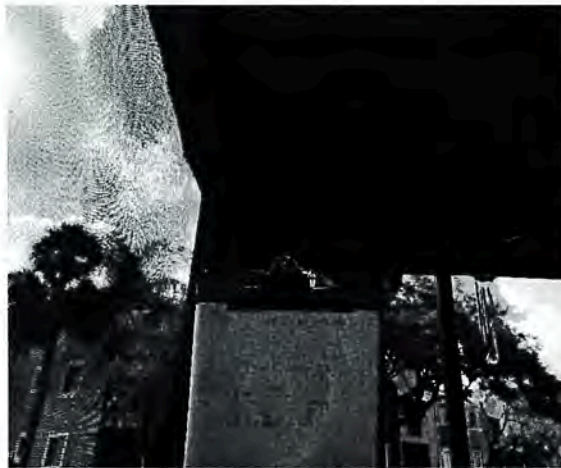
**Photograph 13: Unit 106. Shoring required**

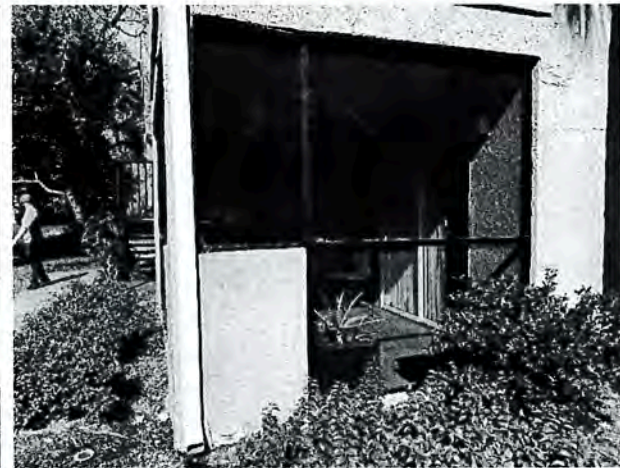
**Photograph 14: Unit 106. Shoring required**

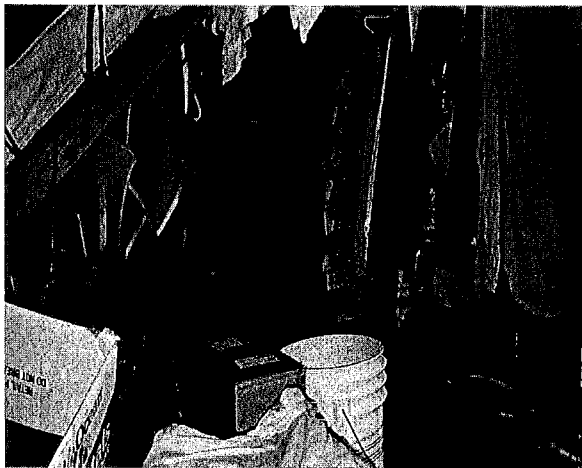
**Photograph 9: Unit 204. Household item within the attic space**

6. All household items stored in the attic space are a fire hazard and must be removed.
7. All staircases must be cleaned from corrosion, welded as needed, and painted. All cracked concrete steps must be replaced.

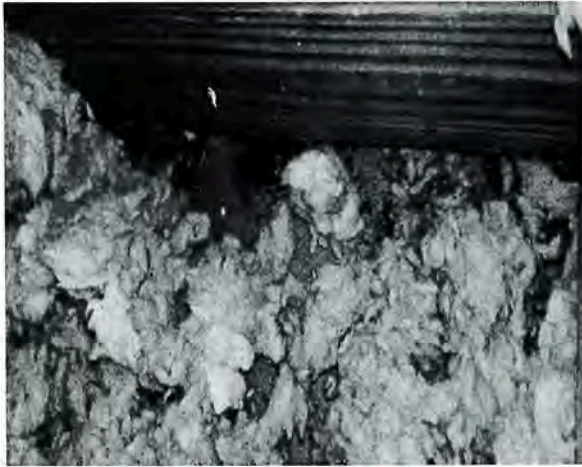
**Photograph 13: Unit 205. Termites infestation**

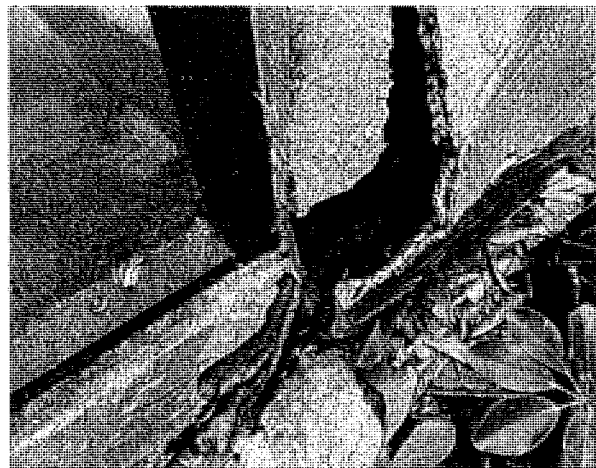
**Photograph 4: Unit 105. Opening in the exterior wall**
