**NOTICE OF FILING PART 1 OF FINAL ENGINEERING REPORT OF SPECIALTY  
ENGINEERING CONSULTANTS, INC. DATED NOVEMBER 5, 2024**

**PROFESSIONAL CONSULTING SERVICES FOR:  
Heron Pond Condominium Association, Inc.**

Building #9  
8343 SW 5<sup>th</sup> Street,  
Pembroke Pines, FL 33025

Re: Investigation and Documentation of Deteriorated and Damaged Structural Items

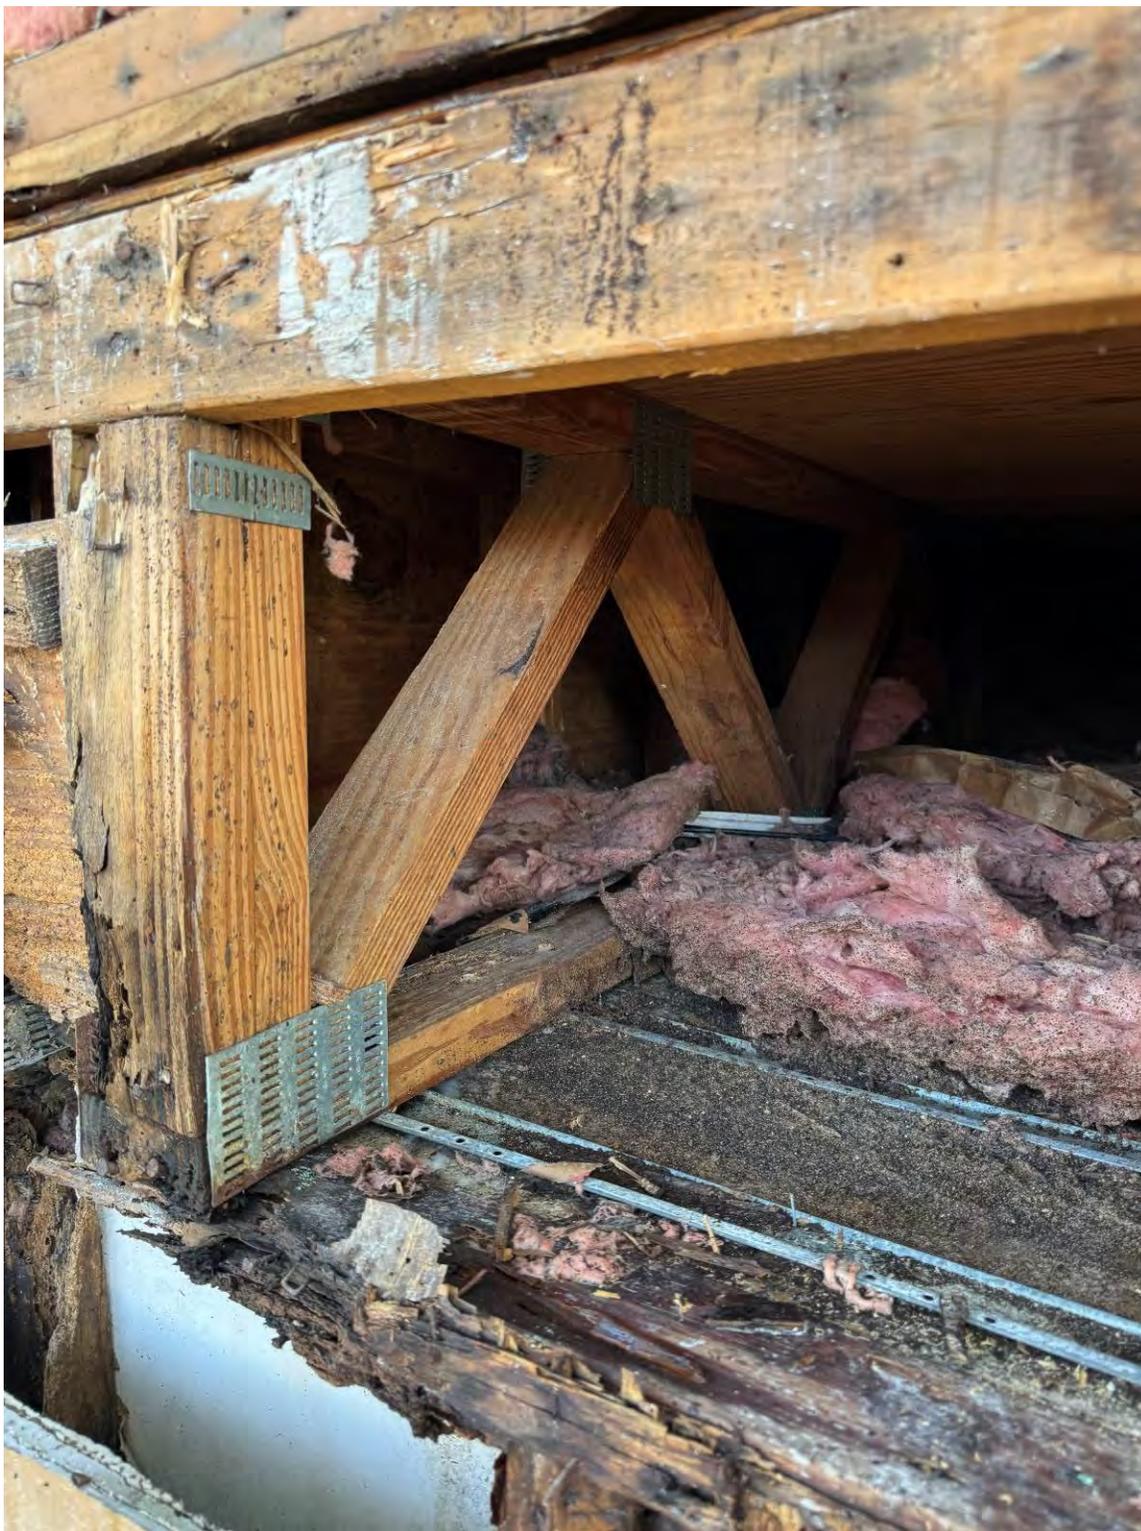
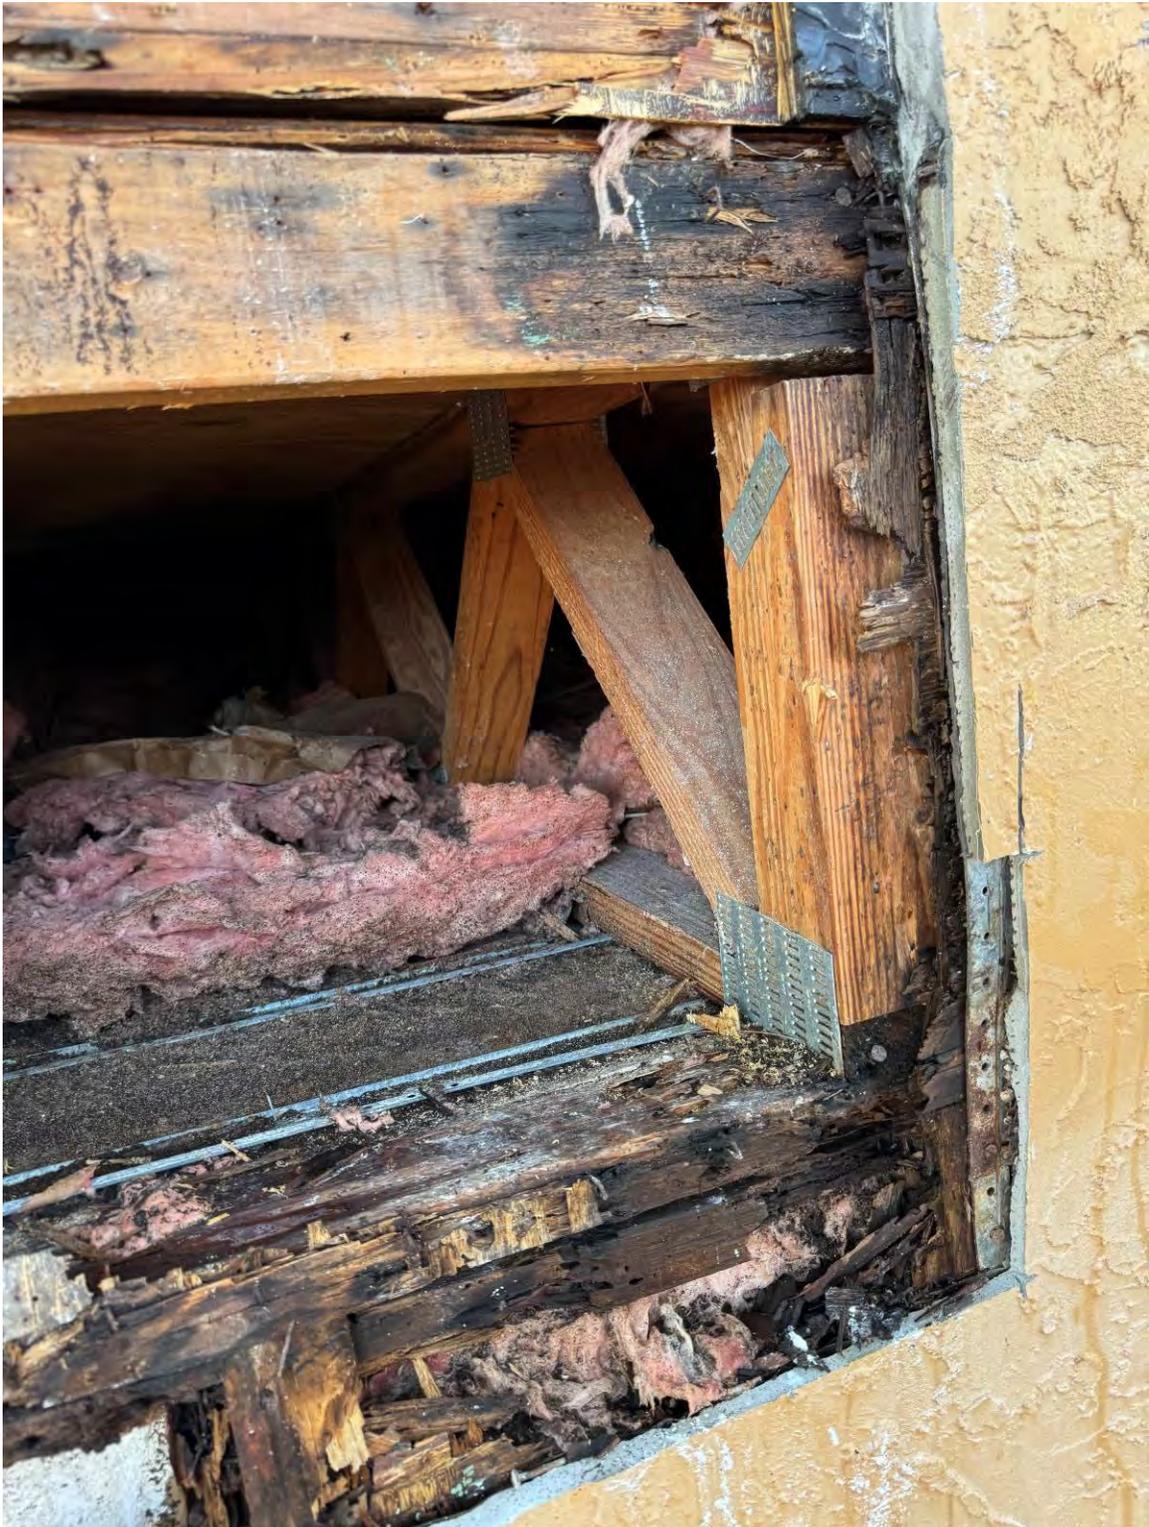
# OPENING #1

- Floor trusses are rotted
- Tie down strap to bearing wall not nailed
- Bearing wall studs rotted away
- Top bearing wall top plate rotted
- End of patio joist is rotted with termite damage
- Insulation is wet
- Damage to floor trusses about 12" deep
- Floor framing is rotted
- Floor sheathing is rotted
- Bottom sill has termite damage, rotted wood and water damage
- Damage to stud

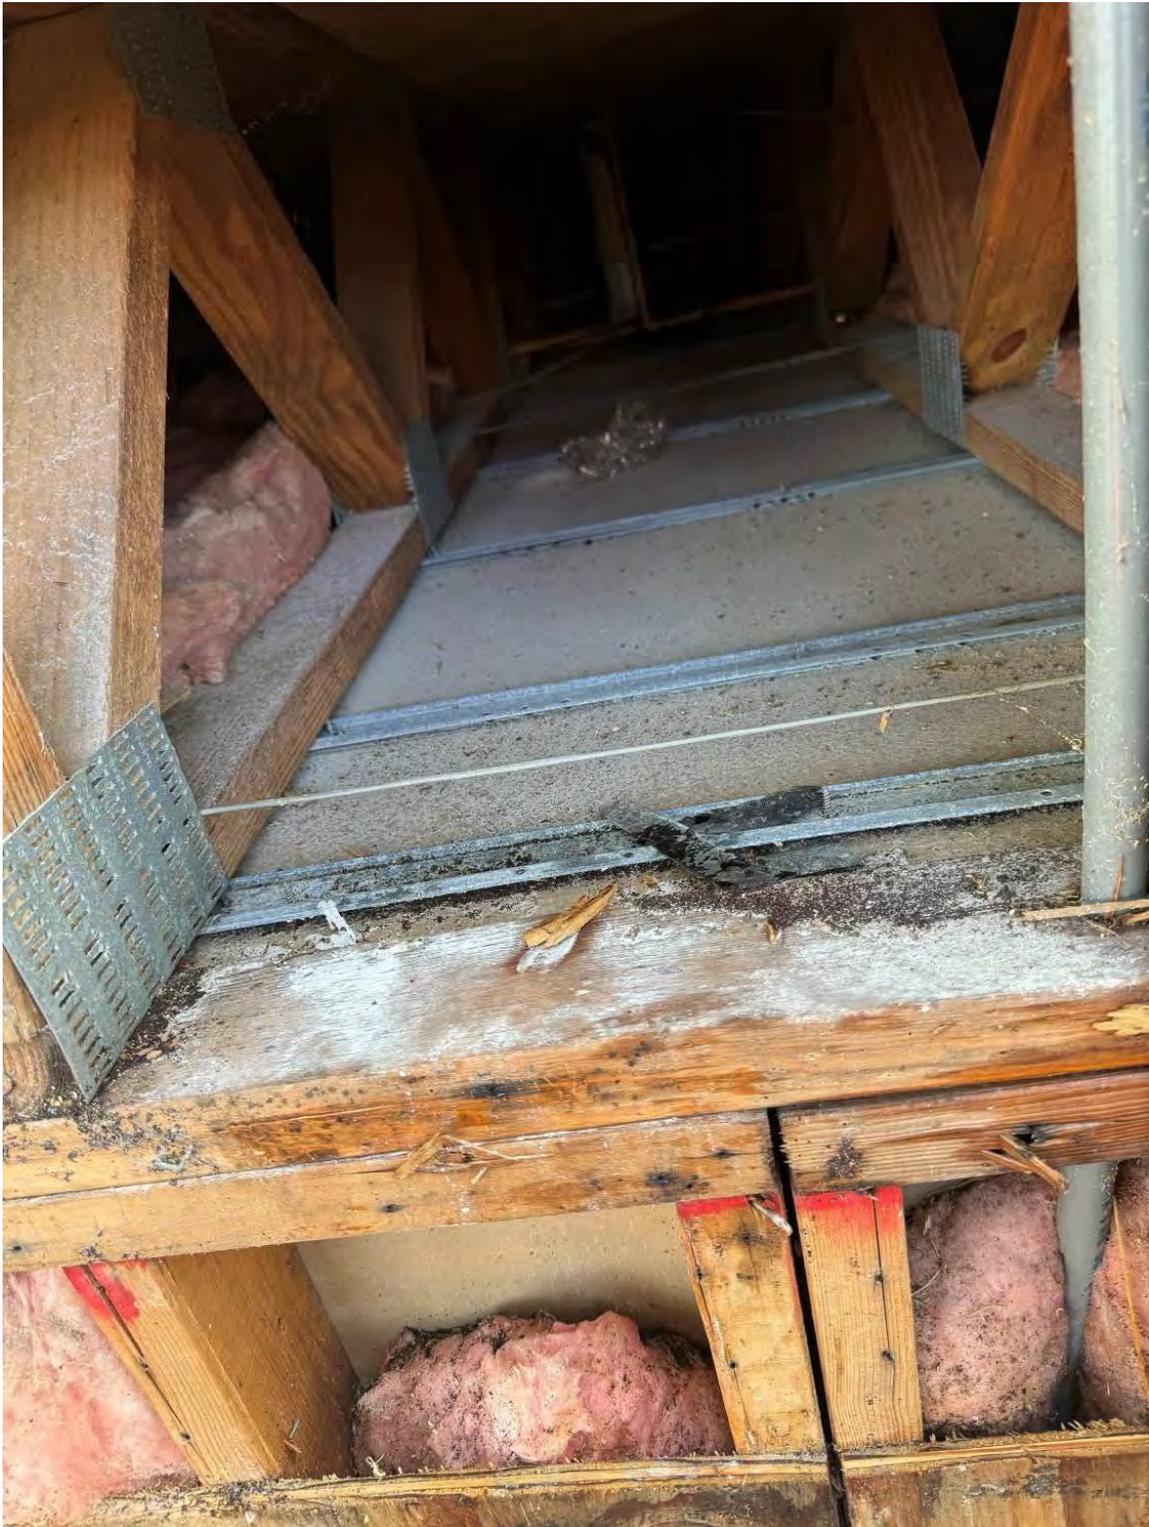
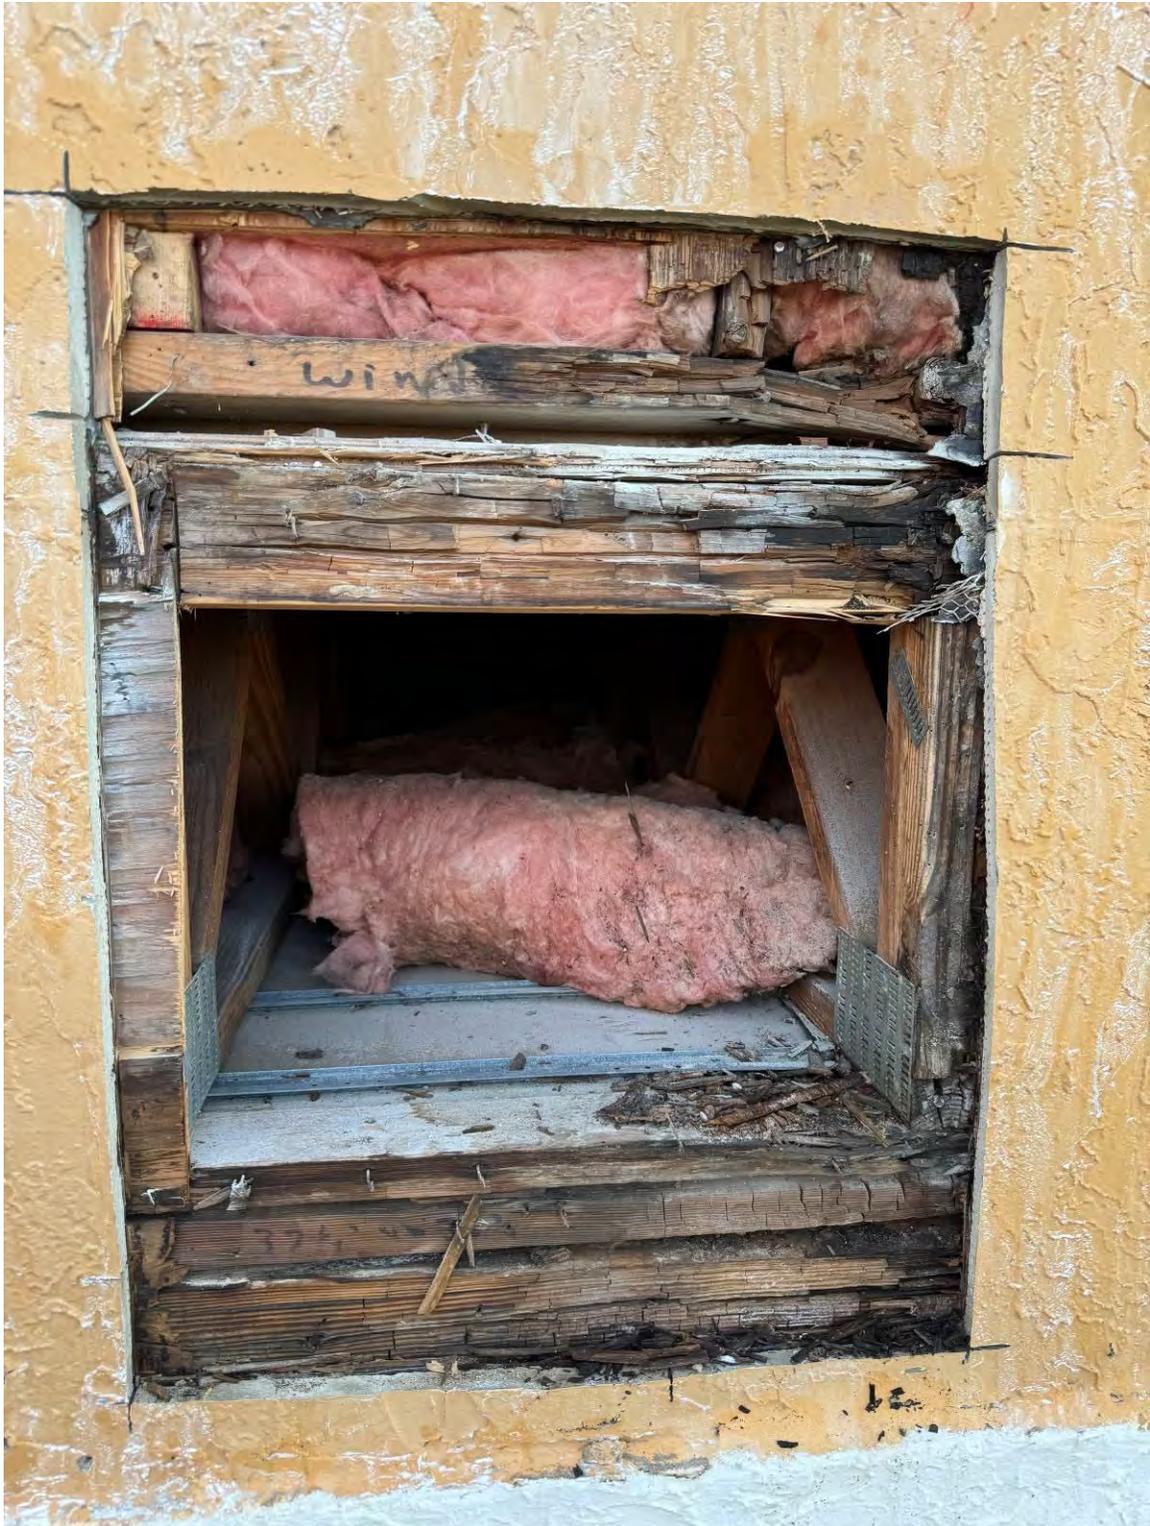
- Evidence of termites
- 1st floor bearing wall studs have no mechanical connection to the top plate
- Some damage to the studs for the bottom of the 2<sup>nd</sup> floor bearing wall
- Some damage to the 1<sup>st</sup> floor studs to their top plate
- Plywood is half inch

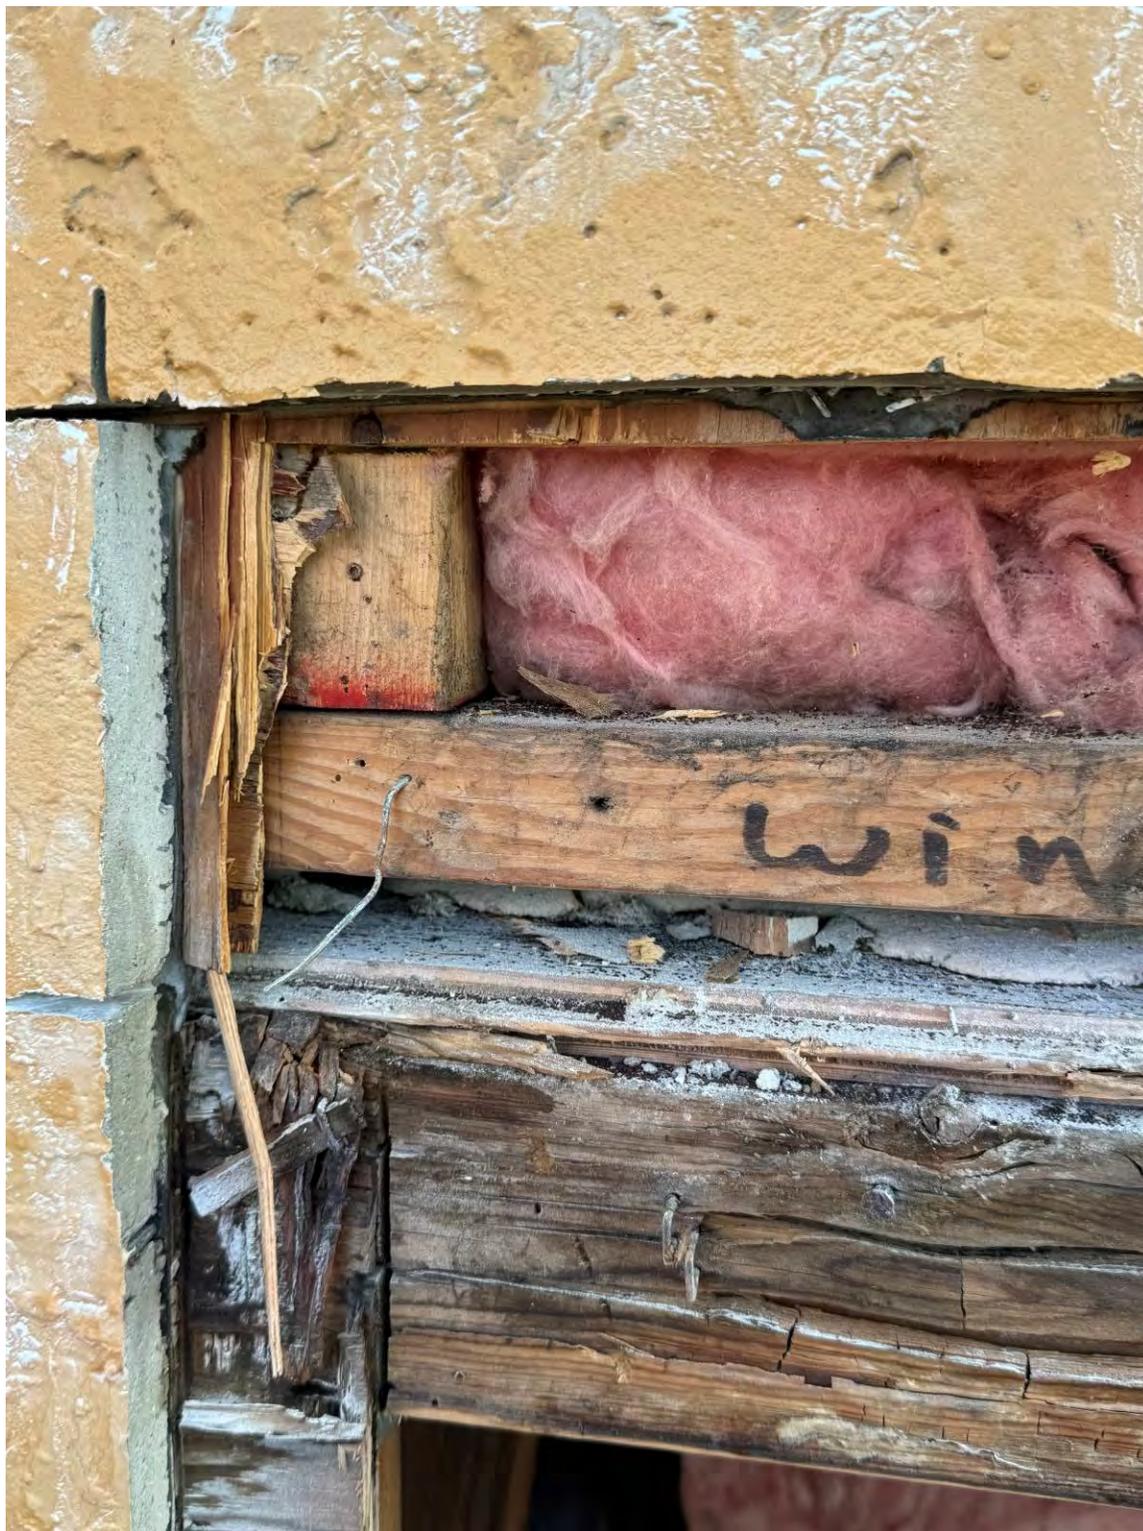
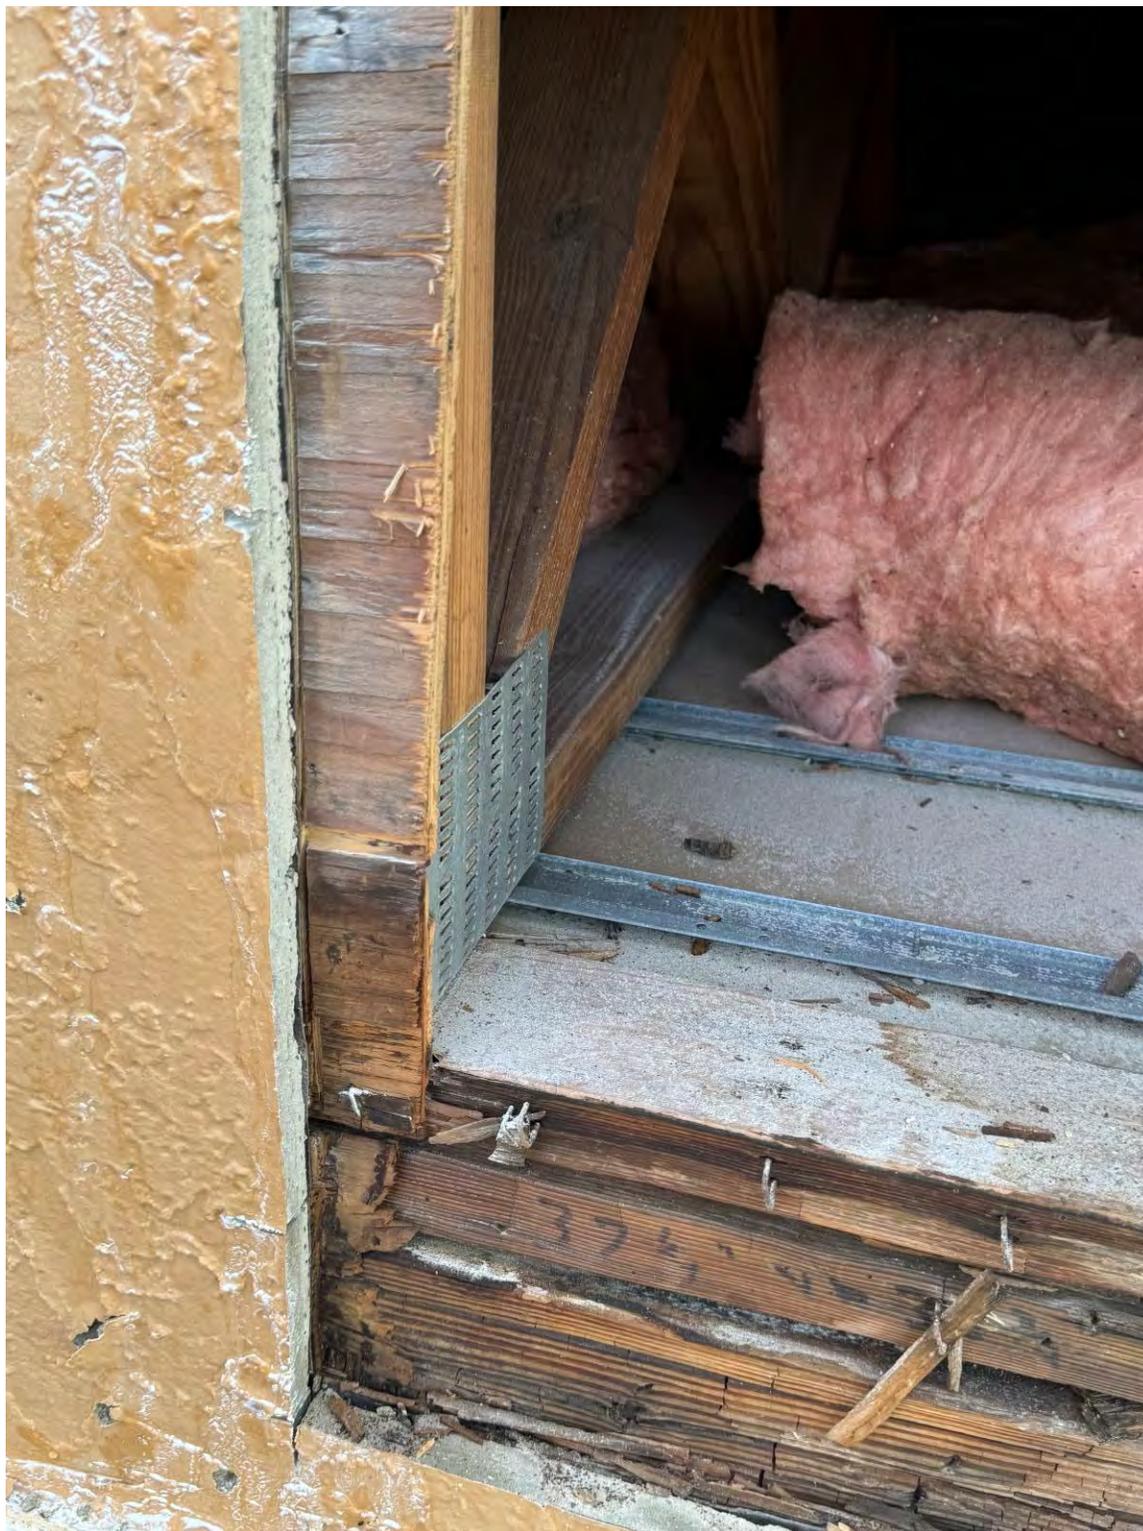
- Wood rot at top plate of 1<sup>st</sup> floor bearing wall
- Wood rot at end of ceiling floor truss
- Wood rot to sill plate for 2<sup>nd</sup> floor bearing wall
- Wood rot at 2<sup>nd</sup> floor wall studs

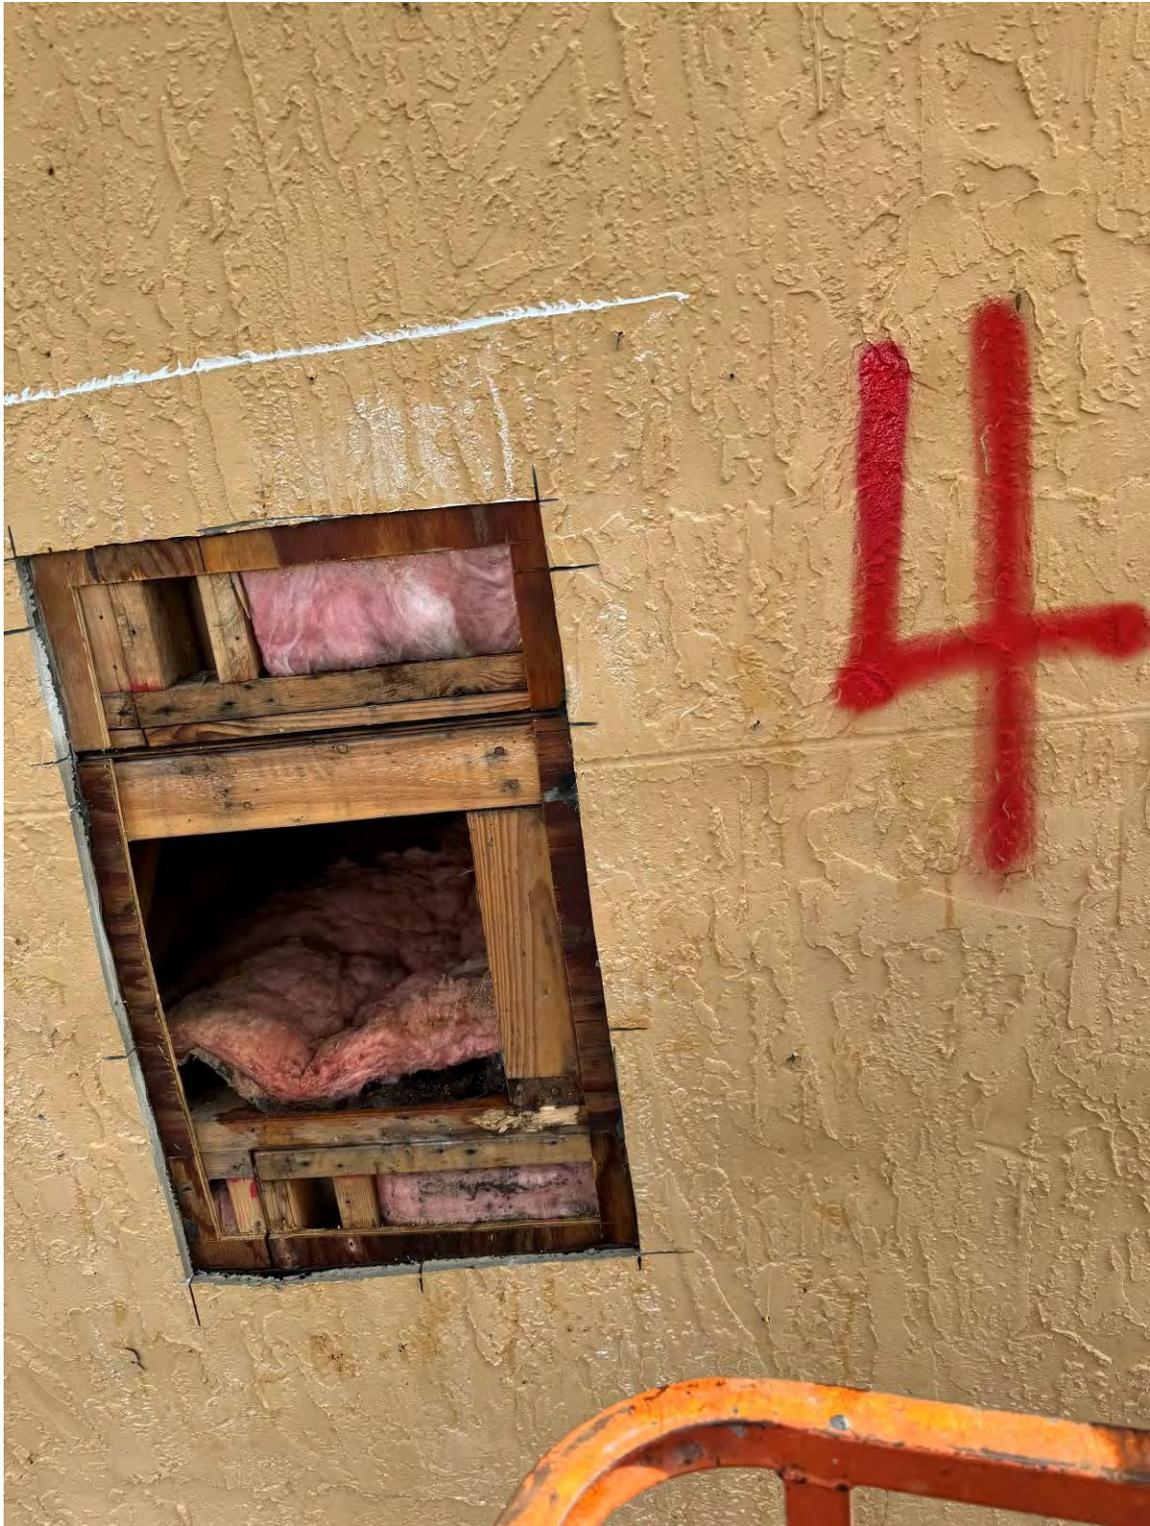
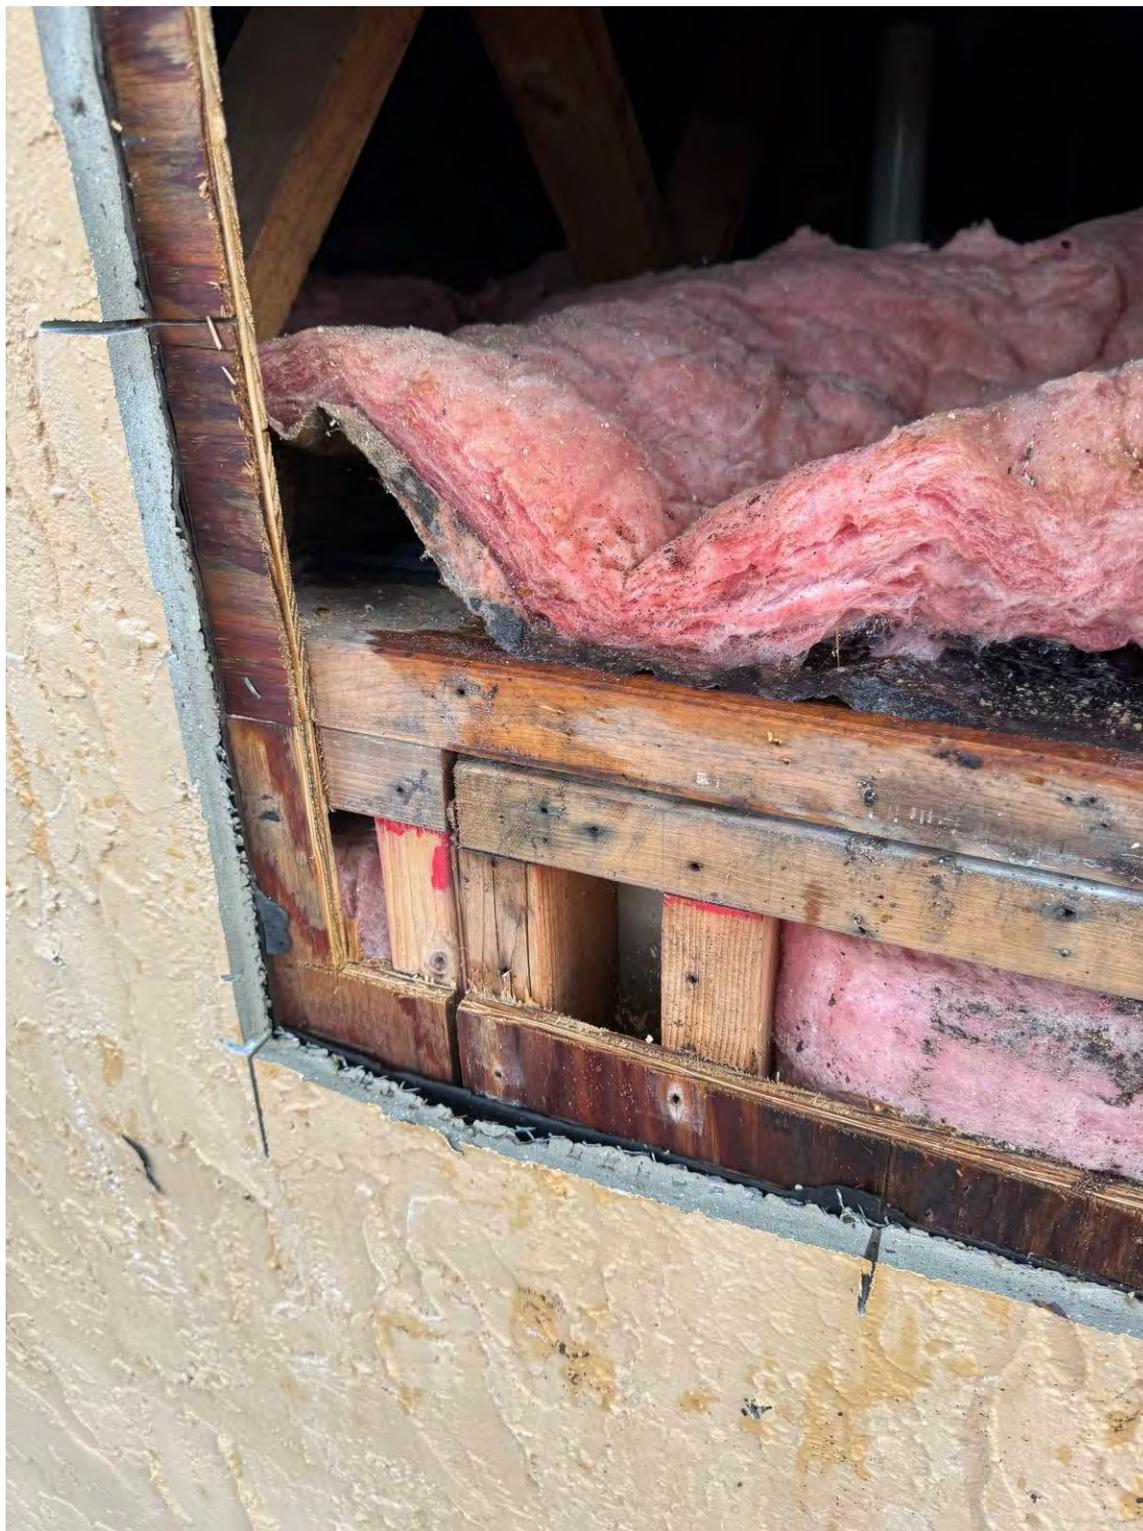
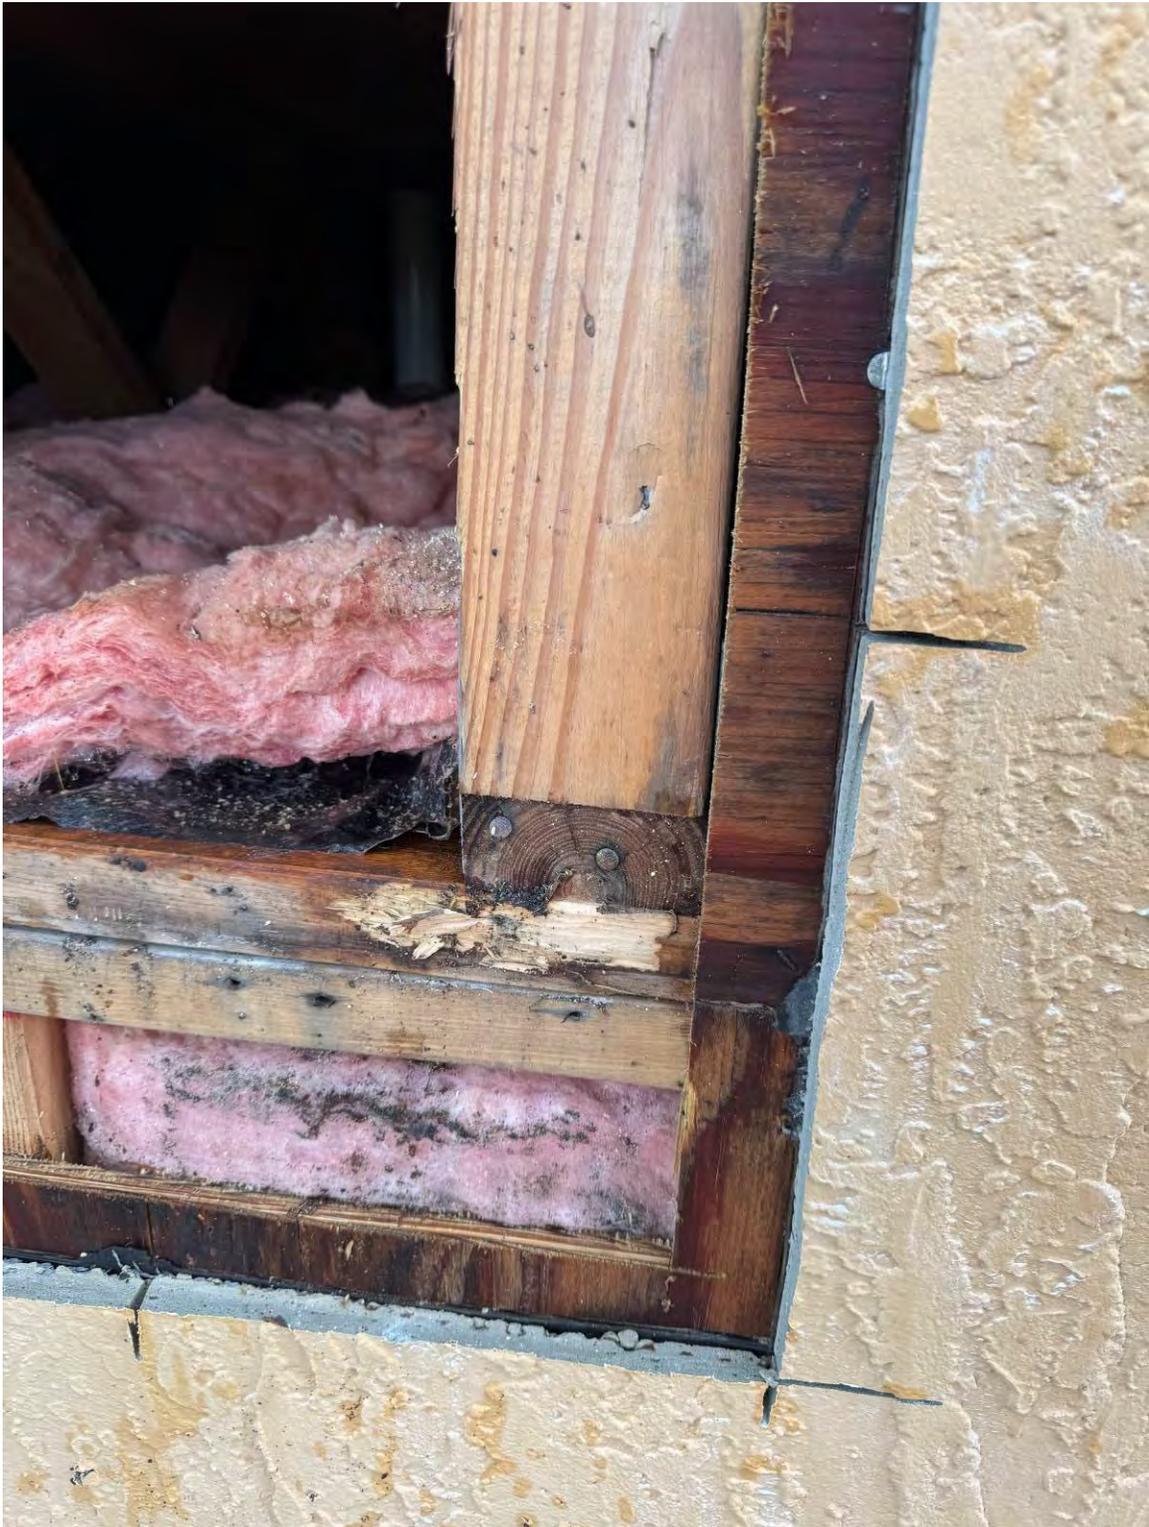
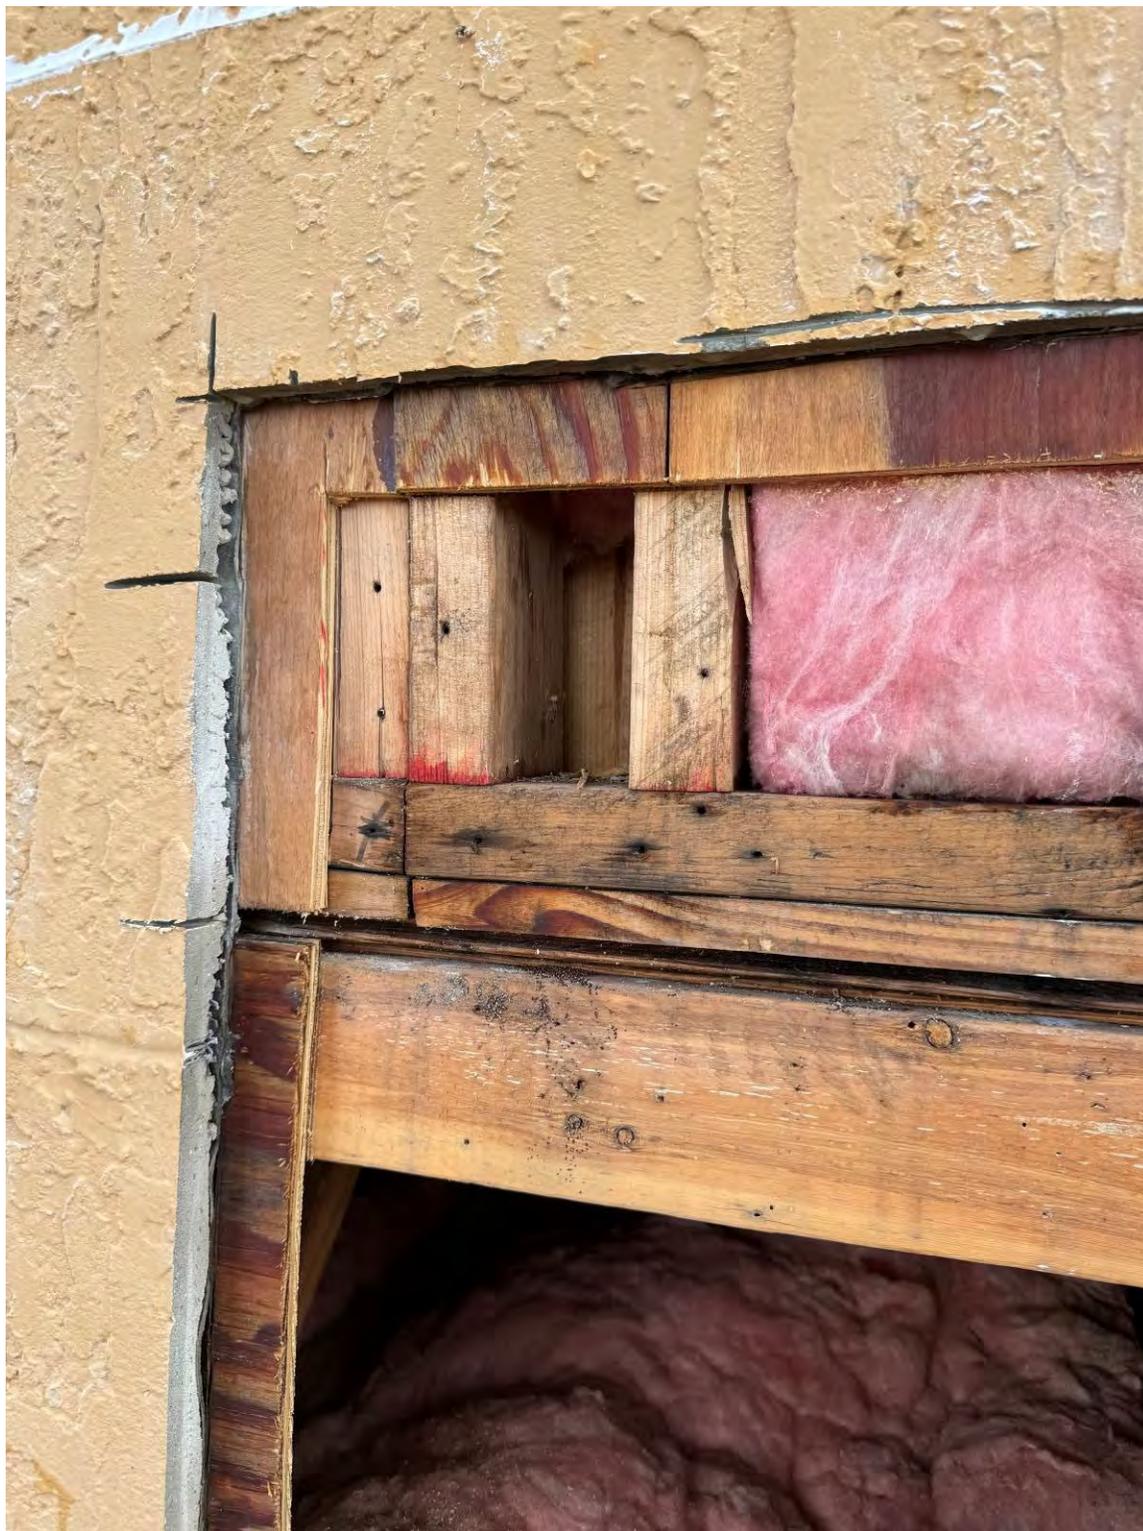
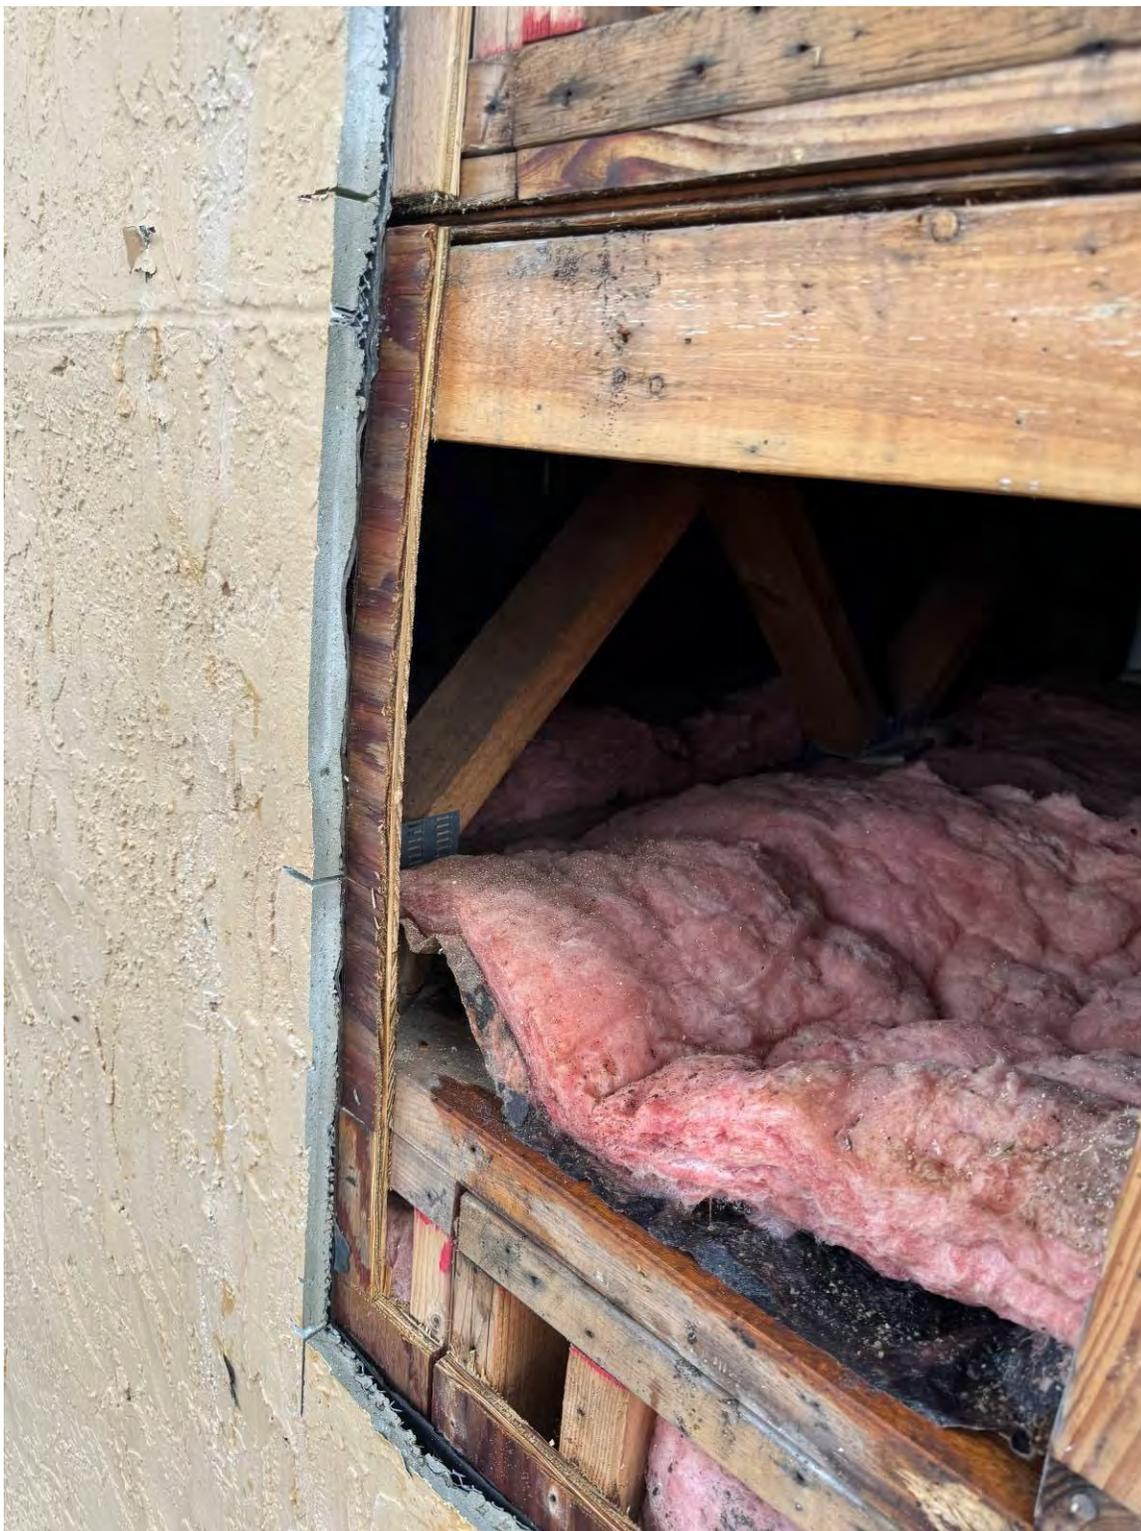
# OPENING #4

- Minor water damage to plywood flooring
- No mechanical connections from studs to bottom plate or sill plate

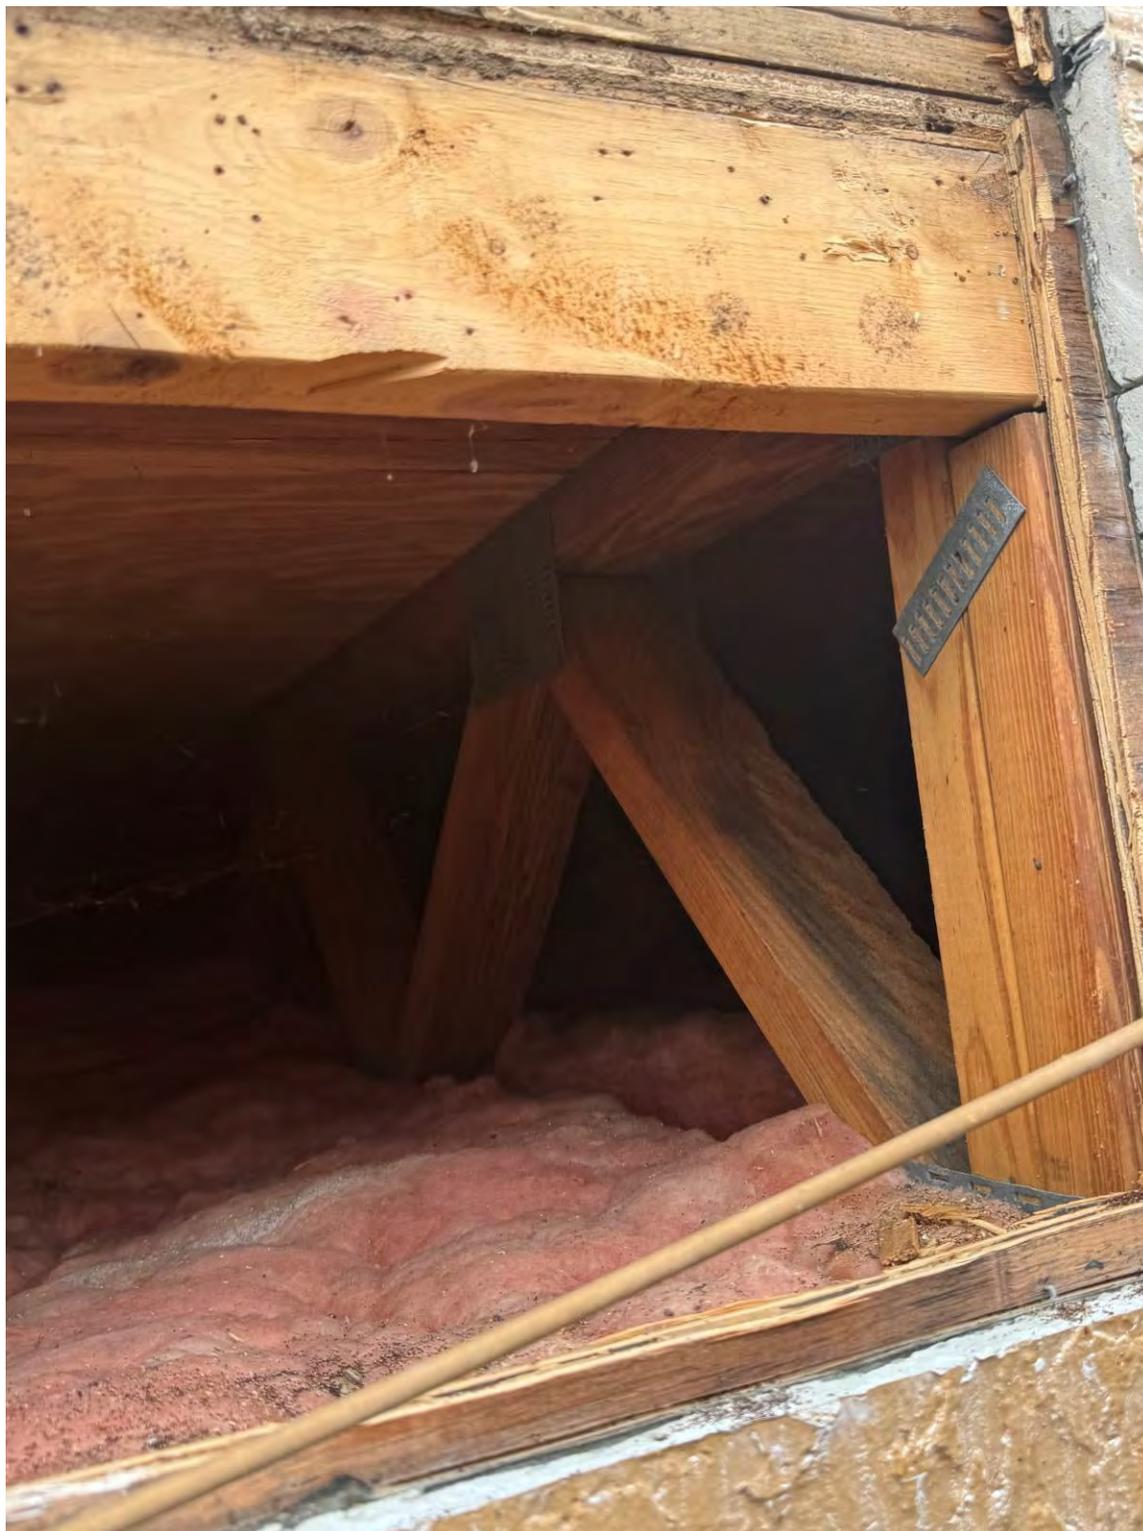
- Wall sheathing has water damage and termite damage
- 2<sup>nd</sup> floor sheathing has water damage and termite damage
- 2<sup>nd</sup> floor bearing wall bottom plate has termite damage
- 2<sup>nd</sup> floor wall studs have termite damage

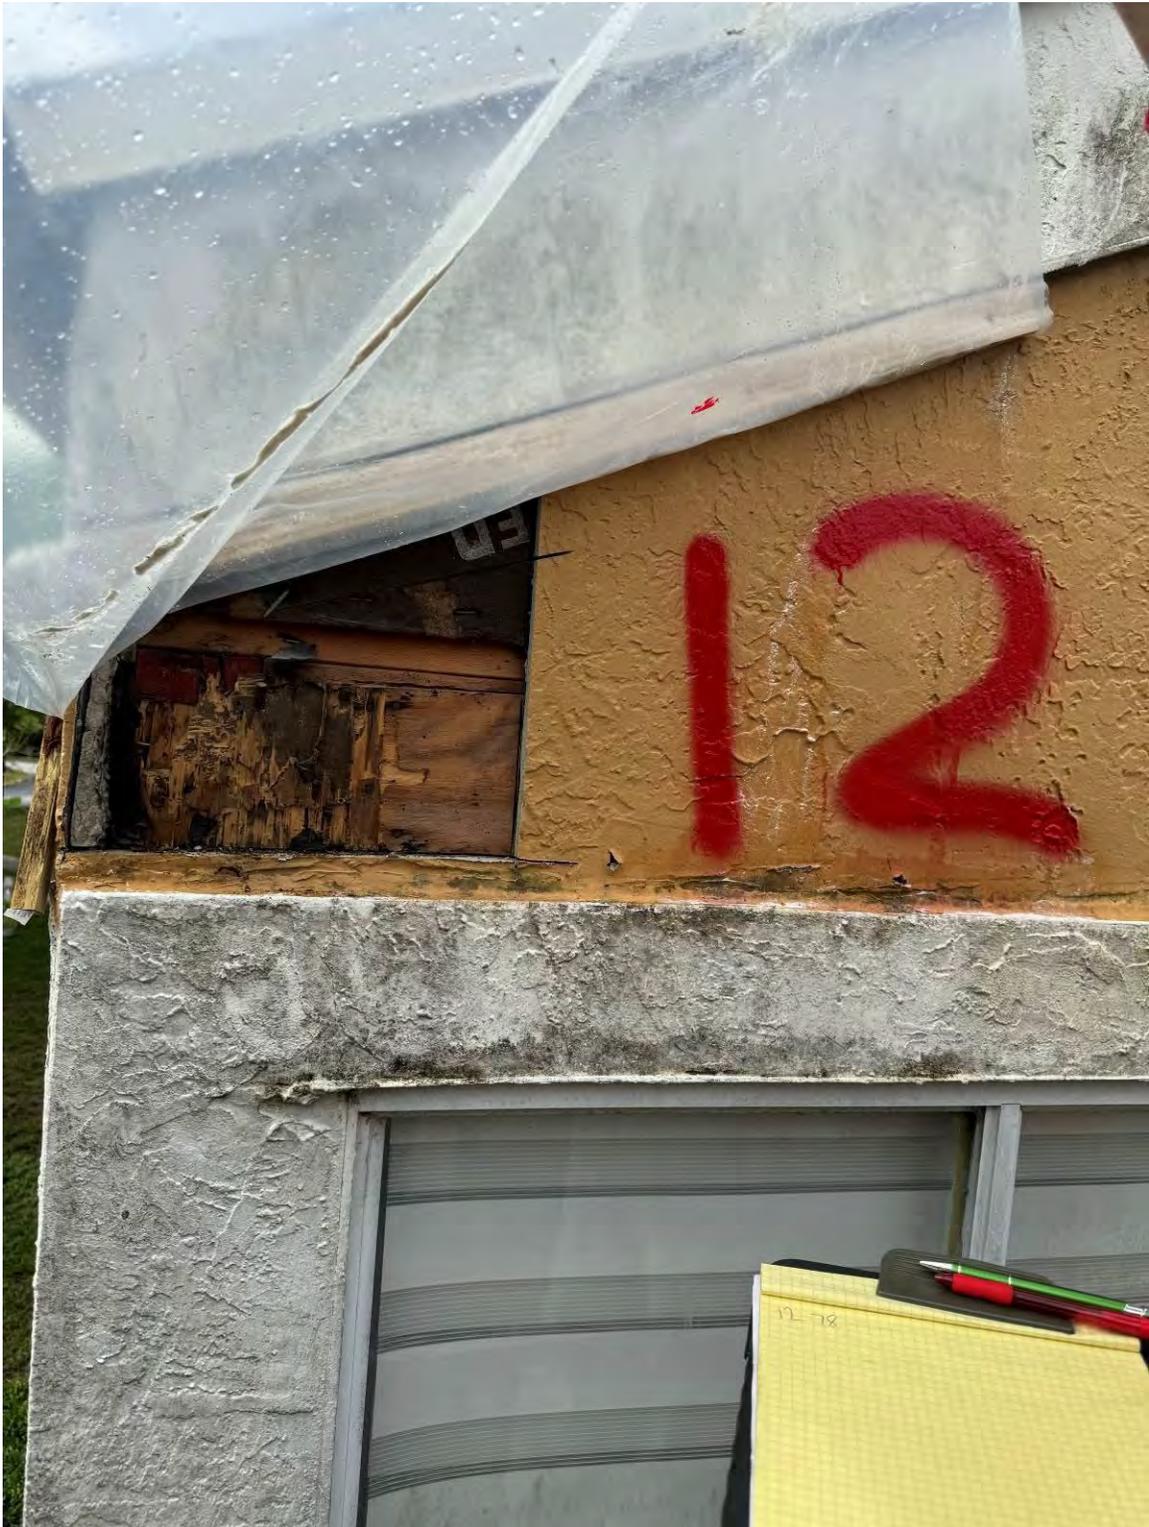
## OPENING #12 OBSERVATIONS:

- Exterior sheathing has termite damage and water damage
- Floor joist has water damage and termite damage
- Roof has no fascia board
- Feld board faces gabled end
- No visible connector for north 2<sup>nd</sup> floor wall to east 2<sup>nd</sup> floor wall
