**NOTICE OF FILING PART 1 OF FINAL ENGINEERING REPORT OF SPECIALTY  
ENGINEERING CONSULTANTS, INC. DATED NOVEMBER 5, 2024**

**PROFESSIONAL CONSULTING SERVICES FOR:  
Heron Pond Condominium Association, Inc.**

Building #9  
8343 SW 5<sup>th</sup> Street,  
Pembroke Pines, FL 33025

Re: Investigation and Documentation of Deteriorated and Damaged Structural Items

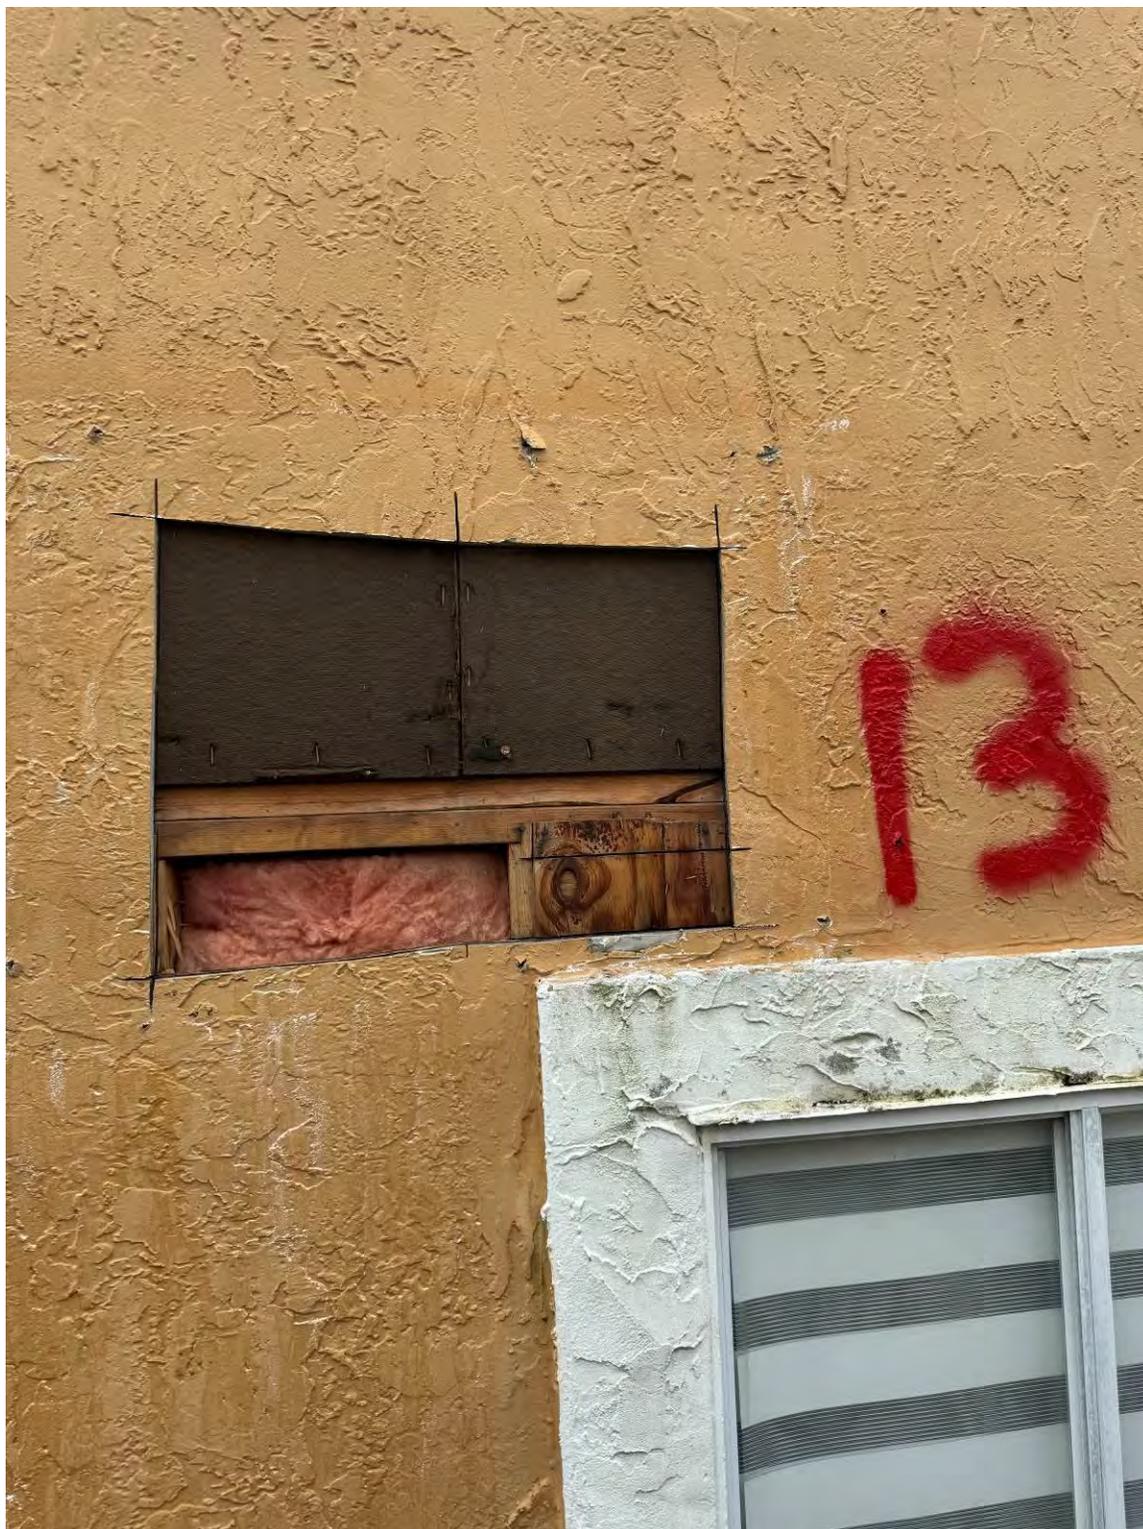
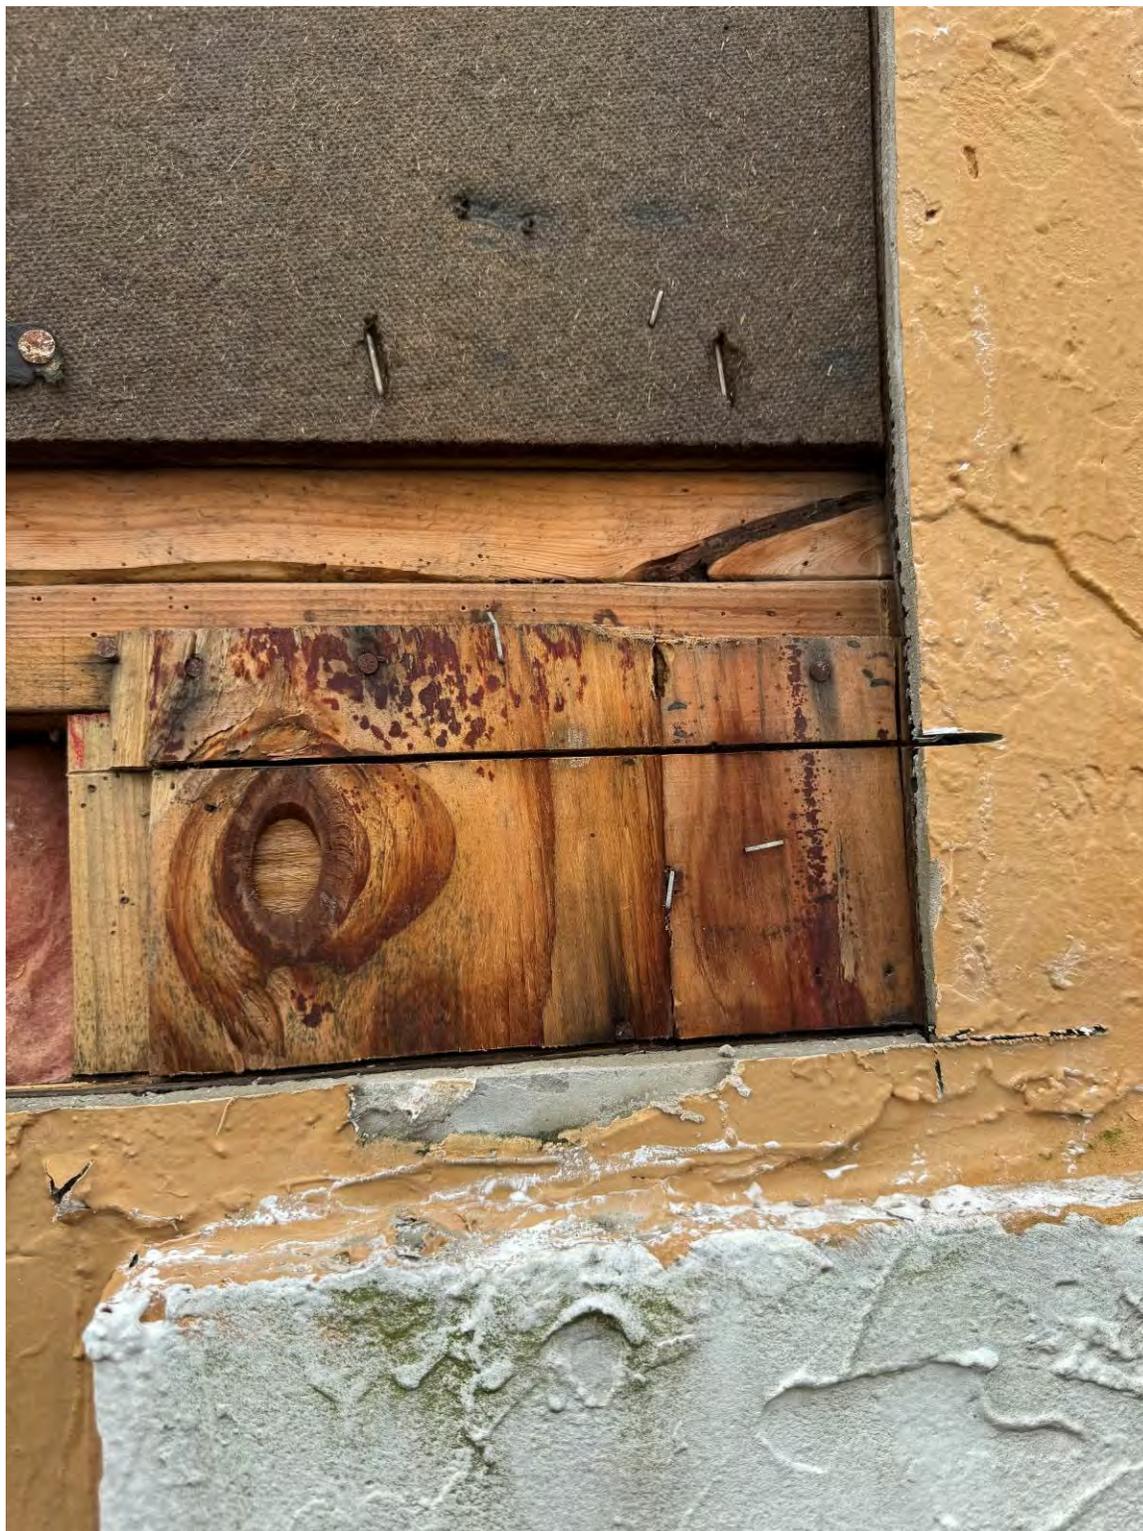
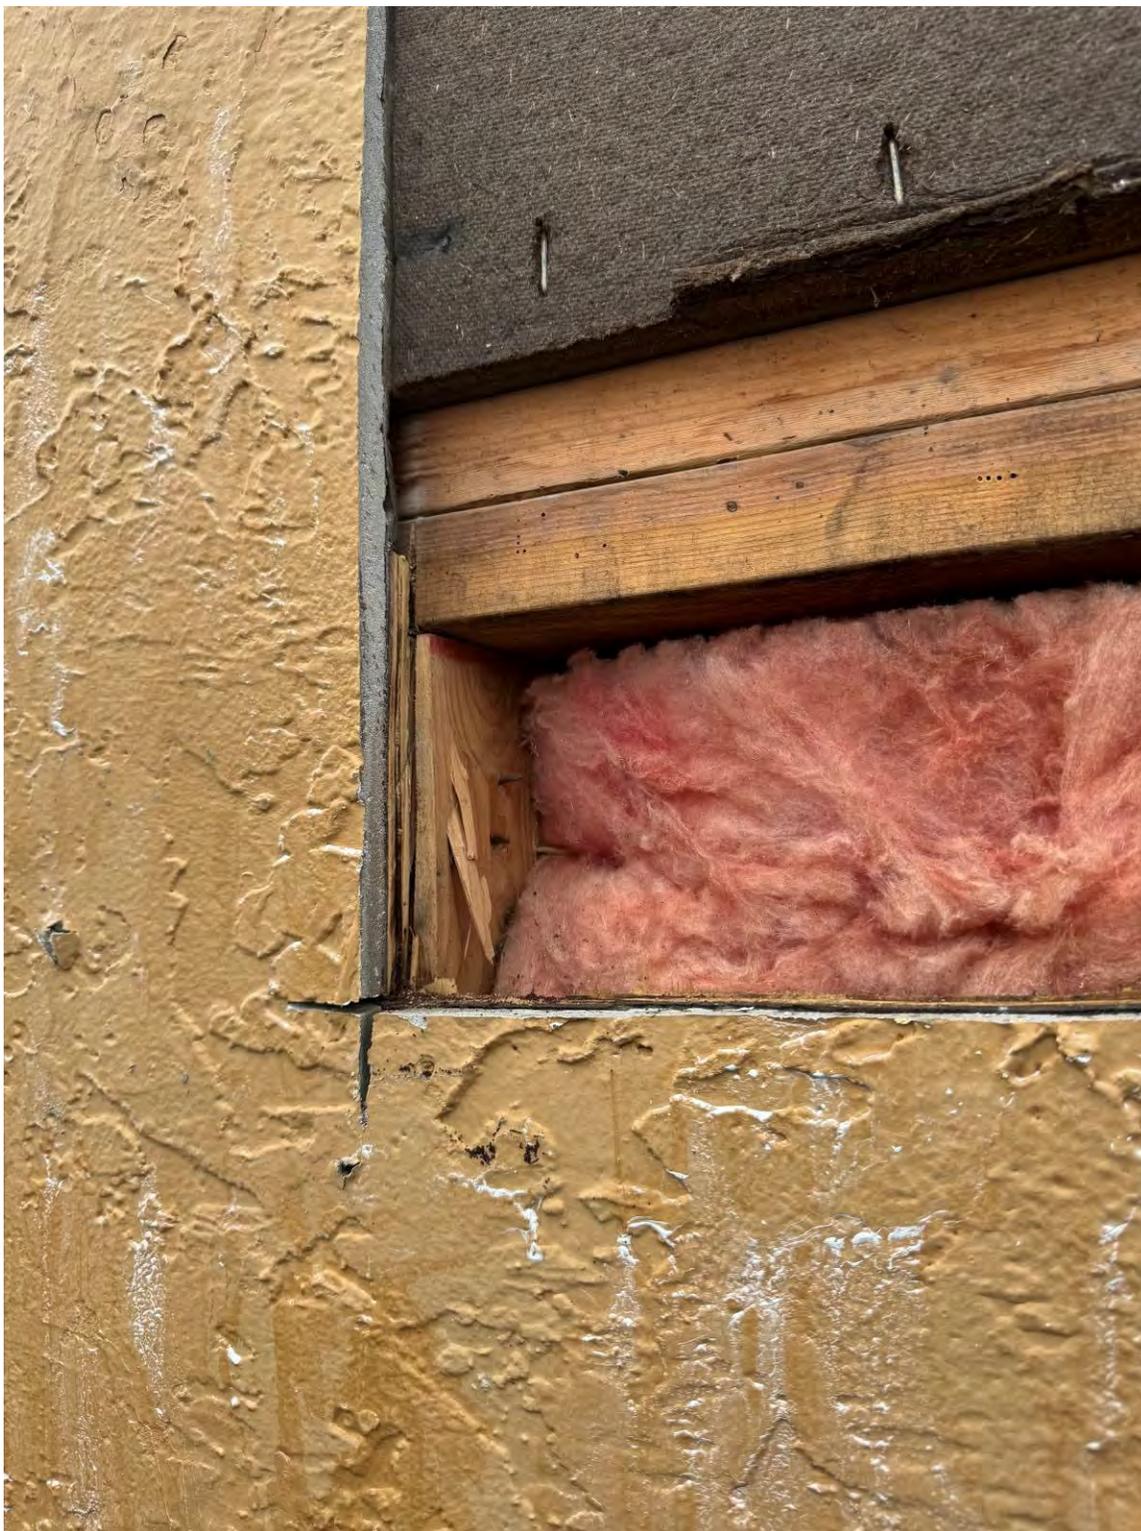
# OPENING #13

- Exterior sheathing has water damage
- Gabled end faced with felt board

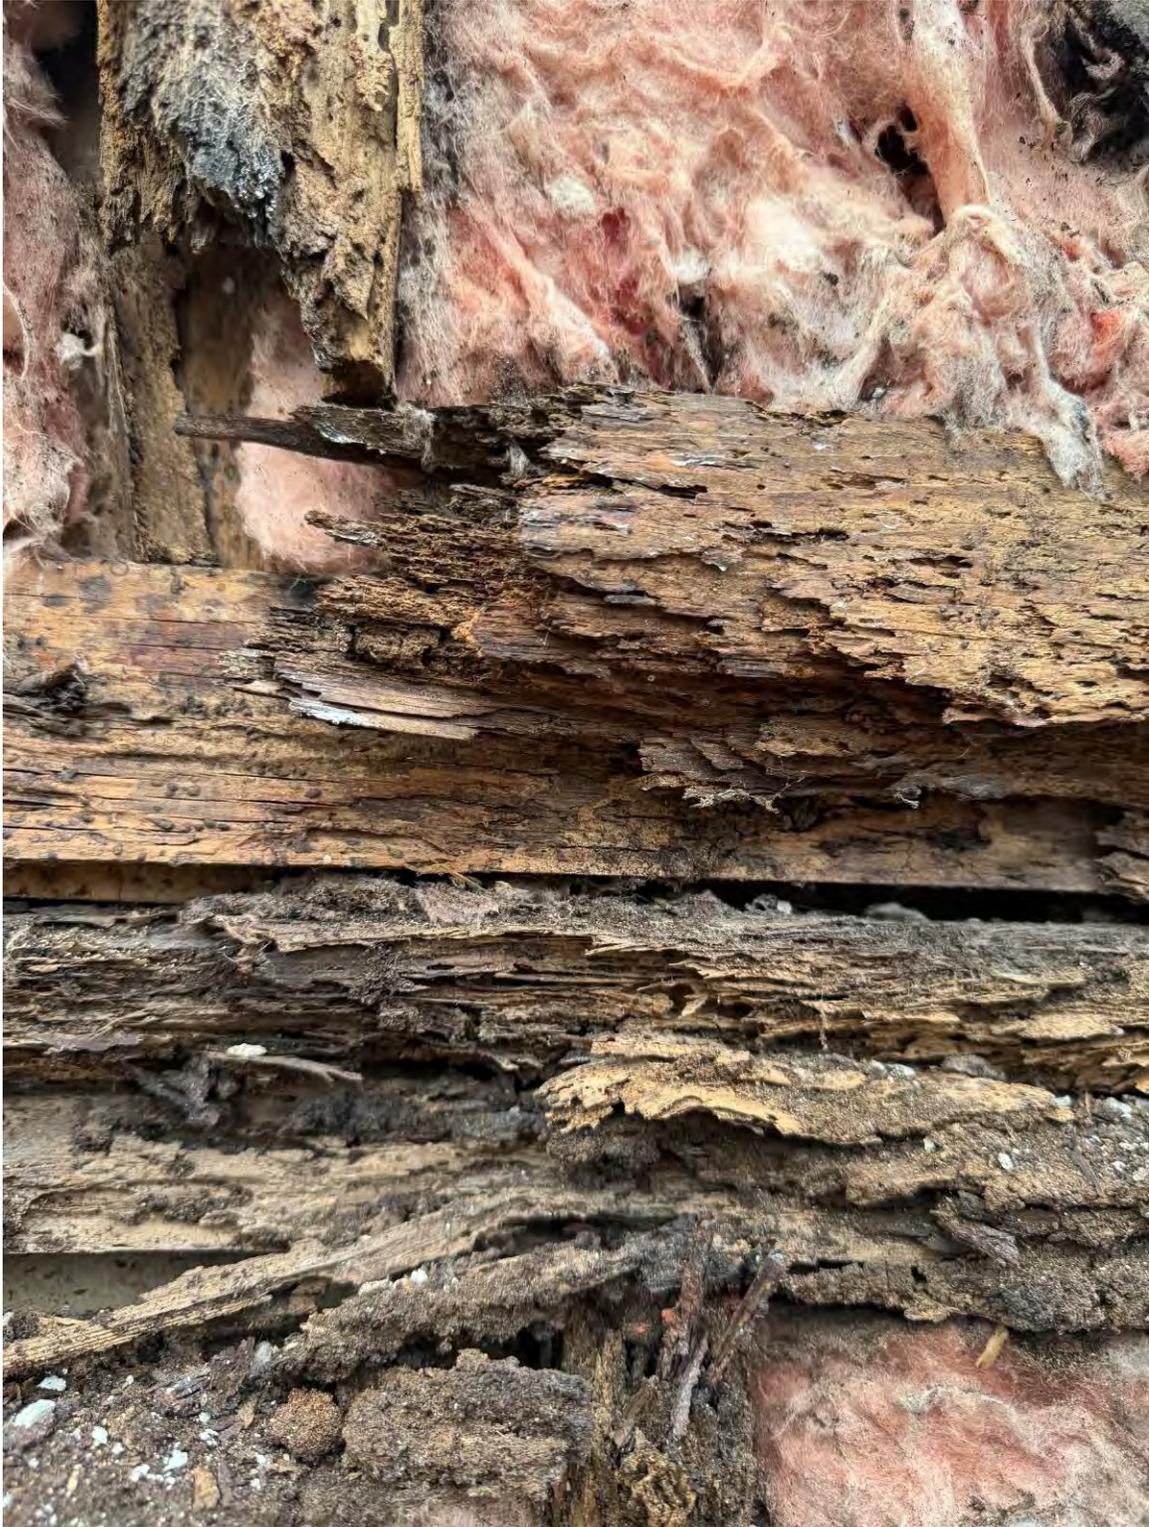
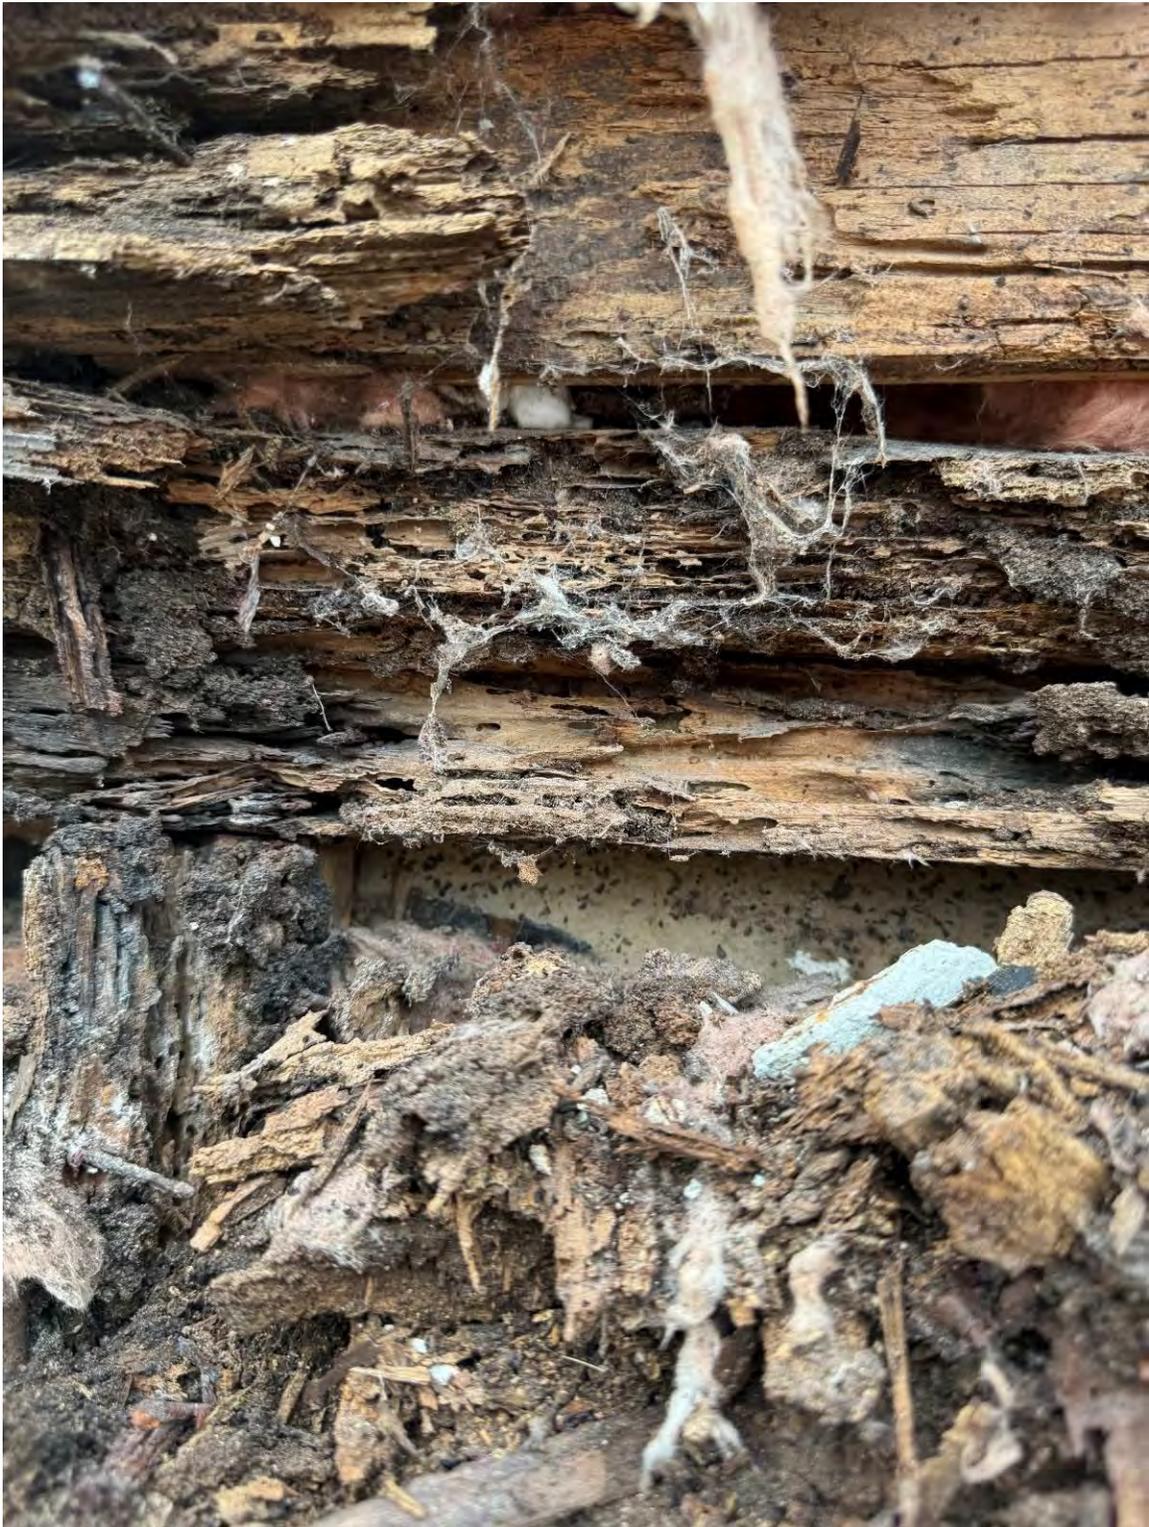
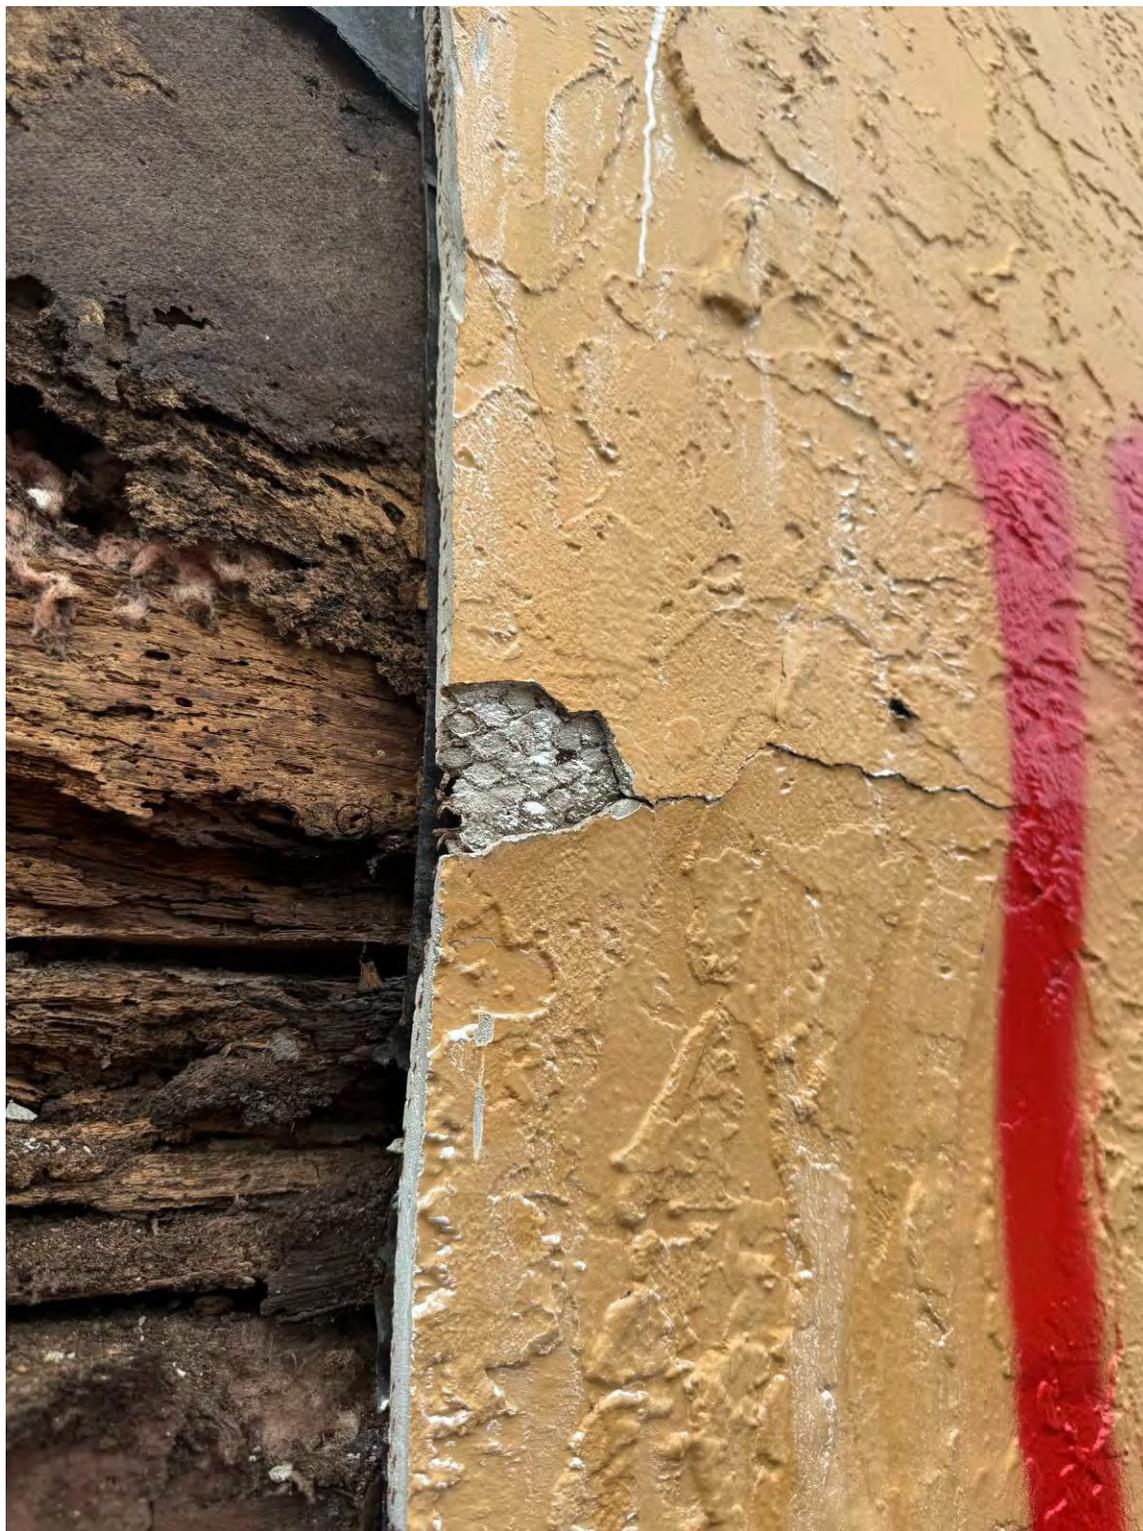
- Gabled end roof truss destroyed by water damage and termite damage
- Bearing wall top plate destroyed by water damage and termite damage
- Bearing wall studs destroyed by water damage and termite damage
- Wall sheathing destroyed by water damage and termite damage
- Gabled end faced with felt board
