**NOTICE OF FILING PART 2 OF FINAL ENGINEERING REPORT OF SPECIALTY  
ENGINEERING CONSULTANTS, INC. DATED NOVEMBER 5, 2024**

Daniel J. Stermer, not individually, but solely in his capacity as Court Appointed Receiver (the "Receiver"), over the Heron Pond Condominium Association, Inc., (the "Association") by and through its undersigned counsel, hereby gives notice of filing Part 2 of the attached final Engineering Report of Specialty Engineering Consultants, Inc. dated November 5, 2024, opining on the existing condition of Building 9.

# OPENING #15

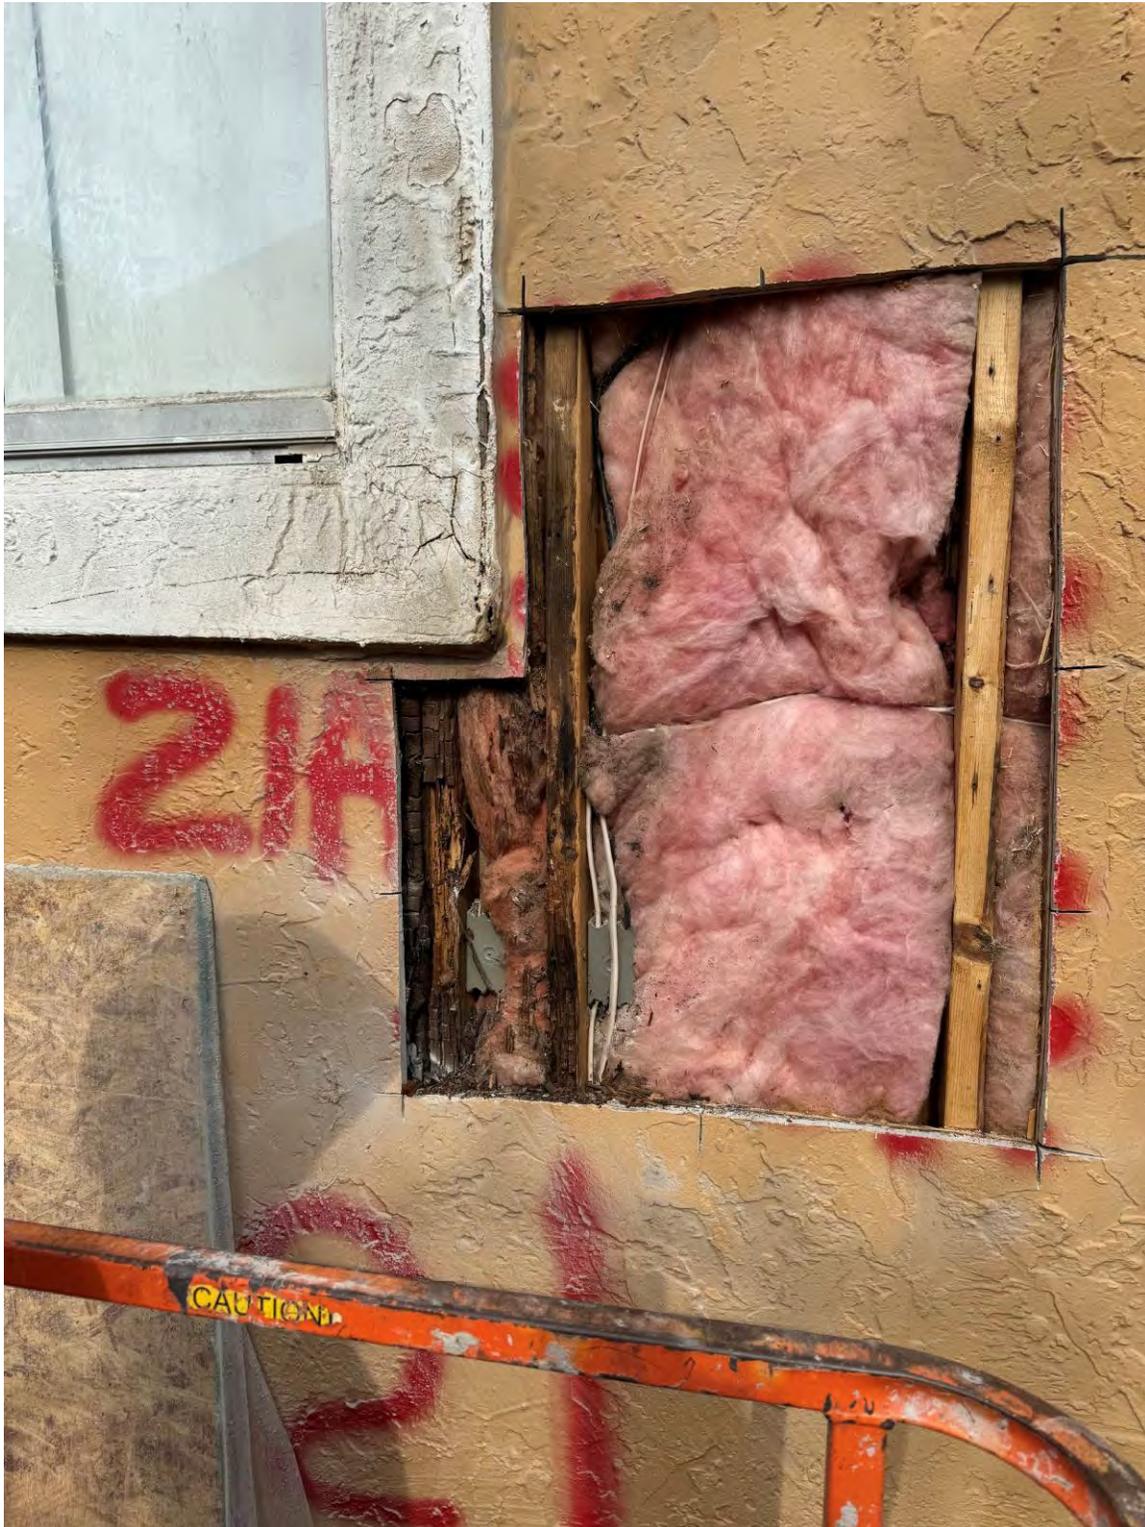
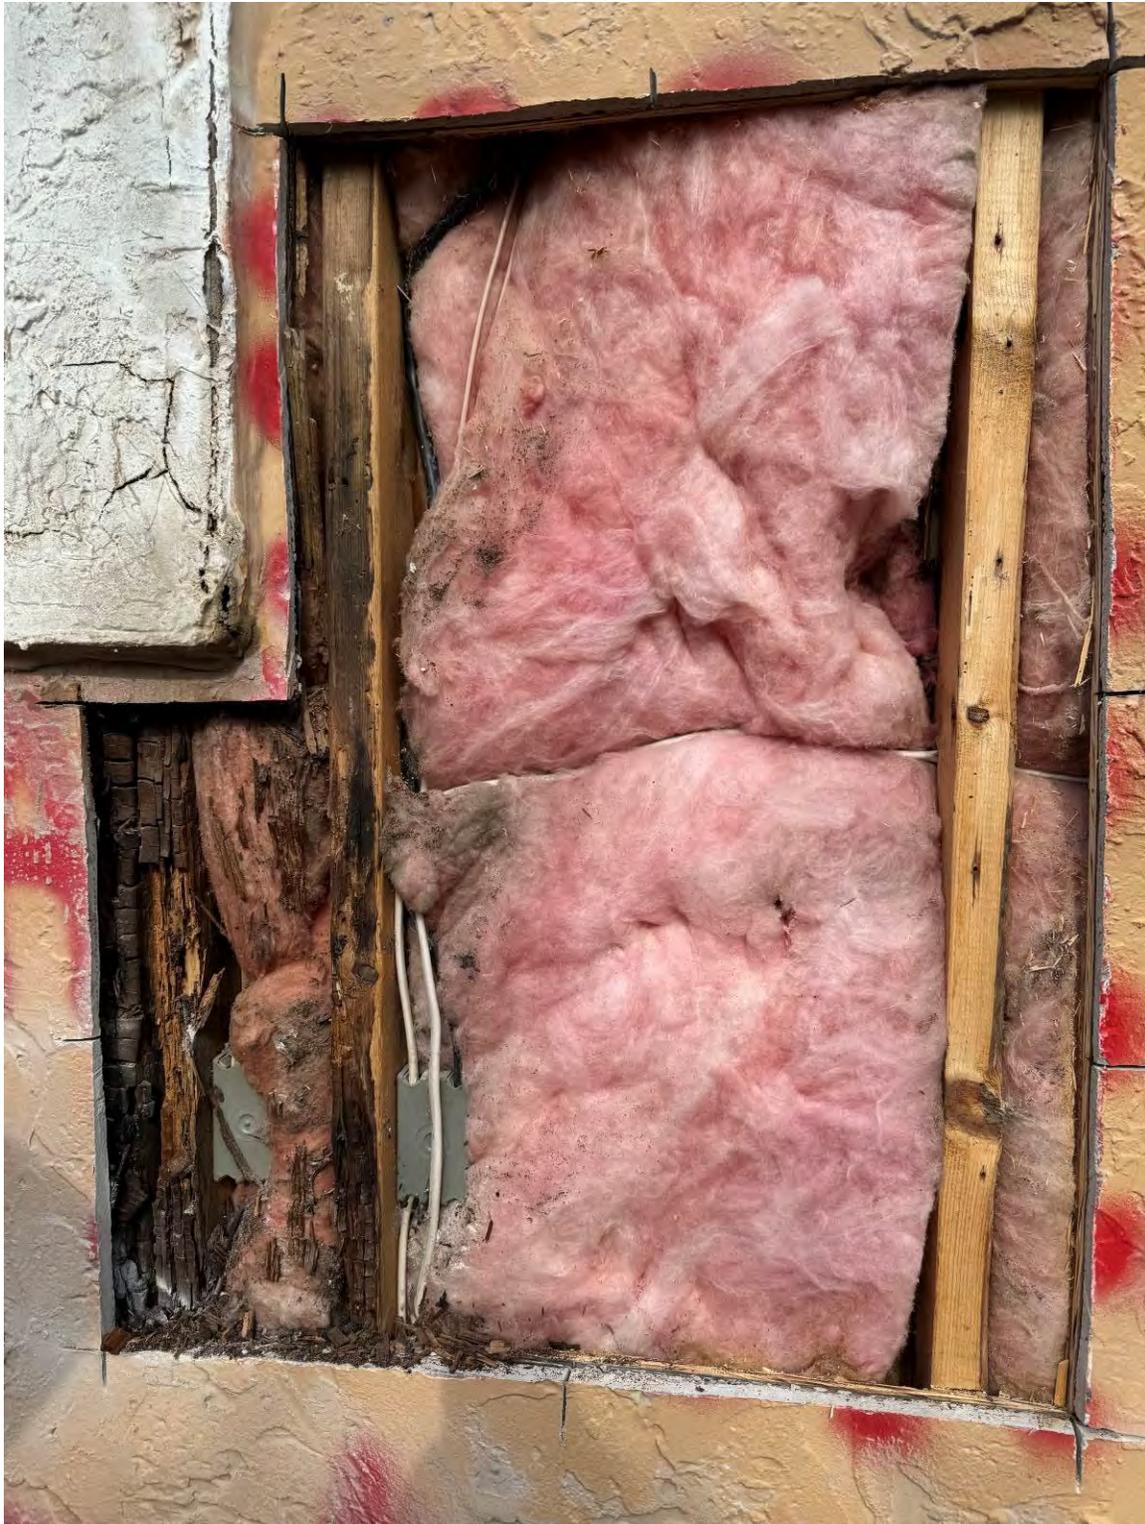
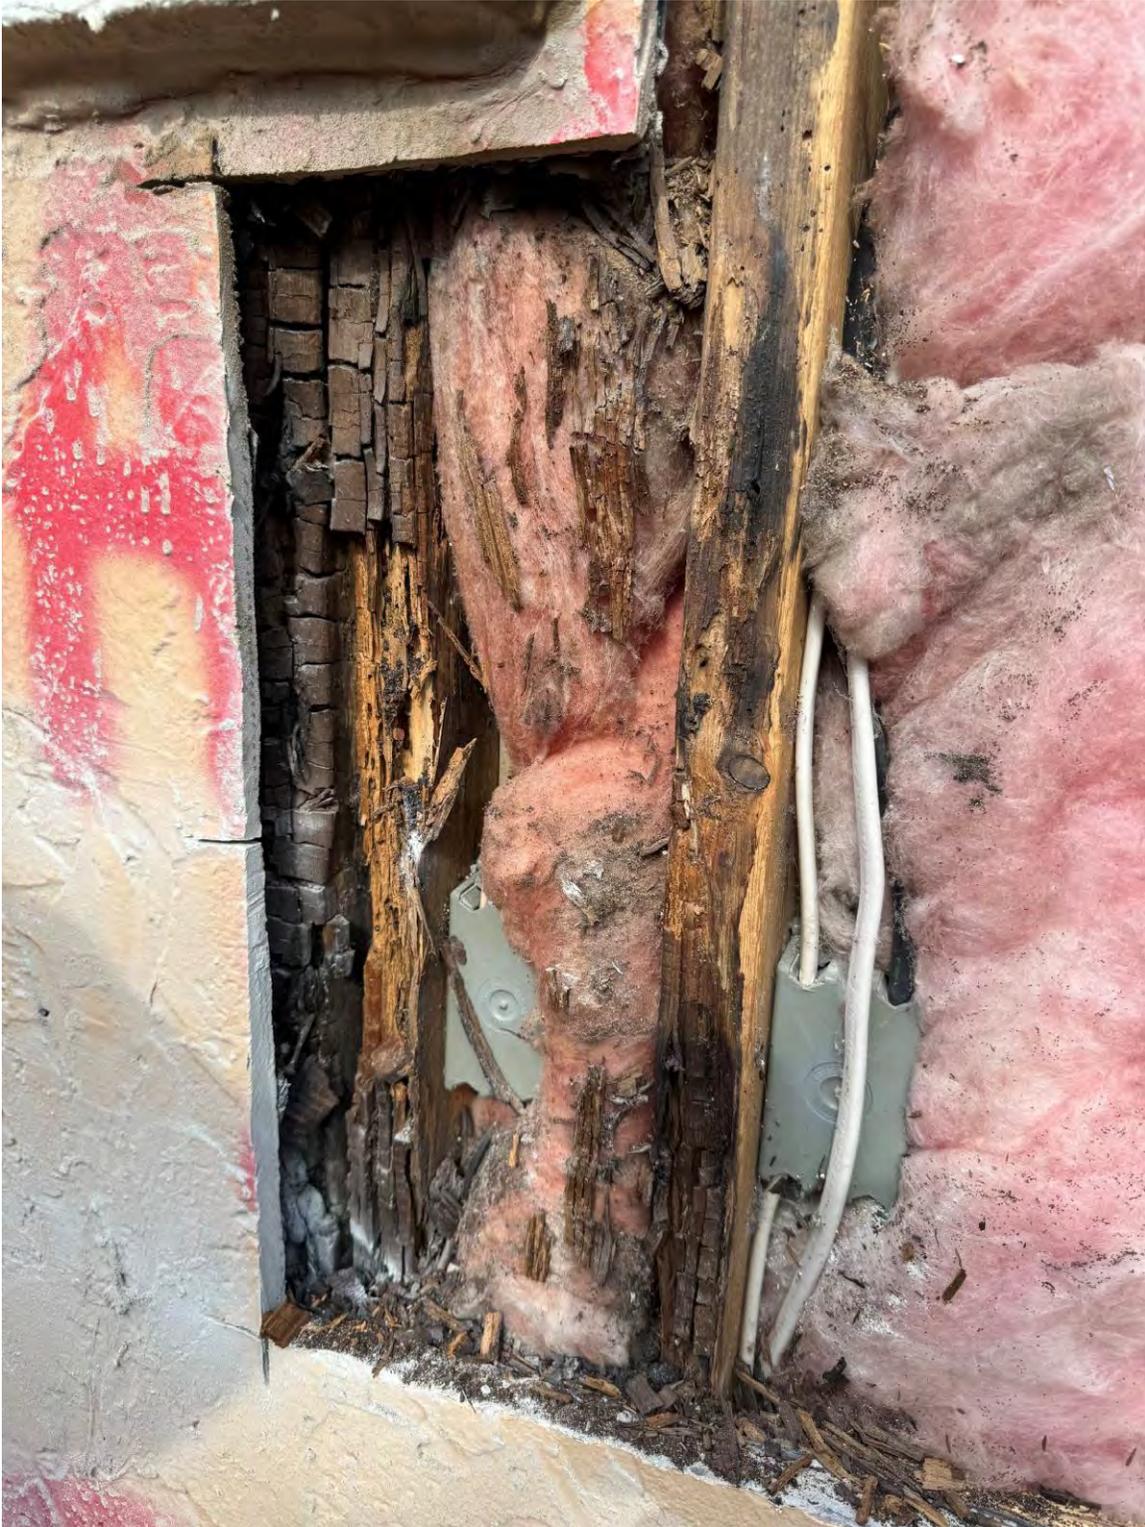
# OPENING #21A

- 2<sup>nd</sup> floor wall stud water damage and termite damage
- Water intrusion around window

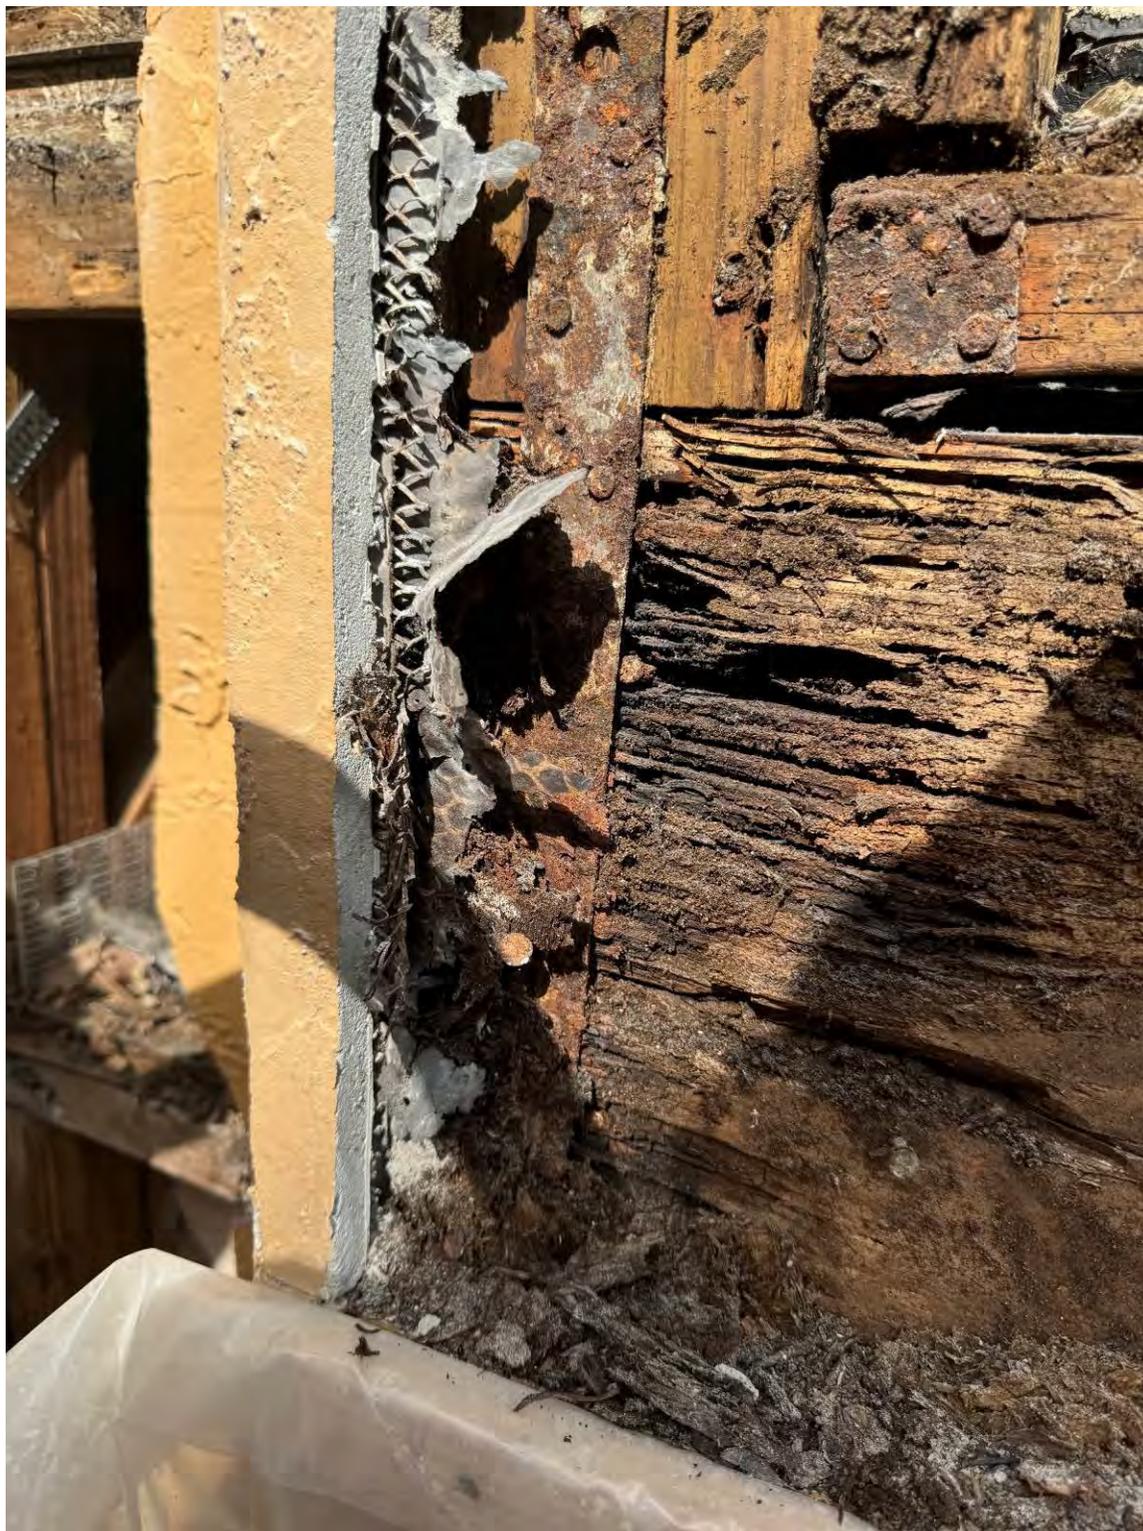
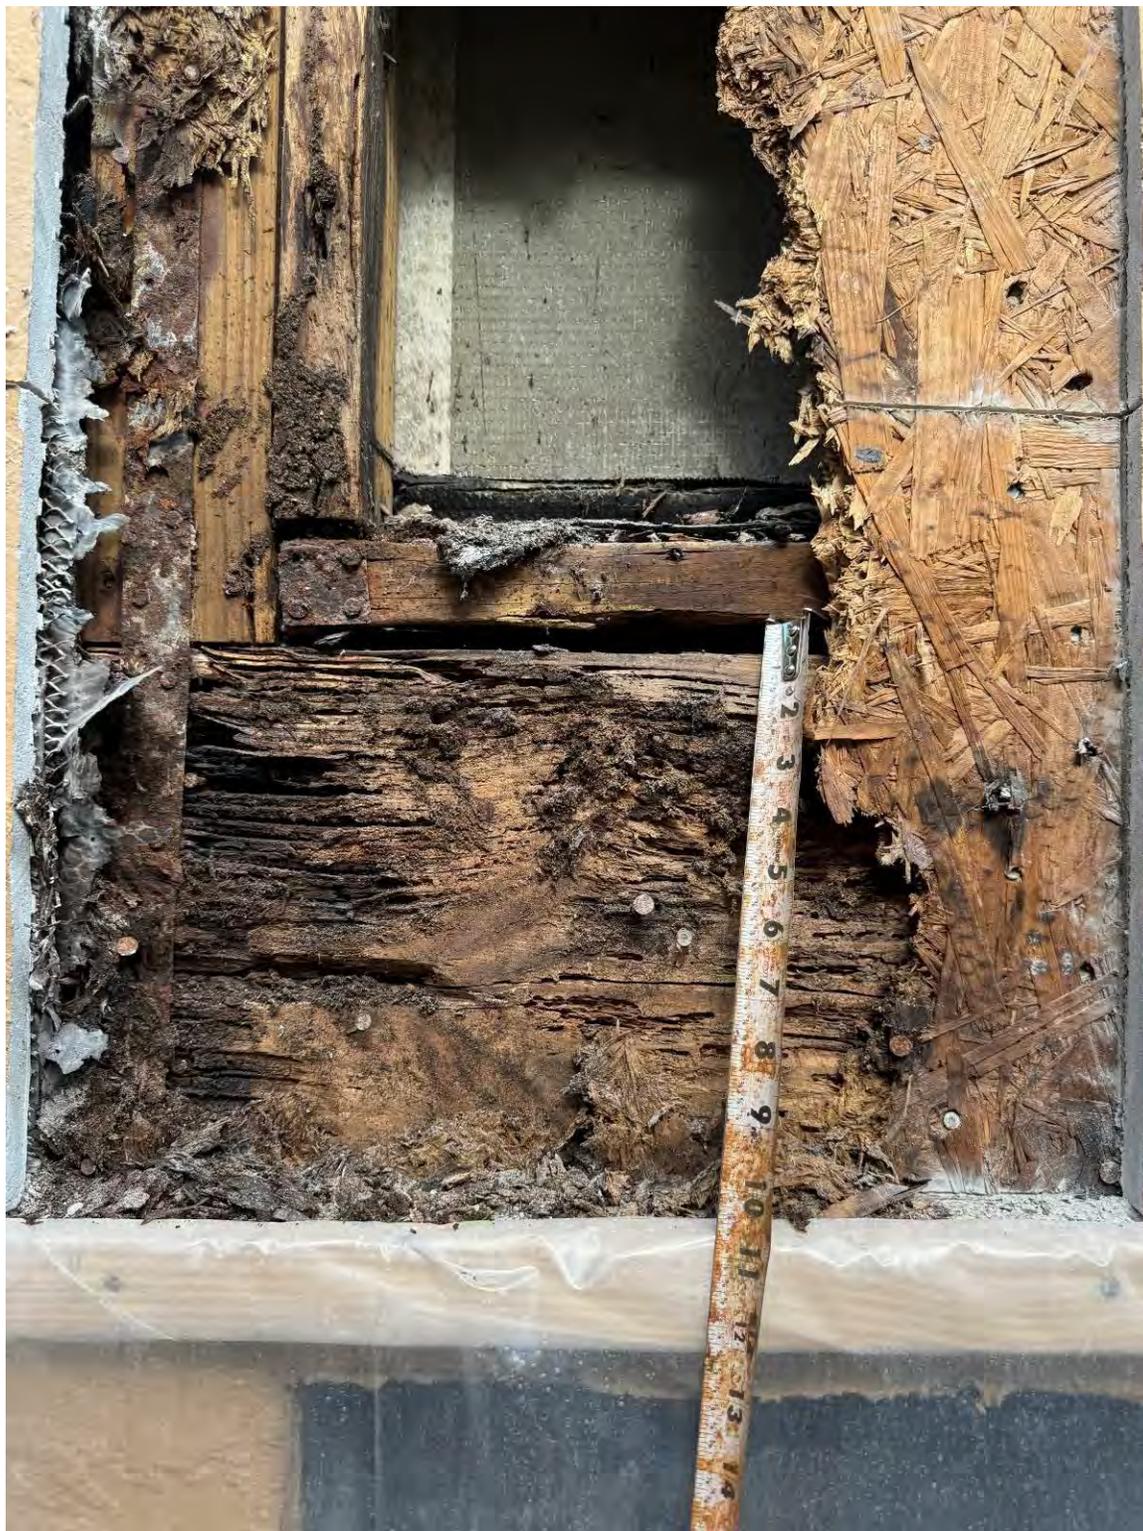
- 2x12 floor joist termite damage and water damage
- 2<sup>nd</sup> floor wall studs termite damage and water damage
- Evidence of a metal connecting plate at 1 wall stud to bottom plate completely deteriorated
- Wall sheathing OSB
- 3/4" gap between floor joist and sill plate indicating deflection of floor joist
- At end of cut, the gap is 3/4"
- At start of cut, gap is 3/8"
- Metal strap deteriorated = comprised

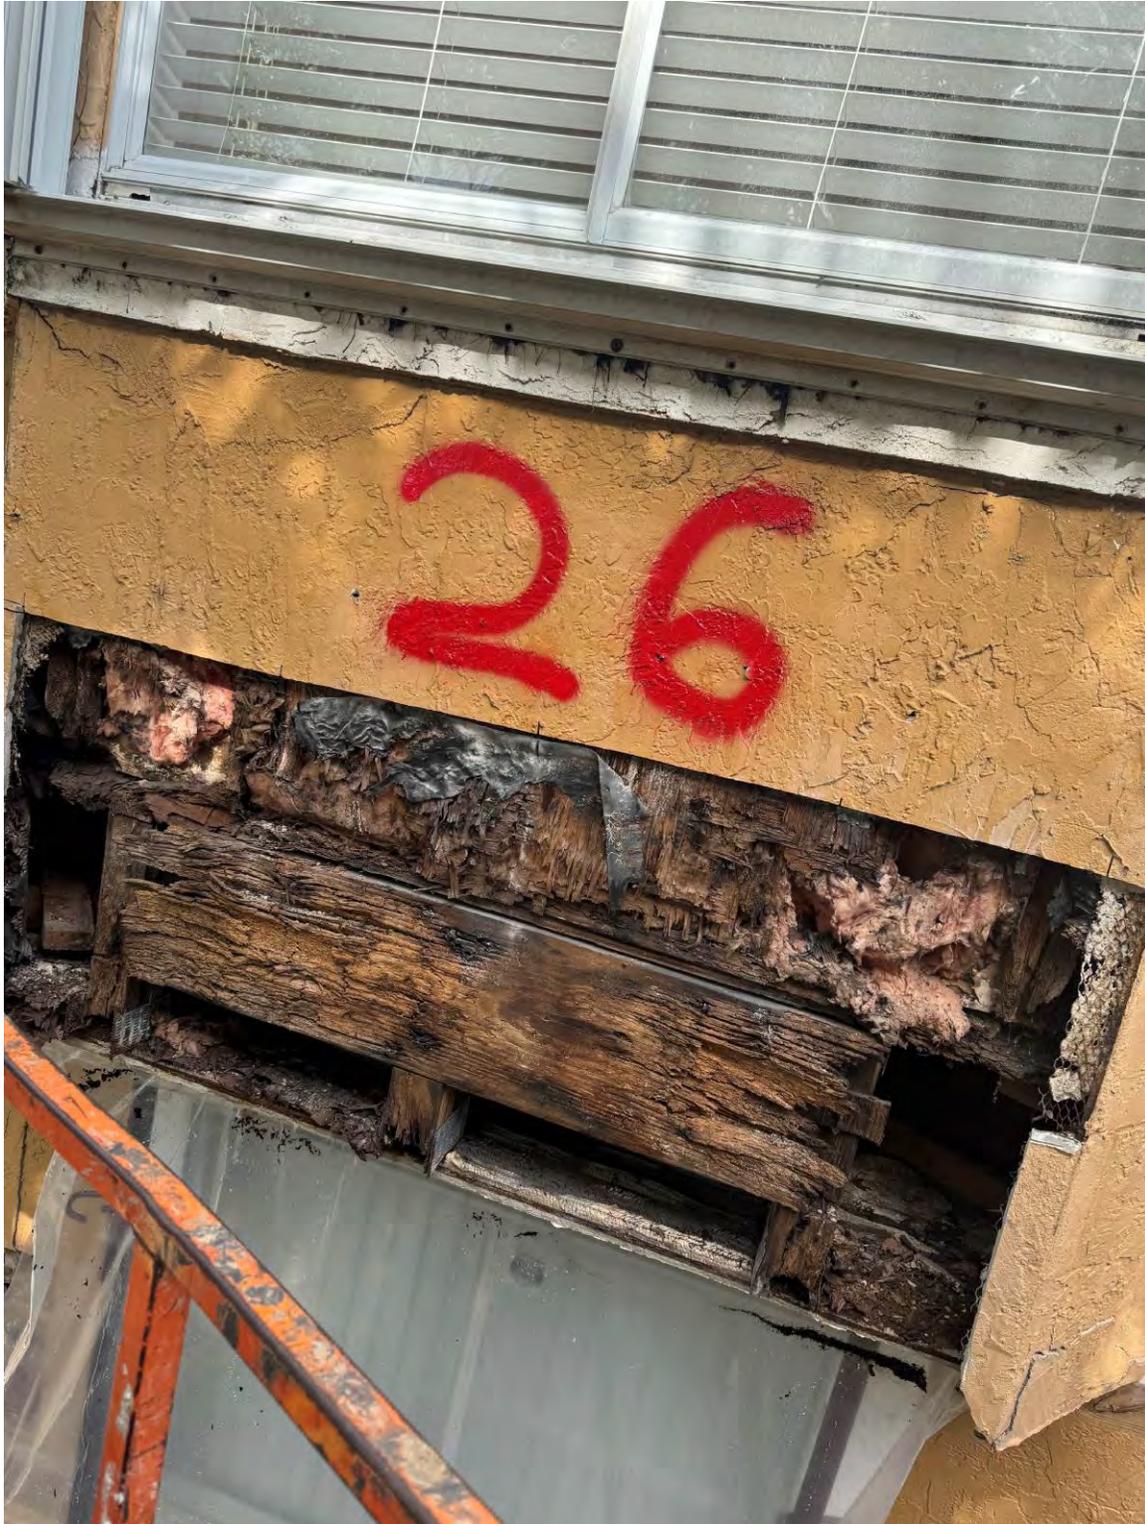
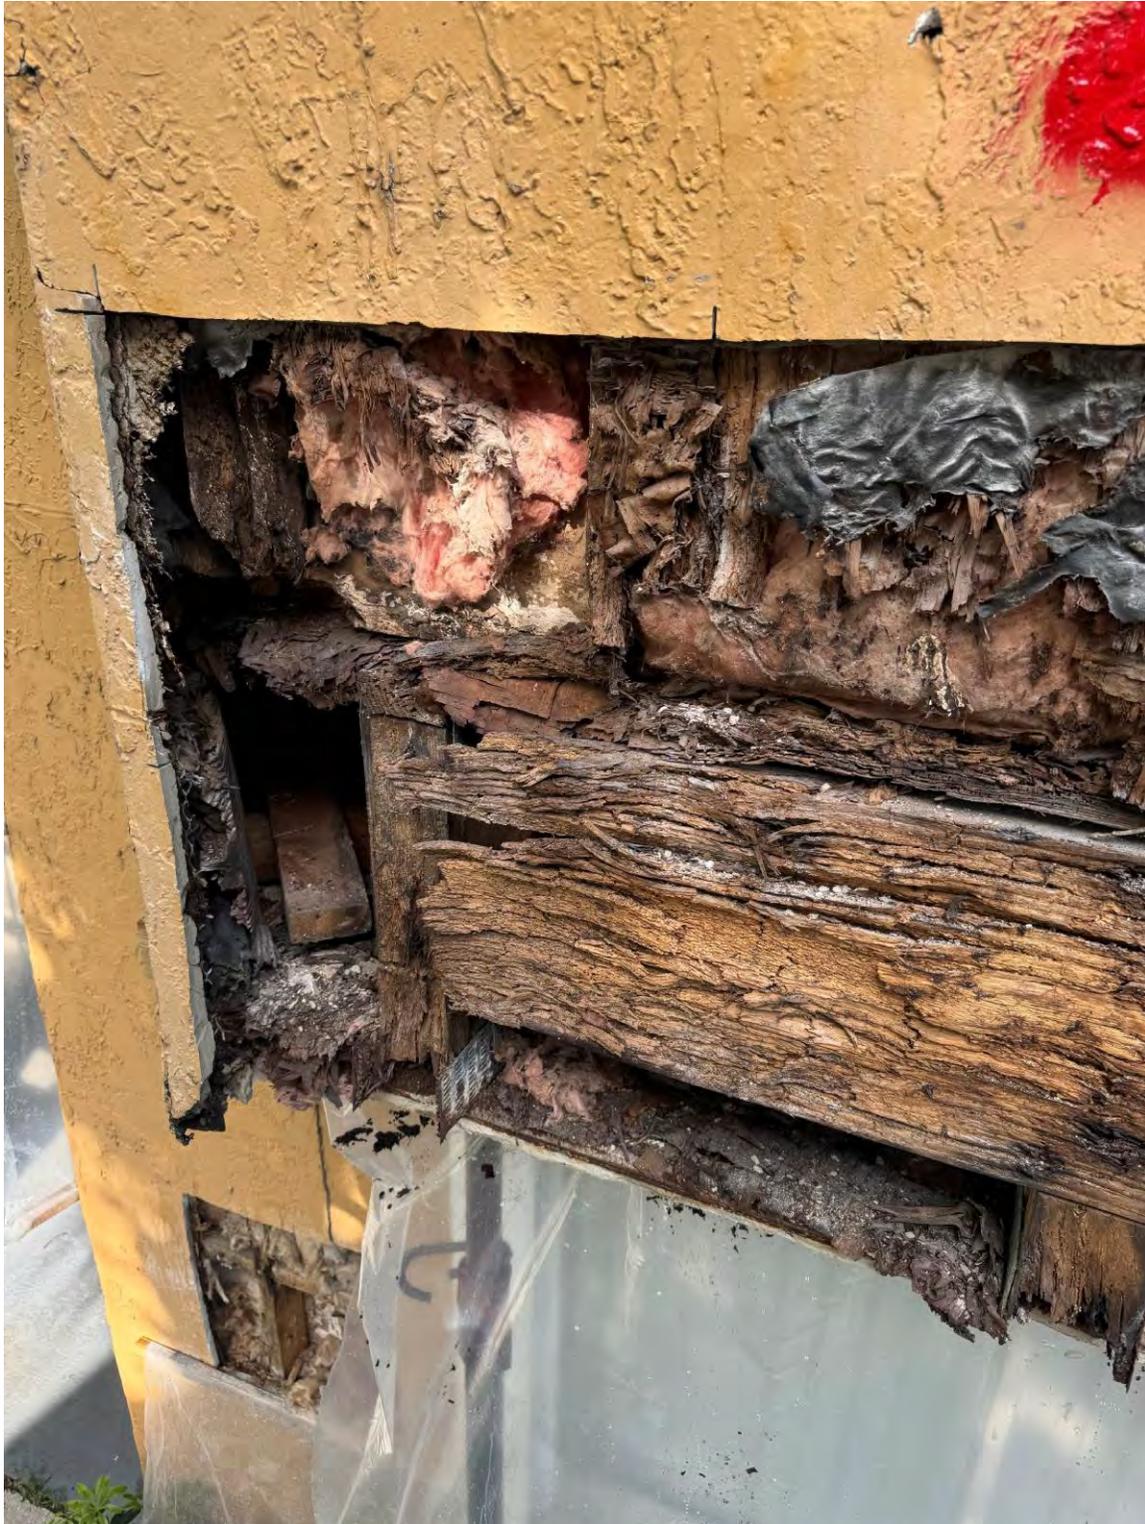
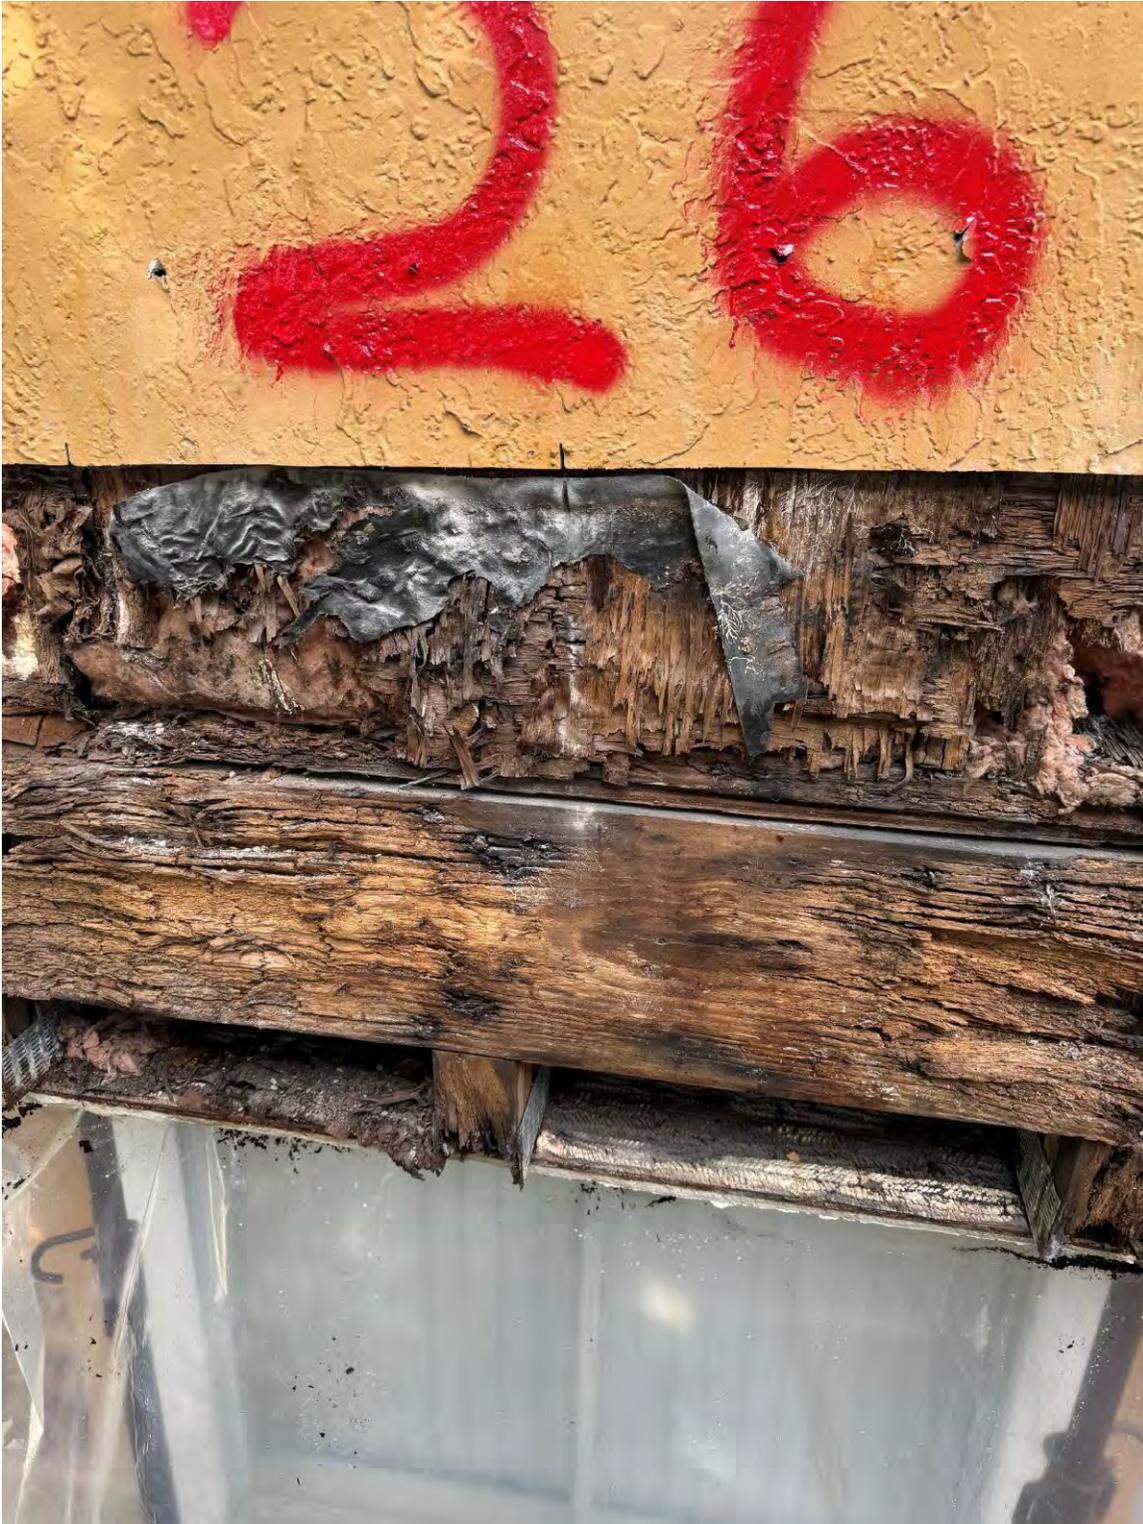
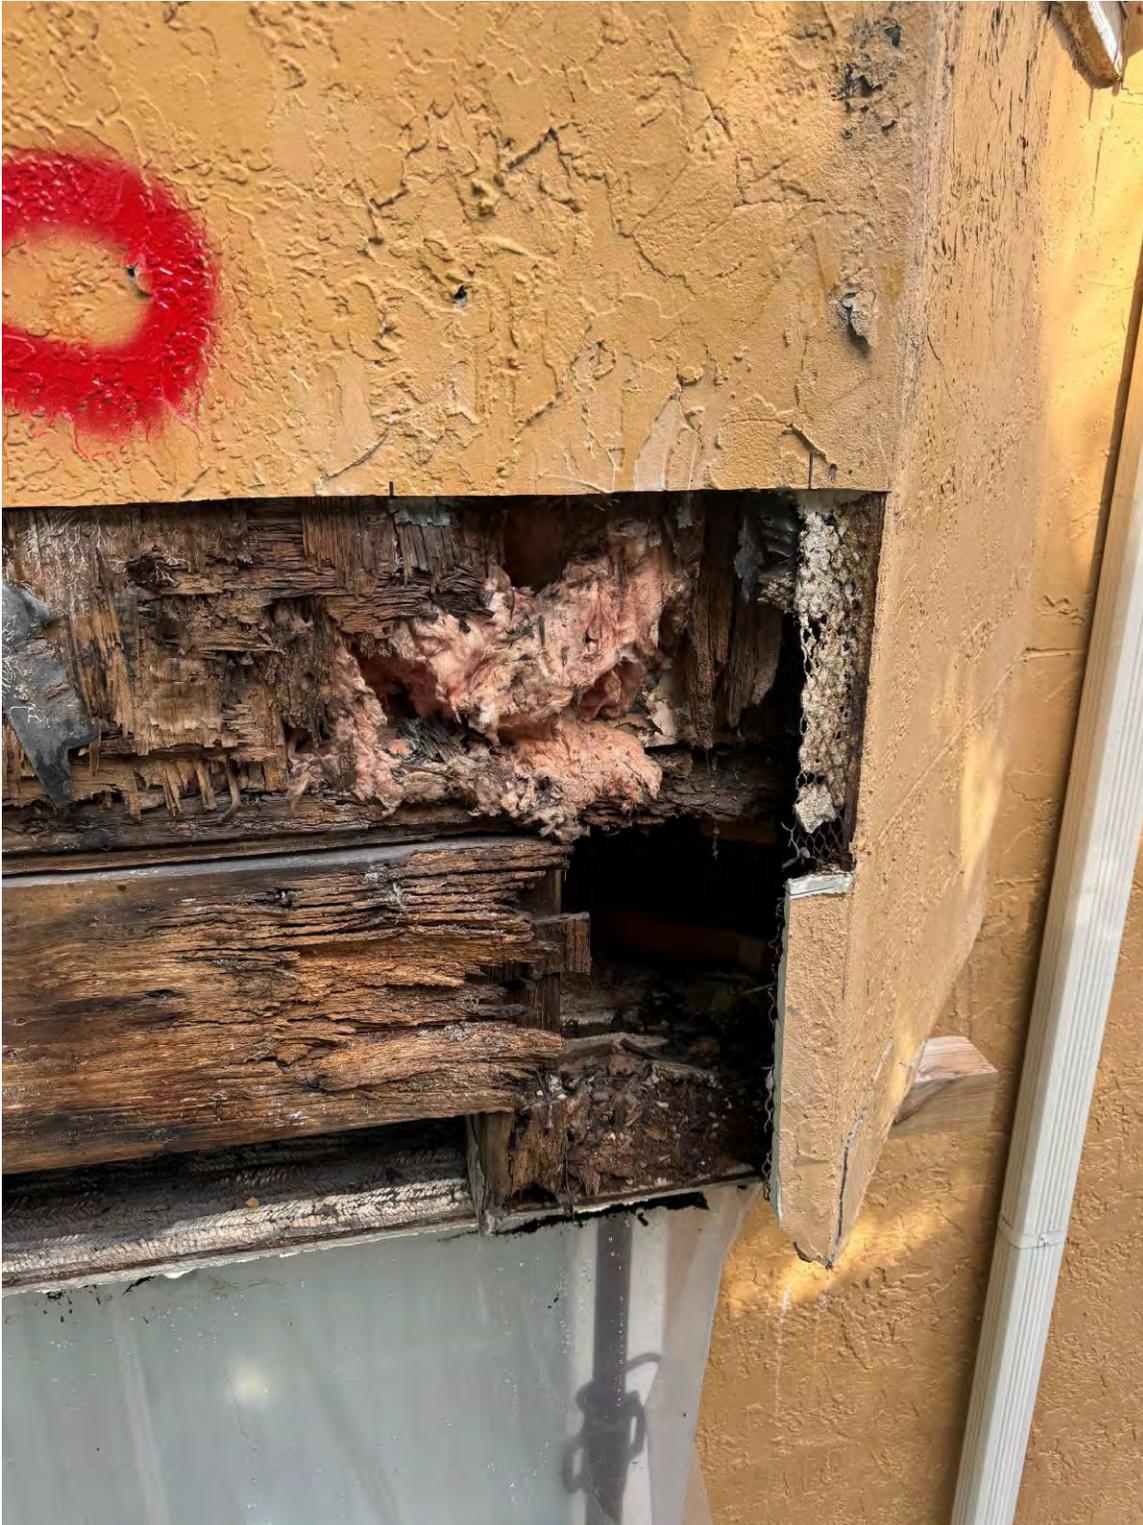
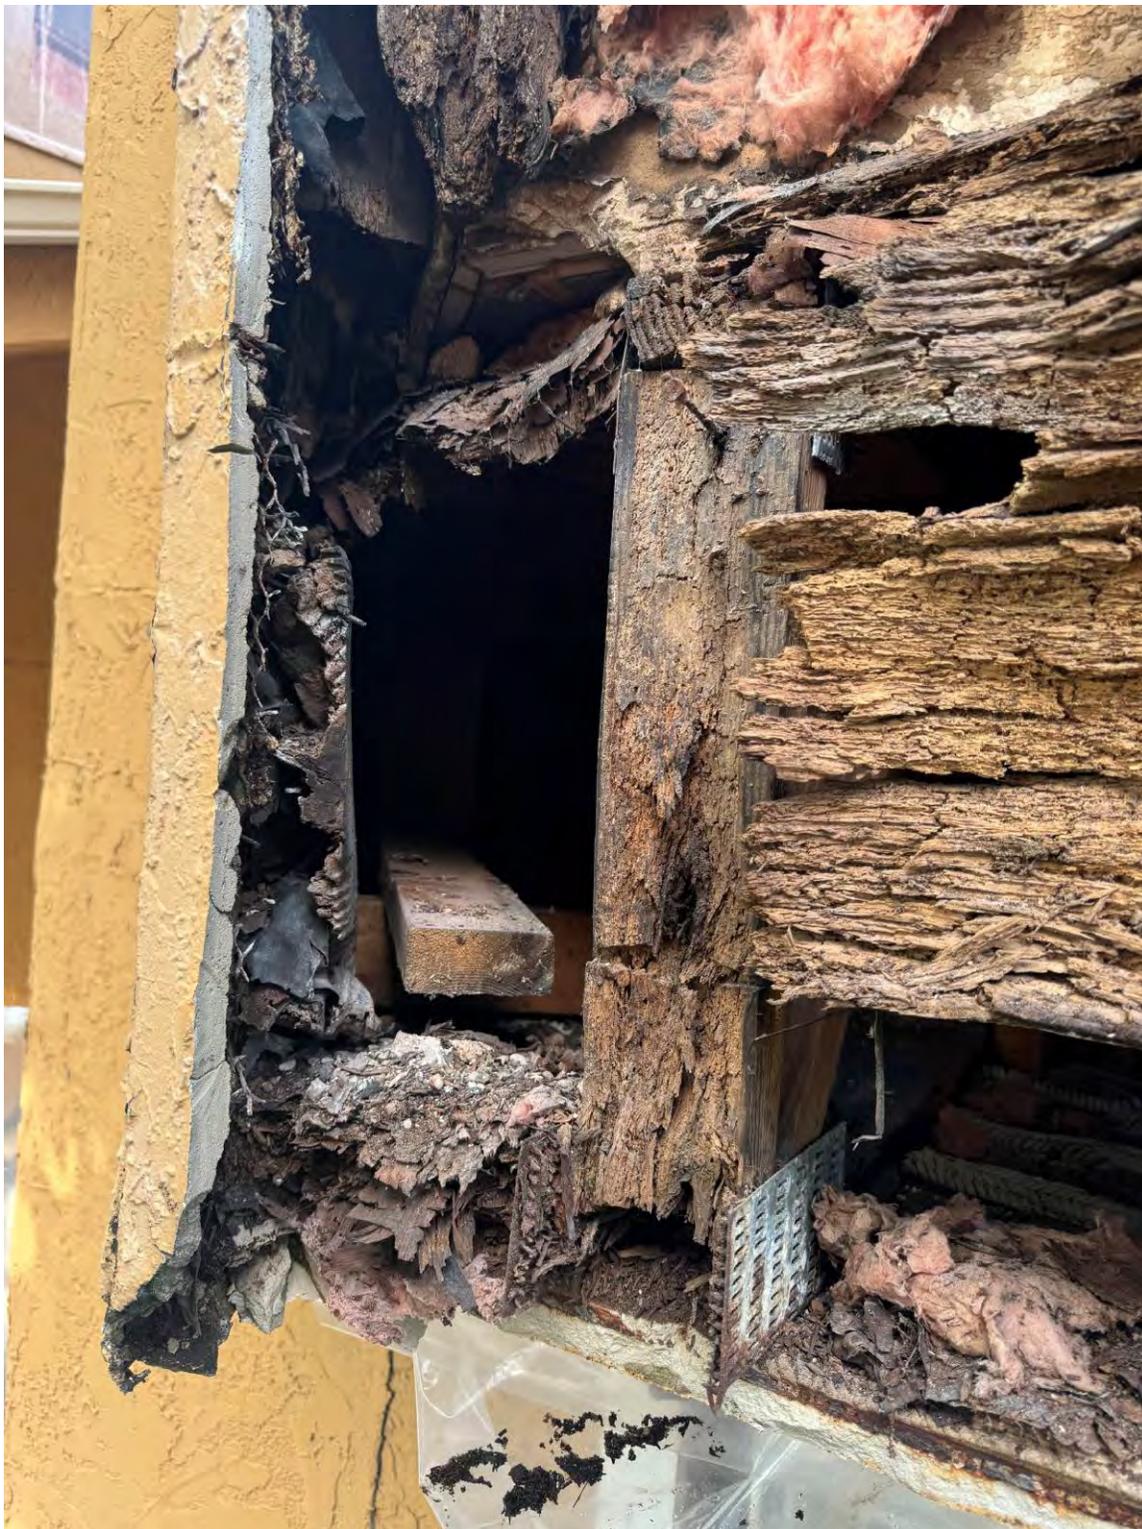
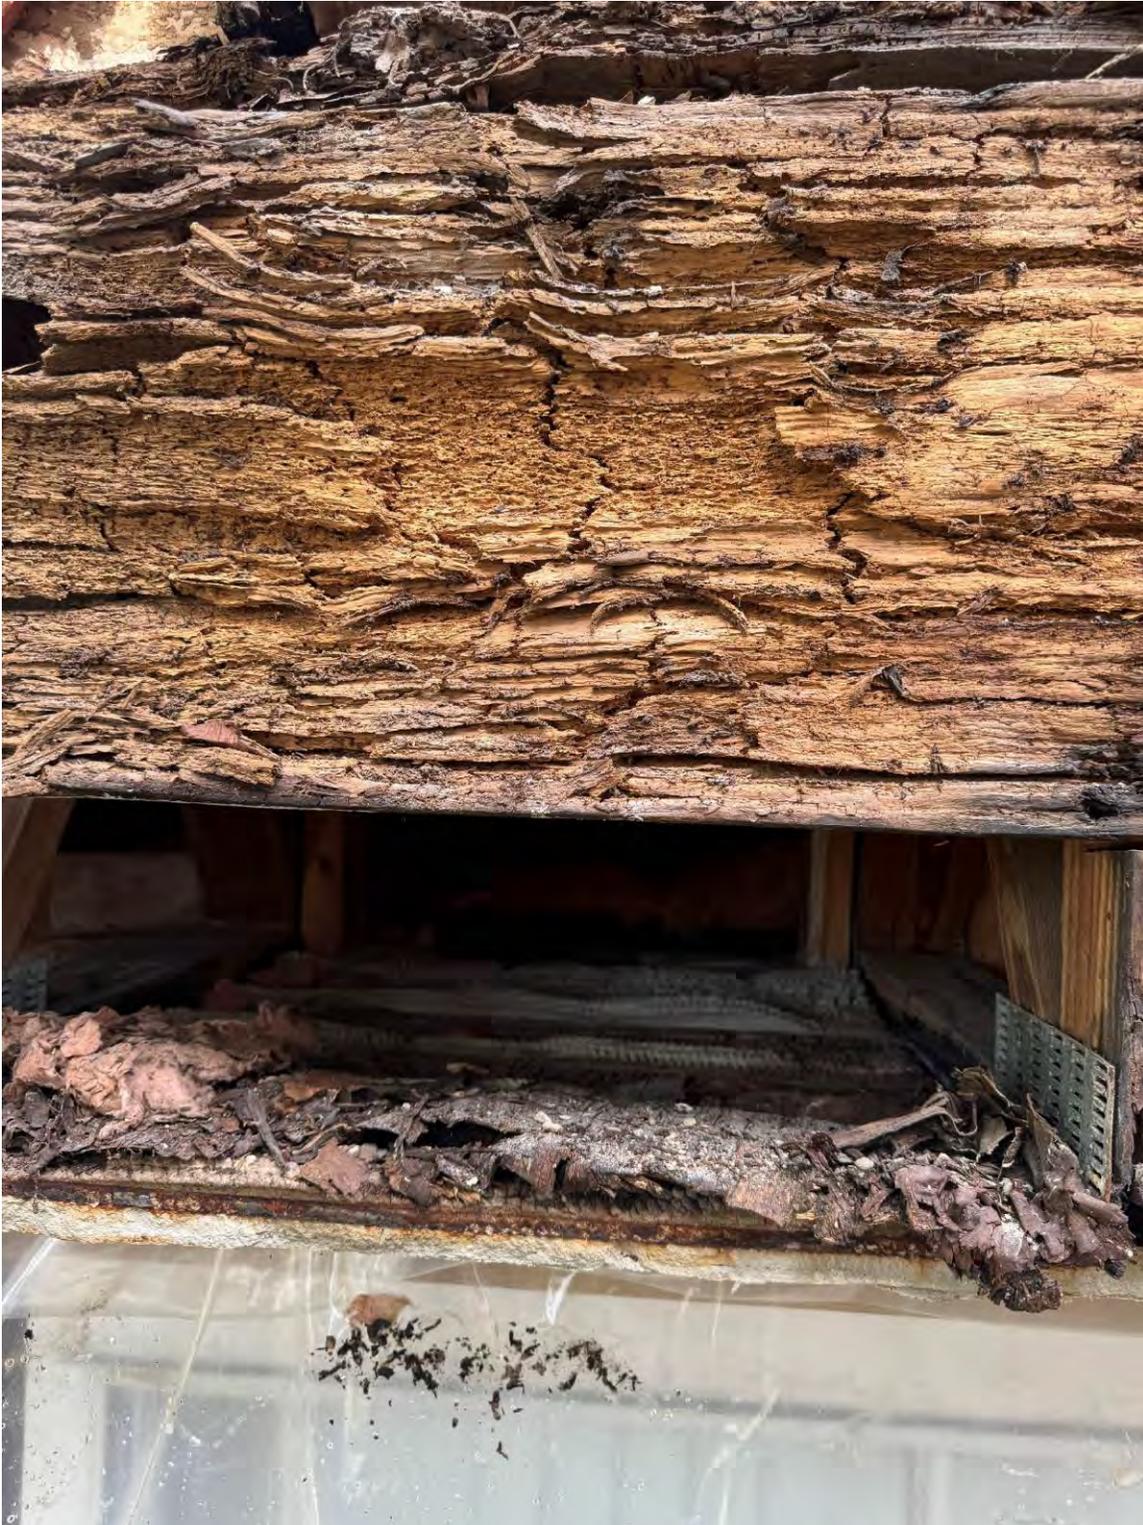
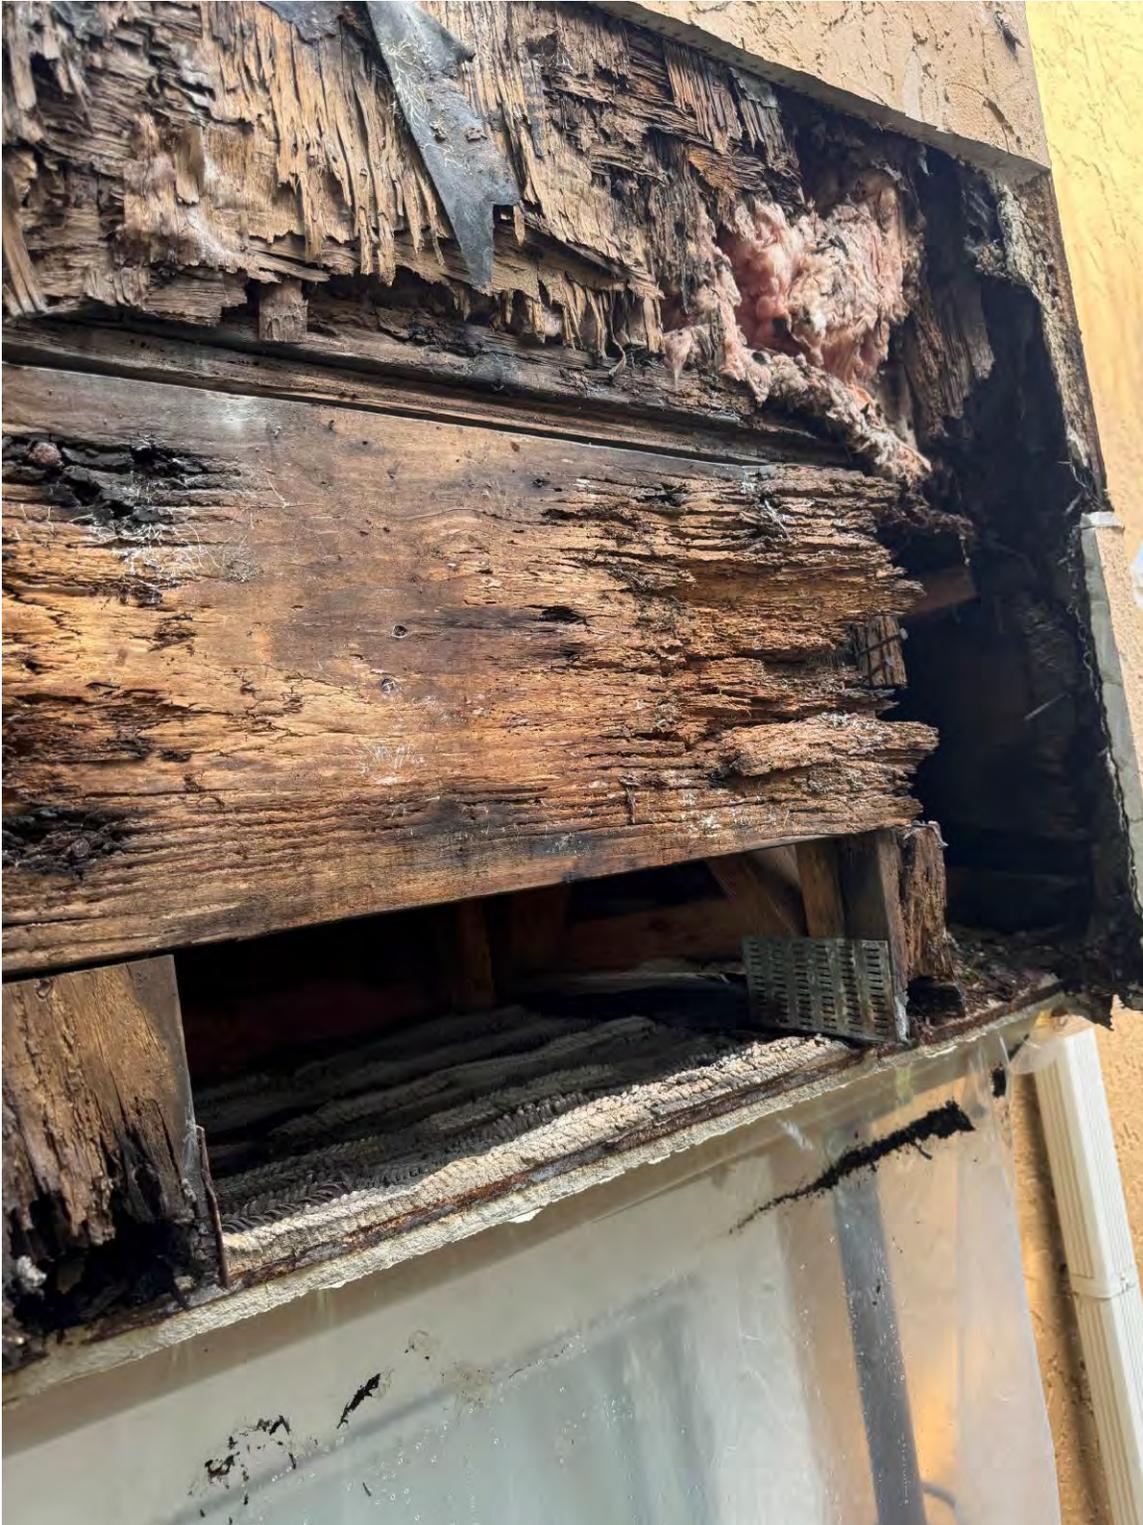
- 2<sup>nd</sup> floor bay window – shored in place
- Wall studs completely deteriorated
- Wall sheathing deteriorated
- Floor joists deteriorated
- No straps from wall studs to floor joists
- Large cracks in remaining sheathing and around windows
- Floor sheathing deteriorated
- Interior drywall exposed and compromised
- Wire lath and corner bead deteriorated
