**NOTICE OF FILING PART 2 OF FINAL ENGINEERING REPORT OF SPECIALTY  
ENGINEERING CONSULTANTS, INC. DATED NOVEMBER 5, 2024**

Daniel J. Stermer, not individually, but solely in his capacity as Court Appointed Receiver (the "Receiver"), over the Heron Pond Condominium Association, Inc., (the "Association") by and through its undersigned counsel, hereby gives notice of filing Part 2 of the attached final Engineering Report of Specialty Engineering Consultants, Inc. dated November 5, 2024, opining on the existing condition of Building 9.

# OPENING #15

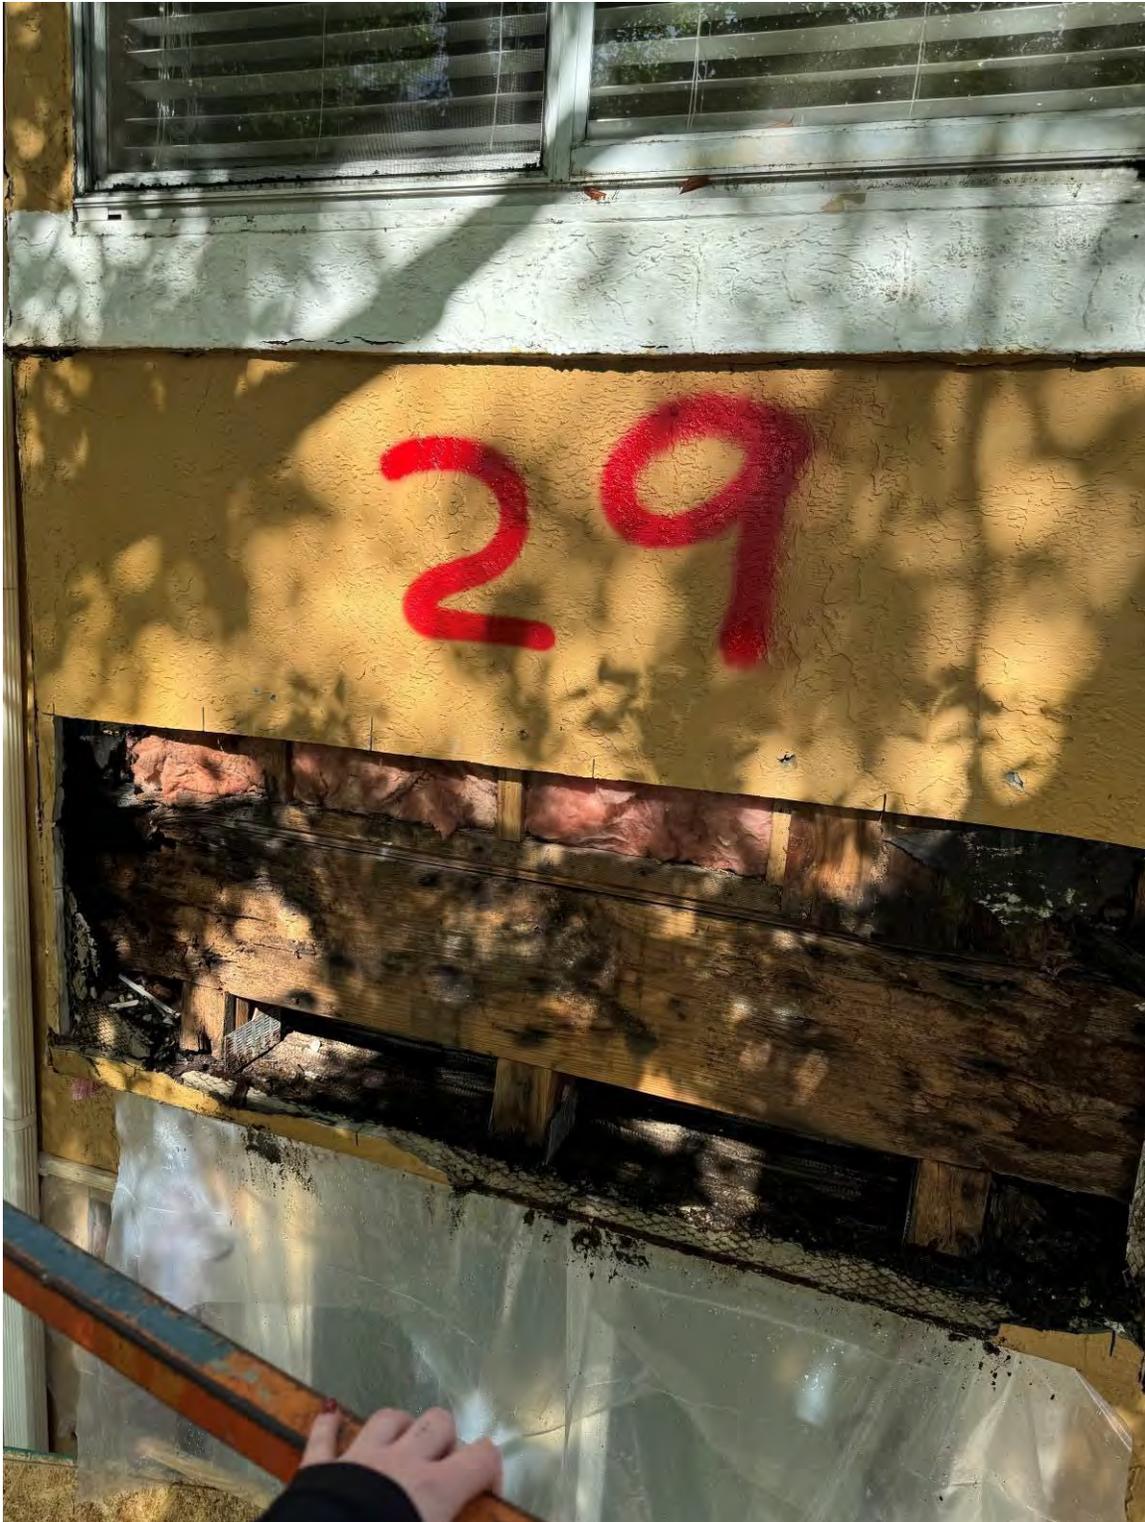
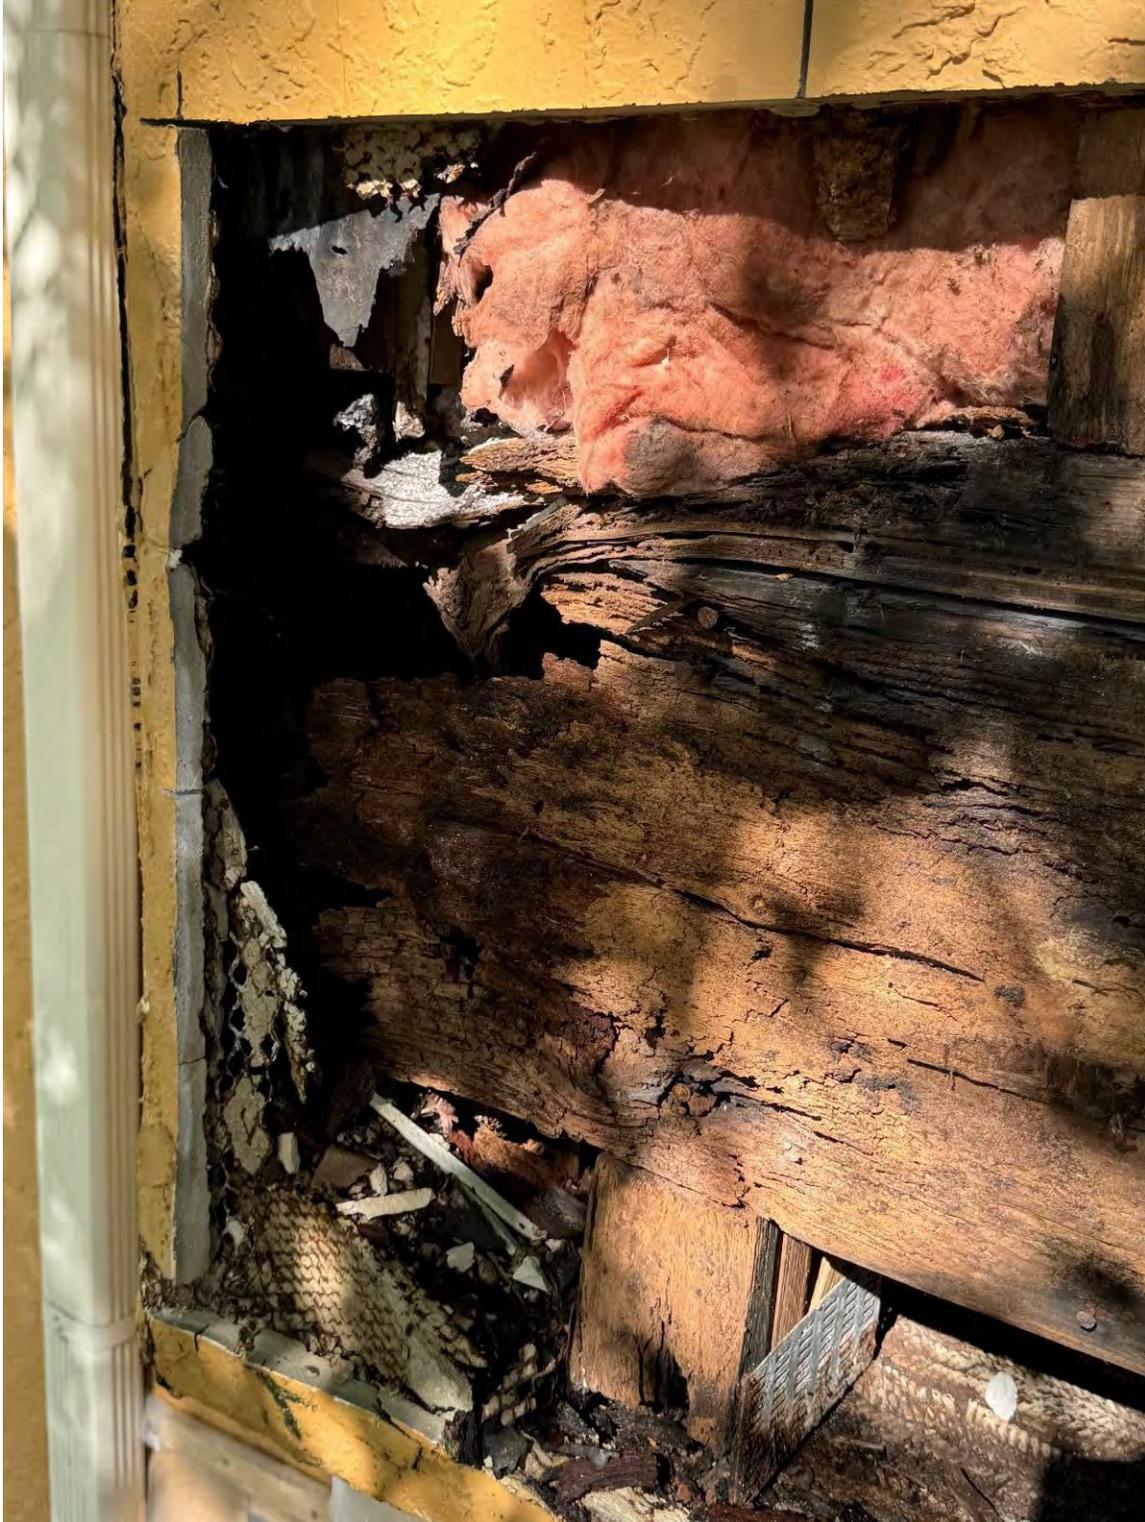
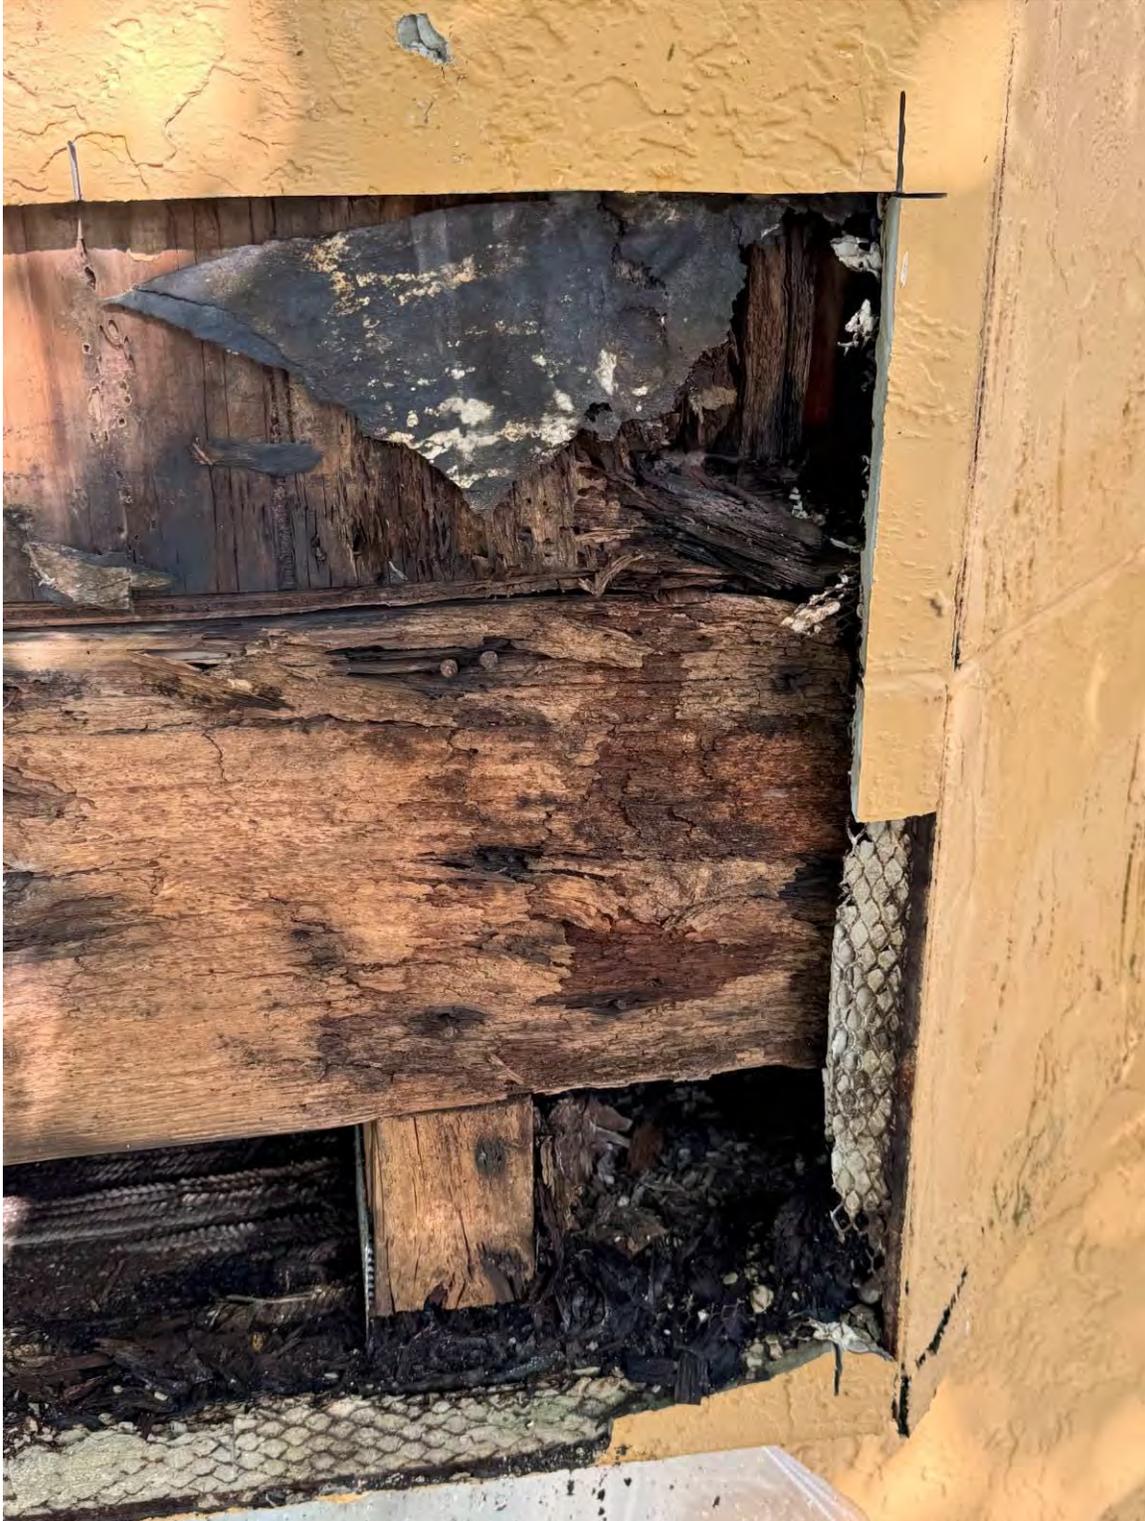
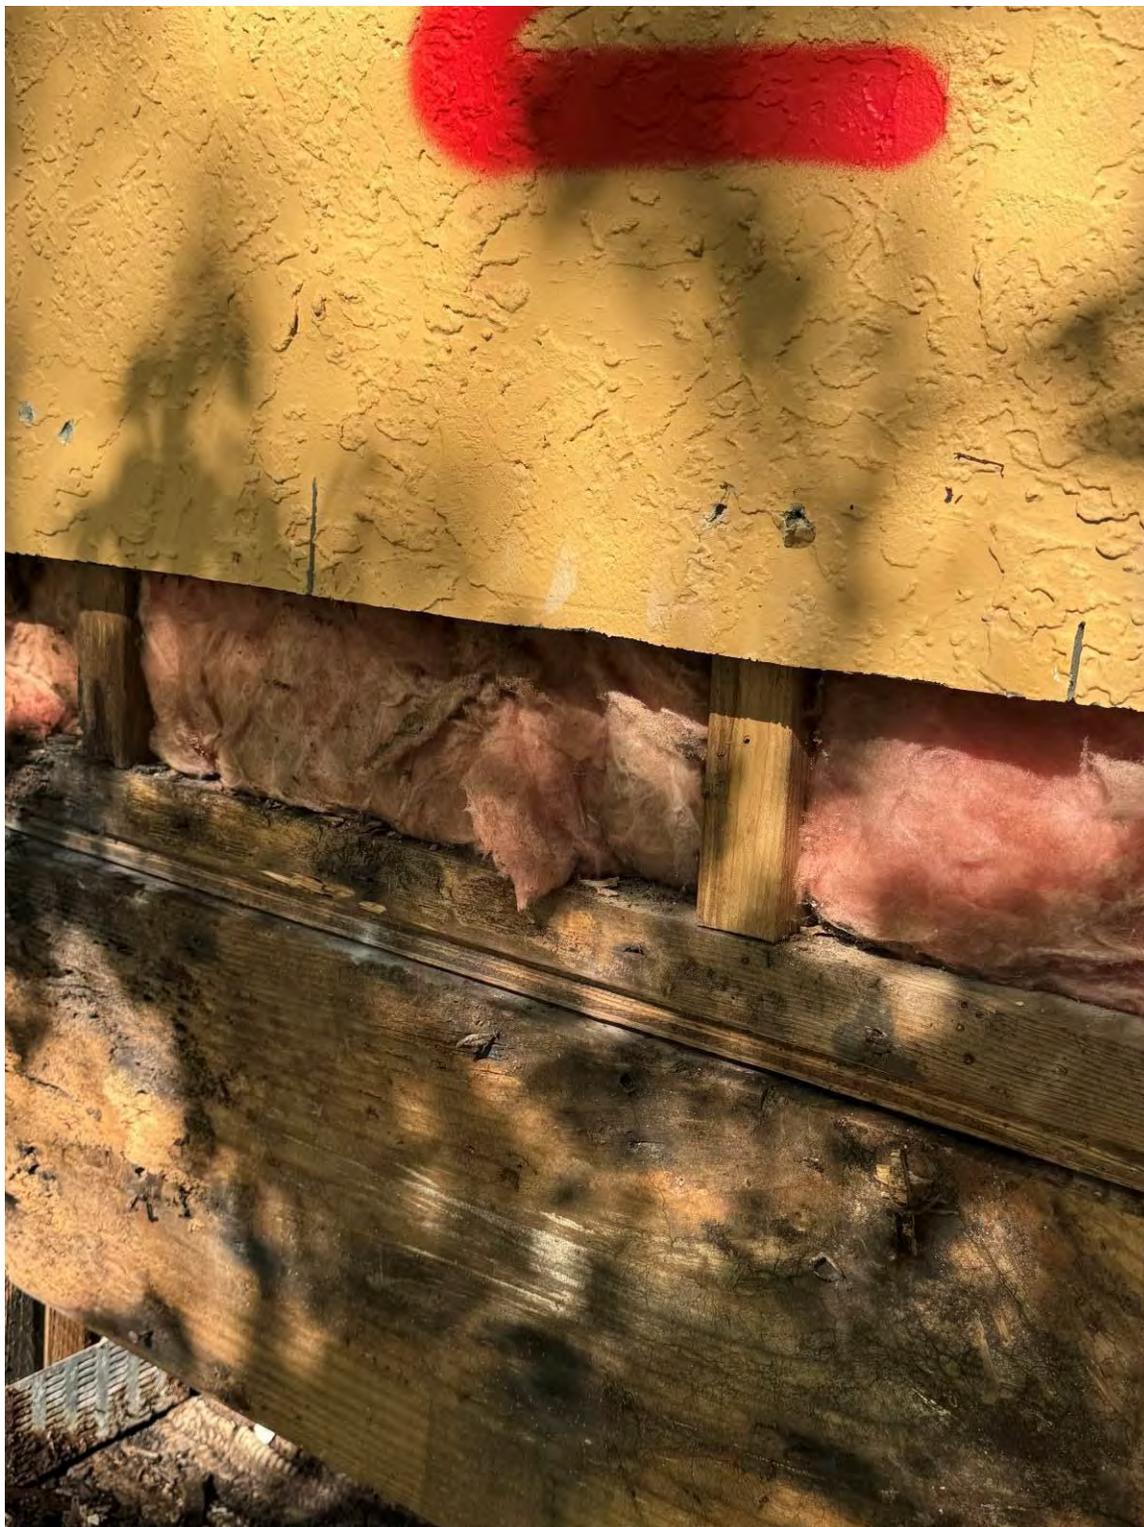
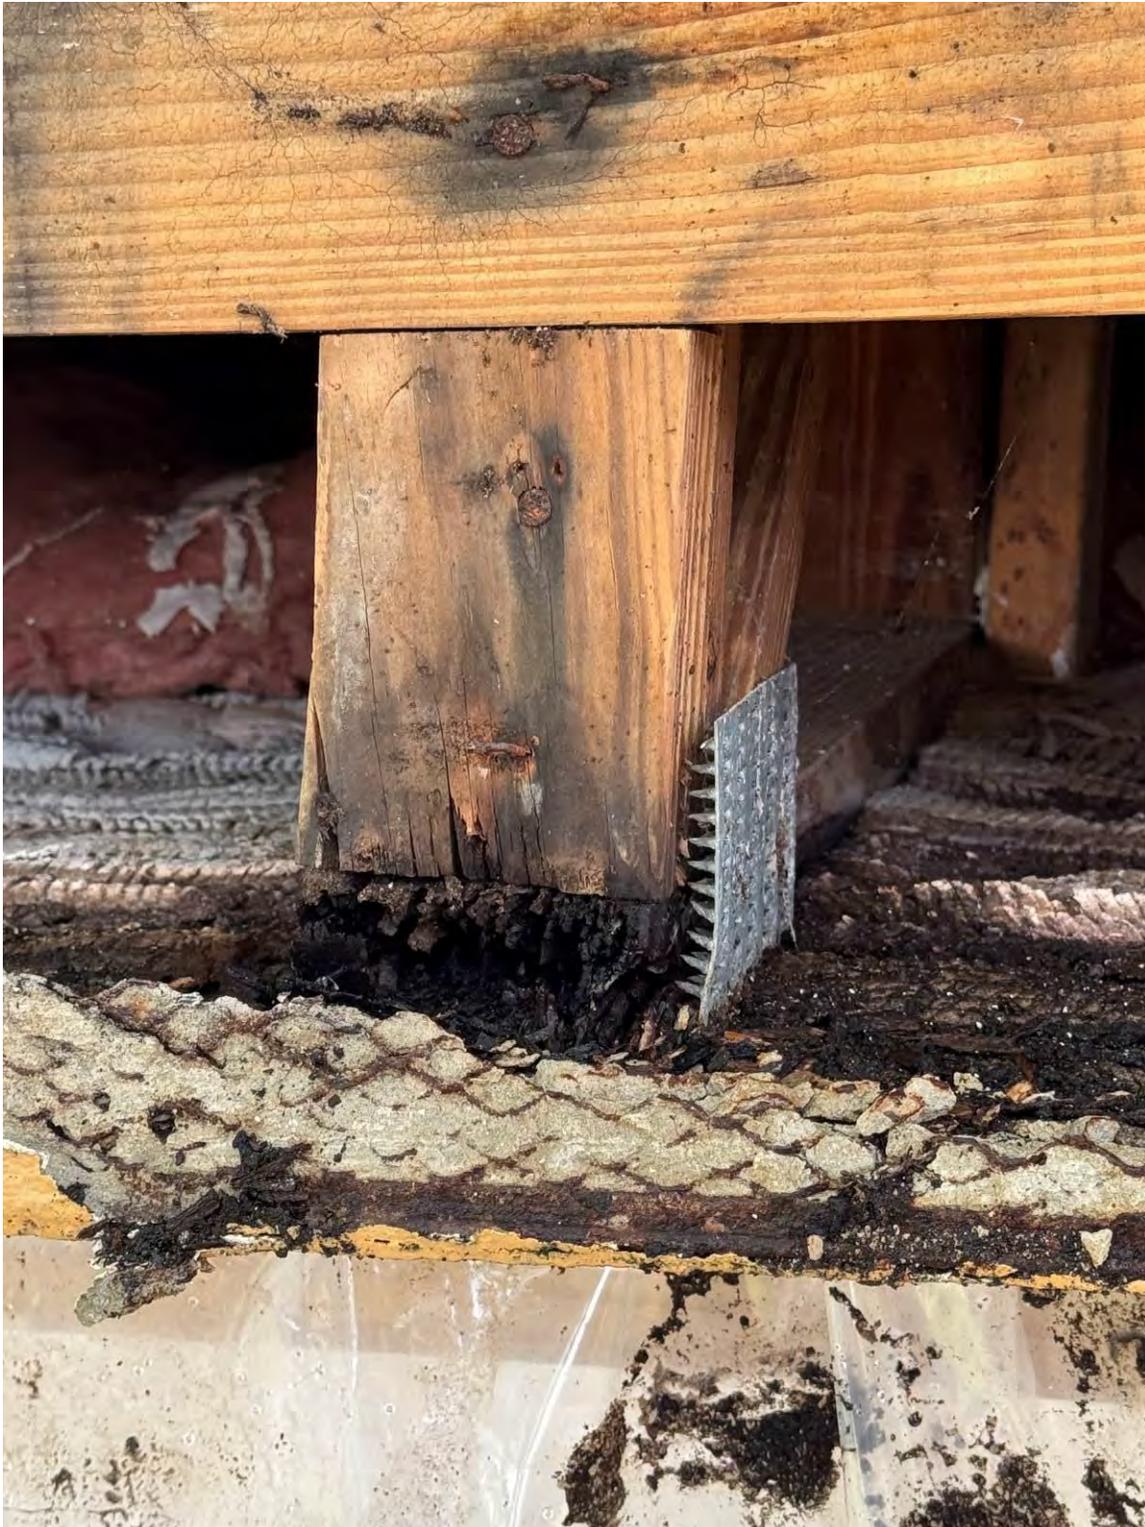
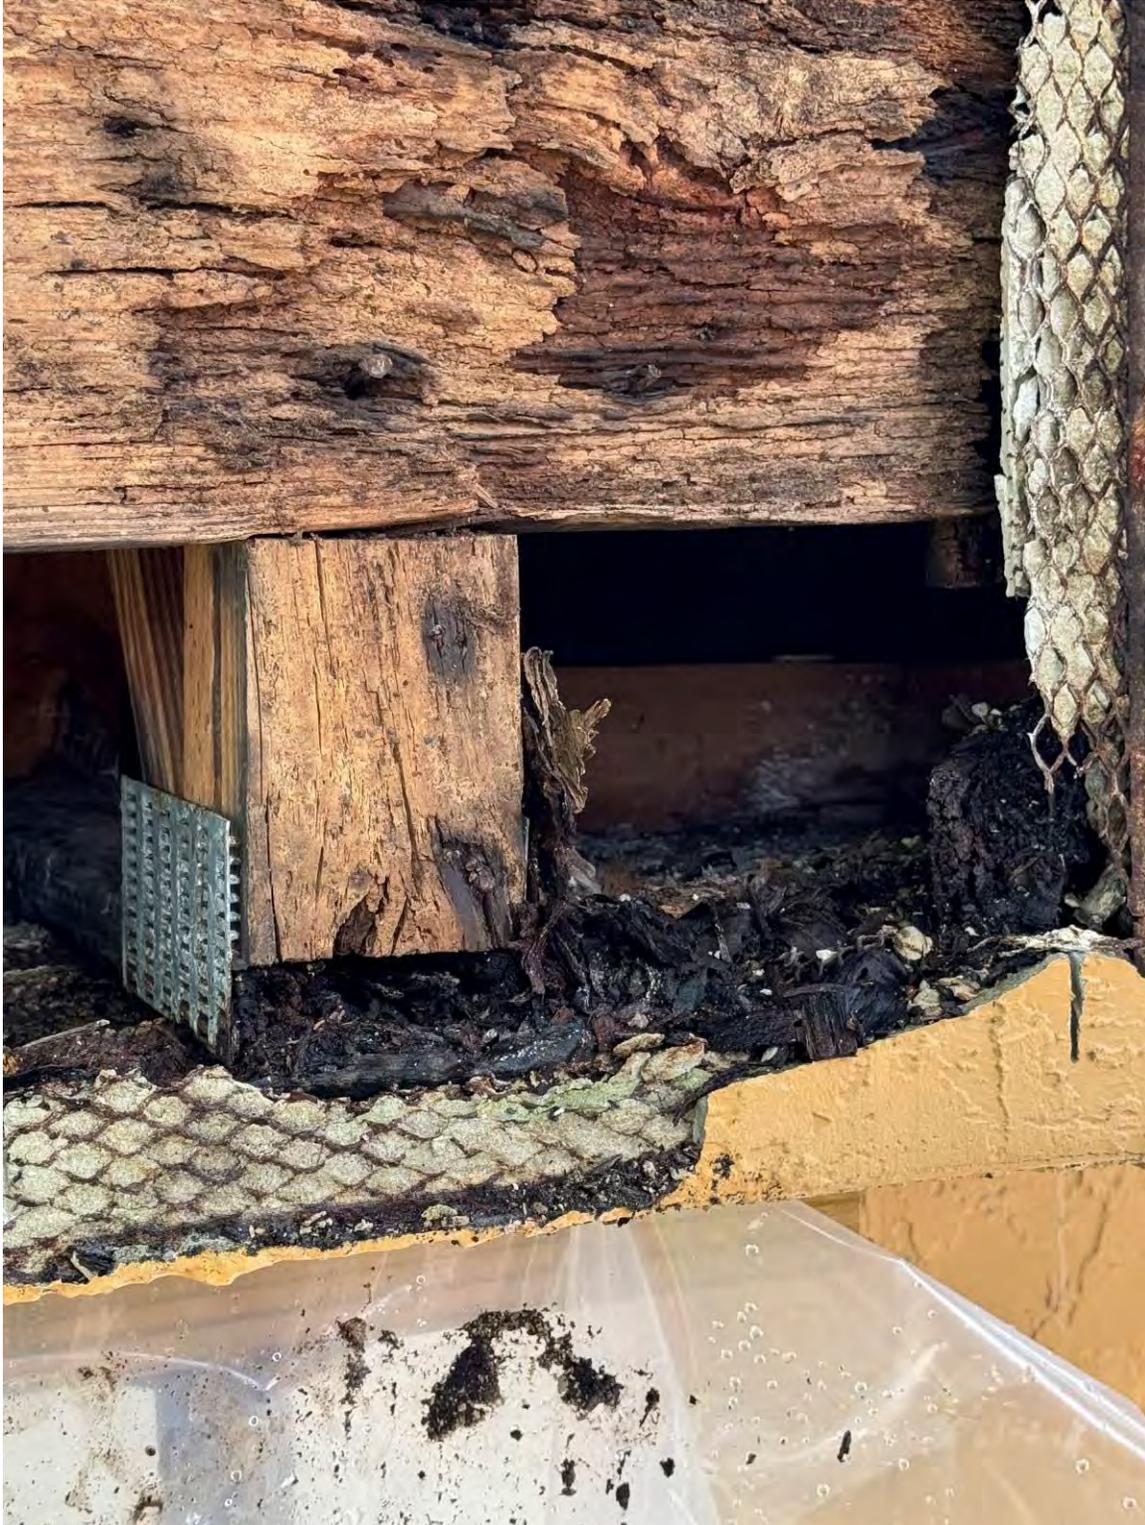
- Floor joists water damage and termite damage
- 2x12 bearing member water damage, termite damage, not strapped to floor joists
- 2<sup>nd</sup> floor wall studs not strapped to bottom plate
- Bottom plate destroyed
- Floor sheathing destroyed
- Wall sheathing destroyed

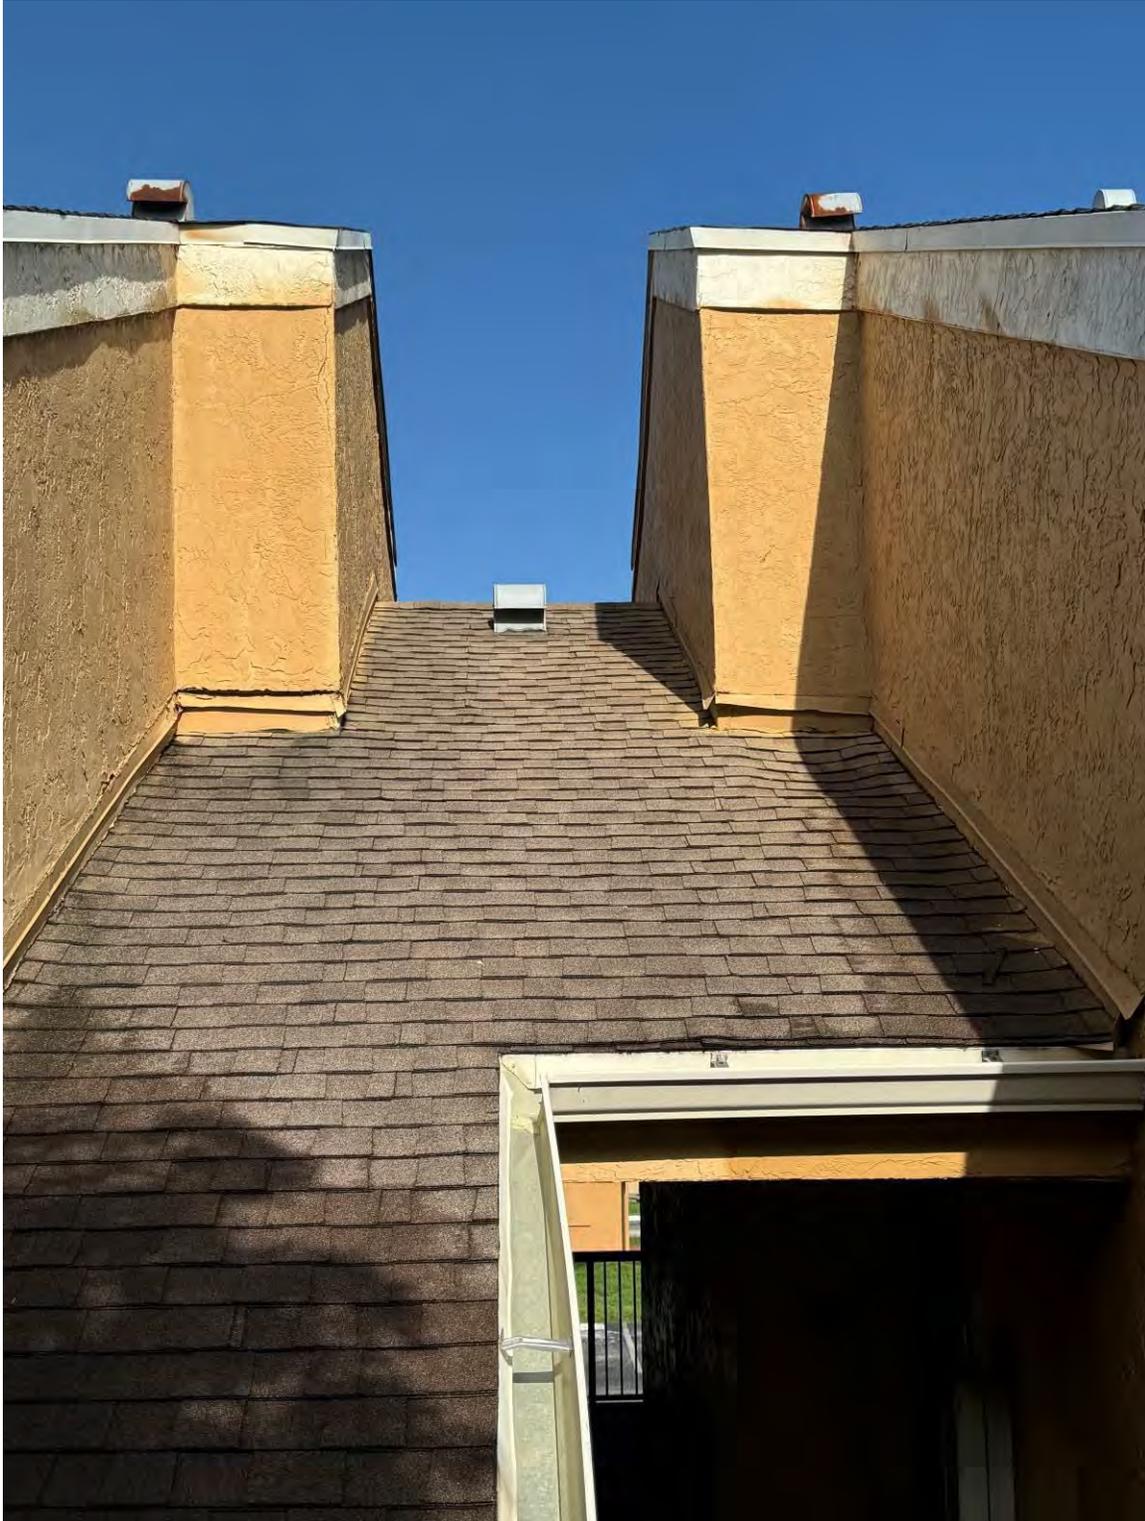
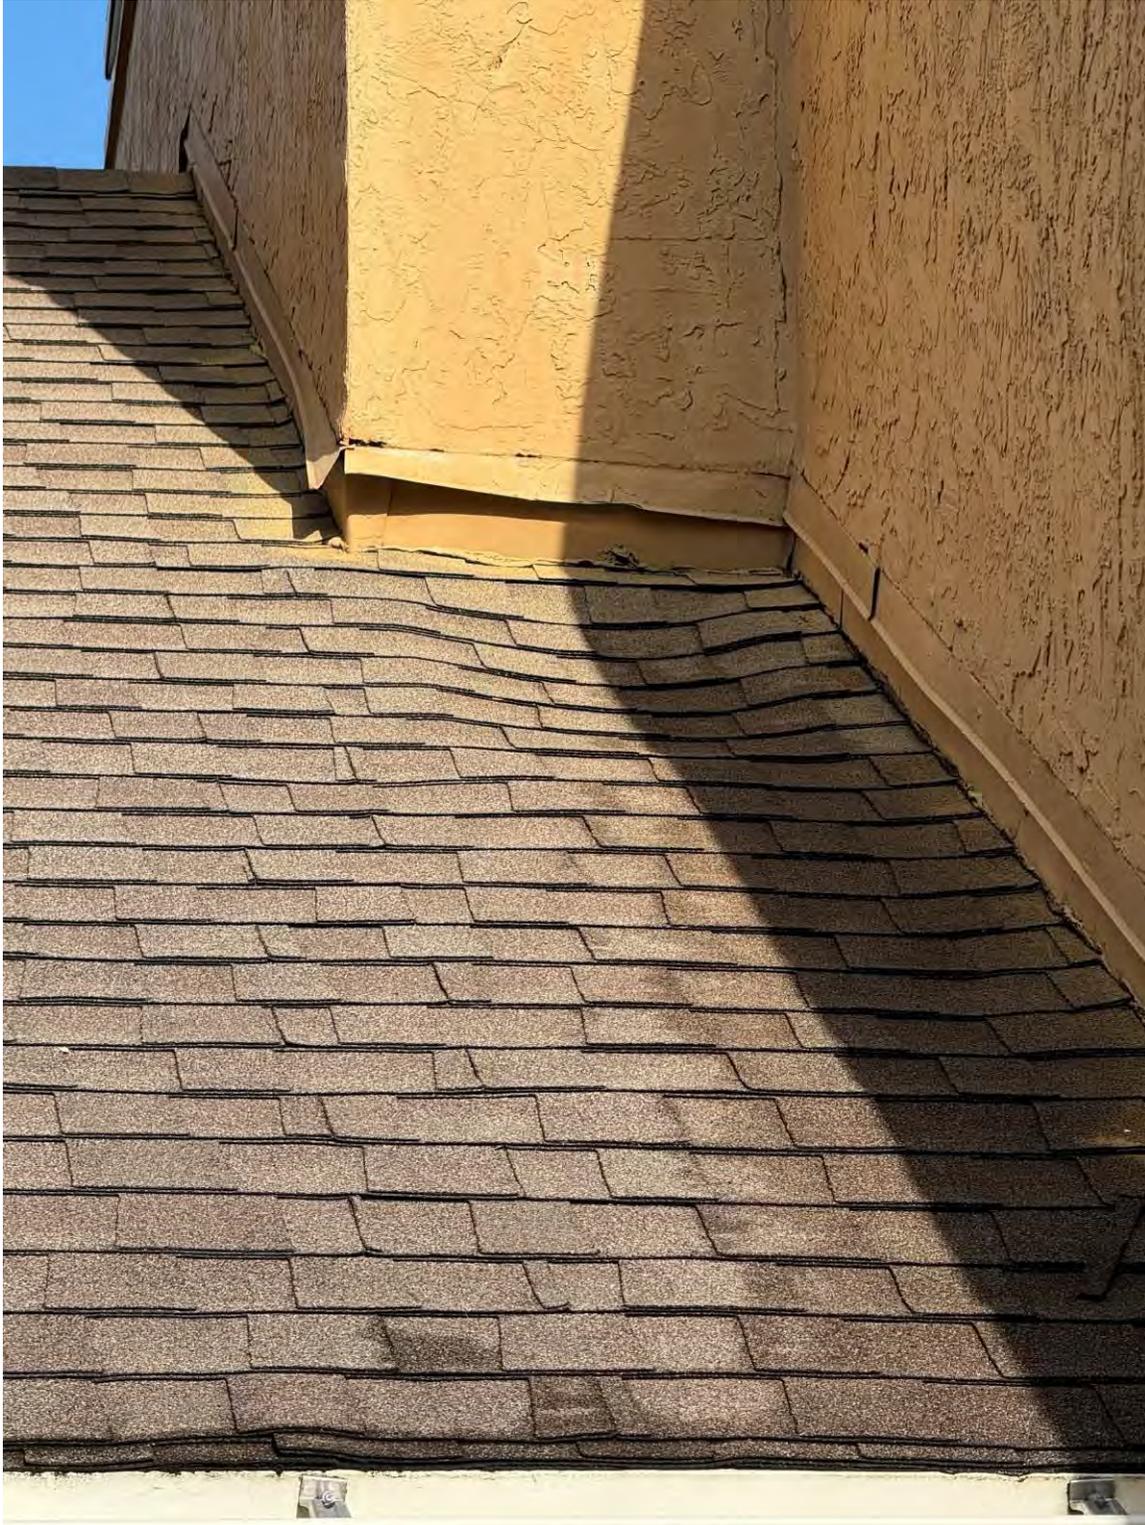
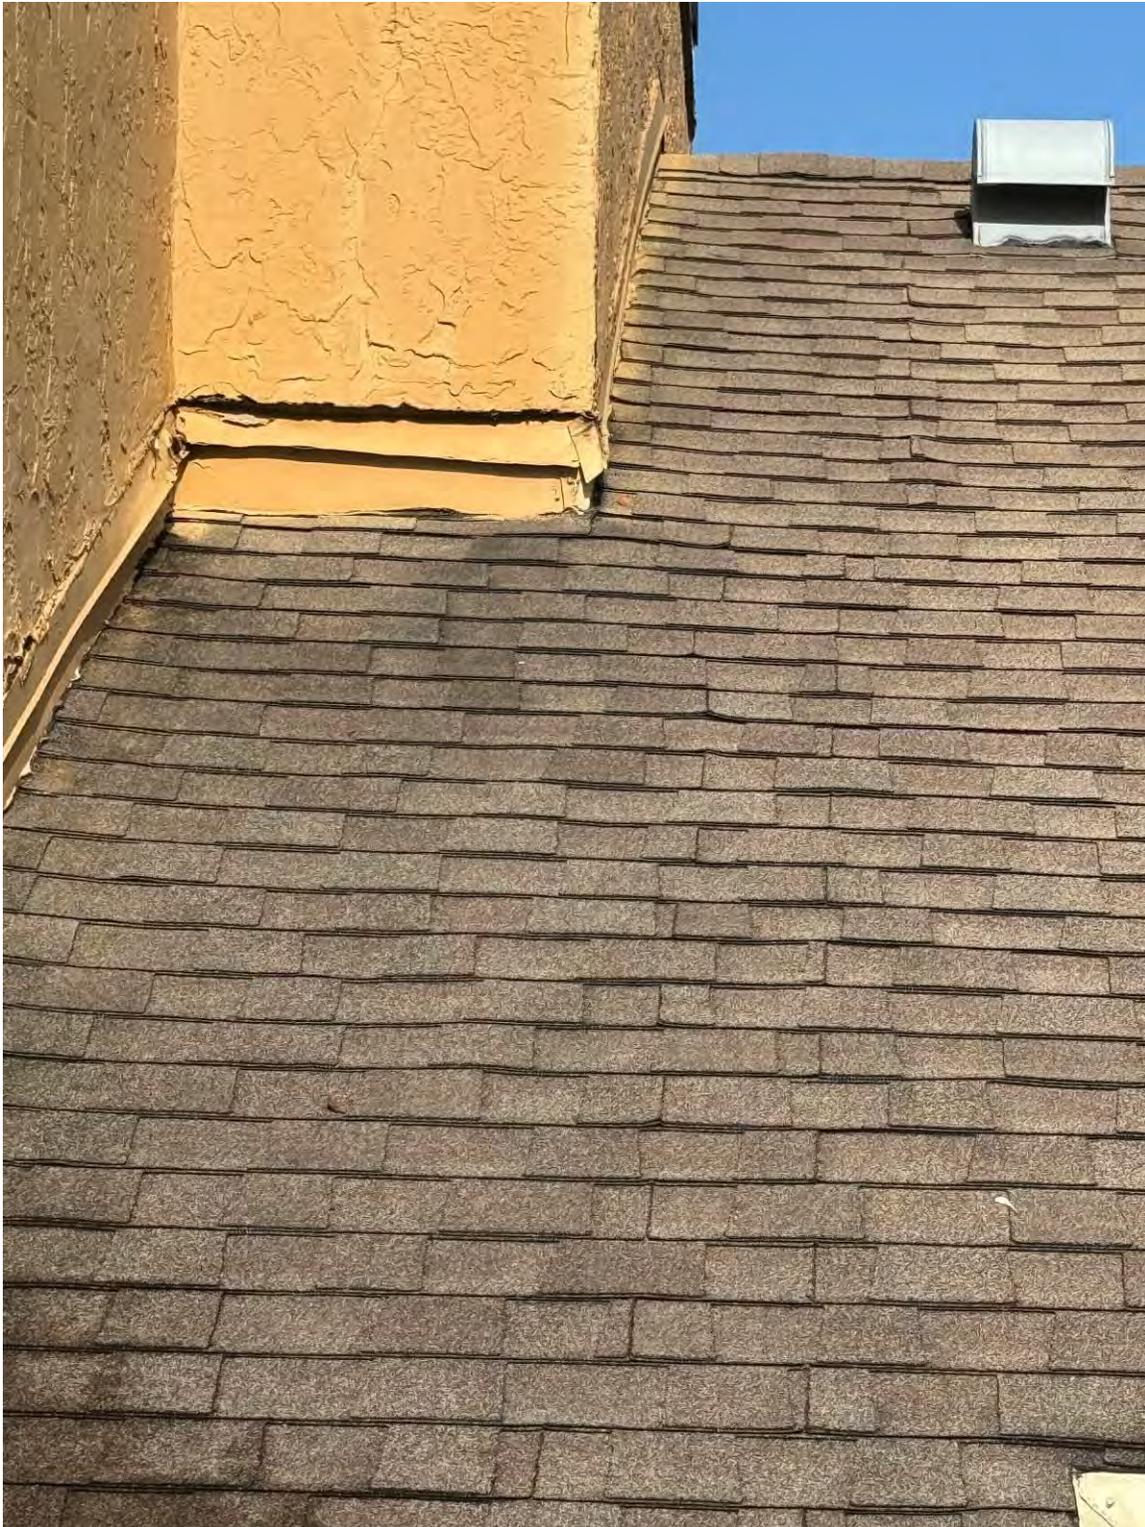
- Large depressions at both walls
- Cracking above and around flashing
- Probable sheathing and or truss damage
- Significant stucco cracking various spots

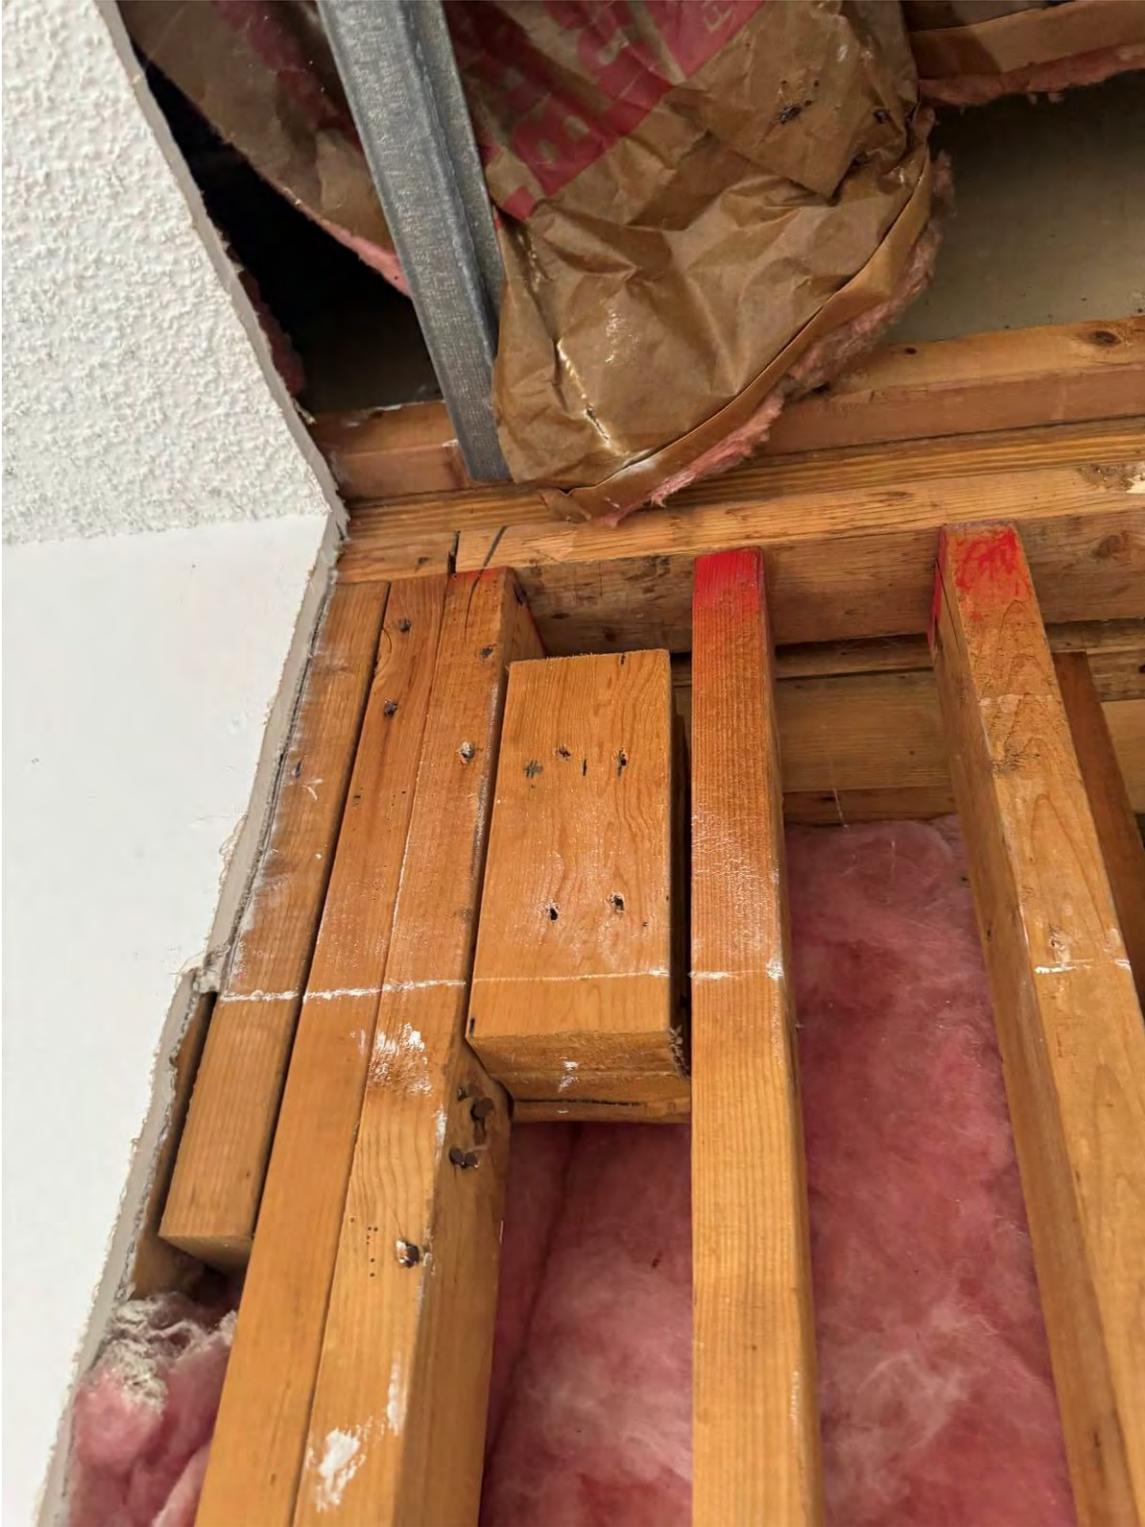
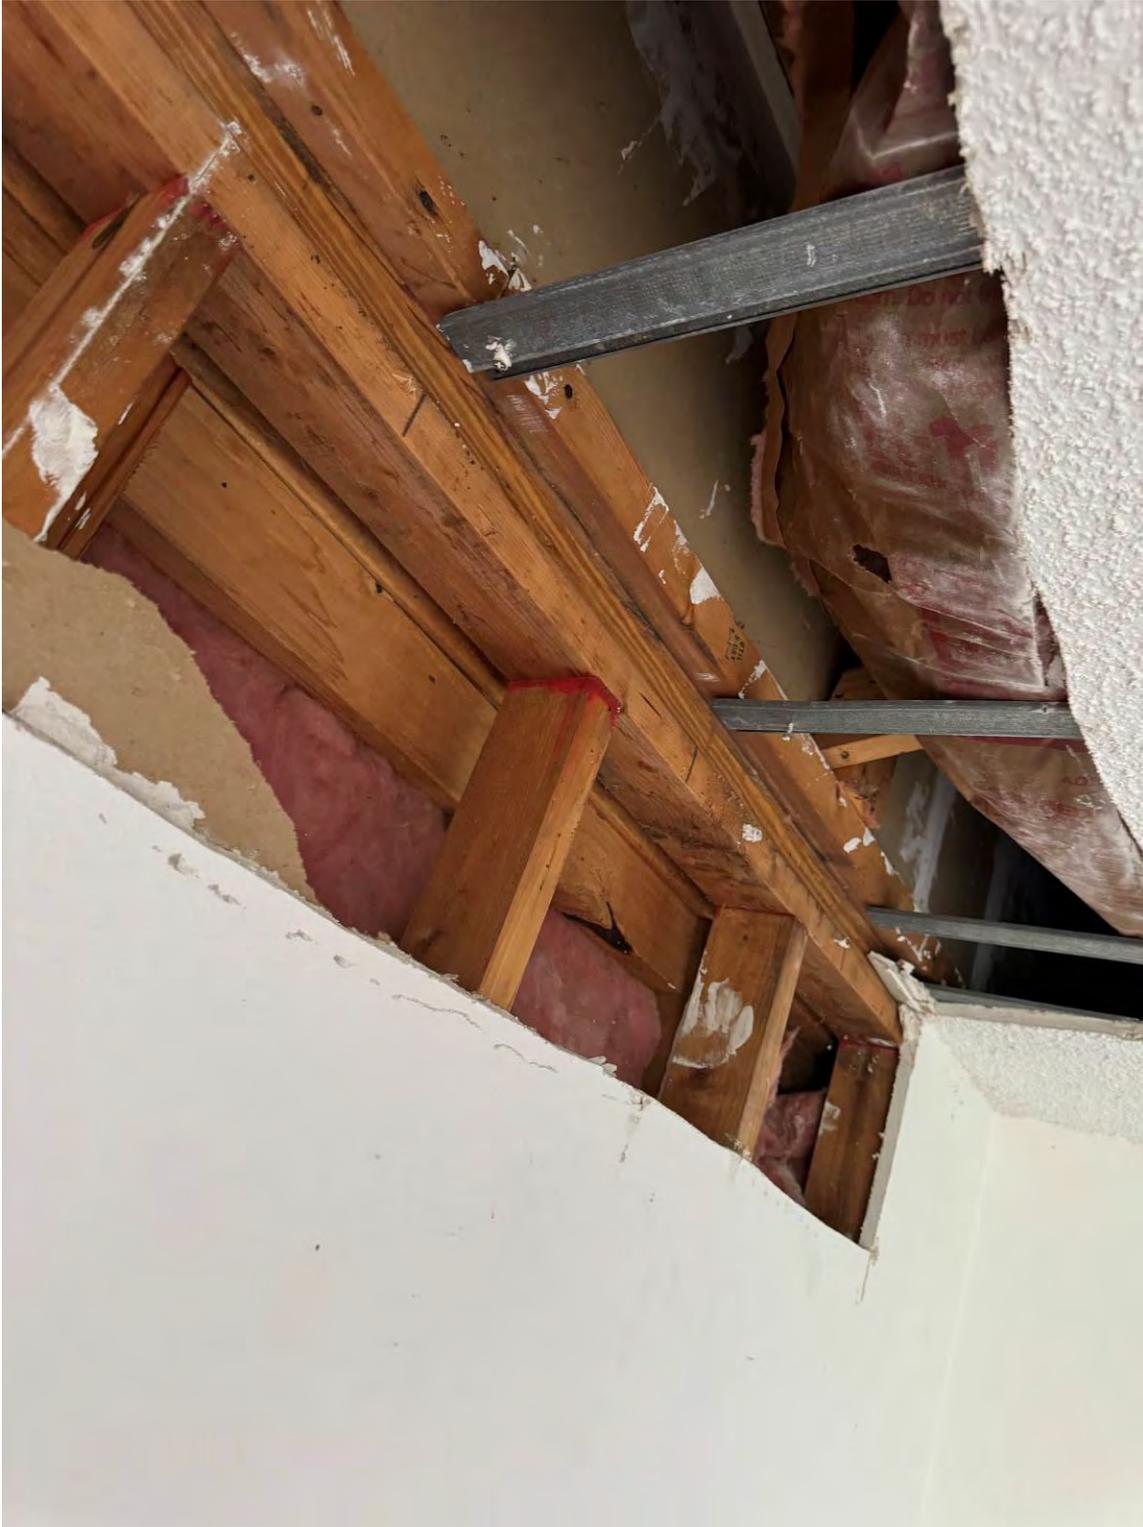
- 2<sup>nd</sup> wall shows signs of 2 layers of drywall in part of the cut away
- No anchor bolts from bearing wall to slab on grade
- Many studs not clipped to the sill plate or to the top plate
- Exterior wall at patio no anchor bolts
- Bedroom exterior wall water damage and termite damage
- Bedroom exterior wall no anchor bolts, no stud clips
- Bedroom closet water damage, missing draft stop
