IN THE CIRCUIT COURT OF THE SEVENTEENTH JUDICIAL CIRCUIT  
IN AND FOR BROWARD COUNTY, FLORIDA

HERON POND CONDOMINIUM  
ASSOCIATION, INC.

**VERIFIED PETITION FOR APPOINTMENT OF A RECEIVER**

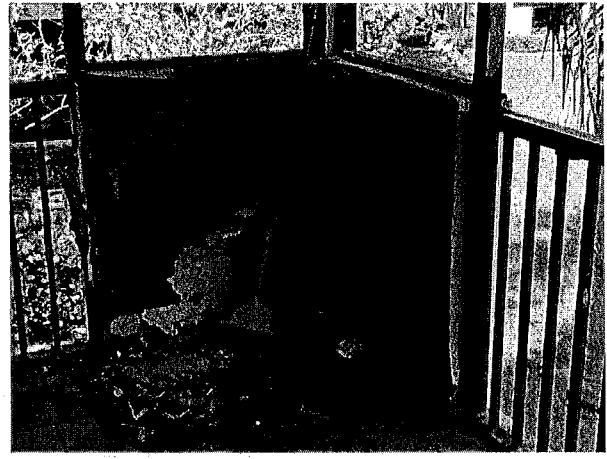
Balcony in Unit 208 was found to have a deteriorated structural wooden column compromising the safety of the residents. Temporarily shoring system must be installed immediately in accordance with plans and specifications.

**Photograph 8: Unit 208 Balcony**

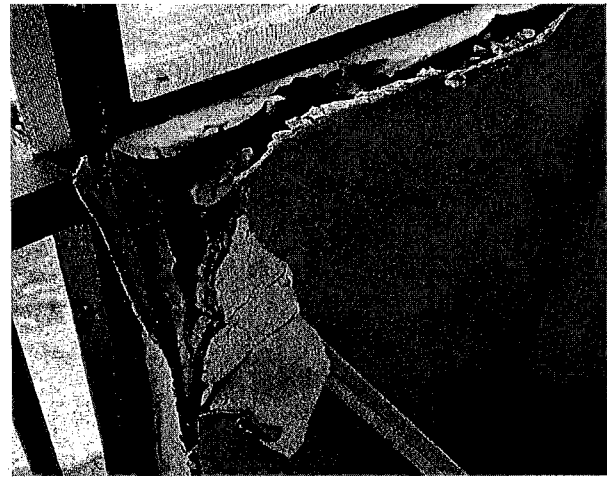
**Photograph 10: Unit 208 Balcony**
